**Federal Railroad
Administration**

Vehicle Proximity Alert System for Highway-Railroad Grade Crossings-Prototype Research

DOT/FRA/ORD-01/01

Final Report
April 2001

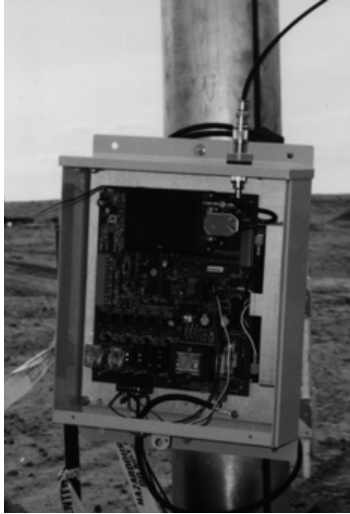
Figure 3-5. SmartStops Crossing Transceiver

As shown in [Figure 3-2](#), this system consisted of a transceiver mounted in a locomotive, another transceiver mounted on a pole at a crossing, and a receiver installed in a motor vehicle. The transceivers use an RF signal, operating at 151.7 MHz, and dual-tone multiple frequency (DTMF) codes. An unregulated 12-VDC battery powers the receiver. The transceiver installed in the locomotive is shown in [Figure 3-3](#), the mounted antenna for the locomotive transceiver is shown in [Figure 3-4](#), the transceiver mounted at the crossing is shown in [Figure 3-5](#), the mounted antenna for the crossing transceiver is shown in [Figure 3-6](#), the receiver is shown in [Figure 3-7](#).

The locomotive transceiver transmits its signal at a constant rate when the locomotive is operating. As the locomotive approaches a crossing, the pole-mounted transceiver decodes the DTMF signal from the locomotive. If the appropriate code is received, the pole-mounted transceiver transmits another signal, which is coded differently from the locomotive signal. The signal from the pole-mounted transceiver is collected by any motor vehicle with a receiver within range of the crossing, and an alarm is sounded and displayed in the vehicle. That signal is also collected by the locomotive transceiver, which displays a message to the locomotive operator that the locomotive signal has been received at the crossing and a second signal has been transmitted.

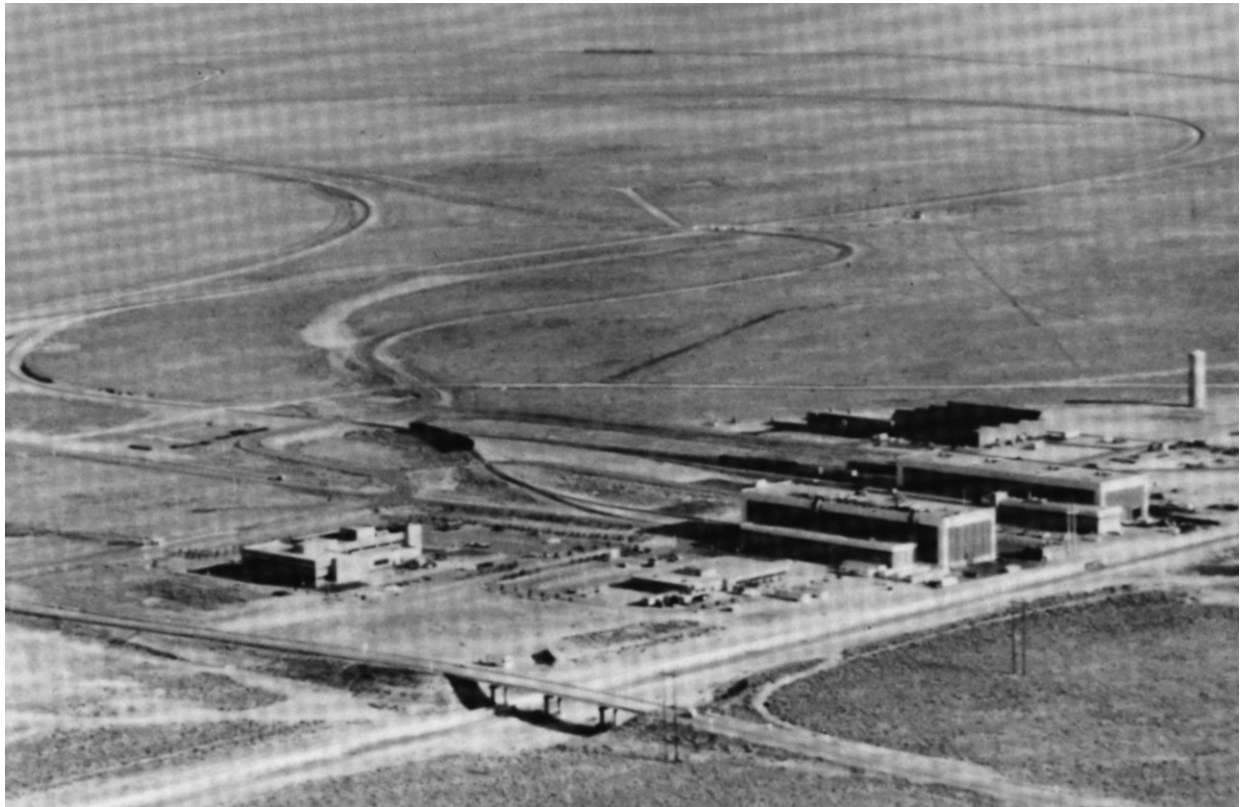
Figure 4-1. TTC Test Site Aerial Photograph

The TTC test site (shown in Figure 4-1) is located in a generally flat, semi-arid, high-altitude open area with little vegetation in Pueblo, Colorado. This area is subject to heavy sustained gusting winds and sudden shifts in wind speed and direction. It is also subject to wide fluctuations in temperature between daytime and nighttime. Since the testing was regularly conducted during pre-dawn hours as well as mid-day, the temperature swings during testing were

a factor. Since all of the tests were also conducted during winter or late fall, the test temperatures ranged from subfreezing to 70s° F (25° C), and the precipitation consisted of snow, rain, and a mixture of both. Although weather was not a formal test variable in any of the test phases, it was always considered to be a factor that could affect system performance and was monitored regularly, as discussed in Section 4.2.

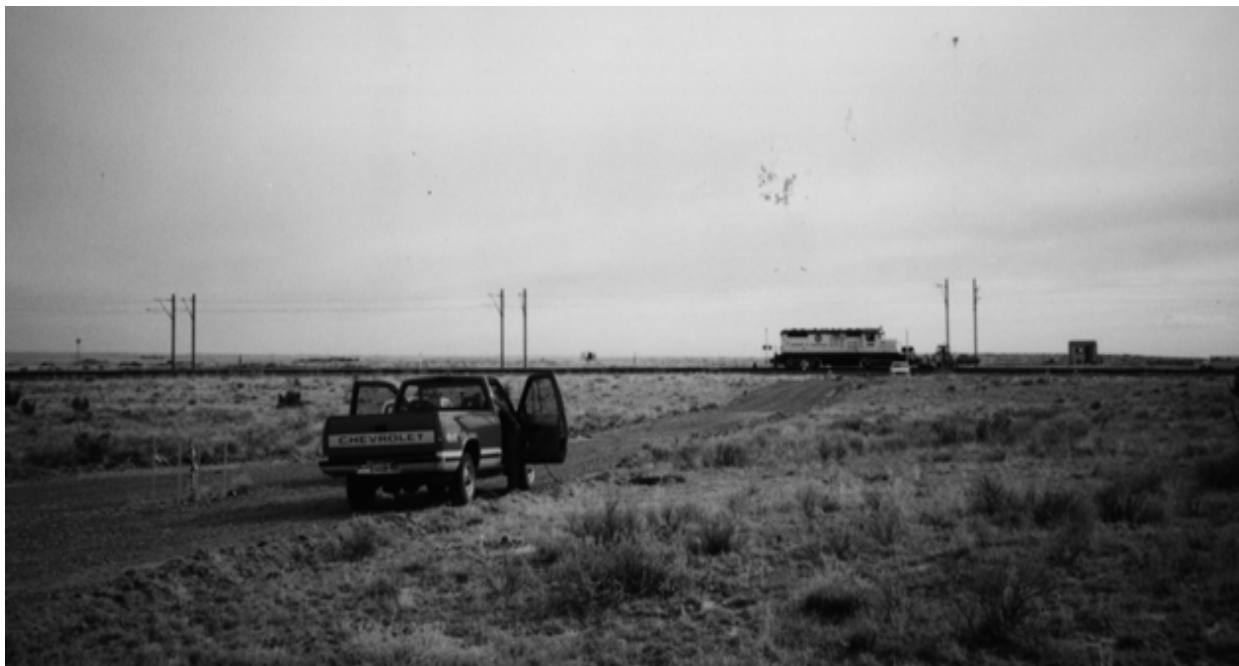
Figure 4-5. Zone A Test Area

Phase 1 testing was performed with the locomotive moving in Zone A at speeds up to 40 mph (64 km/h) while the vehicle remained stationary on a straight roadway approximately 500 ft. (150 m) from and perpendicular to a simulated crossing; see Figures 4-5 and 4-6. The locomotive's test zone boundary was 1,760 ft. (528 m) on both sides of the crossing. An ALD was installed at each end of the zone and at midpoint of the crossing, activating the locomotive transmitter or horn when the locomotive entered the zone and shutting it off when the locomotive exited.

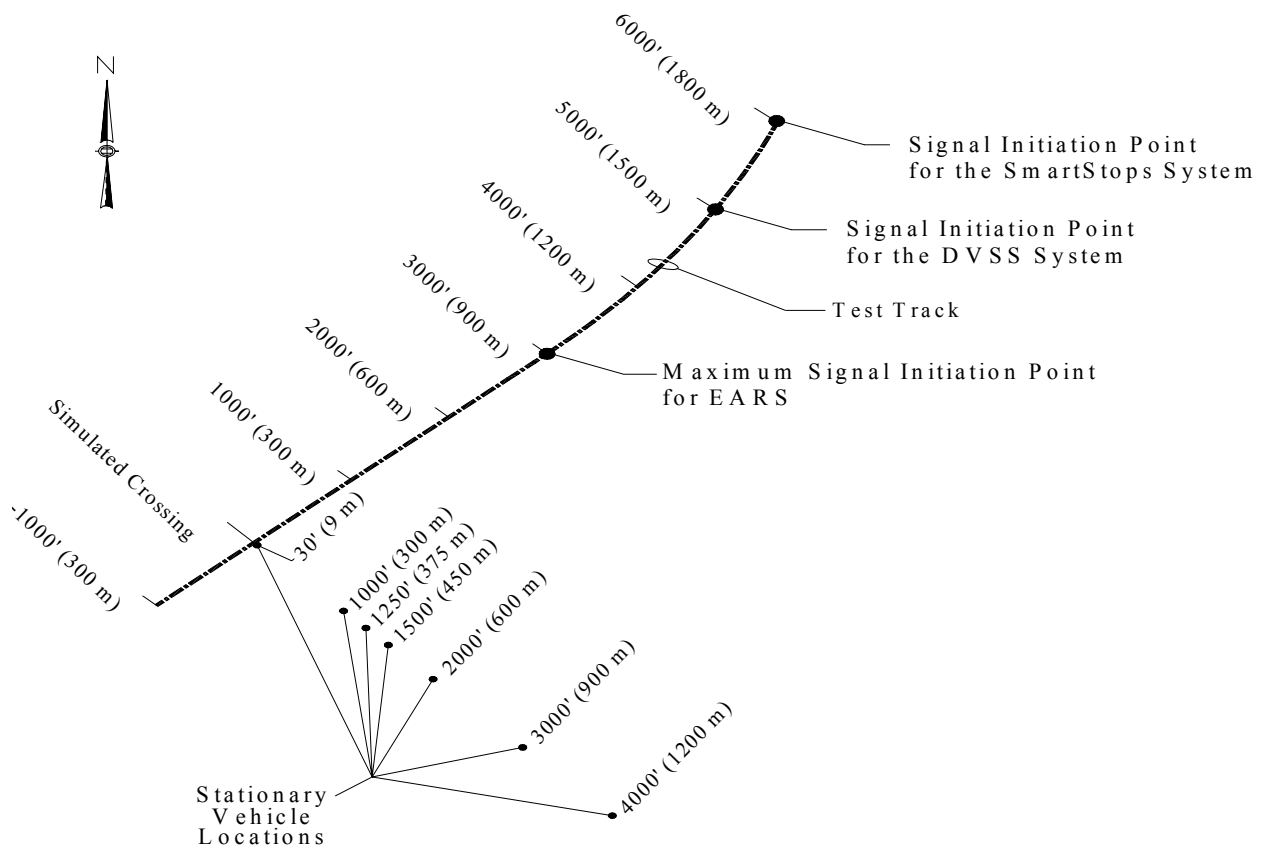
Figure 4-7. Zone B Test-Bed Setup

The segment with the locomotive stationary was performed with the vehicle traveling at different speeds, including two test runs when the vehicle was also stationary. Test runs were performed with the locomotive at different distances from a paved crossing, to determine both train detection sensitivity and the range at which warnings reach the vehicle. The number of test runs performed, the locomotive locations, and vehicle speeds varied from system to system to accommodate differences in system designs. These tests were performed in two groups (in two different test zones), to test detection and reception at opposite directions of vehicle travel and different terrain. The vehicle route in each test zone was 1 mi. (1600 m) long ending at a paved crossing, and had markers along the road every 0.1 mi. (160 m).

The scheduled testing of this segment was performed in Zone B (see Figure 4-7) while the vehicle was stationary. Specific tests and methods of introducing energy interference varied from system to system to accommodate differences in system designs and to test the most likely failure modes, which were identified for each system during the previous test phases. The locomotive was stationary during some of the test runs, and was mobile at varying speeds during others. Tests of the acoustic-detection system introduced other acoustic signals and other horn signals to cause interference. Hand-held FM transceivers were used in testing of the two RF systems to create RFI at a similar frequency to the system's operating frequency. The antennas for those two systems were also moved from their normal positions to try to degrade system performance.

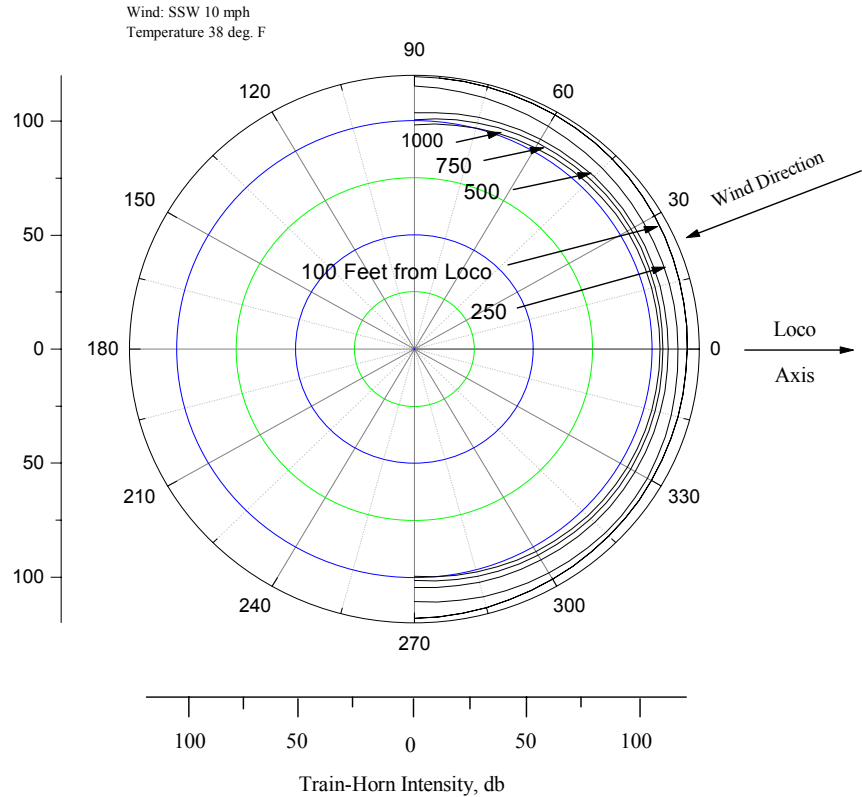
Figure 5-4. Measured Sound Intensity of Nathan P5 Horn*

⁷The smooth curve between these measured points is generated by the cubic-spline method, which is a classical method for putting a smooth curve through known data points. It uses a third order polynomial to interpolate between each pair of data points.

Nathan P5 Horn	
Horn #	Frequency Hz
1	227.18
2	329.60
3	391.90
4	440.00
5	554.30

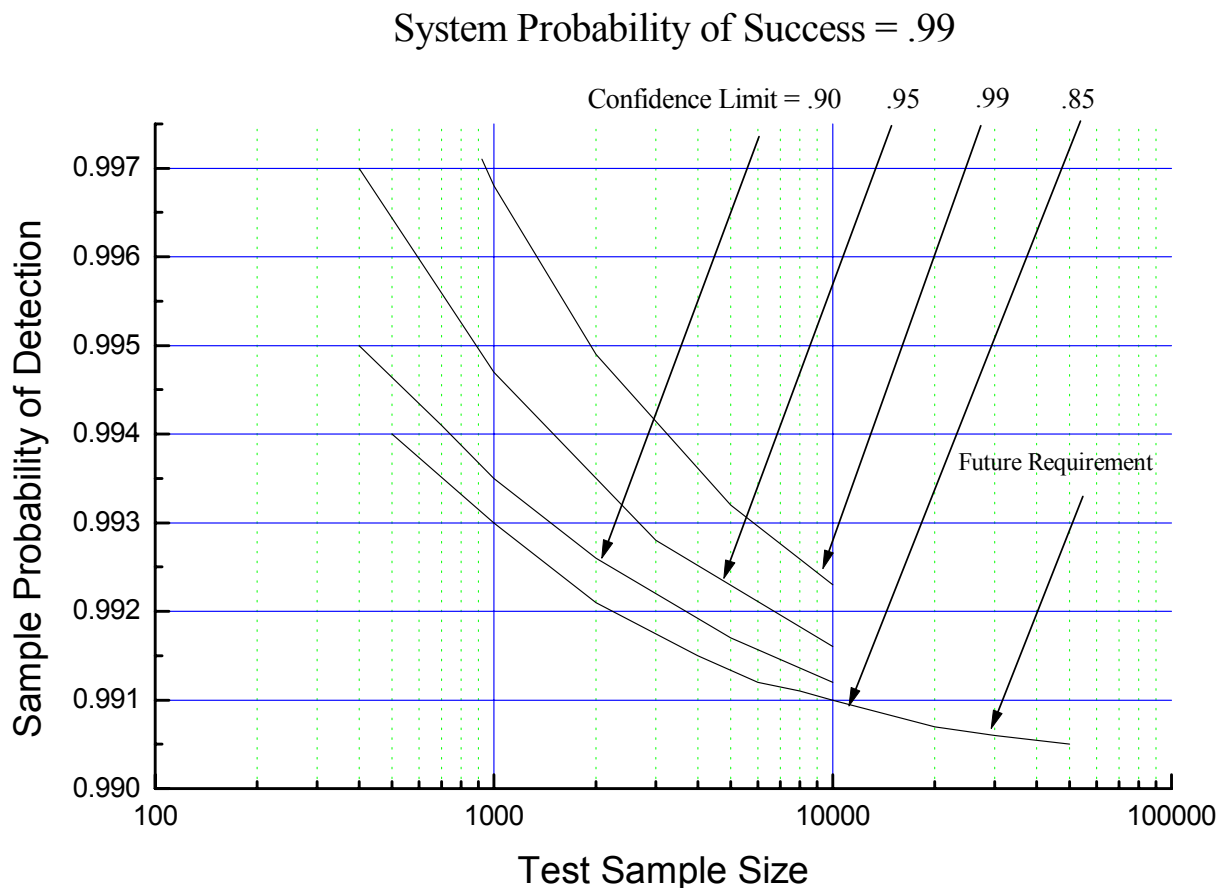
Figure 7-1. Detection Probability Confidence Limit Curve

The sample size needed depends on the desired probability of a successful warning and the desired level of confidence for achieving that probability. Using these two values, curves can be developed that will provide guidelines for sample size and for evaluation of the results. The following values seem to be appropriate for field operational testing (see Figure 7-1):

- Probability of success of the VPAS system = 0.99
- Confidence Limit for Probability of Success of 0.99 = 0.95

Based on these assumptions, at least 2,000 samples should be collected at each crossing. Data should be analyzed as testing proceeds to determine whether 2,000 samples are sufficient. If the rate of successful detections is below the confidence limit curve, additional testing may provide more insight into the system performance. The alternative would be to lower the performance requirements (i.e., accept a lower probability of success and/or lower confidence limit).
