Rail Commuter Vehicle Curving Performance

Foster-Miller, Inc.
350 Second Avenue
Waltham, MA 02451-1196

1. Report No.		2. Government Accession No.		3. Recipient's Catalog No.	
4. Title and Subtitle Rail Commuter Passenger Vehicle Curving Performance				5. Report Date April 2002

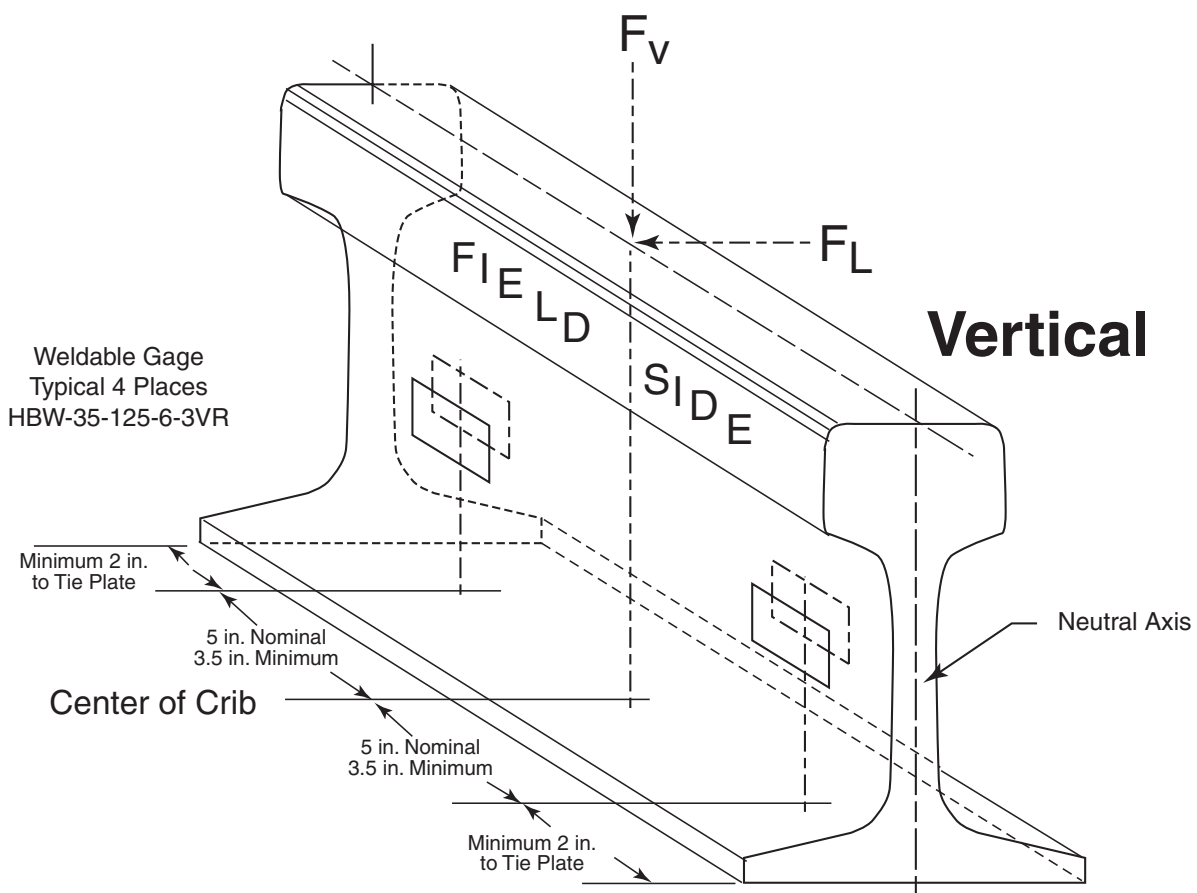
Figures 4 and 5 show the rail installation configurations for the vertical and lateral gauges, respectively. After each of the gauges was installed and calibrated, the gauges were environmentally sealed over with a silicone sealant to prevent moisture from entering the gauge area. A steel protective cover was installed over each of the gauge positions, and wiring was run from each gauge location through plastic conduit to the instrumentation shack.

Figure 4. Vertical gauge installation configuration

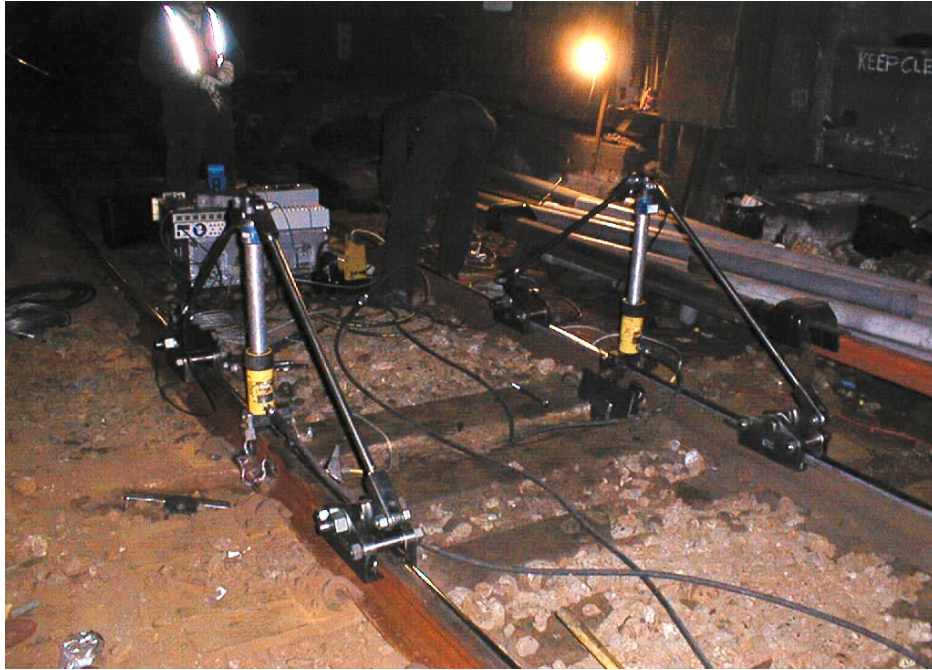
As the hydraulic cylinders were loaded, the strain gauge voltage outputs were plotted versus the load to calculate the conversion factors for the gauges. Figures 6 and 7 show the fixtures used to calibrate the vertical and lateral gauges, respectively. The vertical calibration fixture consisted of a titanium a-frame. The hydraulic cylinder pushed down against the railhead to produce a vertical force. The lateral calibration fixture was placed between the gauge faces of the two rails and an outward lateral force was applied to the gauges for calibration.

Figure 6. Vertical calibration fixture

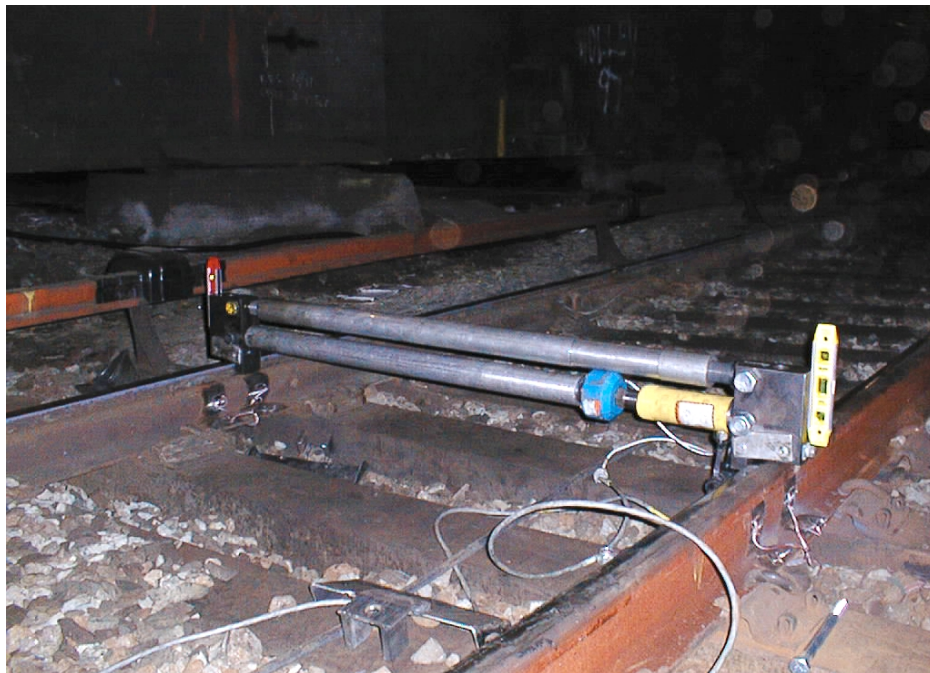
Figure 7. Lateral calibration fixture

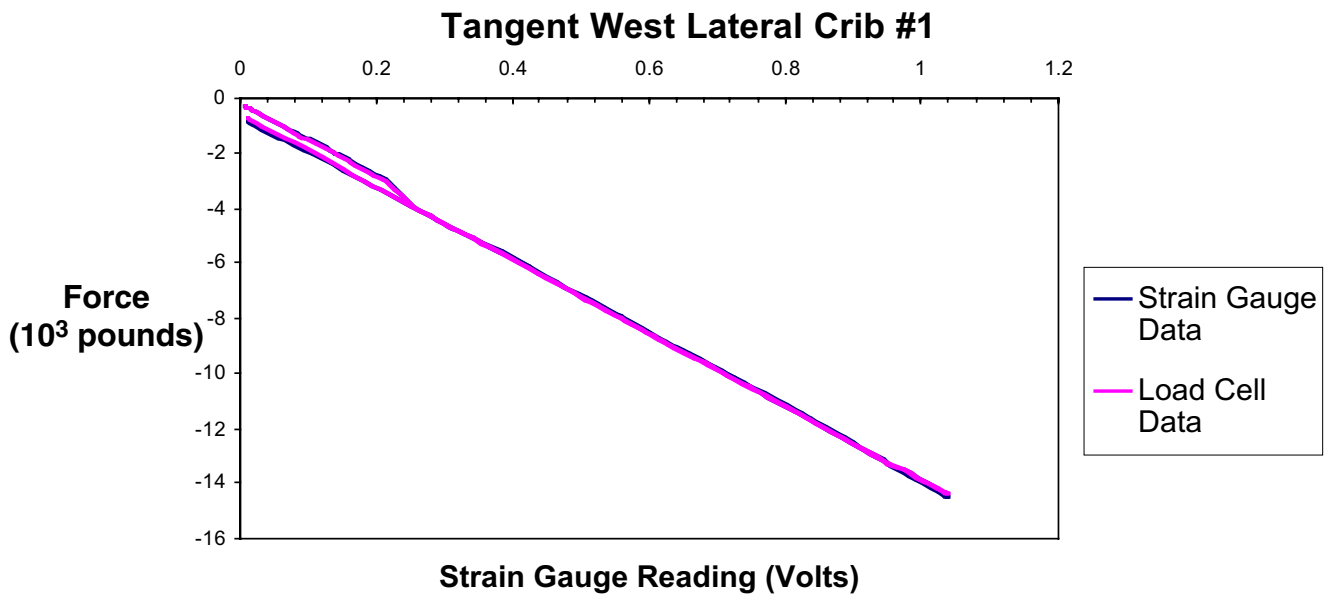
Figure A-4. Tangent west lateral crib No. 1

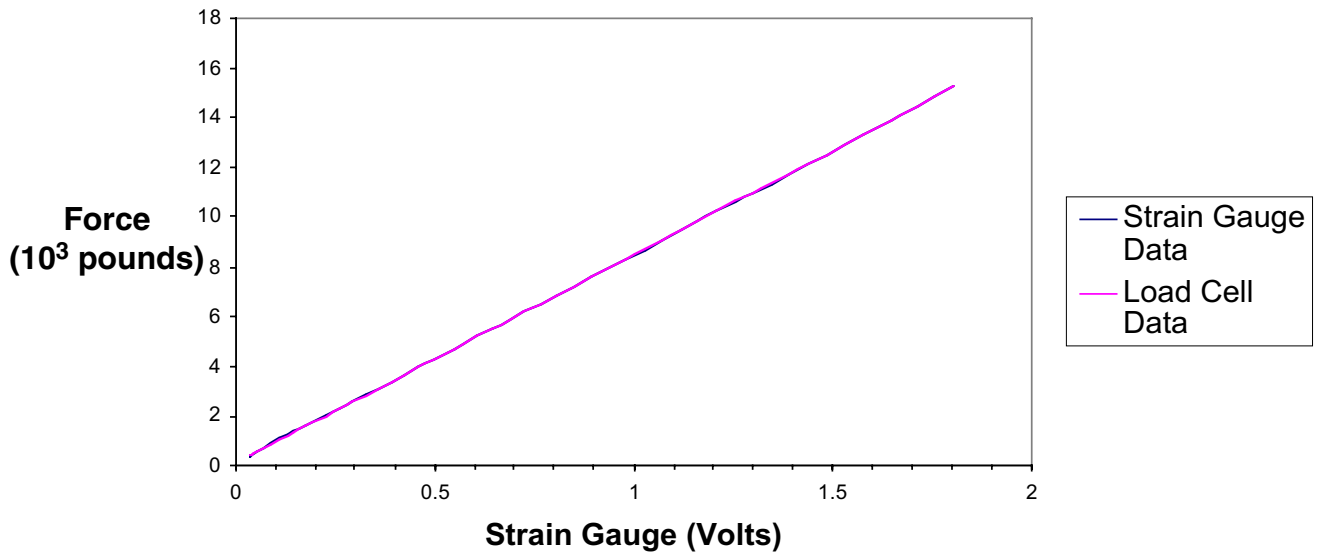
Figure A-7. Tangent east vertical crib No. 2

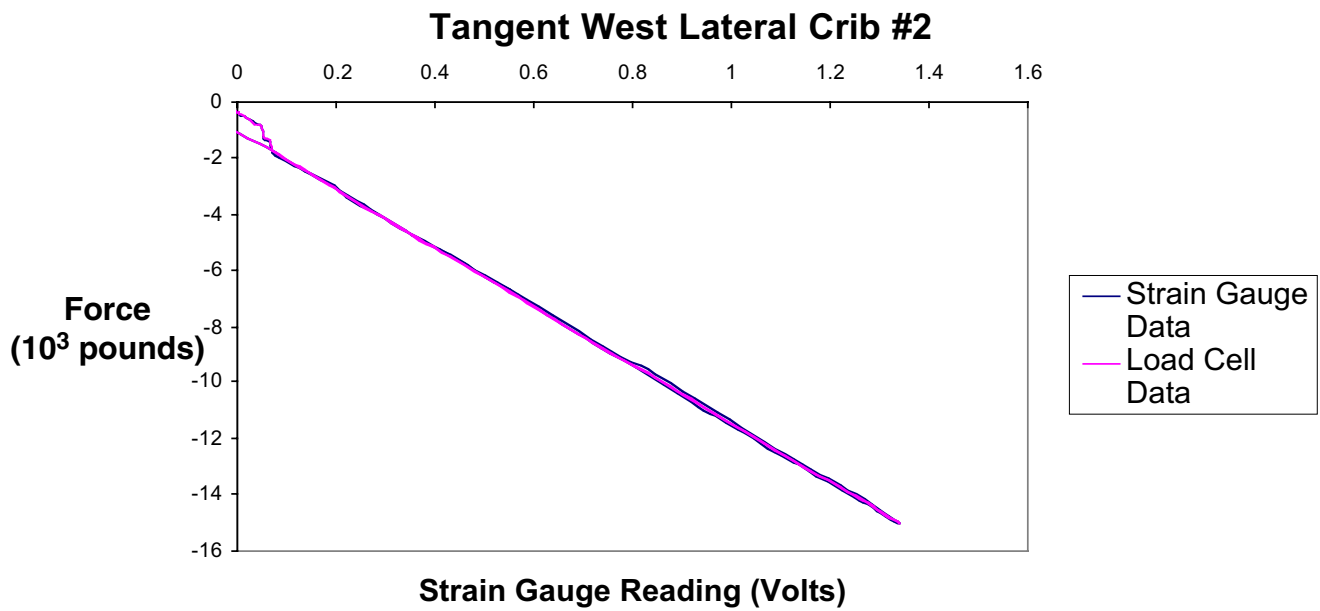
Figure A-8. Tangent west lateral crib No. 2

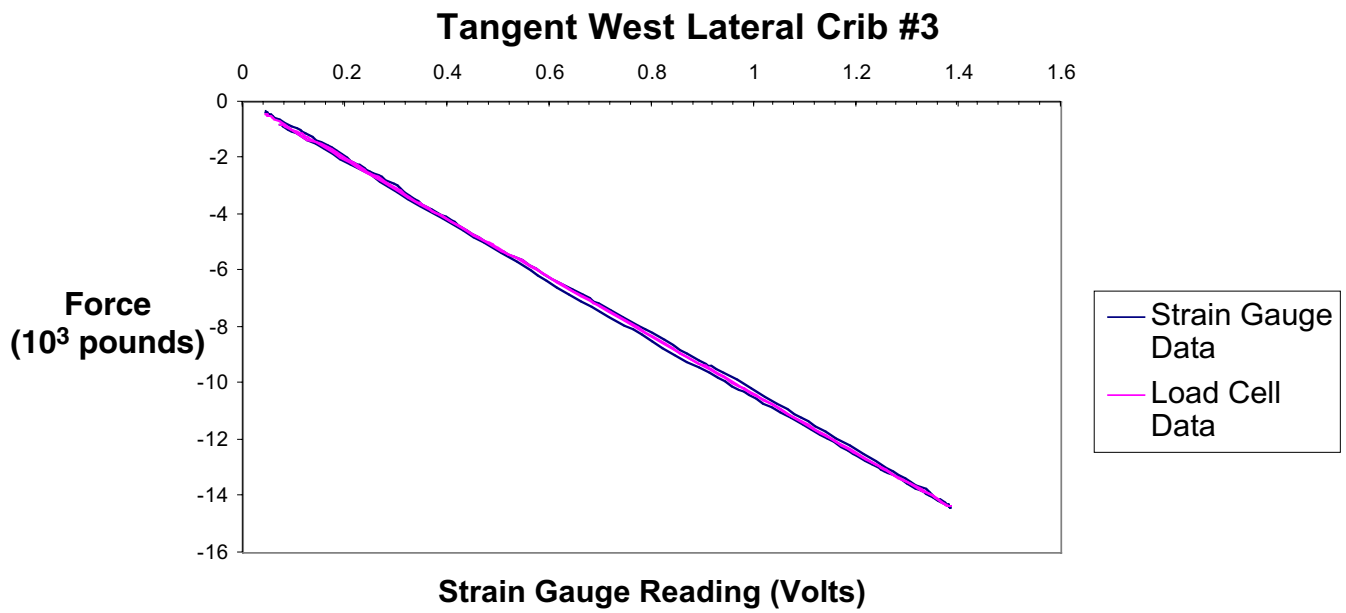
Figure A-12. Tangent west lateral crib No. 3

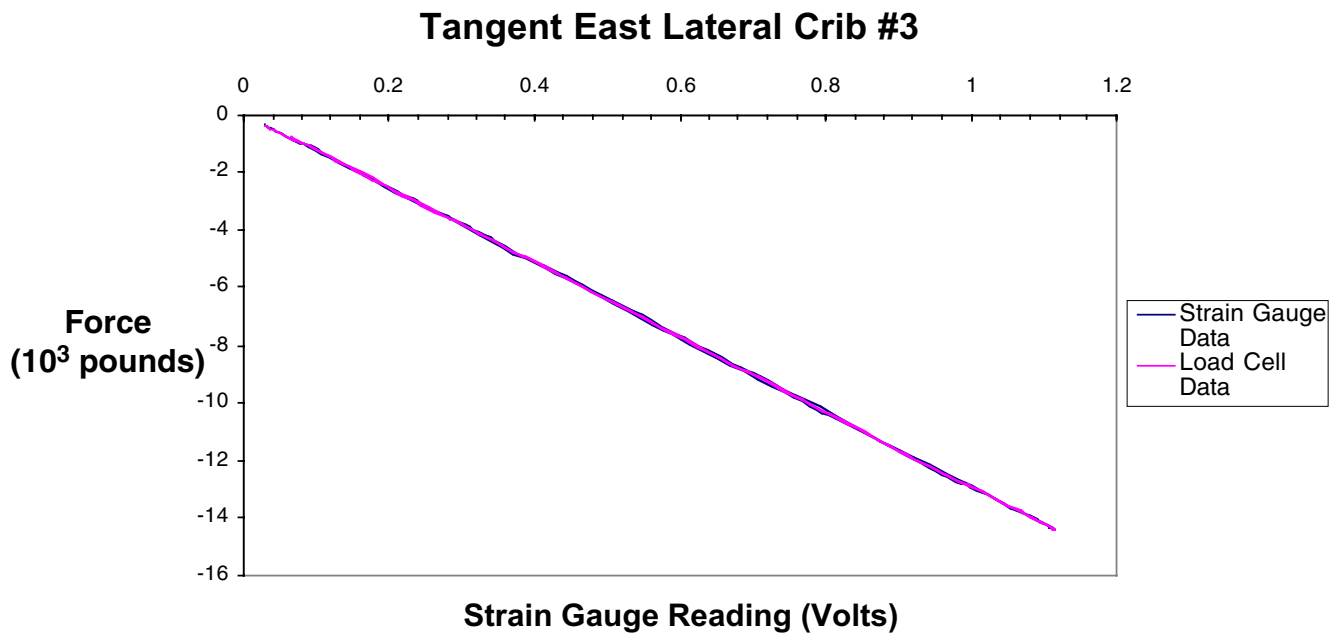
Figure A-13. Tangent east lateral crib No. 3

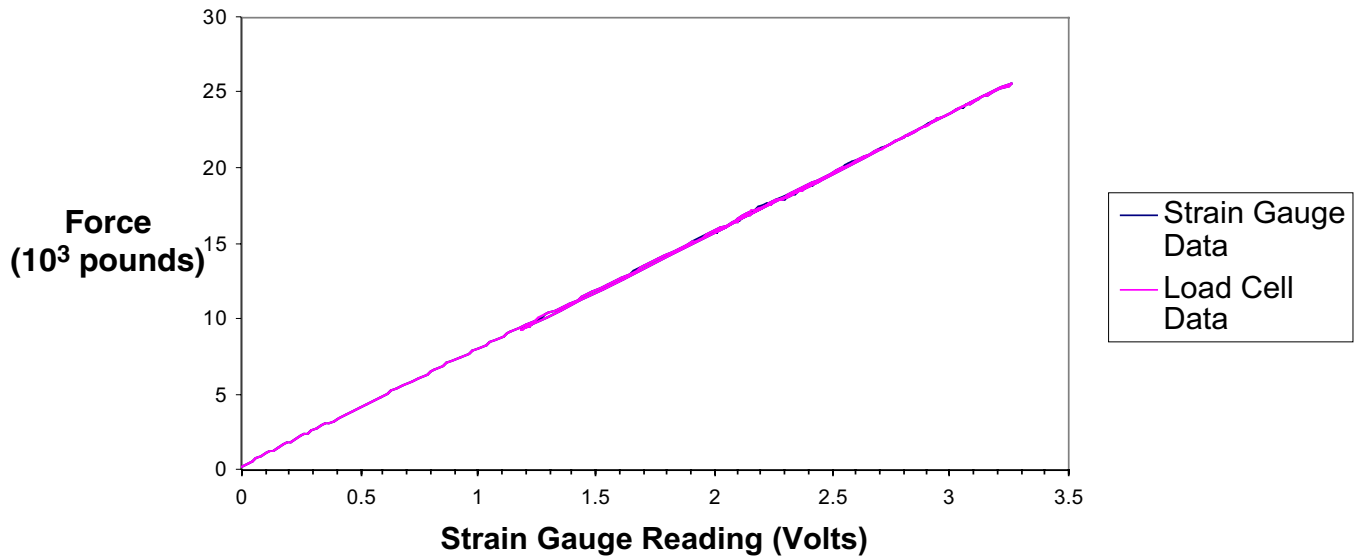
Figure A-14. Turnout west vertical crib No. 1

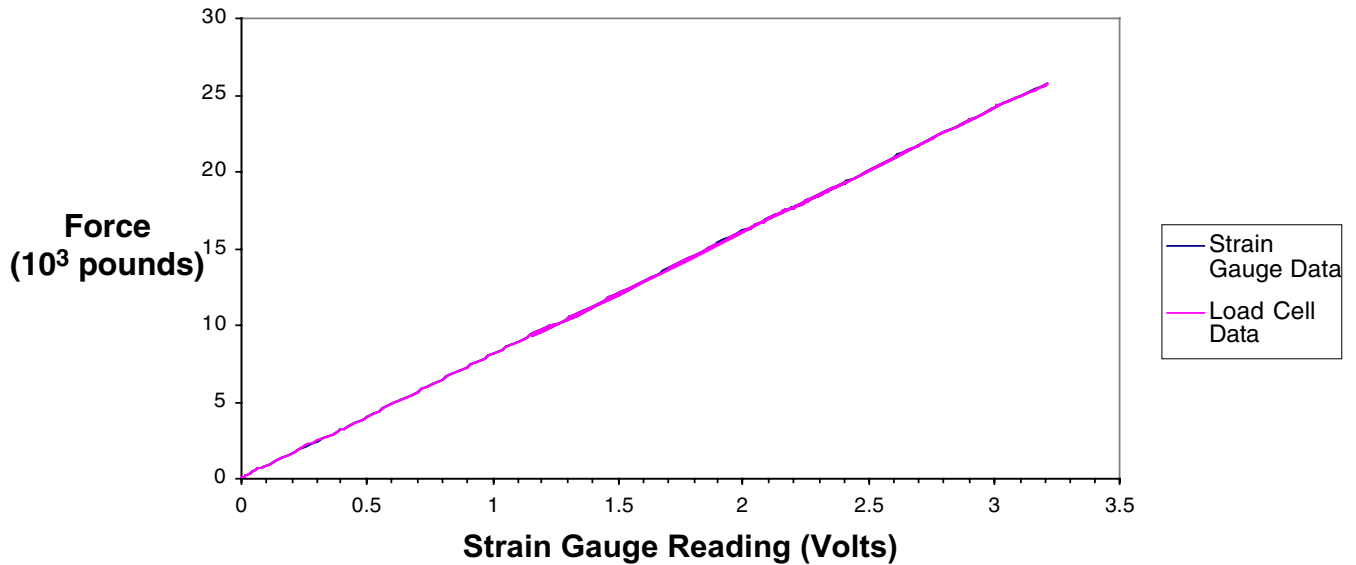
Figure A-15. Turnout east vertical crib No. 1

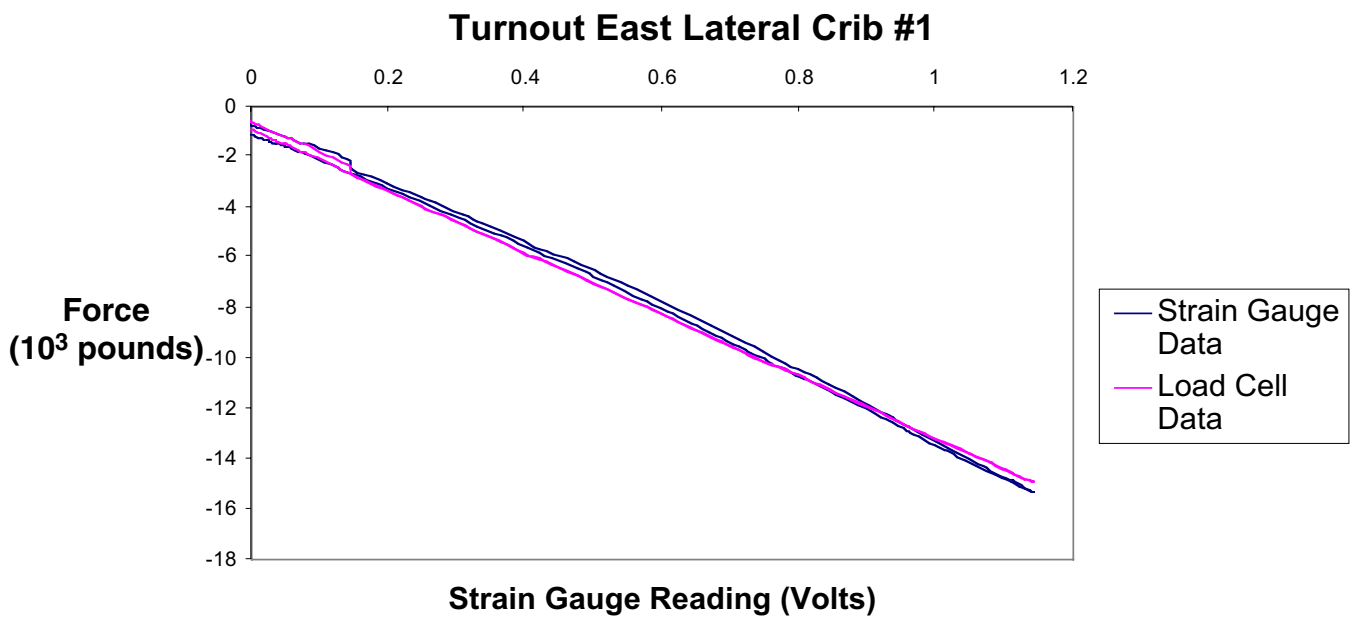
Figure A-17. Turnout east lateral crib No. 1

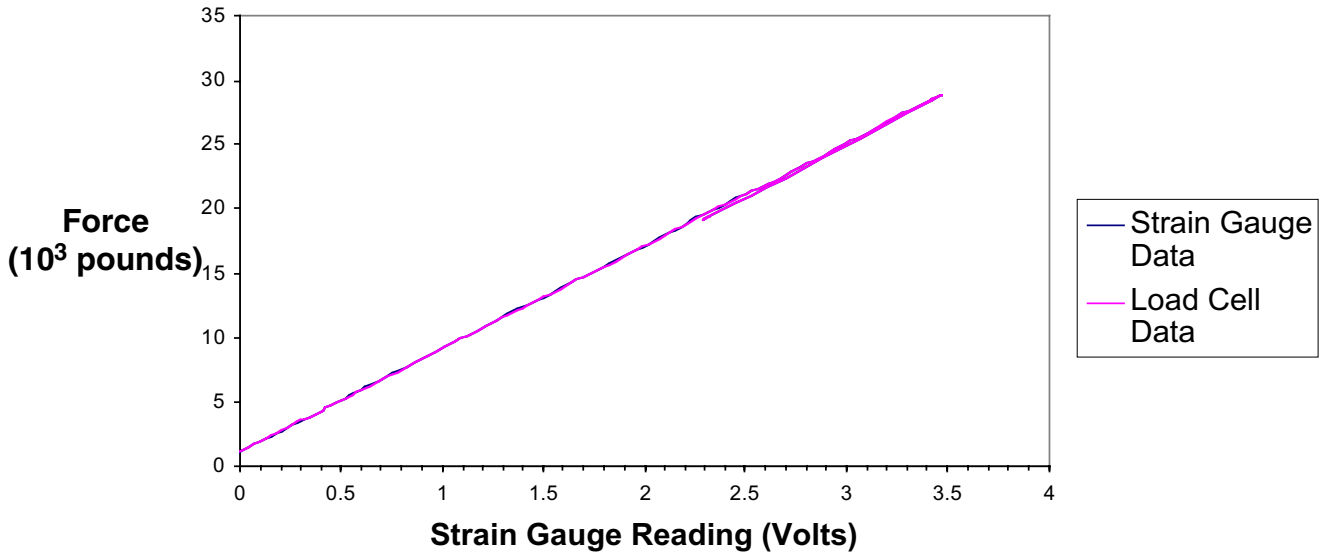
Figure A-18. Turnout west vertical crib No. 2

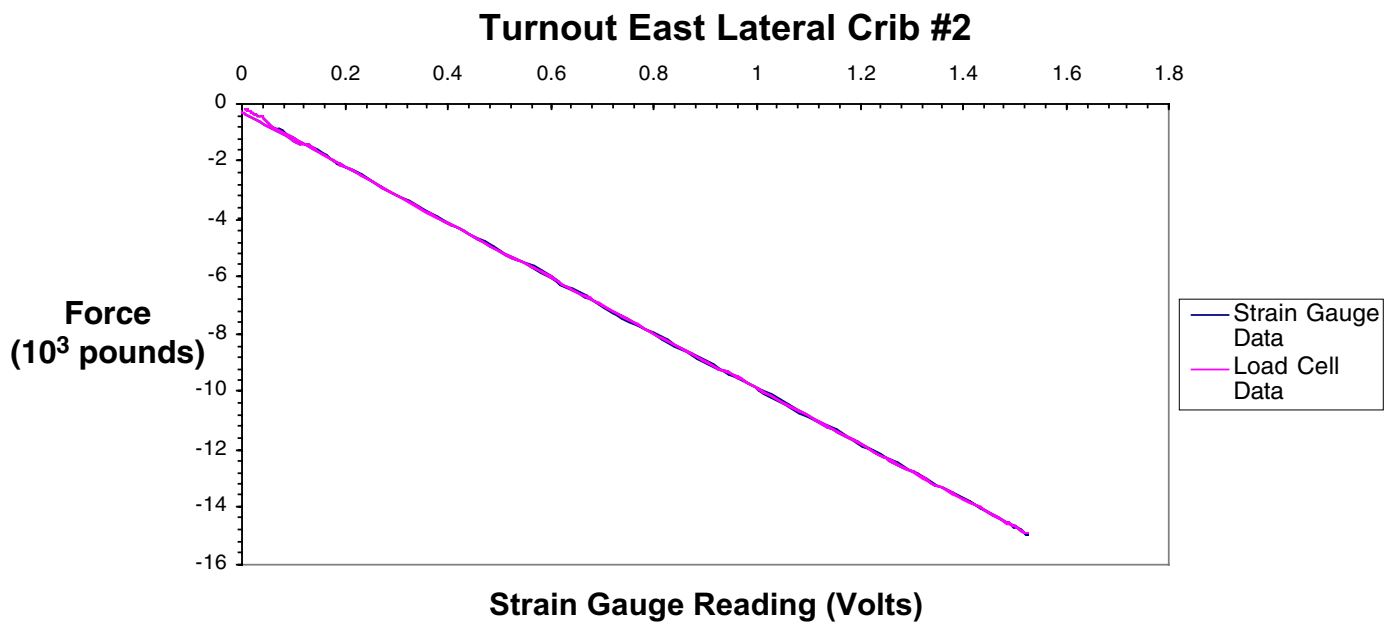
Figure A-21. Turnout east lateral crib No. 2

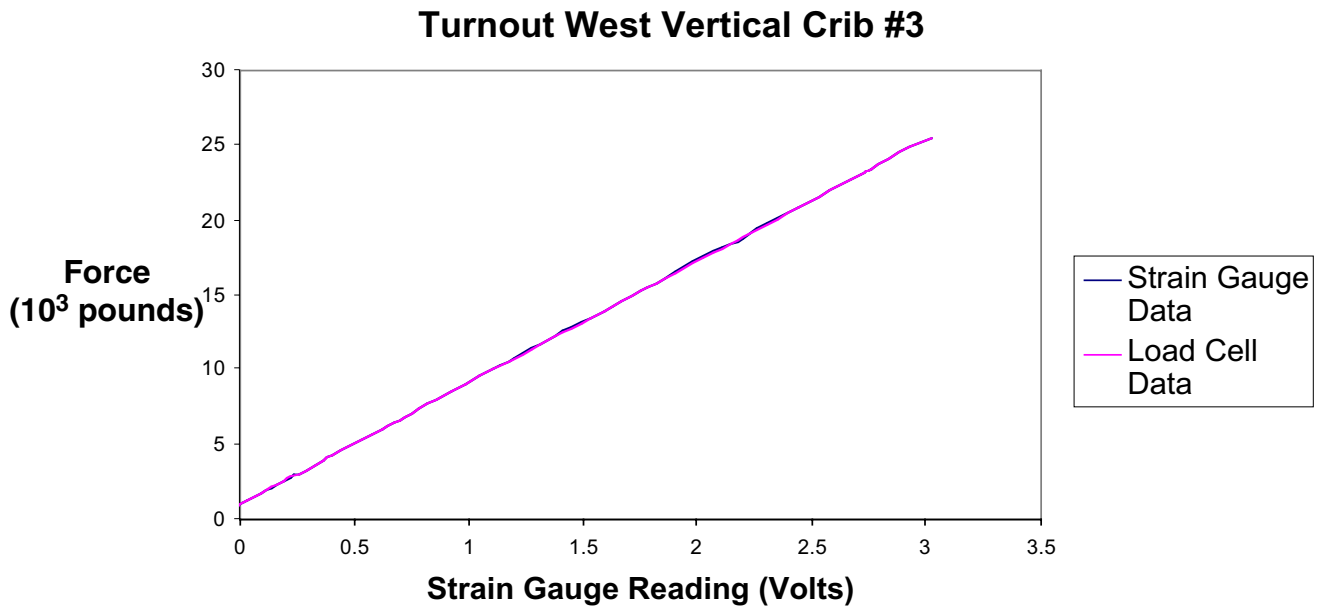
Figure A-22. Turnout west vertical crib No. 3
