Passenger Rail Train-to-Train Impact Test Volume II: Summary of Occupant Protection Program

Rail Passenger Equipment Impact Tests

Final Report
July 2003

DOT/FRA/ORD-03/17.II

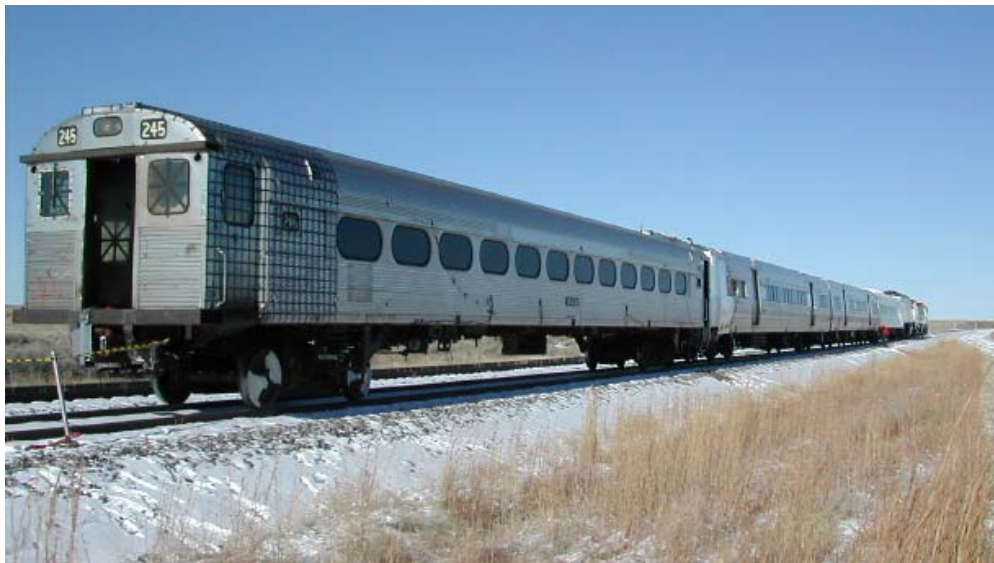
Figure 9. The Cab-Car-Led Consist with Three Trailing Coach Cars and a Locomotive

The train-to-train test was conducted on January 31, 2002, at the US Department of Transportation (DOT) Transportation Technology Center (TTC) in Pueblo, CO. This test involved a cab-car-led consist with three coach cars trailed by a locomotive (Figure 9). At a speed of approximately 30 mph, this five-car consist impacted a standing locomotive that was coupled to two ballasted freight cars. The pre-test impact site with the cab car and locomotive is shown in Figure 10.

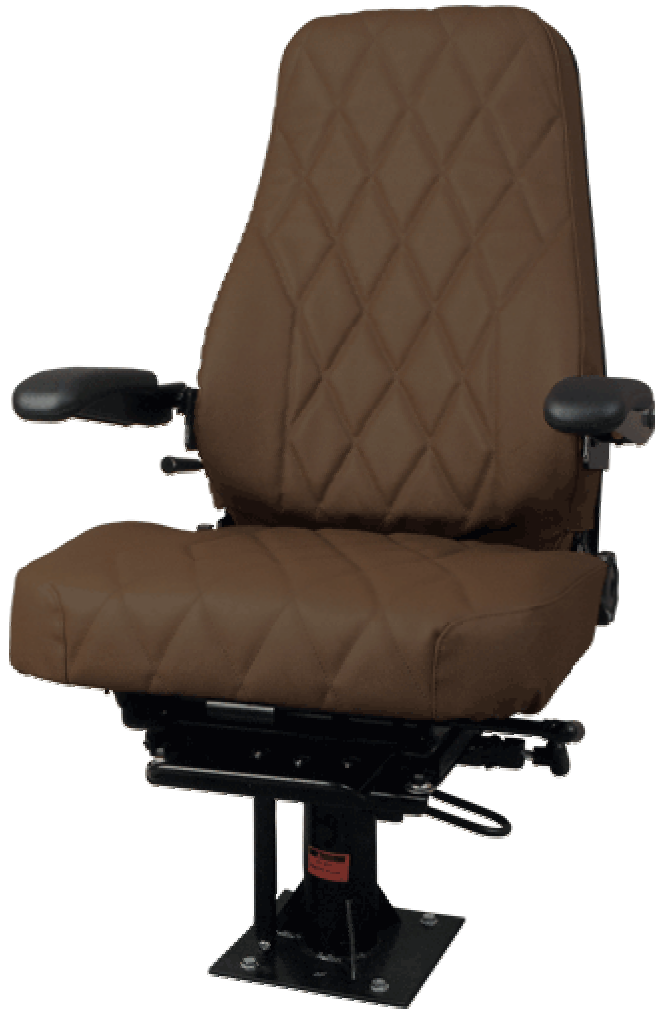
Figure 13. Locomotive Operator, High-Back Seat

Locomotive operator seat experiments were designed to determine the occupant kinematics by observing the ATD's interaction with the console and front windshield. High-back, pedestal-mounted operator seat replaced the sidewall mounted operator seat originally installed in the locomotive. This seat is typical for locomotives currently being manufactured. A photo of the seat is provided in Figure 13.

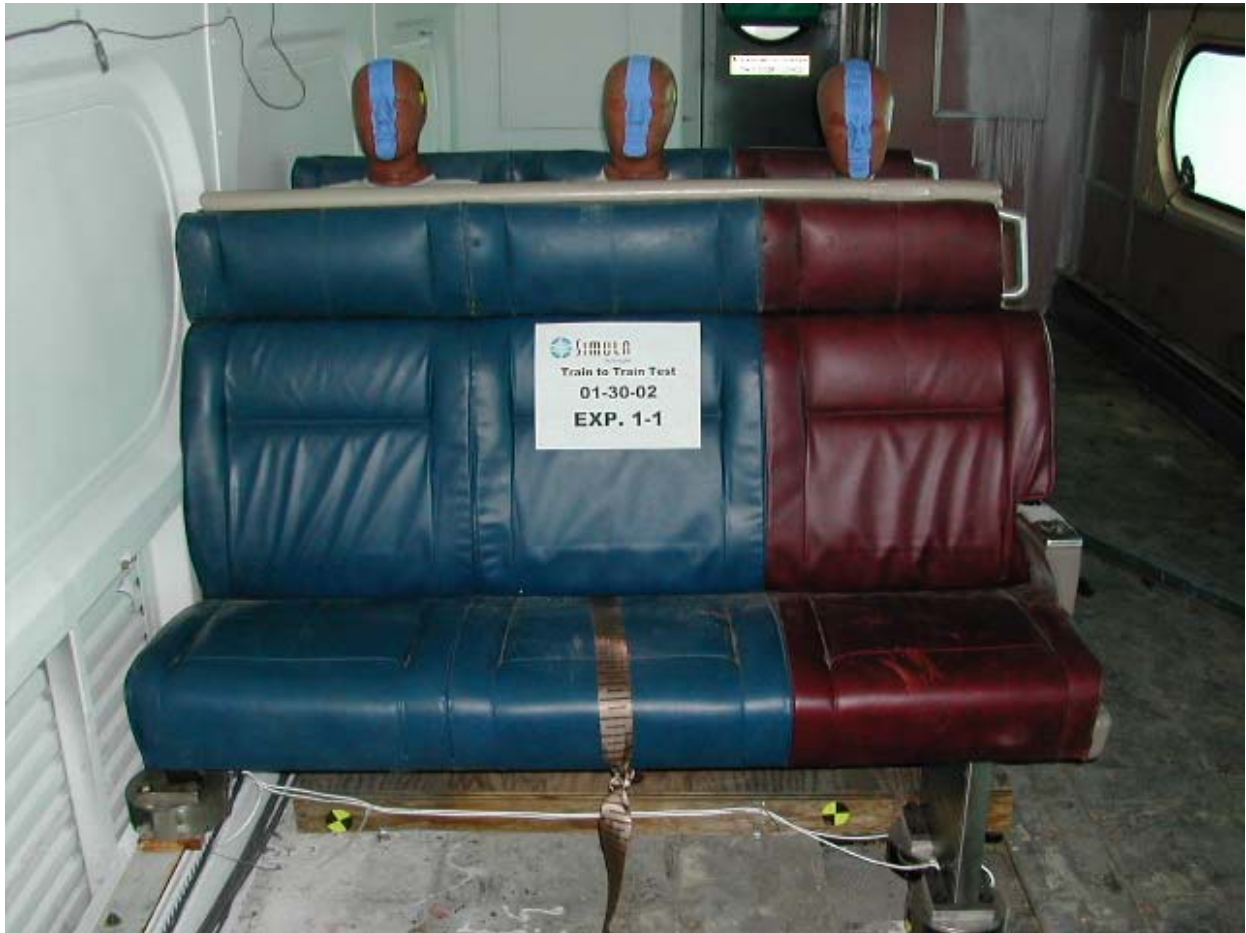
Figure 18. Pre-Test Photo of Experiment No. 1-1, Row-to-Row M-Style Seats

The focus of this experiment was on the rear-seat occupants impacting the front-row seat and observing the reaction of the front-row seat (the floor and sidewall attachment loads and the seat structural response). A pre-test photo of Experiment 1-1 is provided in Figure 18.

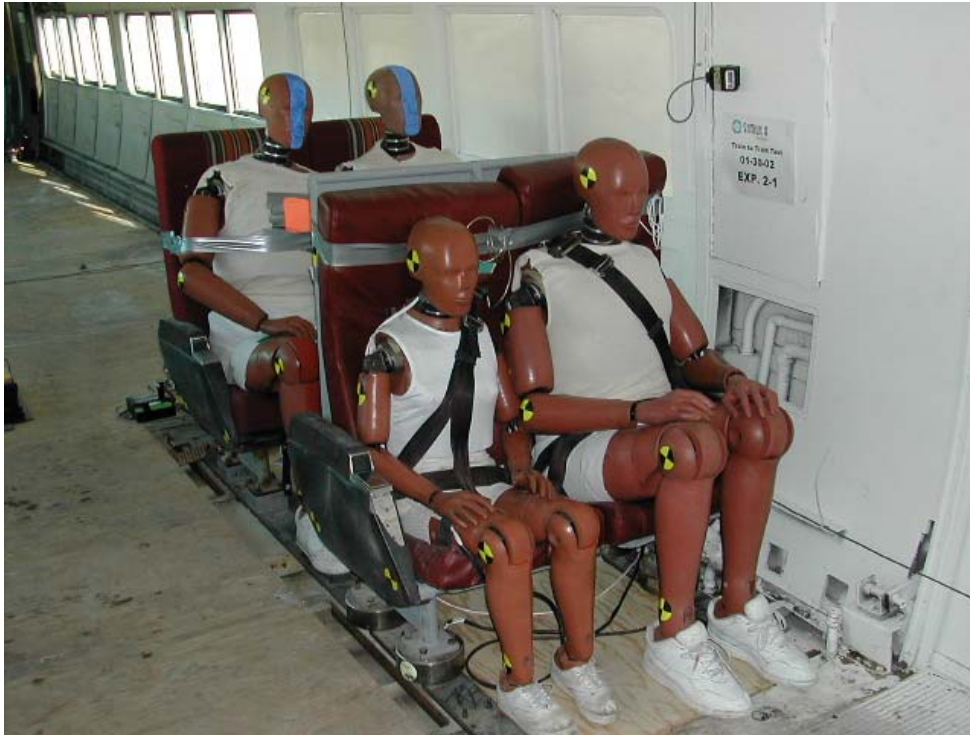
Figure 19. Pre-Test Photo of Experiment No. 2-1, Row-to-Row Intercity Seats with Front-Row Restraints

Experiment No. 2-1 was installed toward the front, left section of the first trailing coach car. The floor attachment of the front-row seat was approximately 23 feet from the front-most panel of the car. The seats were installed with a 42-inch seat pitch. The front-row seat was occupied by two restrained ATDs: a 5th-percentile ATD in the aisle seat (instrumented with a neck load cell), and a 95th-percentile ATD in the window seat (also instrumented with a neck load cell). The back-row seat was occupied by two unrestrained 95th-percentile ATDs (the aisle-seated ATD was fully instrumented).

The focus of this experiment was on the rear-seat occupants impacting the front-row seat occupied by the restrained ATDs, and on observing the reaction of the front-row seat, the restrained occupants in the seat, and the unrestrained ATDs impacting the seat from behind. A pre-test photo of Experiment 2-1 is provided in Figure 19.

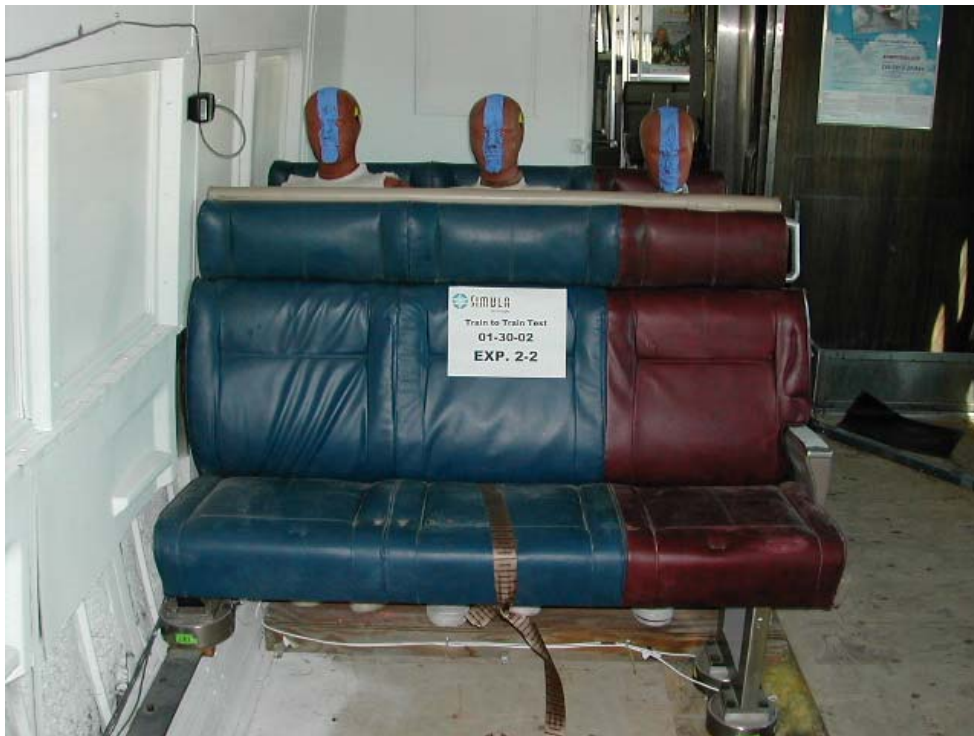
Figure 20. Pre-Test Photo of Experiment No. 2-2, Row-to-Row M-Style Seats

Experiment No. 2-2 was installed in the right, aft section of the rail car, 9 feet from the aft-most panel of the car. These seats were installed with a 32-inch seat pitch, similar to Experiment 1-1.

Unlike previous tests, there were no seat design modifications incorporated into the seat; they were installed as manufactured. The focus of this experiment was on the rear-seat occupants impacting the front-row seat and observing the reaction of the front-row seat (floor and wall attachment loads and seat structural response). A pre-test photo of Experiment 2-2 is provided in Figure 20.

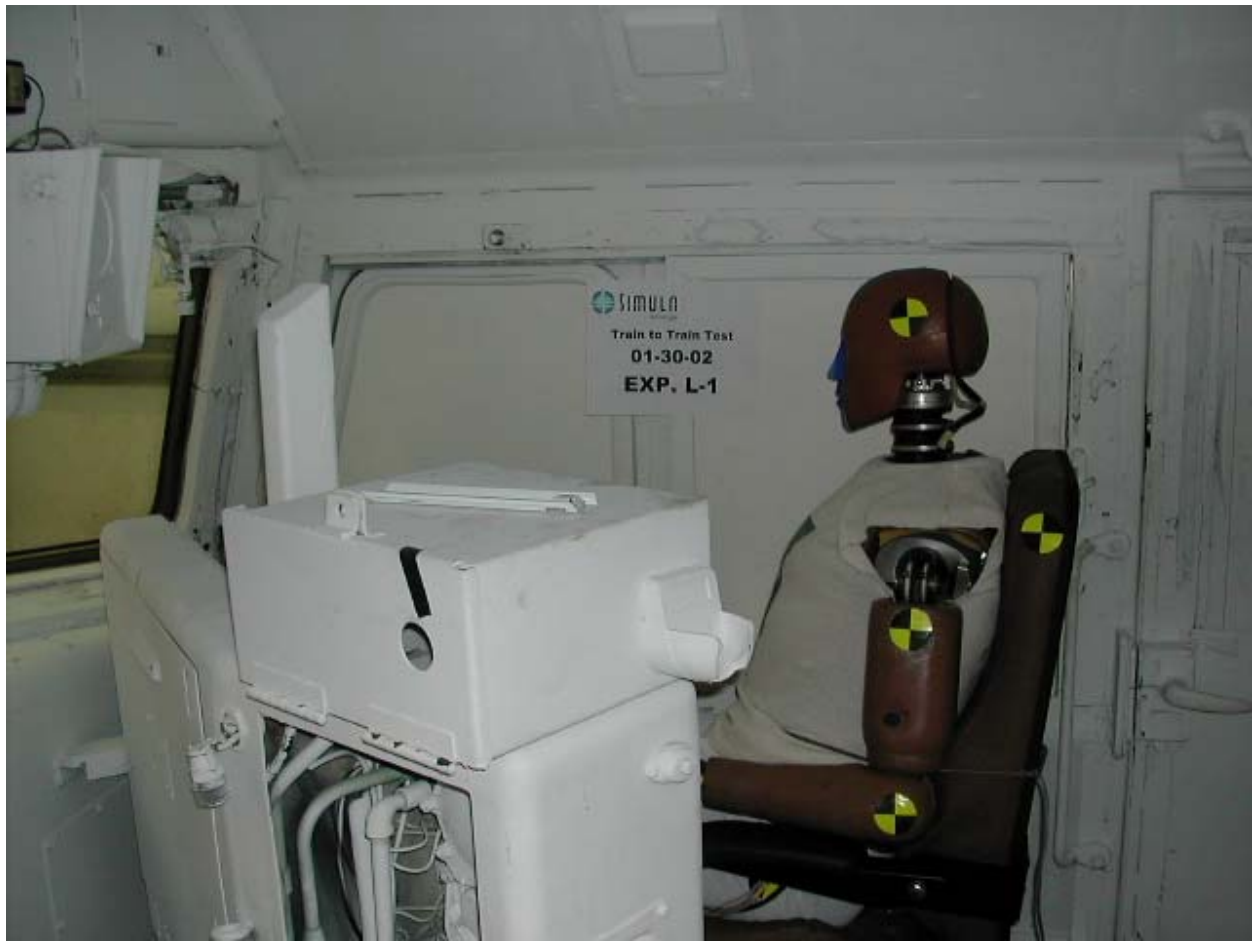
Figure 21. Pre-Test Photo of Experiment No. L-1, Locomotive Operator Seat

The focus of this experiment was on the occupant kinematics and the ATD's interaction with the console and front windshield. The inertial forces on the seat would also be measured through the seat/floor attachment load cells. A pre-test photo of Experiment L-1 is provided in Figure 21.

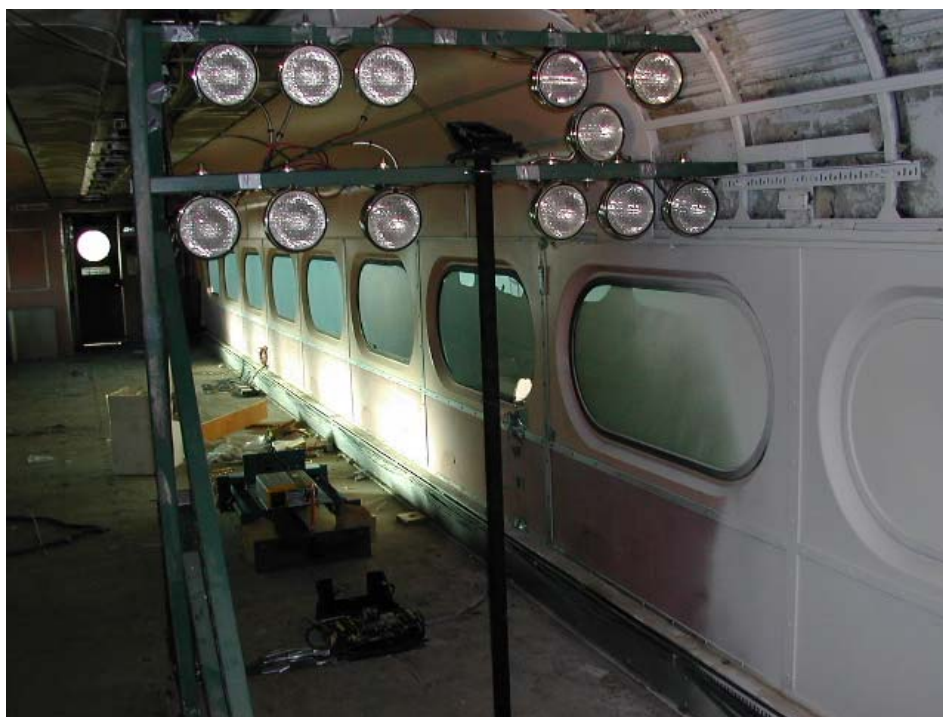
Figure 26. Experiment No. 1-1, Front-View Lights and Fixtures

The front-view camera of each experiment was mounted on a dovetail mount that was attached to the top of a uni-strut fixture built in front of each seat/occupant experiment. The side-view cameras were installed level and perpendicular to the centerline of the car on rugged frames constructed of slotted angle iron. In the locomotive, the side-view camera was restricted to a side-angled aft-view of the seat, and the front-view camera was replaced with an aft-view camera. Figures 26, 27, 28, and 29 are photographs of the lights installed for each experiment.

A total of 91 ruggedized automotive floodlights, each 100W and 12V, were installed to cover all of the experiments in this test. The power source for each set of 4 lights consisted of a single 12V battery and a trigger circuit that contained 3 solid-state triggers (for 3 sets of 4 lights) and a single trip wire which, when broken, supplied power to all 12 lights. The trigger circuit and 12V battery were mounted together on a small frame located as near to the lights as possible, and energy-absorbing foam was inserted in each mount to protect the battery. Six 12V power supply units were built and installed in the rail cars. Each battery pack was individually tested for a full set of lights by simultaneously tripping all three of its triggers. The wires from the lights to the

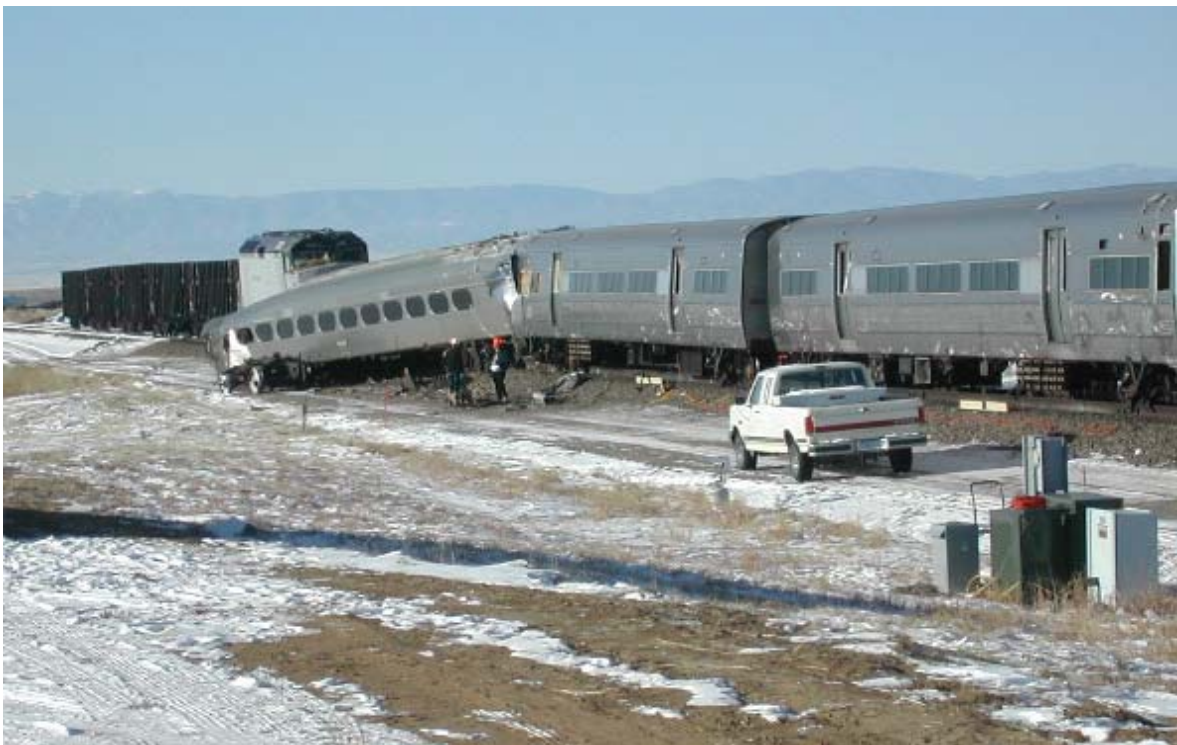
Figure 30. Post-Test Impact Site

The train-to-train test was conducted on January 31, 2002. A five-car consist (leading cab car, three coach cars and a trailing locomotive) impacted a stationary locomotive (coupled with two ballasted freight cars) at 30 mph. The post-test residue is shown in Figures 30, 31, and 32.

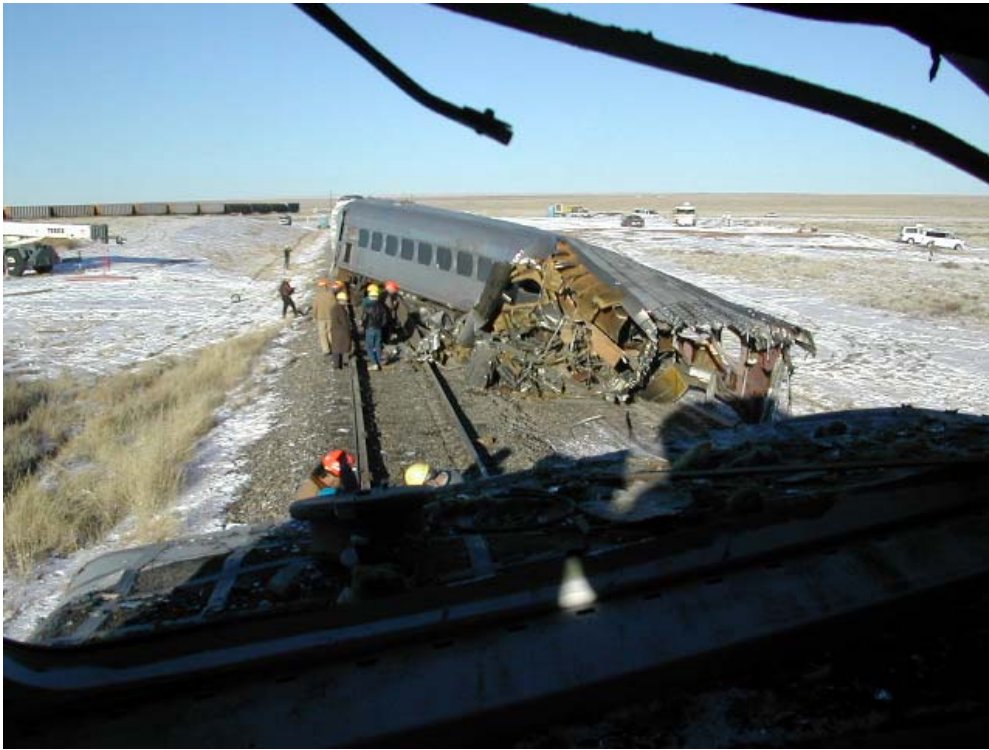
Figure 32. Post-Test View of Leading Cab Car, Right Side, Through the Broken Windshield of the Impacted Locomotive

The leading cab car overrode the stationary locomotive, climbing on top and over half of the front end of the locomotive, tearing off the front end and the front half of the cab car's understructure, and losing all survivable volume from the front third of the cab car. The front truck on the cab car was completely severed from the main body, and the trailing coach cars derailed as a result of lateral buckling. The severity of the damage to the leading cab car, combined with the energy absorbed by the impacted locomotive when it moved backward along the track, plus the continuing forward acceleration provided by the trailing cars of the moving consist, all contributed to the reduced collision acceleration and occupant injury severity recorded in the test.

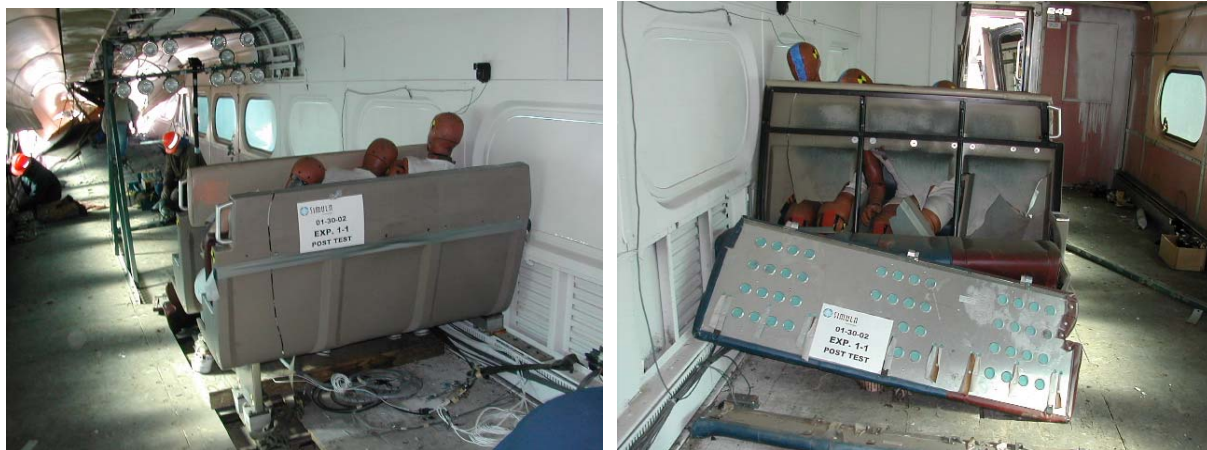
Figure 35. Experiment No. 1-1 – Front and Aft Views, Post-Test

The seats used in this experiment were not modified; they were OEM M-style seats and were identical to the seats used in the single-car test, although they were more aged. All of the M-style seats were purchased prior to the first single-car test in November 1999, and were stored outdoors during the period before the train-to-train test took place in January 2002. The ATDs in this experiment were compartmentalized; and the loads measured on the instrumented ATD (aisle seat) did not exceed any of the injury criteria. There was no deformation of the pedestal nor of the seat frame; however, the shroud on the seat back failed when the knees from the occupants behind penetrated this seat back panel (Figures 35 and 36).

There was no observable deformation in the aft-row seat; however, the back cushion in the aft-row detached from the frame.

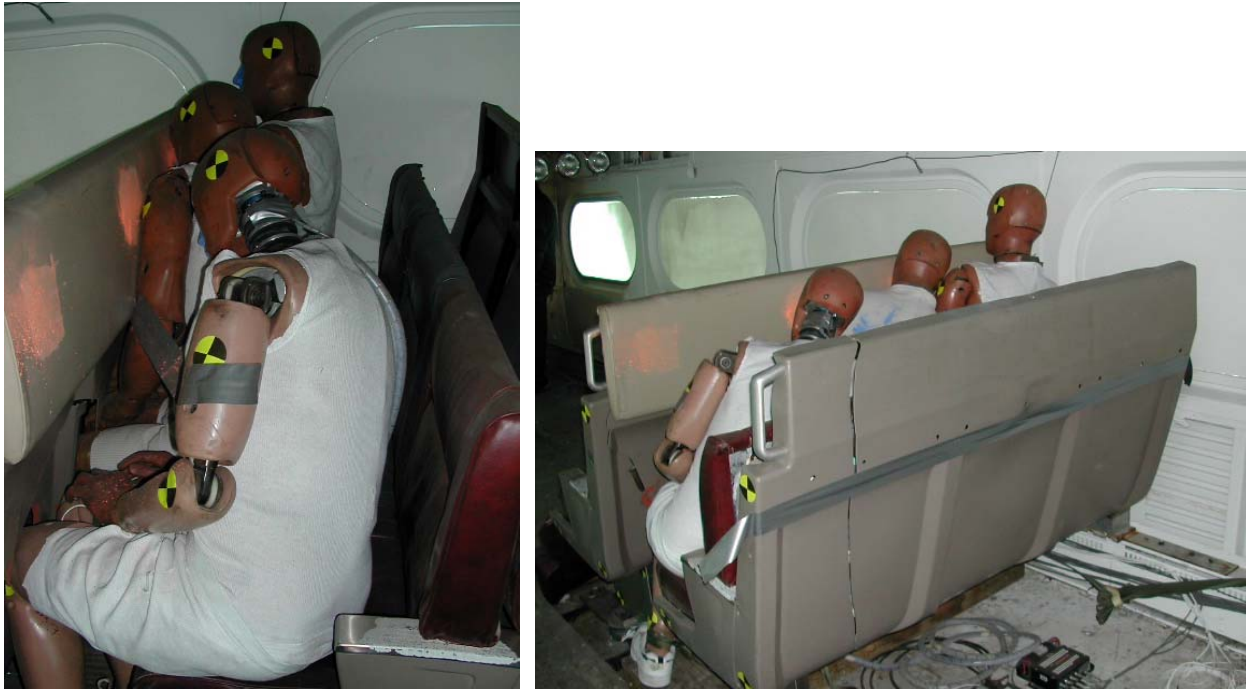
Figure 36. Experiment No. 1-1 – Occupants Remain Compartmentalized

There also was no observable deformation in the front-row seat. The secondary velocity of the ATDs from the aft-row seat was lower than in past tests. In addition, there was a much higher vertical acceleration that precluded the ATD's from traveling forward as much as they had in previous collision scenarios. The front-row seat and the floor attachments of the seat to the

pedestal remained intact. The load cell attachment of the front-row seat to the sidewall remained intact. The seat back cushion on the front-row seat detached when the ATDs impacted the seat from behind. The seat attachment loads are provided in Appendix B in Figure B-1, and the seat attachment data plots are provided in Appendix C in Figures C-1 to C-12.

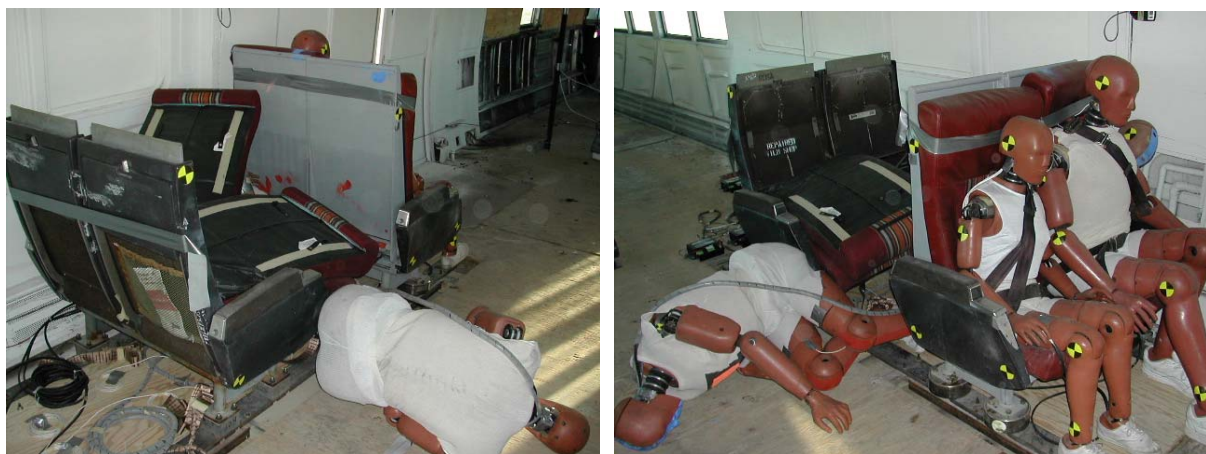
Figure 37. Experiment No. 2-1 - Front and Aft Views, Post-Test

The intercity seats used in this two-car test were refurbished seats from the single-car test and the two-car test, including new seat cushions that were donated by Amtrak for the program. The ATDs in this experiment were compartmentalized, and the loads measured by the unrestrained, instrumented ATD, which was seated in the aft row on the aisle side, did not exceed any of the injury criteria. The ATD seated in the aft row on the window side was not instrumented; however, the ATD was found at the end of the test with its head stuck between the front row seat and the sidewall. There was no seat deformation; only the cushions from the aft-row seat detached (Figures 37 and 38).

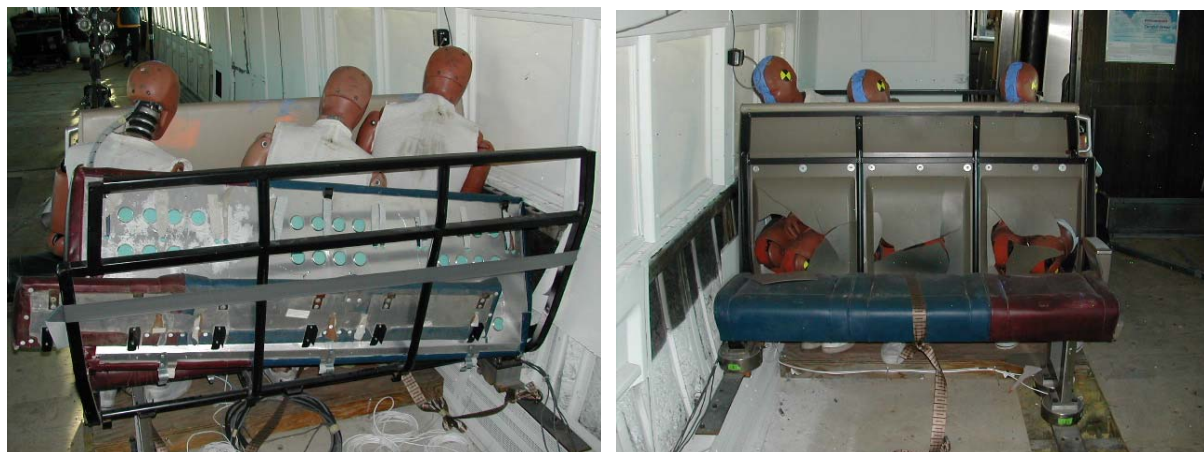
Figure 39. Experiment No. 2-2 - Front and Aft Views, Post-Test

There was no deformation of the pedestal nor of the seat frame; however, the shroud on the front-row seat back failed when the knees from the ATDs behind penetrated the seat back panel (Figures 39, 40, and 41).

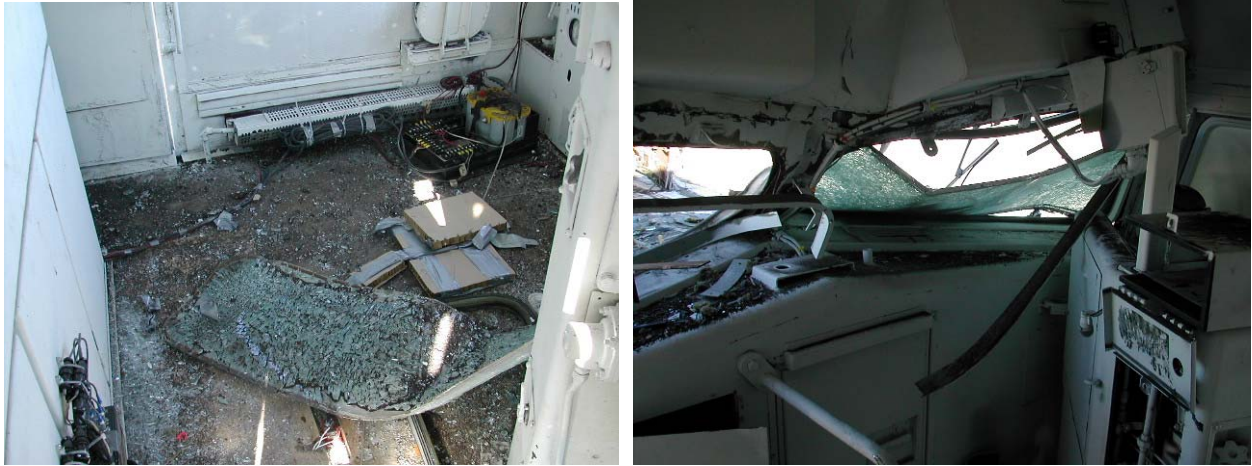
Figure 42. Experiment No. L-1 - Post-Test View of the Locomotive Interior

This was the first time that a locomotive operator seat with an occupant was incorporated into a full-scale collision test for occupant protection evaluation. A pedestal-mounted, high-back seat with armrests was installed, and a 95th-percentile ATD was seated, unrestrained, in the seat. Despite the amount of damage that occurred inside the locomotive (Figure 42), the seat was not damaged and it did not fail under the inertial loads of the collision. Surprisingly, the ATD remained in the seat after sliding forward toward the seat edge. The ATD’s post-test position was slumped forward, and its feet had slipped forward off of the footrest that had been installed to replace the original footrest. There were no markings at all on any of the interior components (See Figures 42, 43, and 44).
