TREAD METAL BUILDUP ON RAILROAD FREIGHT CAR WHEELS – Dynamometer Simulation

DOT/FRA/ORD-03/25

June 2003
Final Report

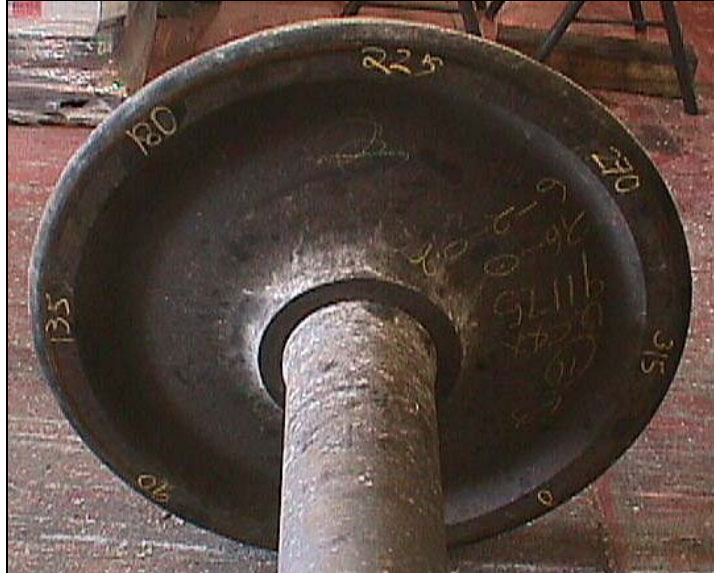
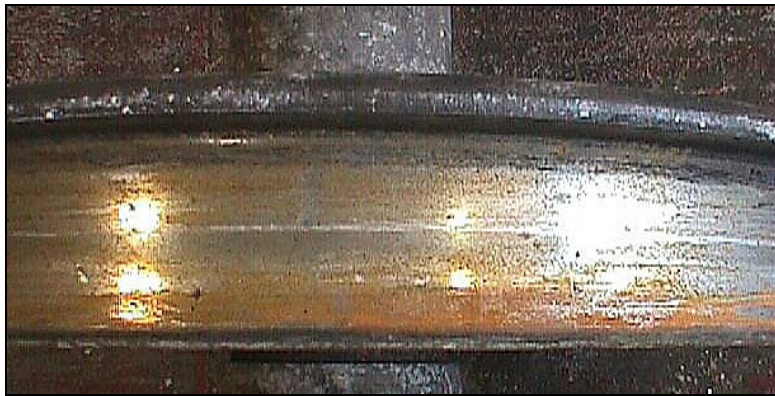
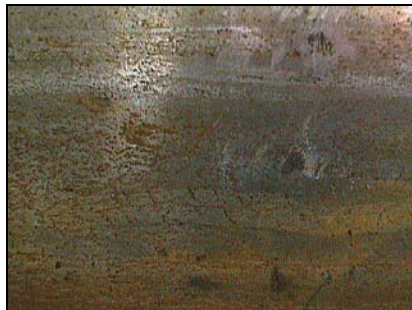
Wheel 07534 No Tread Buildup

FRA TREAD BUILDUP TEST
 SURFACE CONDITION and HARDNESS READINGS
 WHEEL # 07534 Progress Rail Services Corp., Sidney, NE
 June 5, 2002

Location	Near flange	Center	Near outer rim
0 degrees	056	053	029
45 degrees	027	039	018
90 degrees	033	024	035
135 degrees	098	075	039
180 degrees	027	051	043
225 degrees	026	023	058
270 degrees	066	024	021
315 degrees	019	040	025

Location	Near Flange	Center	Near outer rim
0 degrees	522	540	511
45 degrees	526	529	444
90 degrees	503	511	535
135 degrees	383	487	471
180 degrees	430	577	492
225 degrees	427	510	404
270 degrees	424	467	529
315 degrees	531	531	501

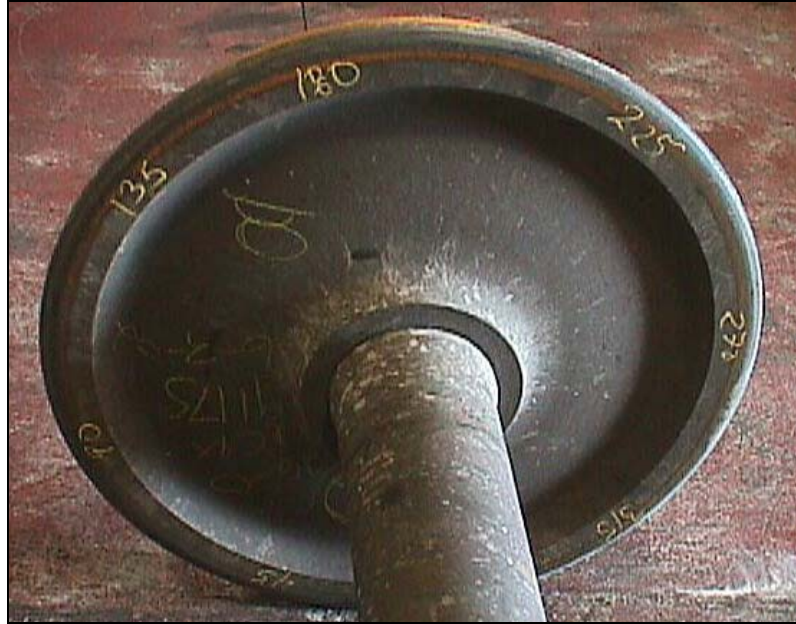
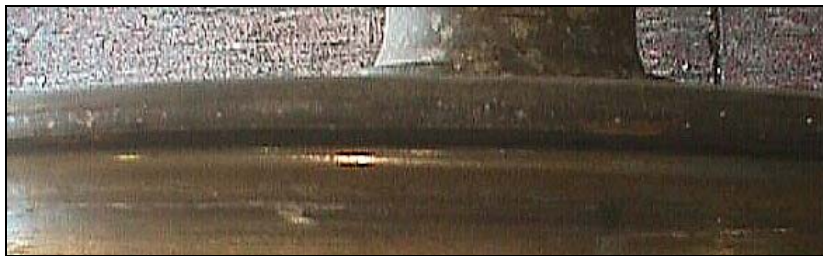
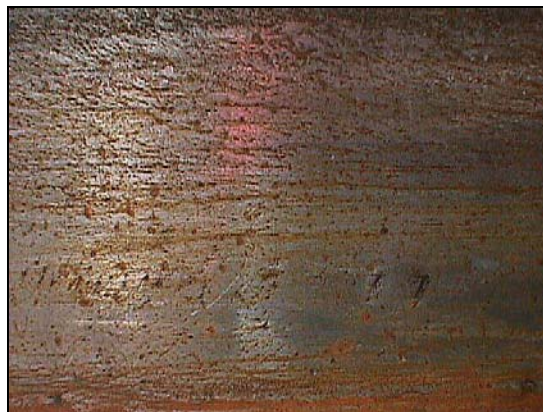
Wheel 07598
No Tread Buildup
(Revenue Service Wheel Evaluation)

FRA TREAD BUILDUP TEST
 SURFACE CONDITION and HARDNESS READINGS
 WHEEL # 07598 Progress Rail Services Corp., Sidney, NE June 5, 2002

Location	Near flange	Center	Near outer rim
0 degrees	150	043	047
45 degrees	128	091	026
90 degrees	122	045	026
135 degrees	114	041	039
180 degrees	112	024	023
225 degrees	144	034	025
270 degrees	106	018	026
315 degrees	107	048	040

Location	Near Flange	Center	Near outer rim
0 degrees	529	520	538
45 degrees	540	548	526
90 degrees	494	466	458
135 degrees	456	518	463
180 degrees	518	533	515
225 degrees	497	436	482
270 degrees	555	503	585
315 degrees	439	520	459

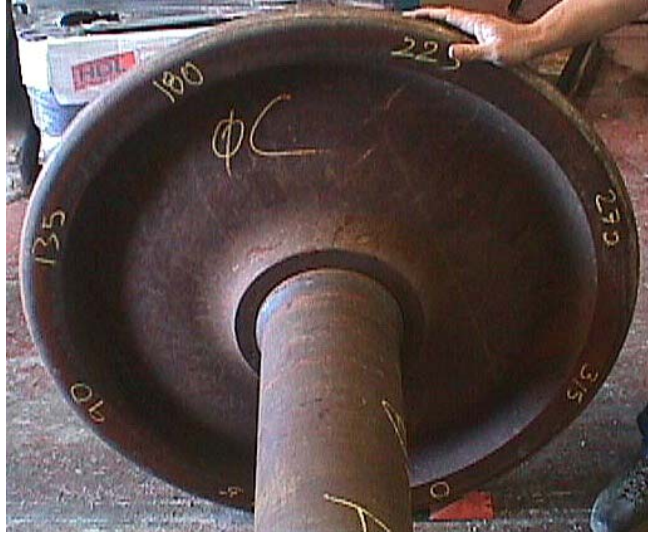
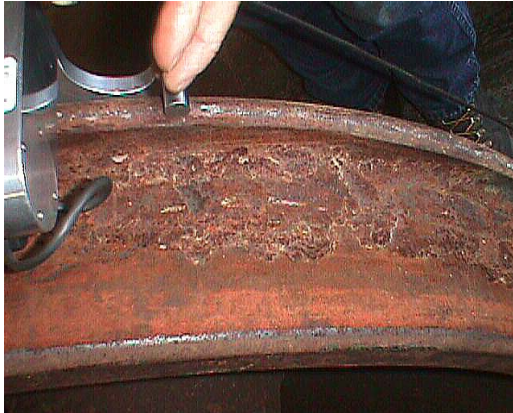
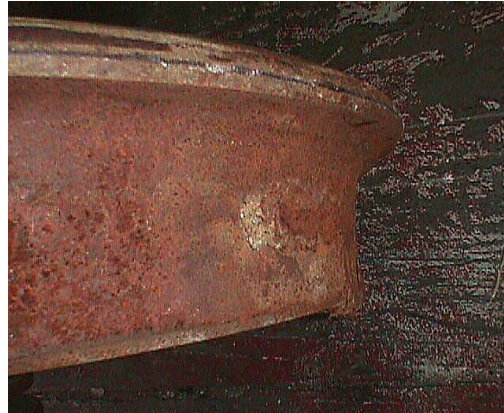
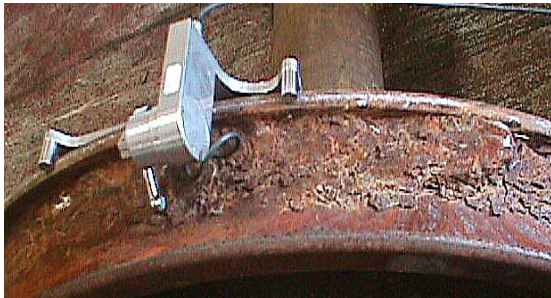
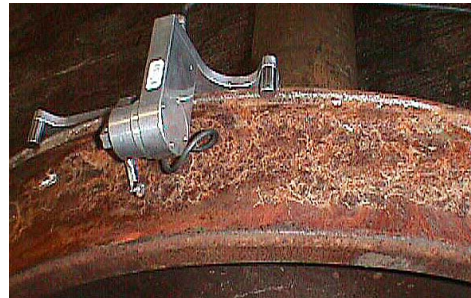
Wheel 10988
Heavy Tread Buildup
(Revenue Service Wheel Evaluation)

FRA TREAD BUILD-UP TEST
 SURFACE CONDITION and HARDNESS READINGS
 WHEEL # 10988 Progress Rail Services Corp., Sidney, NE June 5, 2002

Location	Near flange	Center	Near outer rim
0 degrees	274	331	335
45 degrees	652	273	223
90 degrees	205	546	205
135 degrees	290	170	181
180 degrees	234	168	158
225 degrees	170	225	133
270 degrees	276	687	593
315 degrees	199	085	475

Location	Near Flange	Center	Near outer rim
0 degrees	647	497	438
45 degrees	317	674	471
90 degrees	520	557	484
135 degrees	427	354	463
180 degrees	472	554	435
225 degrees	313	250	286
270 degrees	387	542	321
315 degrees	517	529	339

The maximum range of gauss in this wheel was from -28.0 to $+8.5$ or 36.5 gauss.

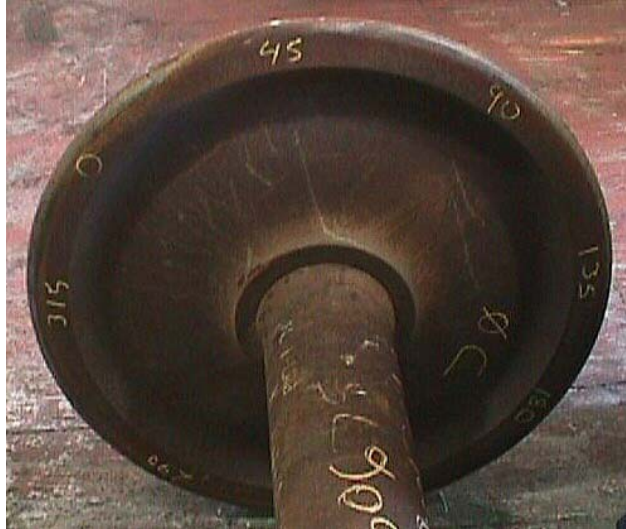
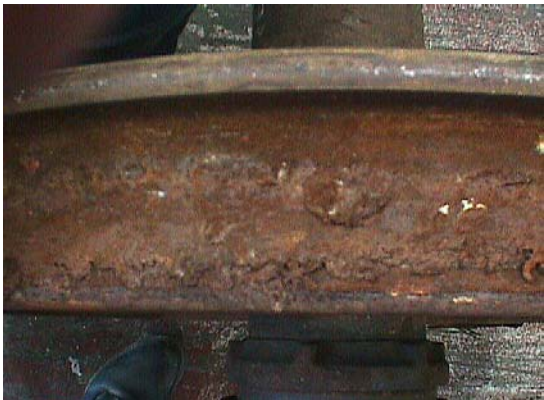
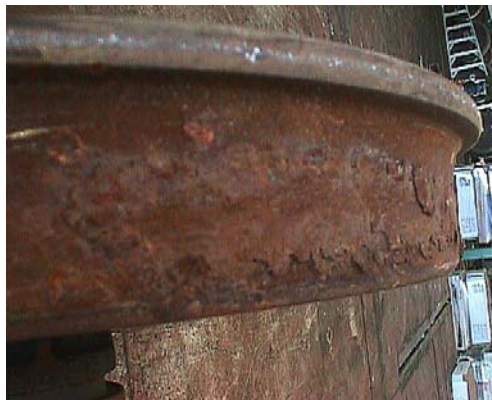
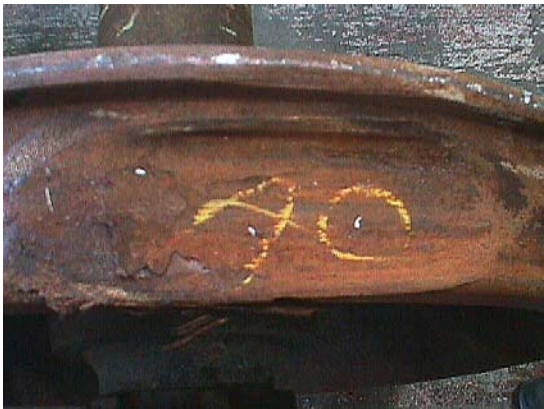
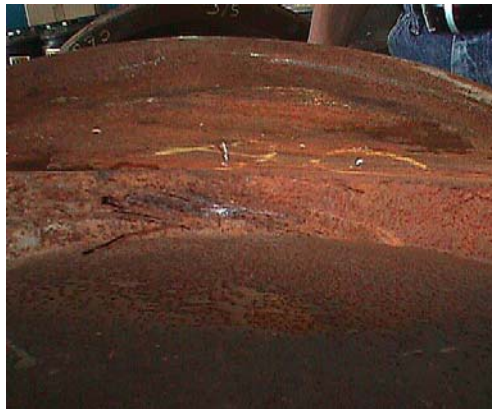
Wheel #10989 a tread damaged wheel at Progress Wheel Shop

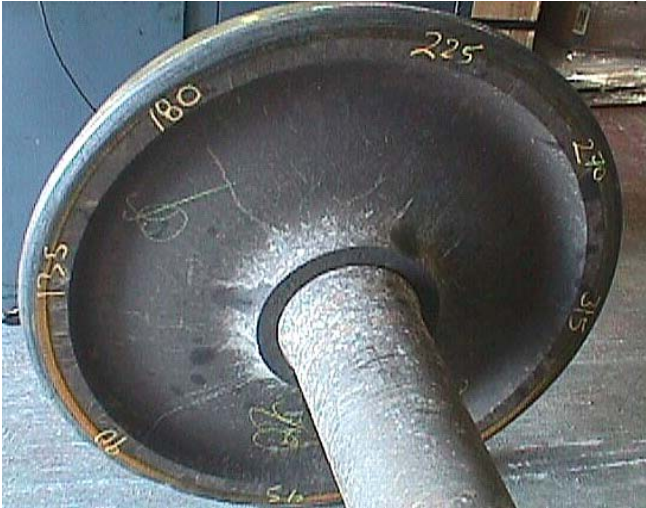
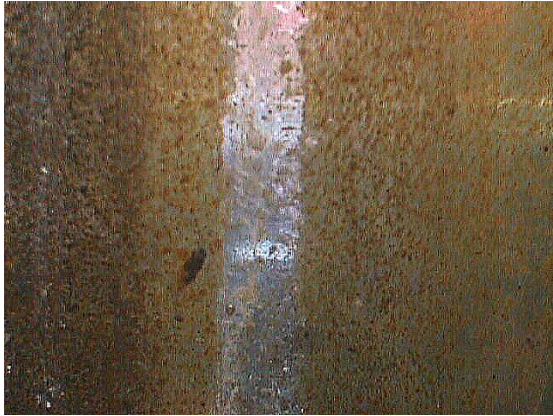
Wheel #12222 a “No tread damage” wheel at Progress Wheel Shop

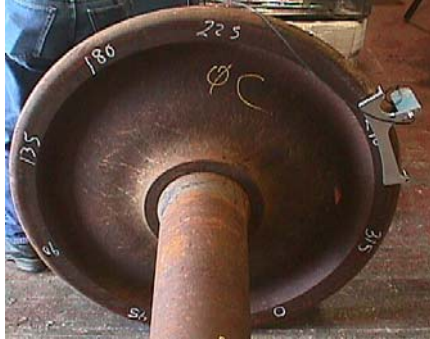
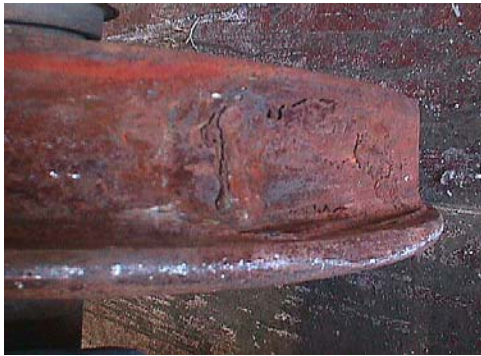
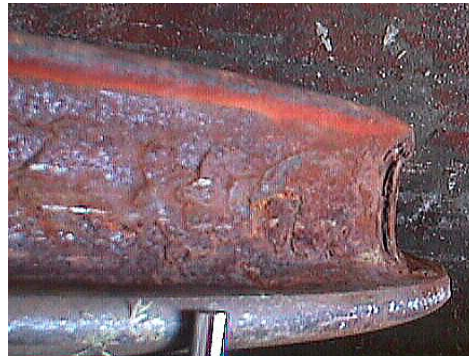
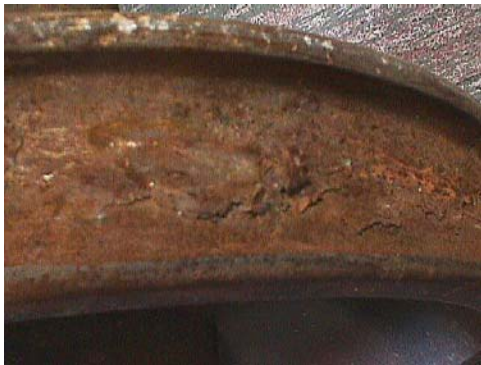
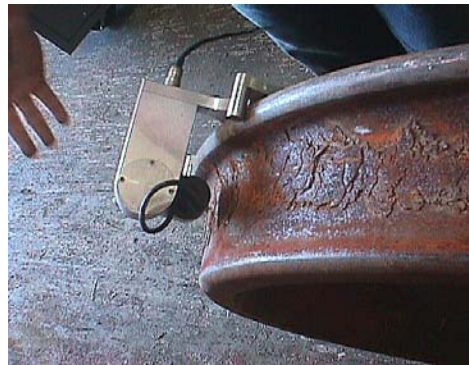
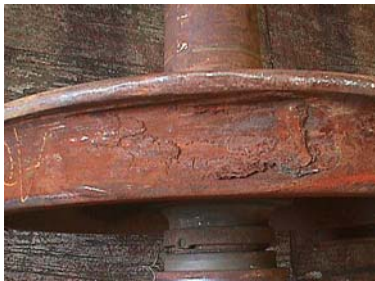
Wheel 14073
Heavy Tread Buildup
(Revenue Service Wheel Examination)
FRA TREAD BUILDUP TEST

Wheel #14073 a tread damaged wheel at Progress Wheel Shop

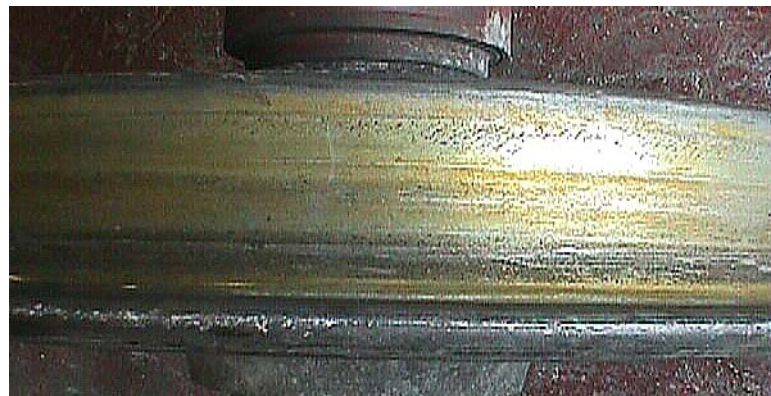
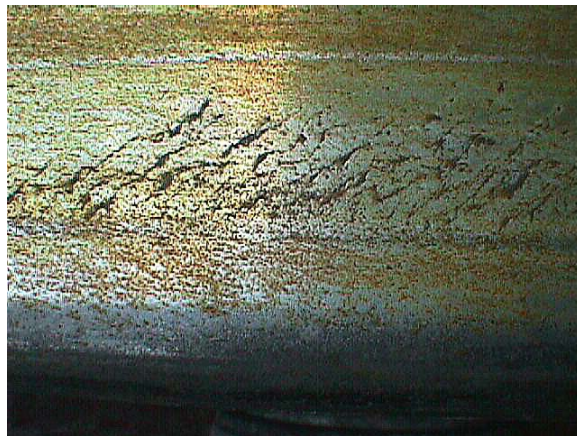
Wheel 15489 Thermal Cracks on Tread

Wheel #15489 a "No tread damage" wheel at Progress Wheel Shop

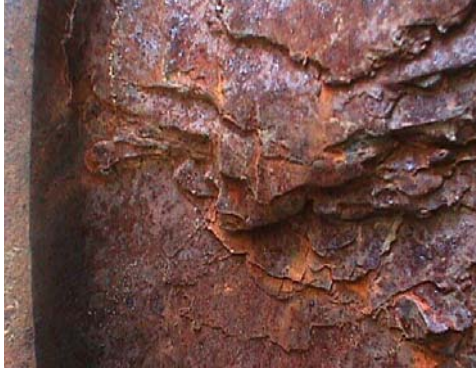
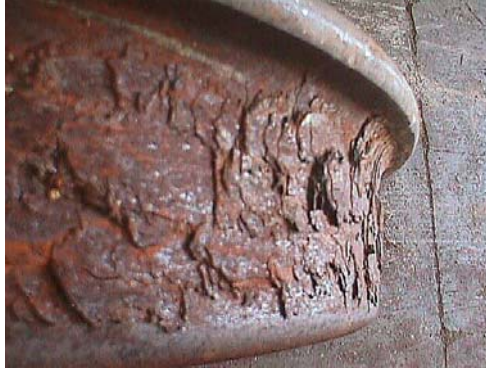
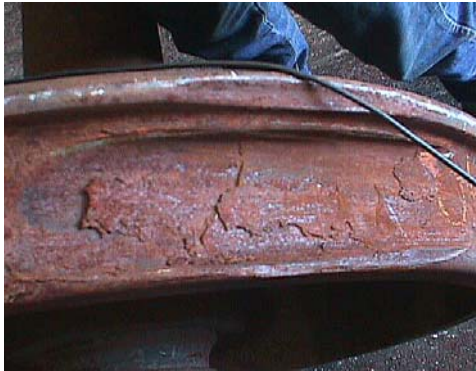
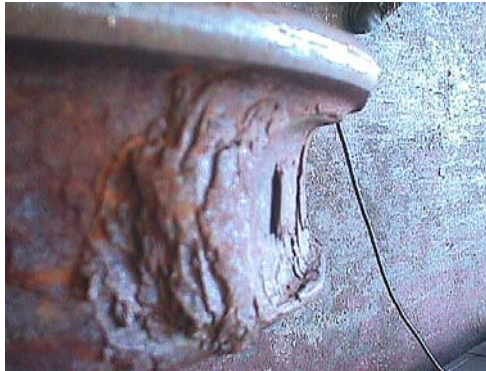
Wheel 38299
Heavy Metal Tread Buildup
(Revenue Service Wheel Evaluation)
FRA TREAD BUILDUP TEST

Wheel #38299 a tread damaged wheel at Progress Wheel Shop

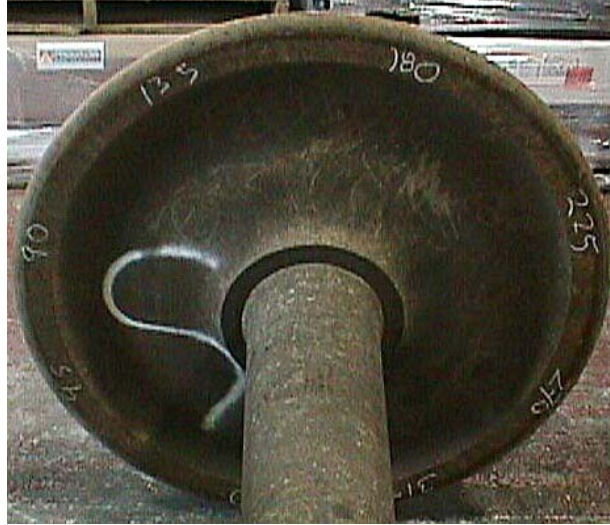
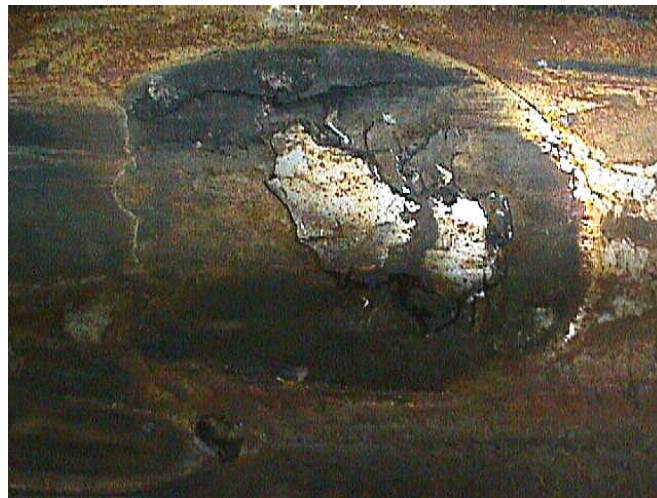
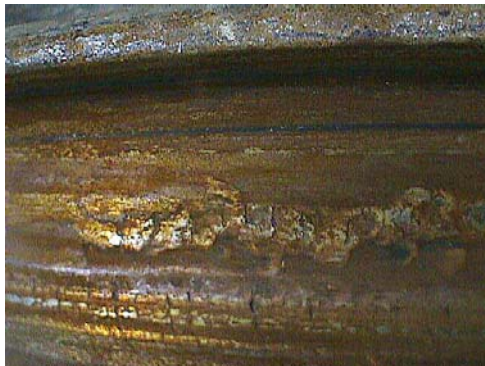
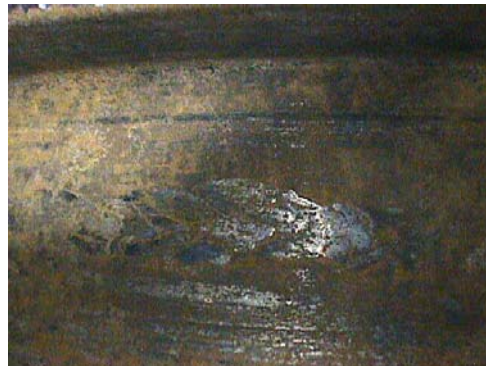
Wheel 49933
Slight Tread Metal Buildup
(Revenue Service Wheel Evaluation)
FRA TREAD BUILDUP TEST

Wheel #49933 a tread damaged wheel at Progress Wheel Shop

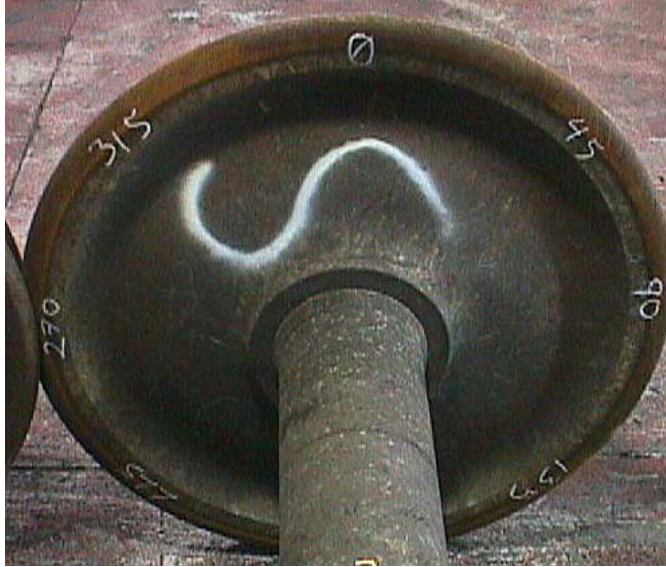
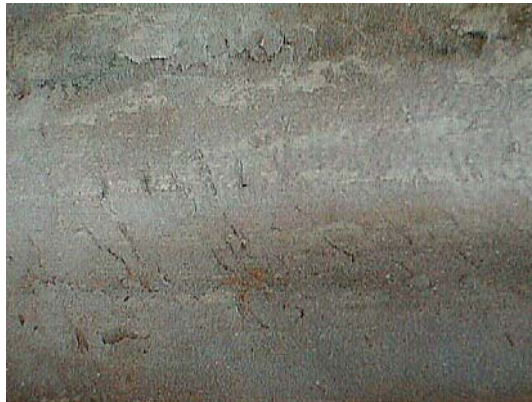
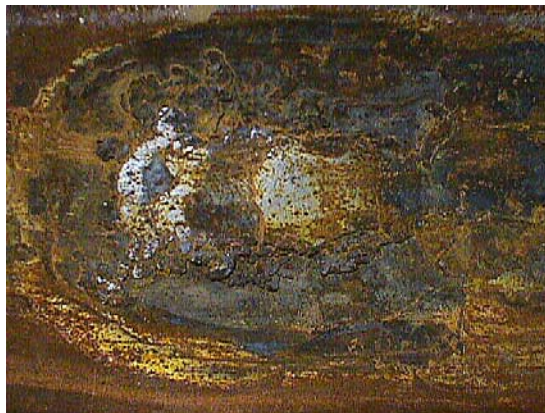
Wheel 50469
No Tread Buildup
(Revenue Service Wheel Evaluation)
FRA TREAD BUILDUP TEST

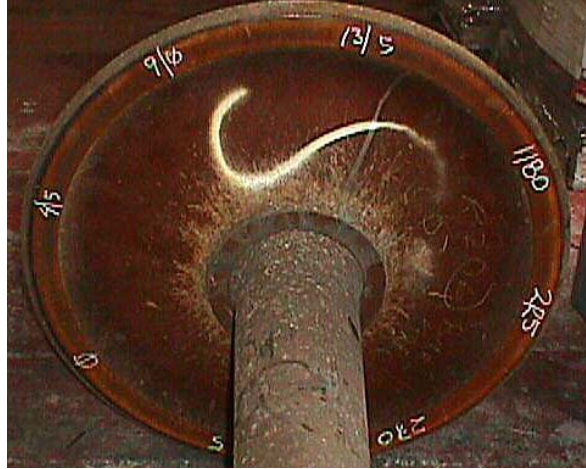
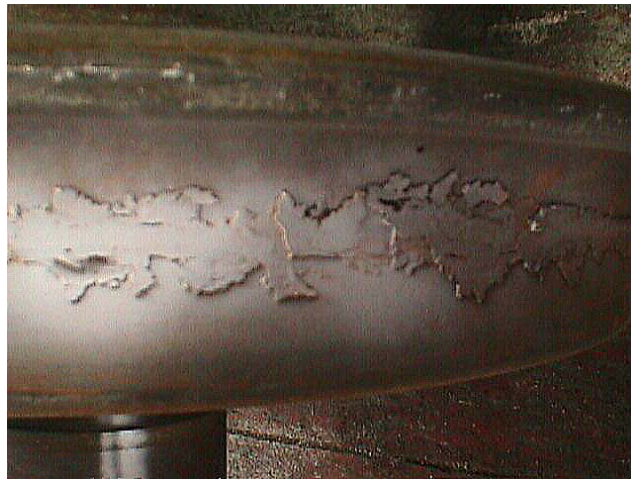
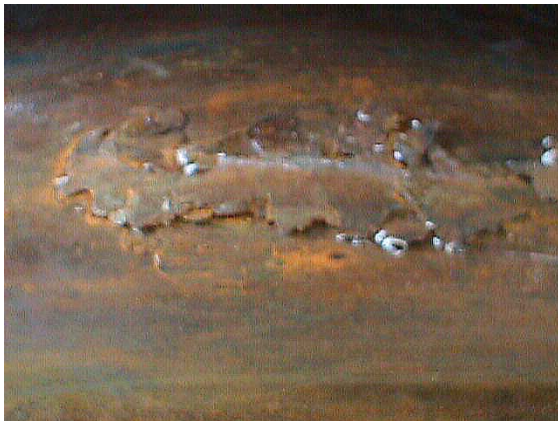
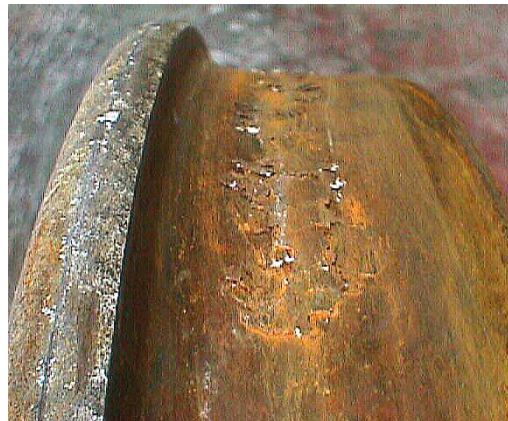
Wheel 51124
Moderate Tread Metal Buildup
(Revenue Service Wheel Evaluation)
FRA TREAD BUILDUP TEST

Wheel #51124 a tread damaged wheel at Progress Wheel Shop

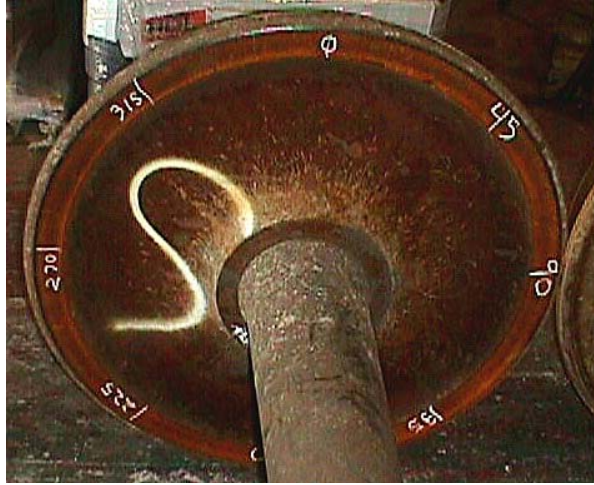
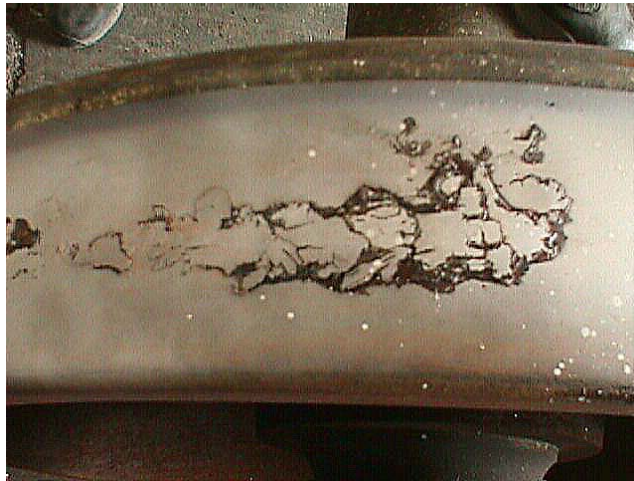
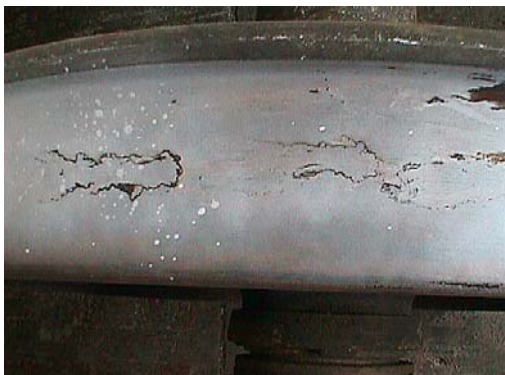
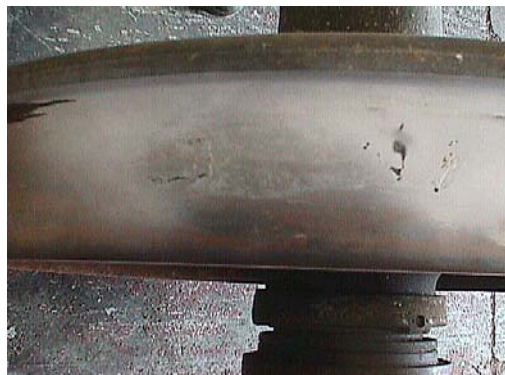
Wheel #53168 a tread damaged wheel at Progress Wheel Shop
