## Gage Restraint Measurement System Comparison Tests: Railbound and Hi-Rail Vehicles

1. AGENCY USE ONLY (Leave blank)		2. REPORT DATE December 2003	3. REPORT TYPE & DATES COVERED Final report	
4. TITLE AND SUBTITLE Gage Restraint Measurement System Comparison Tests: Railbound and Hi-Rail Vehicles			5. FUNDING NUMBERS AB021/RR19

11. SUPPLEMENTARY NOTES				
12a. DISTRIBUTION/AVAILABILITY			12b. DISTRIBUTION CODE	
13. ABSTRACT Comparative tests were conducted to evaluate the gage restraint measurement system (GRMS) testing capabilities of a railbound GRMS vehicle, Federal Railroad Administration's (FRA's) T-6, and a hi-rail vehicle, Holland Company's TrackStar GRMS system. The test objectives were to compare the performance of the two vehicles by monitoring the testing capabilities over the same section of track; evaluate repeatability and accuracy; and assess comparative vehicle performance over known defects. The tests were conducted on track owned by Maryland Midland Railroad, classified as FRA Class 2 track. Test data for both vehicles were analyzed with respect to FRA loading and gage restraint standards for GRMS testing and the requirements stated in the American Railway Engi

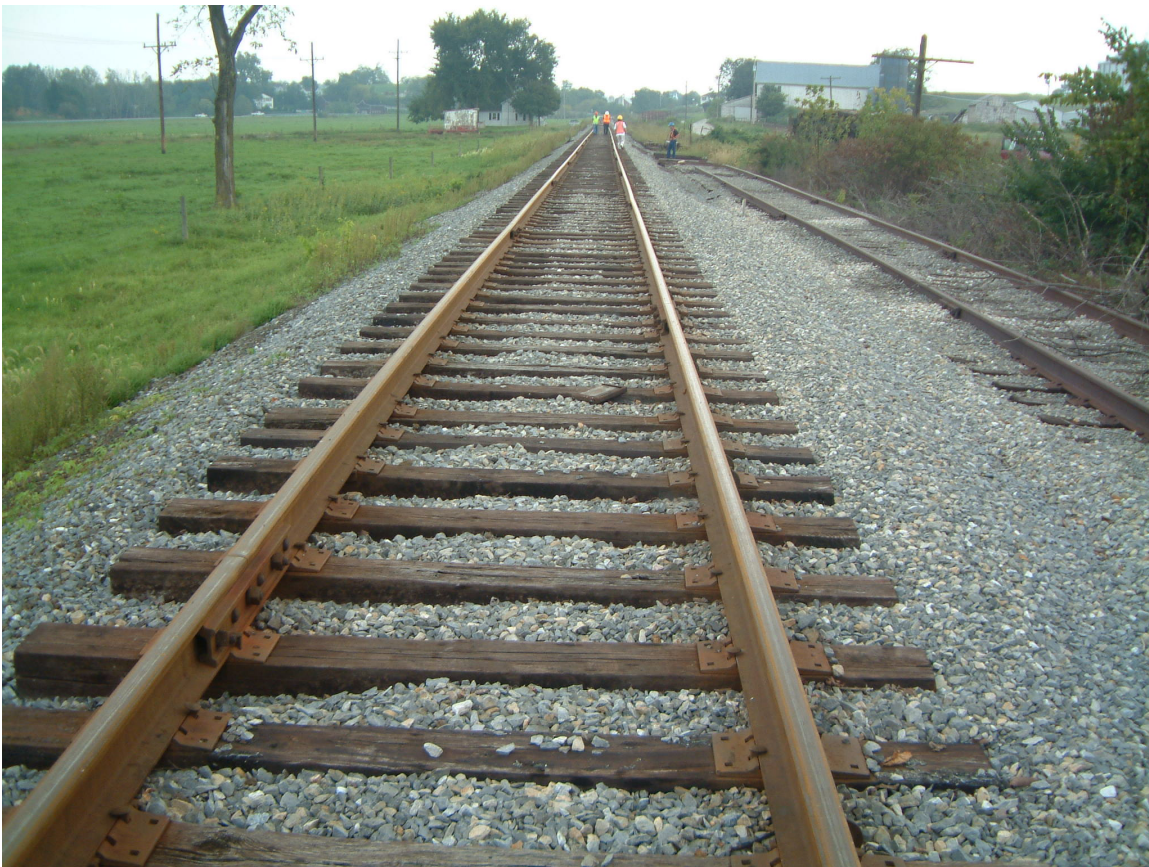
Figure 3. Tangent Track Section East of Union Bridge Used for Phase II Testing

Test sections for Phase II and III tests were identified based on test plan requirements, track condition, and gage widening data obtained during Phase I. The exact location for Phase II and III tests was determined from the Phase I data and previous gage widening data. Figure 3 shows the Phase II test section.

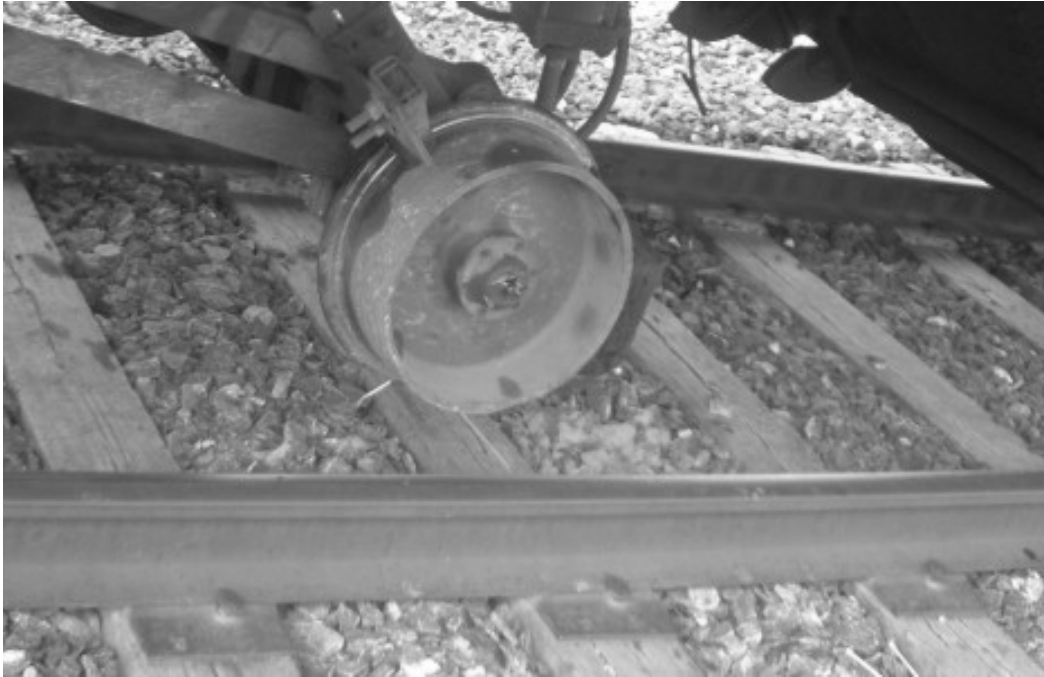
Figure 5. FRA's GRMS Unloaded Gage Measuring Axle Assembly in the Retracted Position

To eliminate the influence of the gage-spreading load, the unloaded gage is measured approximately 10 ft from the split axle using a small split axle trolley with 12-in. diameter wheels. Air pressure lowers and retracts the axle and provides a nominal vertical and lateral load to keep the wheel on the rail during testing. Figure 5 shows the unloaded gage measurement wheels in the retracted position.

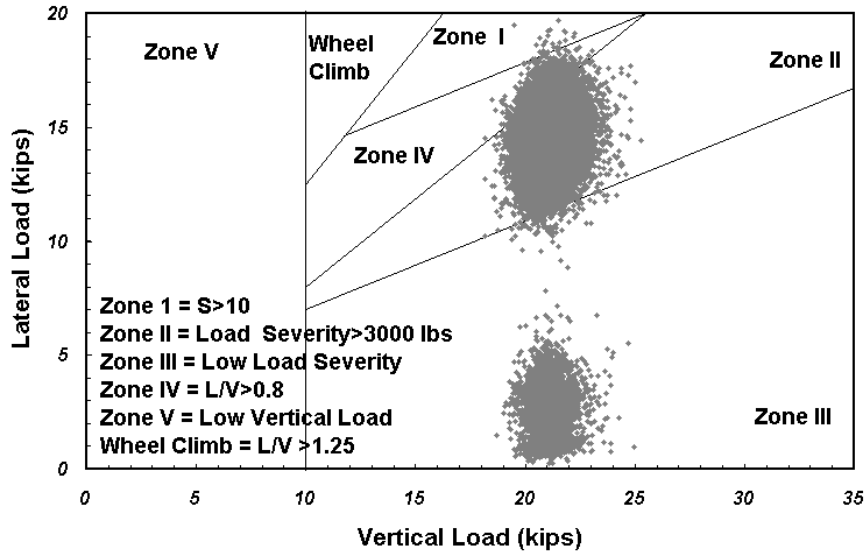
Figure 7. T-6 Vertical and Lateral Test Loads Plotted on AREMA's Recommended Test Load Chart

The figures indicate that both vehicles meet the load criteria. T-6 vertical loads were approximately 21 kips with a standard deviation of 0.71 kips while the lateral loads were 14.52 kips with a standard deviation of 1.35 kips. Nominal load for the T-6 was set at 21 kips vertical and 14 kips lateral. A lateral load cluster between 0 and 5 kips was caused by the release of the applied lateral test load at road crossings, switches, sliding joints, etc., to ensure safe operation.

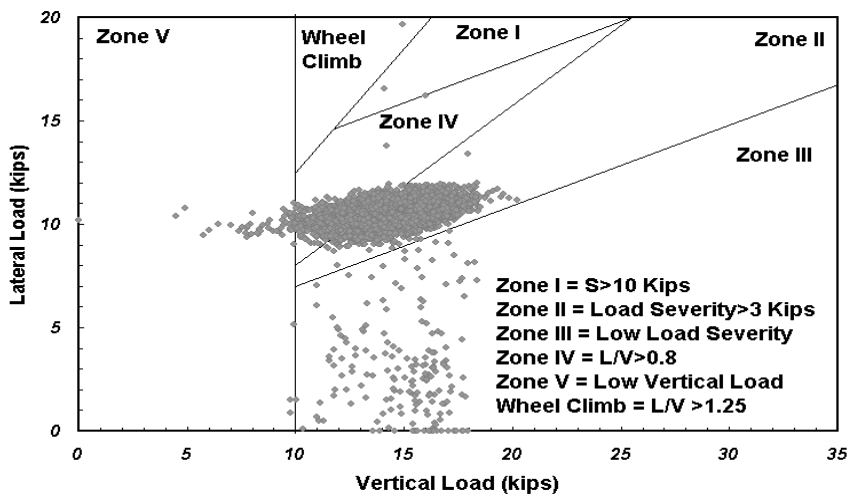
Figure 8. TrackStar Vertical and Lateral Test Loads Plotted on AREMA's Recommended Test Load Chart

The TrackStar vertical load data in Figure 8 is predominately in Zones II and IV, with very few exceptions where the load dropped below 10 kips. There are few lateral load values in Zone III, probably due to the removal of applied lateral test load at crossings, switches, sliding joints, etc. Since the lateral load for the TrackStar is controlled by a servo feedback system, the cluster is more distinct than that observed for the T-6. Nominal loads for the TrackStar were set at 15 kips vertical and 10 kips lateral. The actual loads for this section of track were 14.32 kips vertical with a standard deviation of 1.19 kips and 10.38 kips lateral with a standard deviation of 0.79 kips. With the exception of a few vertical loads falling below 10 kips, the TrackStar meets AREMA's requirements for GRMS testing.

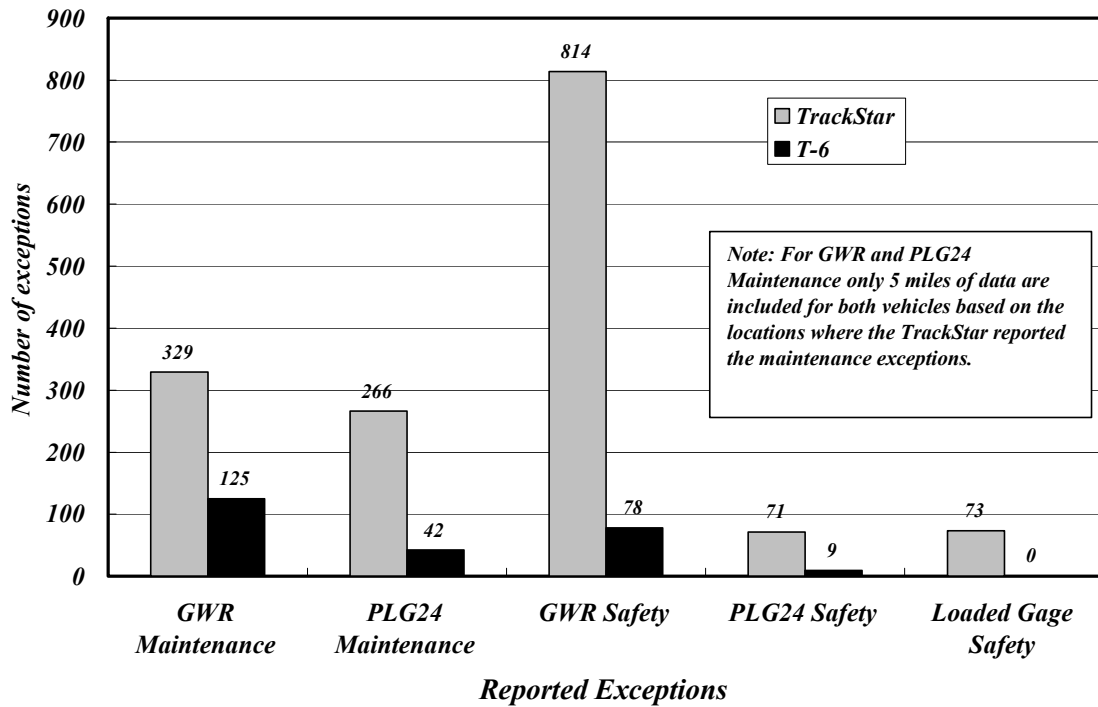
Figure 12. Gage Widening Safety and Maintenance Exception Comparison Between the T-6 and the TrackStar

The number of reportable exceptions—GWR and PLG24 for safety and maintenance and loaded gage safety as recorded by each vehicle—were compared as shown in Figure 12. The principal difference between the numbers of exceptions from the two GRMS vehicles is in GWR safety, with 10.17 more exceptions recorded by the TrackStar relative to the T-6. For GWR maintenance, PLG24 maintenance, and PLG24 safety the TrackStar’s number of reported exceptions was higher by 2.63, 6.33, and 7.89 times, respectively. Loaded gage safety exceptions were not identified by the T-6, thus no comparison can be made; however, the number of exceptions recorded by the TrackStar is given in the figure as 73.

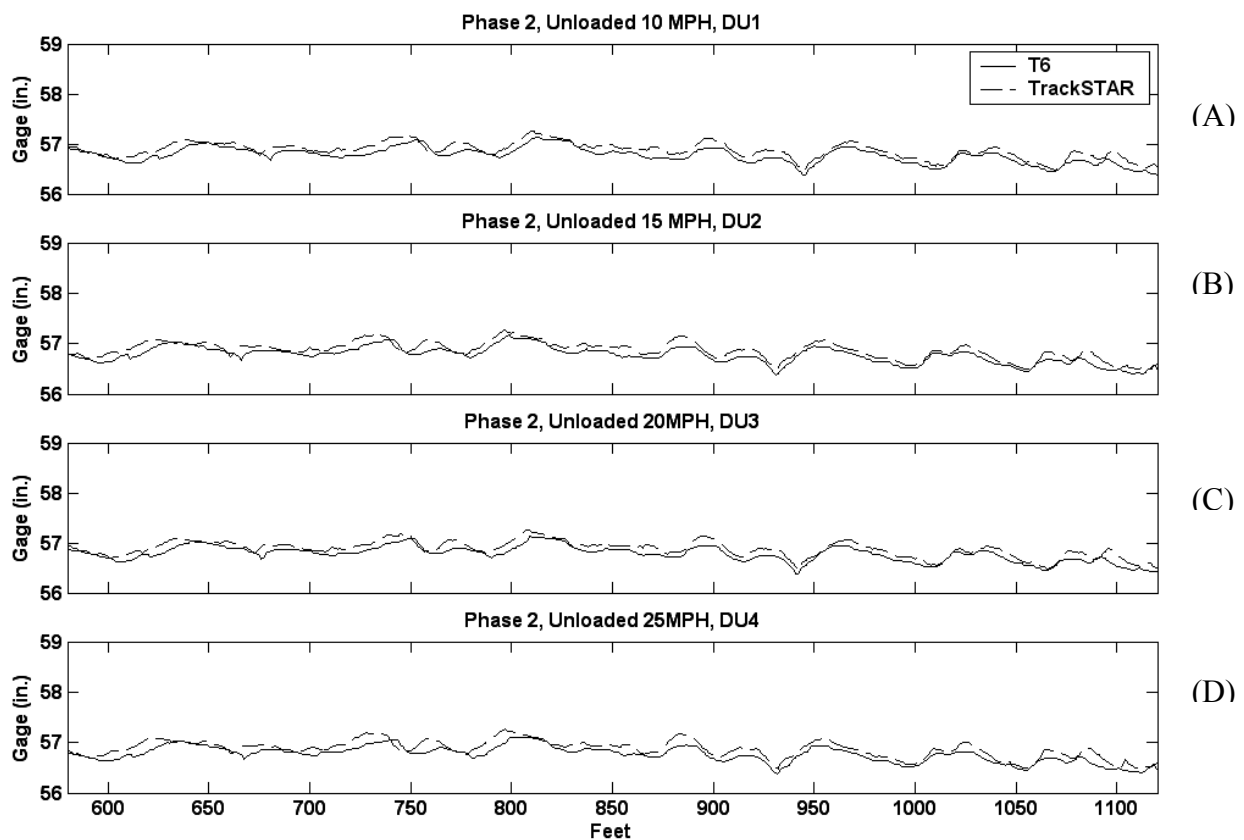
Figure 13. Unloaded Gage Measurement Variation With Speed

Figure 13 shows some very repeatable distinctions between the unloaded gage measurements made by the T-6 and the TrackStar. For example, at approximately 875 to 900 ft, the TrackStar repeatedly measures a peak in the data with higher amplitude than the T-6. By inspection, it also appears that all TrackStar unloaded gage measurements are higher in magnitude than the T-6 data.

The repeatability of both GRMS systems was found to be excellent during the Phase II testing. Both vehicles provided loaded and unloaded gage measurements that were very repeatable for the same test direction and vehicle. The unloaded gage data is indicative of the trend and is shown in Figure 13. The four passes at different speeds indicate the same variations for each vehicle. The track location in this figure varies for the 4 passes by up to 20 ft since these short test runs for Phase II were not aligned. The data from the TrackStar was manually shifted to align it with the T-6 data.

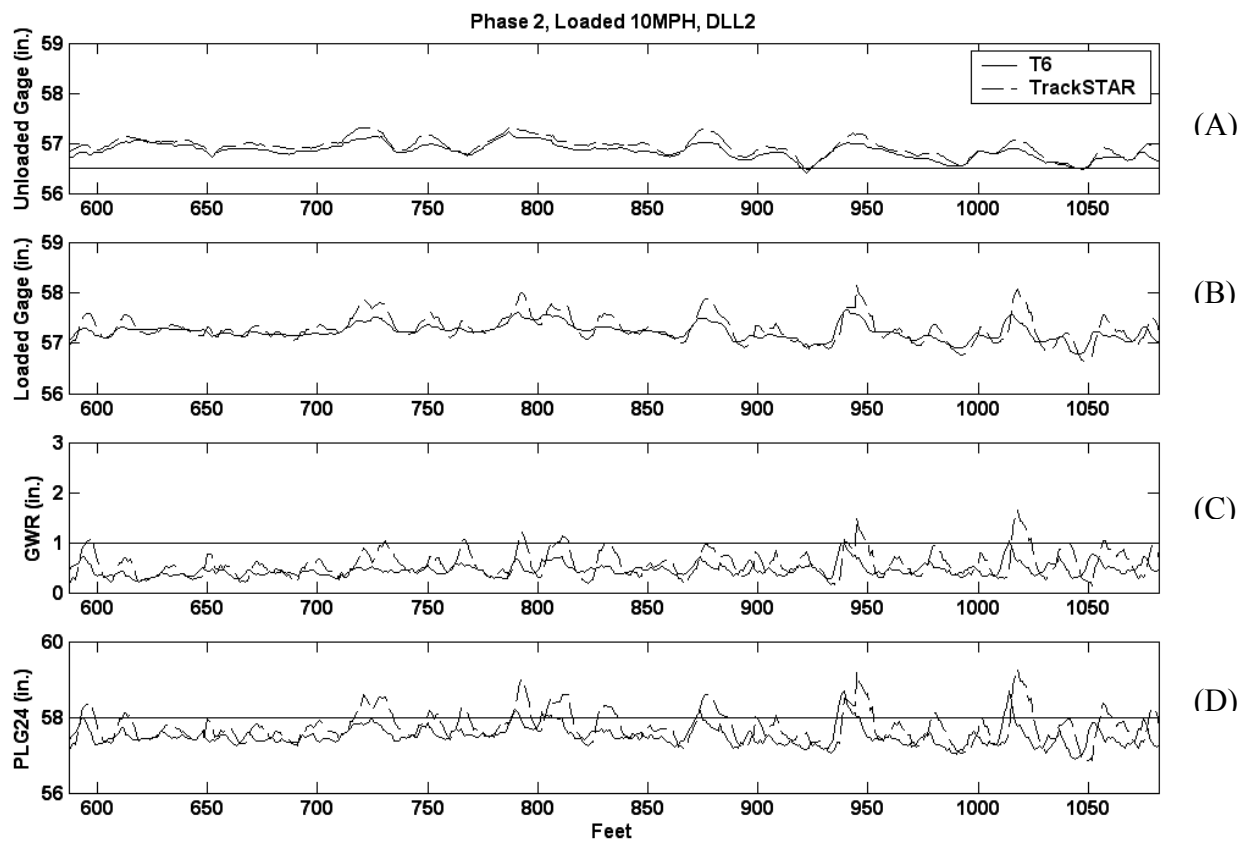
Figure 14. Test Parameters From 10 mph Phase II Test

All test parameters (unloaded gage, loaded gage, GWR, and PLG24) for a 10 mph pass for both vehicles are presented in Figure 14 for which the data from the TrackStar were manually shifted to align it with the T-6 data. The data indicates the previously observed higher unloaded gage for the TrackStar and a higher dynamic range (peaks higher and valleys lower than the T-6 measurements) of loaded gage, but with distinctly higher peaks than the T-6. This trend holds for both the GWR and PLG24 data. As an example, one of the largest peaks in loaded gage in both the T-6 and TrackStar data occurs at approximately 1,030 ft. The relative magnitudes of the loaded gage, GWR, and PLG24 are generally consistent.

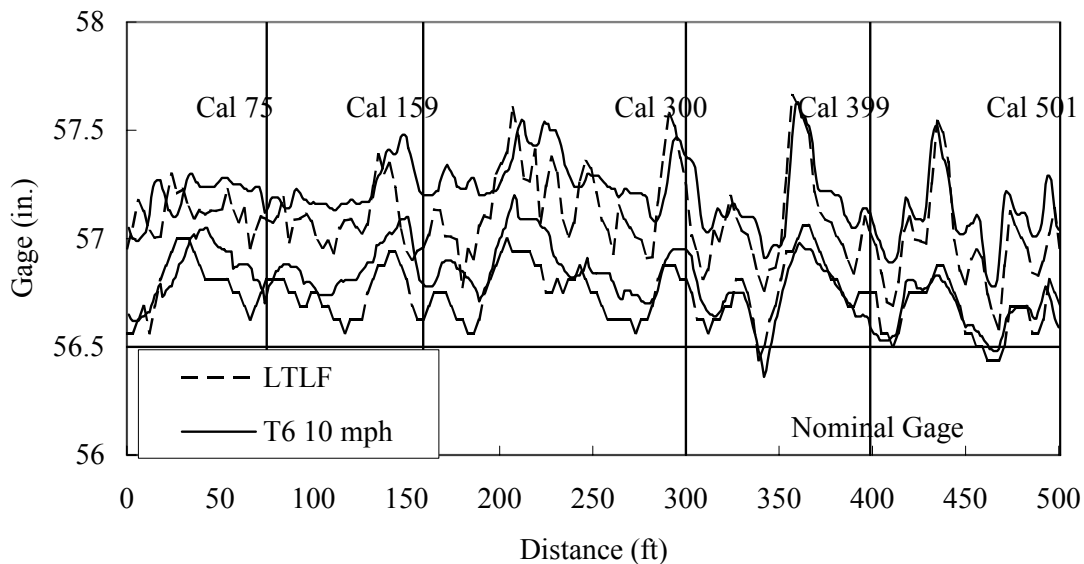
Figure 15. Comparison of T-6 10 mph Data With LTLF

A comparison of a 10 mph test pass from the T-6 and the static LTLF data is presented in Figure 15. The data in the plot are the loaded and unloaded gage measurements with the unloaded values lower in magnitude than the loaded gage. The LTLF data were collected every 3 ft through the 500-ft long tangent track test zone. The trends in the data for both the LTLF and the T-6 are remarkably similar considering that the LTLF provides a very different load condition. In general, the overall magnitude and trends are very consistent between the two measurement systems with some zones of distinct trends, particularly around 150 ft. Potentially, the differences in this zone are due to the applied load or very poor track and tie conditions. The comparison of the LTLF data and the TrackStar data is presented in Figure 16, which indicates higher magnitude unloaded and loaded gage measurements by the TrackStar, but with remarkably similar trends to the LTLF data. In addition, the distinction between the T-6 and LTLF data at 150 ft is also noticeable in the TrackStar data where similar trends are observed, but with a distinct increase in magnitude of both the unloaded and loaded TrackStar gage data. This shows that both vehicles measure track conditions indicative of dynamic gage widening problems since the differences between the LTLF and both vehicles are similar to the differences previously observed and the trends in all three datasets (LTLF, T-6, and TrackStar) are similar.

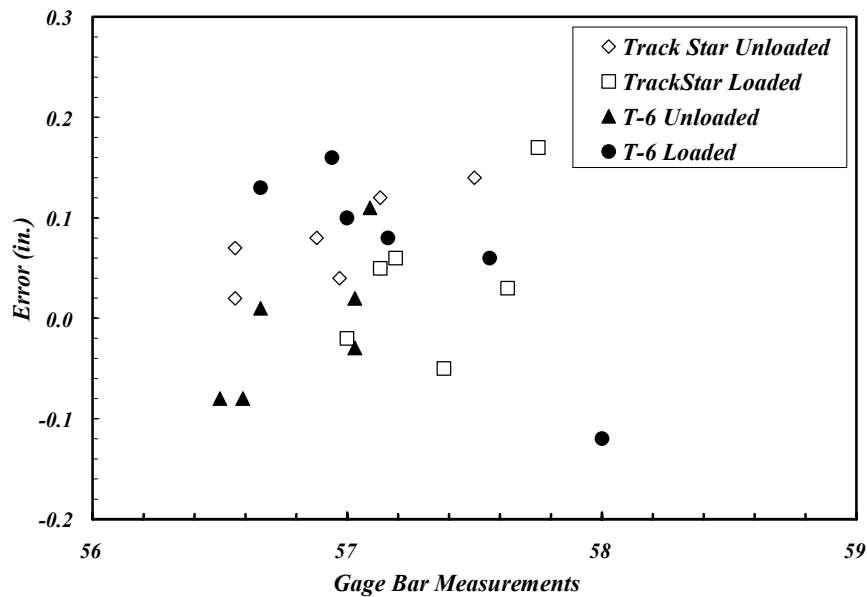
Figure 17. Error Plot Between the Gage Bar Measurements and the Two GRMS Vehicle Readings

The error between the gage bar measurements, which was considered the standard, and the measurements from the two GRMS vehicles, are plotted in Figure 17. As illustrated in the figure, there is no discernable error trend with loaded and unloaded gage for either GRMS vehicle.

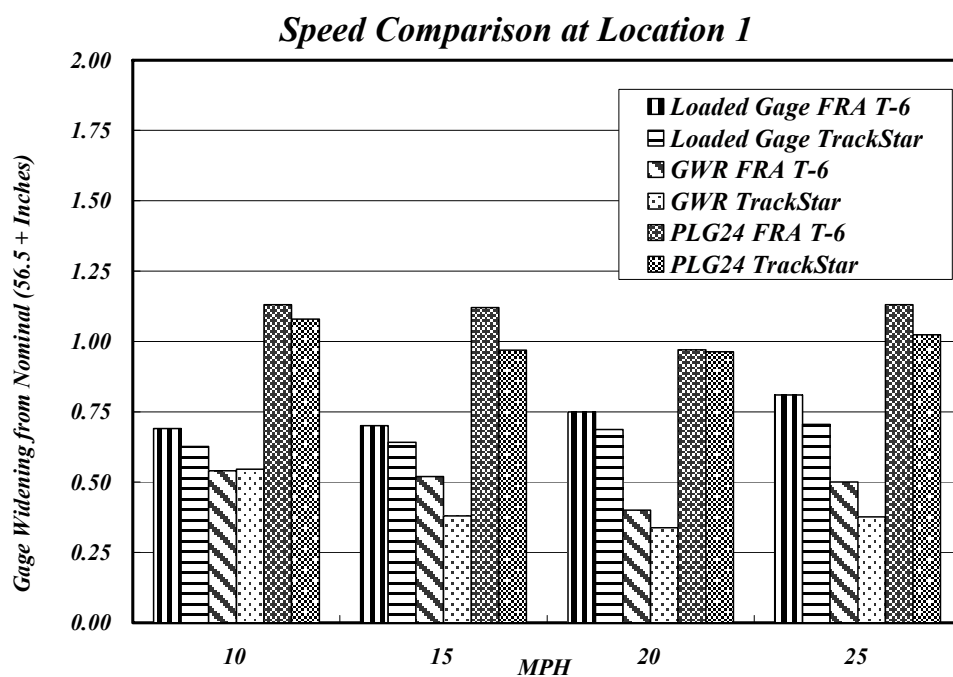
Figure 19. Loaded Gage, Gage Widening Ratio and Projected Loaded Gage 24 at Location 1 for TrackStar and T-6

A comparison of all the pertinent factors at Location 1 for all test speeds is shown in Figure 19. Loaded gage values for both vehicles are plotted as actual value minus nominal gage, 56.50 in. This format is used for all bar charts in this section. The data indicates that for PLG24, GWR, and loaded gage there is no significant change due to speed for both vehicles. A slight change due to speed variation is noted for both vehicles but not sufficient to conclude that there is any speed dependency difference between the vehicles at this location. Hence, it can be concluded that the data from both vehicles is not significantly speed dependent above 10 mph.

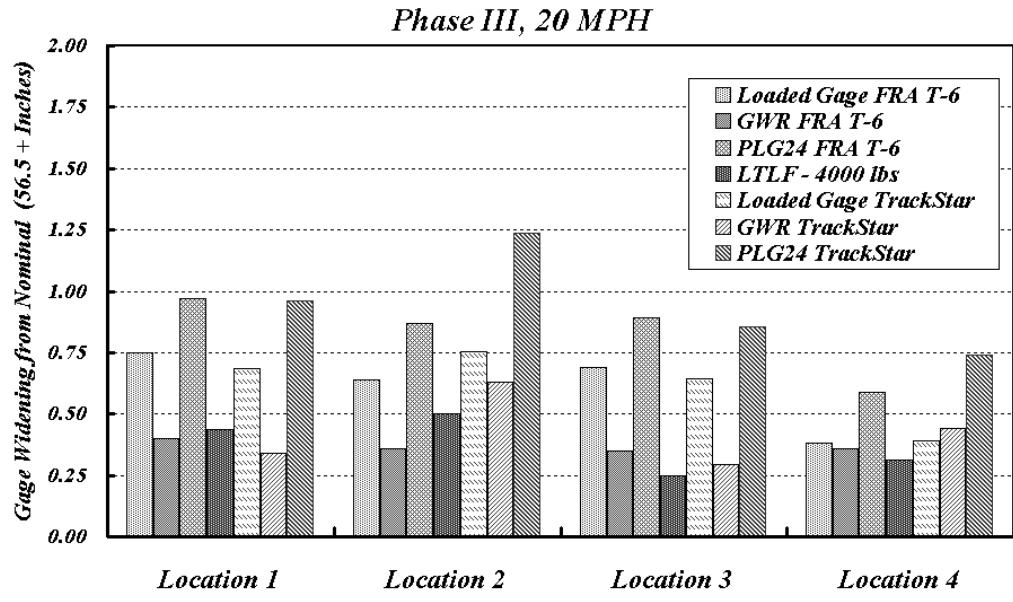
Figure 20. Parametric Comparison between the TrackStar, T-6, and LTLF at Phase III Selected Locations

A comparison of the recorded and derived information from the two GRMS vehicles at 20 mph and the LTLF are given in Figure 20. At all four locations containing “weak” and “strong” track, both vehicles recorded higher loaded gage than the LTLF; there was not a distinguishable pattern to explain the difference in the recorded value at all locations other than that both vehicles showed greater loaded gage widening. The loaded gage range was 25 percent to 157 percent higher for the TrackStar, while for the T-6 the range was 21 percent to 176 percent higher. Although there was variation when looking at the data for all locations, this variation was more consistent at each location between the LTLF and the two vehicles.

As expected, both vehicles recorded higher PLG24, GWR, and loaded gage at Locations 1 and 2, considered the “weak” tracks, than at Locations 3 and 4, considered the “strong” locations. With the exception of Location 4, where the TrackStar recorded higher GWR than loaded gage, none of the other data show any distinguishable patterns.

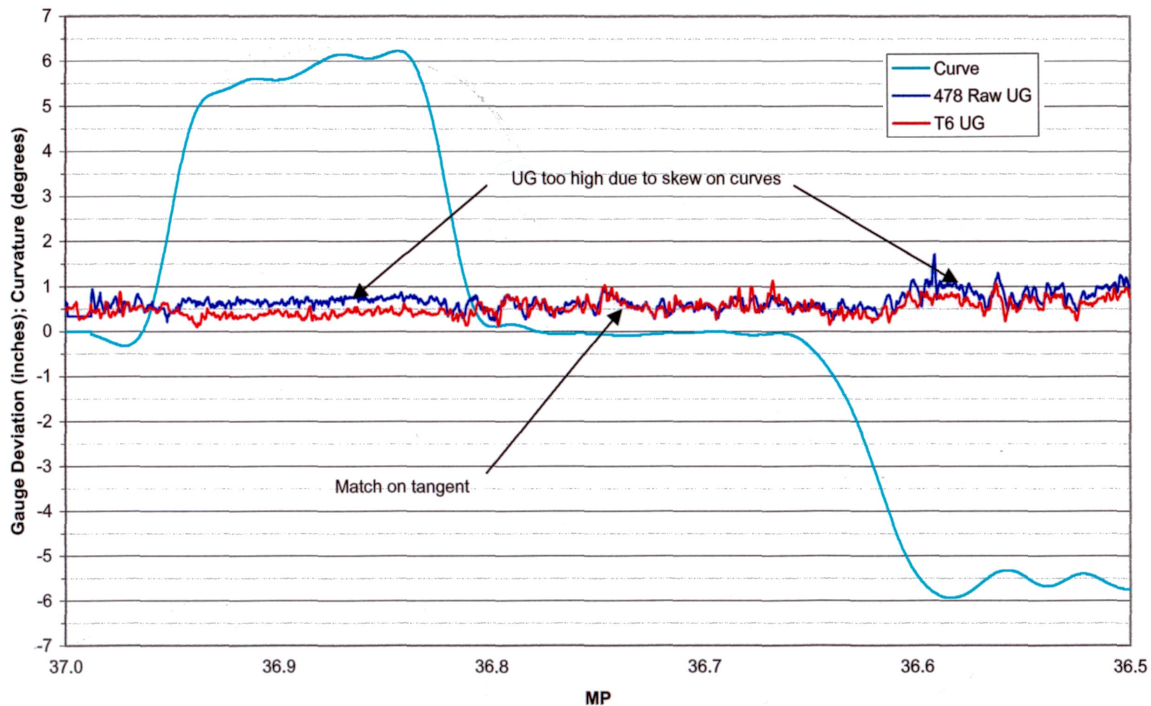
Figure 21. Uncorrected TrackStar Unloaded Gage [7]

where  $ULG_{\text{Corr}}$  is the corrected unloaded gage,  $ULG_{\text{Measured}}$  is the measured unloaded gage, and Curvature indicates the measured degree of curvature. Based on this equation, Holland Company corrected the 0.5-mile long section of data shown in Figure 21. The result of the correction is in Figure 22, which shows improved agreement between the TrackStar and the T-6.

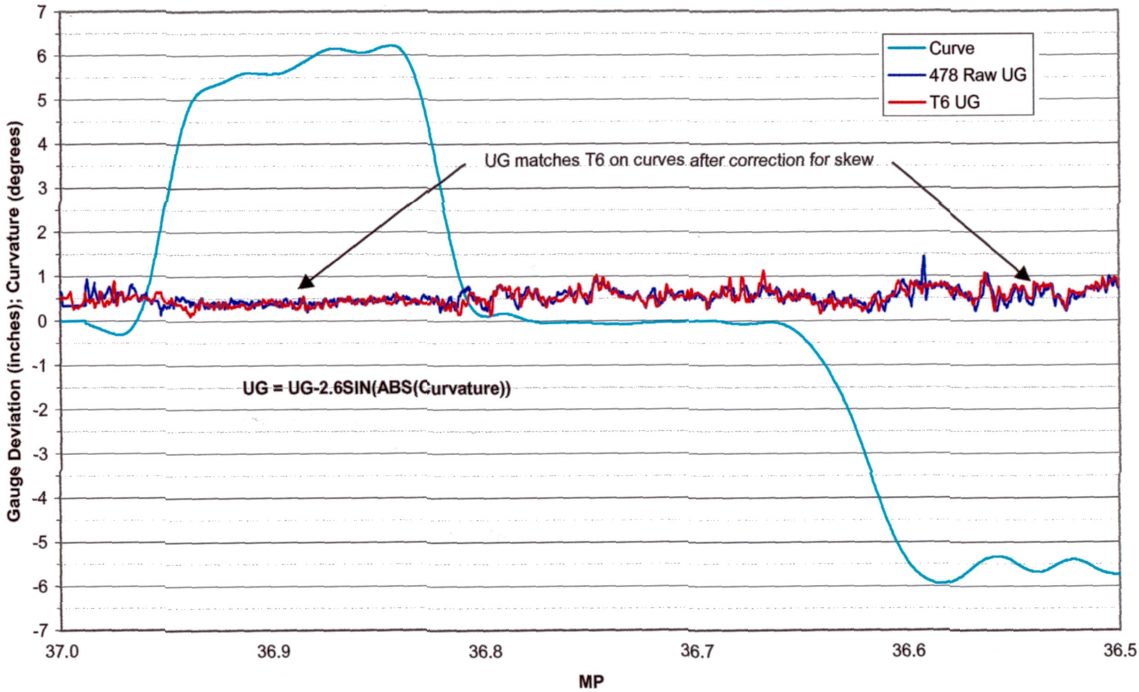
Figure 22. Corrected TrackStar Unloaded Gage [7]

Although the reason given for the unloaded gage error is not the cause of the error, the correction provided improves the agreement between the TrackStar and the T-6. Although further effort is required to identify and understand the error, it appears that the error is systematic and not random, indicating that system modification or calibration could correct the measurement error.

$$ULG_{\text{Corr}} = ULG_{\text{Measured}} - 2.6 \sin|\text{Curvature}| \quad (5)$$

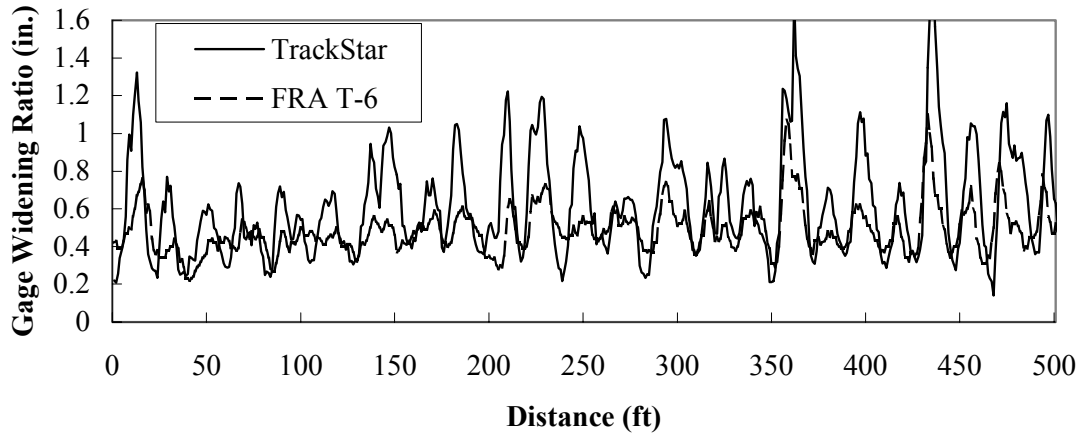
Figure 24. GWR Comparison, Phase II Test Site

In the data analysis from Phase II, it was noted that loaded gage from the TrackStar was both higher and lower in magnitude than the T-6. The larger observed data range for the TrackStar loaded gage likely results from the vehicle differences on the order of 30 percent in weak zones due to differences in loading magnitude, axle configuration, and load control. The difference in loaded gage could cause the observed variation in delta gage that was noted in the GWR data from the Phase II test site shown in Figure 24. The GWR data is mainly dependent upon the  $\Delta$  gage (loaded gage – unloaded gage) measured during testing, Equation 2. The GWR data show the expected higher dynamic range (both higher and lower magnitude) for the TrackStar data relative to the T-6. However, the overall magnitudes in a weak track location, such as the zone at approximately 150 ft, show the much larger values provided by the TrackStar. This large difference in GWR values in weak zones likely resulted in the many GWR safety defects identified by the TrackStar, but not the T-6. For instance, in the zone at 150 ft, the T-6 GWR value was 0.51 in. and the TrackStar value was 1.03 in., which represents a difference of over 100 percent.

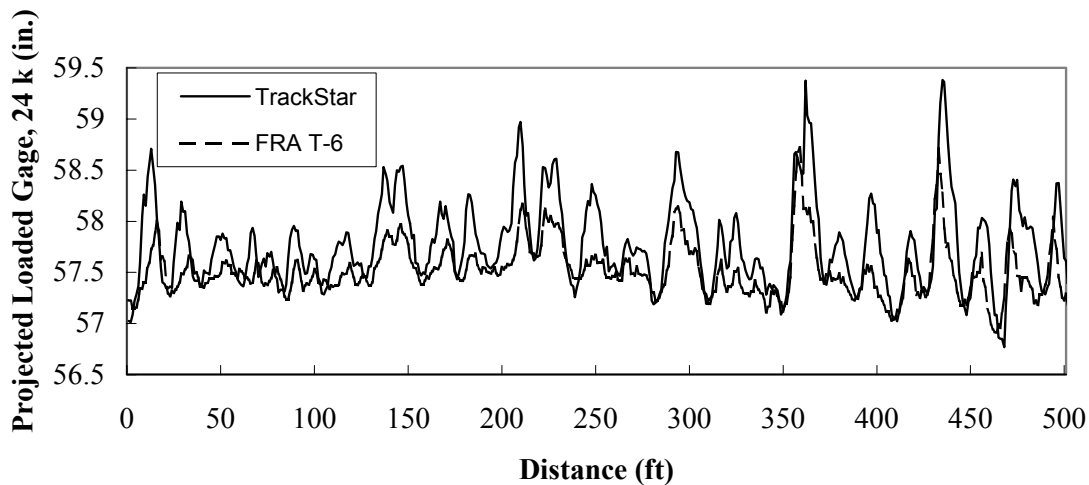
Figure 25. Projected Loaded Gage Comparison, Phase II Test Site

The larger data range of the delta gage data from the TrackStar compared to the T-6 will also affect the projected loaded gage (PLG) data. Projected loaded gage is an indication of the behavior of the track under ultimate acceptable load conditions. Equation 3 presents the formulation for PLG and the data recorded by both the TrackStar and T-6 at the Phase II test site is shown in Figure 25. The data indicate the previously observed trend of TrackStar higher dynamic range compared to the T-6, but with a tendency for overall higher magnitude values especially in weak track zones. In the weak zone at approximately 150 ft, the PLG derived from the TrackStar data was 58.5 in. and 57.9 in. from the T-6.
