Compilation of Pedestrian Safety Devices In Use at Grade Crossings

Federal Railroad Administration

Prepared by the Office of Safety, Federal Railroad Administration

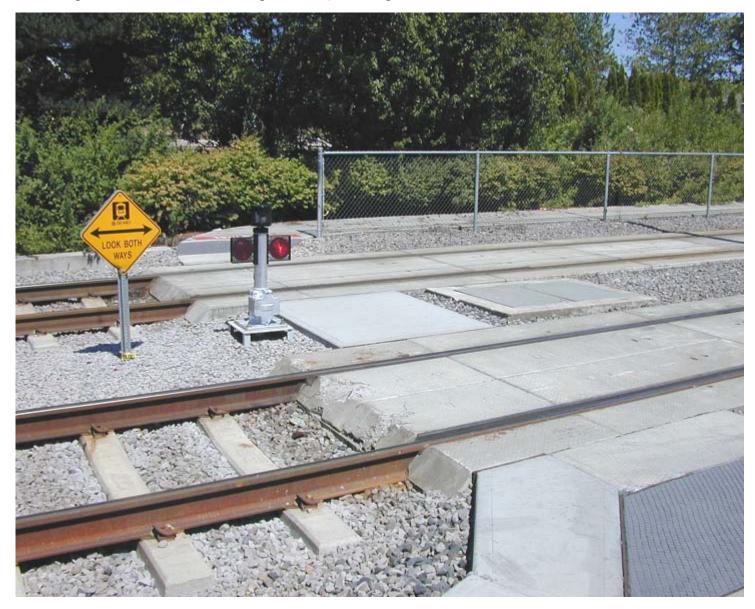
Light rail transit systems often include pedestrian grade crossings. As a result, they are also the greatest source for warning devices aimed at pedestrians. Some examples are discussed here. This low-rise flashing pedestrian signal is in use on the Portland, OR, light rail transit system. This device was studied locally, and was found effective (in conjunction with the fencing used as a pedestrian channelization improvement) based upon before and after data.

The intended pathway for pedestrians in this situation is clearly defined. A design drawing for this device, developed by Tri-Met, the light rail system in Portland, Oregon, is included on the next page.

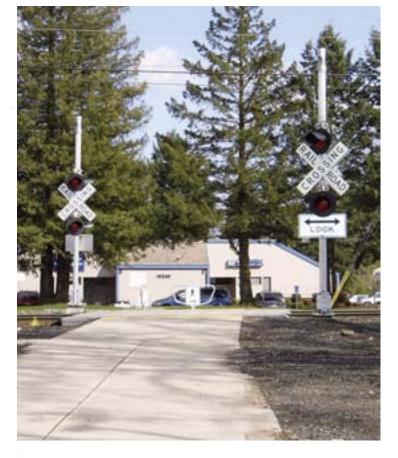
OAR 741-110-0030(3)(c) OAR 741-110-0040(4) FIGURE 9

The State of Oregon has developed a pedestrian signal that has been used at stand-alone, "multi use" crossings. It is similar to a standard flashing light signal except the lights are oriented in a vertical line, rather than the more commonly seen horizontal alignment. One of Oregon's most recent installations of these devices is shown in the photo above, at a new pathway grade crossing in Tualatin, OR. The railroad is the Washington County Commuter Rail line between Beaverton and Wilsonville. Commuter rail service is anticipated to be underway within the next couple of years.

Oregon also routes any pedestrian facility 5' behind any crossing gate arm assembly to account for the position of the gate arm counterweight when the gate is horizontal. Additionally, Oregon has expressed interest in the use of some sort of train-activated, in-pavement flashing lights at high profile, high traffic pedestrian locations. To date, there have been none installed in Oregon. Such a train-activated device will likely involve coordination with the railroad involved, given the need to establish (or interface with) a train detection system for device activation.

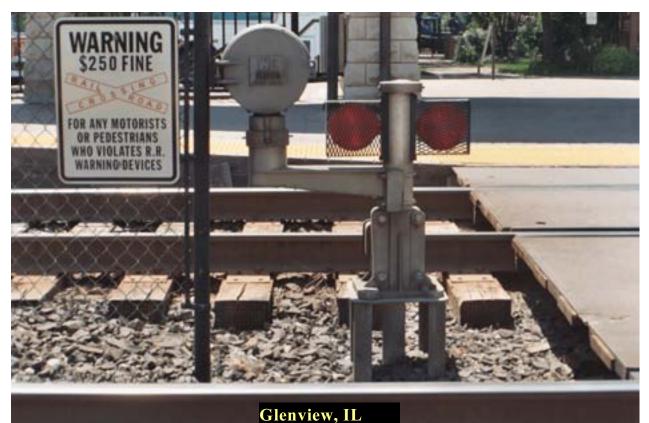
ABOVE: Glenview, IL, on Metra's Milwaukee District North Line, has established a \$250 fine for any pedestrian who violates railroad warning devices. Warning devices include both a bell and flashing light signals.

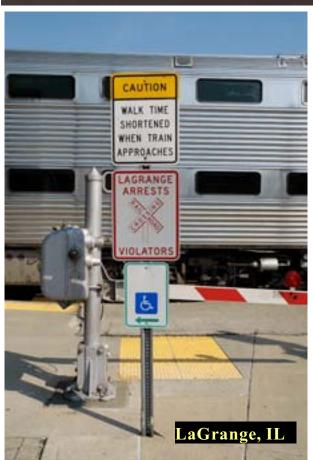
> LEFT: This signing is in place at LaGrange Road Metra station. The numerous pedestrian crossings in this area make tougher sanctions necessary to prevent tragedies.

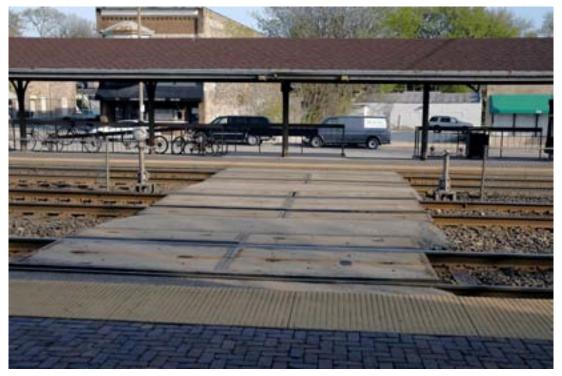
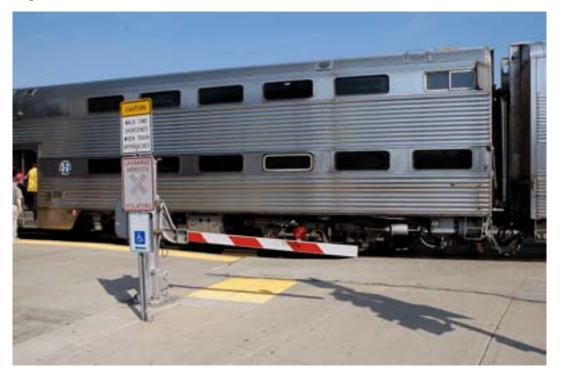
Stone Avenue Metra station (ABOVE) in LaGrange, IL features these pedestrian warning devices between inbound and outbound platforms. Short gate arms (BELOW) are used at the LaGrange Road station.

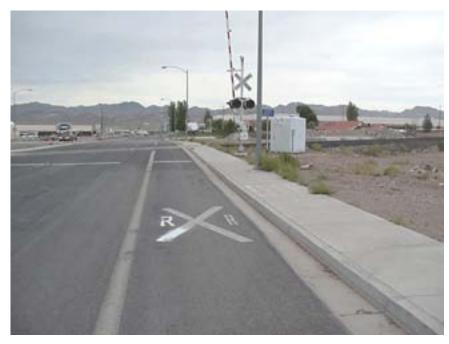
LEFT: In Henderson. Nevada, along Horizon Drive, both the bike lane and the sidewalk are included in the same crossing. With the warning device assembly located behind the sidewalk, a single gate arm serves pedestrians, bicyclists and motor vehicle traffic. The crossing surface is continuous across the tracks to the other side, delineating the safe crossing path for pedestrians.

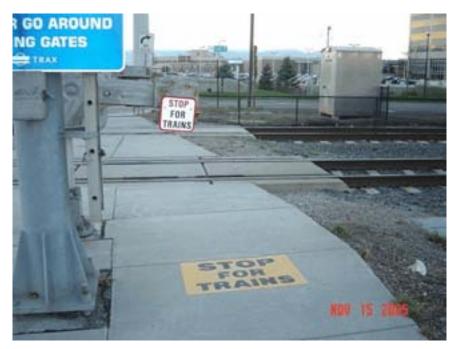
RIGHT: In Utah, Salt Lake City's UTA TRAX light rail system is evaluating the effectiveness of specialized warning signs for pedestrians. Below is a safety treatment that they installed at one crossing, which is close to a middle school and other sources of pedestrian traffic. Light rail trains run at 55mph over this crossing, so this was felt to be a good test site for these devices intended to provide additional safety awareness to pedestrians. Notice the small sign placed on the crossing gate counterweight.

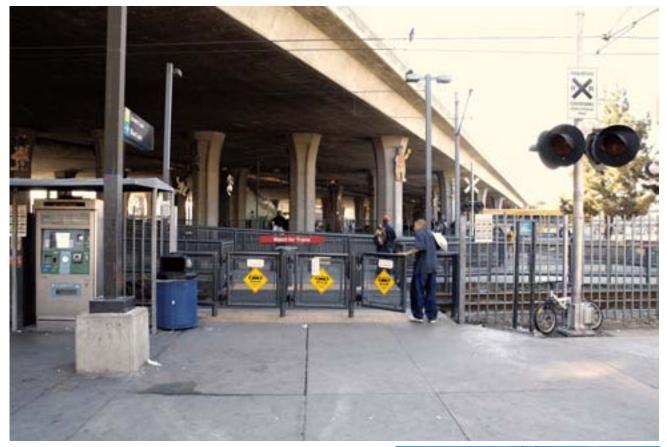
The use of channelizing devices can help encourage some of the desired behavior in pedestrians when they attempt to cross the tracks. In the case shown above, the use of "swing gates" at this light rail transit station serves to focus the eyes of the pedestrian in the direction from which a train on the near track would be entering the station. This has reduced incidents related to passenger inattention to trains in the station area.

In order to operate the gate, and enter the station, the user must turn in the direction of oncoming train traffic, and then stop to open the gate. This can reduce sudden, inattentive "dart outs" into the path of an oncoming LRT train. In addition, signing is used on each gate : PULL TO OPEN, LOOK BOTH WAYS, along with a large Watch For Trains sign posted in clear view.

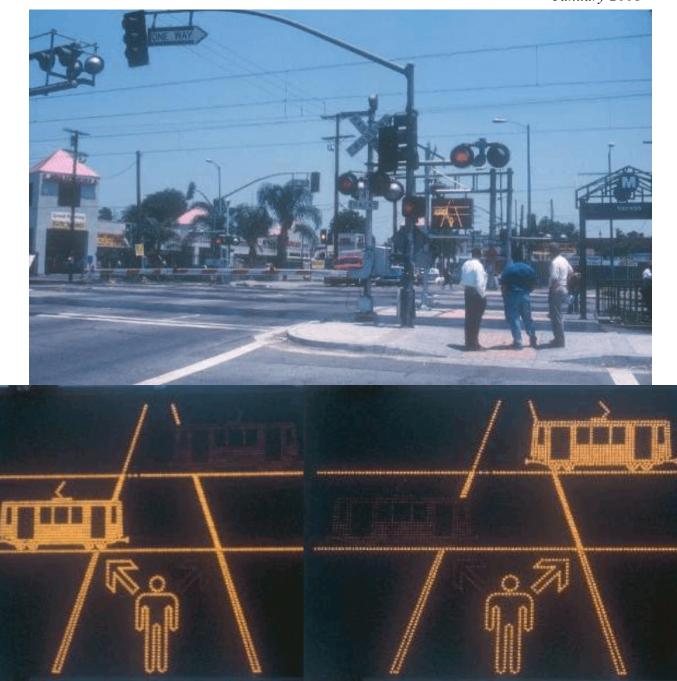
An innovative Second Train Coming warning sign at a transit station stop is in use at the Vernon Avenue stop on the Los Angeles Metro Blue Line. The sign features a unique series of picture images intended to remind pedestrians to look in both directions, on both tracks, for approaching trains. This sign was originally designed and installed at Vernon Avenue as a demonstration

project funded by the Federal Transit Administration (FTA), under the Transit Cooperative Research Program. The project evaluated the use of a train-activated device to give pedestrians additional warning of the potential for two trains to enter the crossing at the same time.

The Vernon Avenue crossing was selected because it had one of the highest collision counts of any crossing in the system. The crossing has two Blue Line light rail transit tracks adjacent to two Union Pacific general system freight railroad tracks. The entrance to the adjacent Vernon Avenue station is on the crossing, between the two Blue Line tracks.

The effectiveness of the new sign was evaluated by a "before and after" study, along with a survey of pedestrians at the crossing. The intent of the survey was to ascertain pedestrian awareness of the new sign, and to determine the level of understanding of the sign's display.

The sign was found to successfully reduce the frequency of risky behaviors at the Vernon Avenue crossing. The pedestrian survey revealed that over three-quarters (77%) of the 556 people interviewed said that they recalled seeing the new sign.

At the same time, not many of them (4%) actually related its display to the presence of two trains at the crossing at the same time. It should be noted, however, that the overwhelming majority of those asked said that they understood that the sign's display was meant to indicate danger.

The sign has recently had its operation modified so as to illuminate upon the approach of even a single train on any track. It is believed that this will lead to better and more careful observation of the crossing and tracks by pedestrians as they approach the Vernon Avenue crossing and adjacent passenger station.

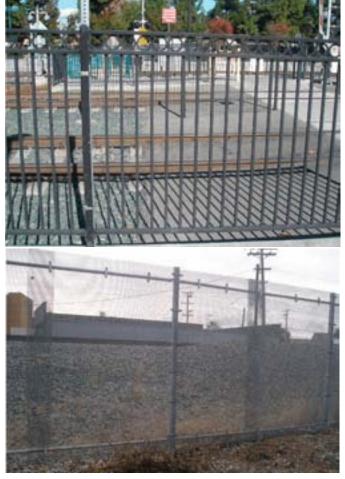
RIGHT: The "zigzag" or "Z-Gate" crossing is a good example of channelization that also can improve pedestrians' observation of any approaching trains as they traverse the crossing approaches. Pedestrians are forced to look in the direction of oncoming trains as they make the turns approaching the crossing. While this type of crossing does increase the distance that pedestrians have to travel, sturdy fencing provides good compliance.

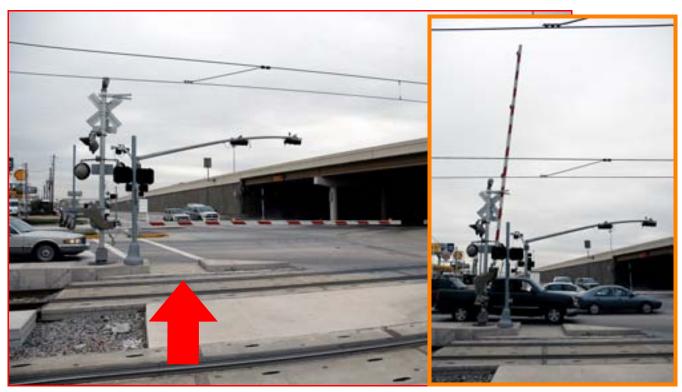
LEFT: As these two examples show, many different types of fencing can be effective as a channelization device. Fencing should be substantial enough to command respect, and provide positive guidance along the desired travel pathway. But at the same time, fencing is an element of the visual environment, and must be reasonably pleasing to the eye.

Fencing does add a fair amount of maintenance responsibility, as fences are prime targets for graffiti and vandalism. Agencies that plan on using fencing extensively need to plan on performing regular maintenance on their runs of fencing, in order to maintain effective channelization as well as a pleasing appearance to the area.

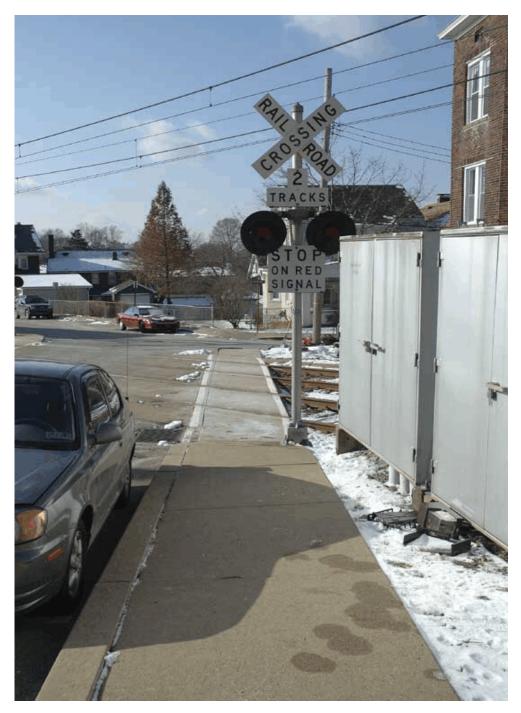
Light rail systems that are the remnants of streetcar networks constructed in the early 20th century often feature a higher frequency of pedestrian and street crossings. Many of these systems retain crossings with restricted sight distances due to the development that has taken place around the transit line. In this photo, there are railroad wayside signal cabinets adjacent to the sidewalk approaching the light rail station, as well as the controllers for the grade crossing system. For pedestrians walking downhill toward the station, sight distances to the right are extremely limited. This makes the pedestrians very dependent upon the crossing warning devices for notice of an approaching train.

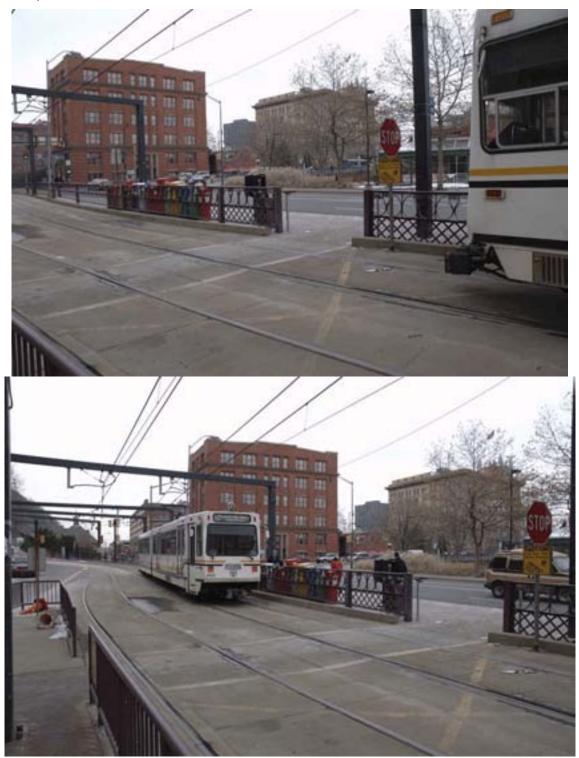
In rare circumstances within a station, a transit system may elect to have a safety stop for all outbound vehicles. This stop is used to allow passengers to cross over to the inbound platform, which only has access from this side.
