Summary and Conclusions from Investigation of the Effects of Historical Mining in the Boulder River Watershed, Jefferson County, Montana

**Integrated Investigations of Environmental Effects of Historical
Mining in the Basin and Boulder Mining Districts, Boulder River
Watershed, Jefferson County, Montana**

Professional Paper 1652–A

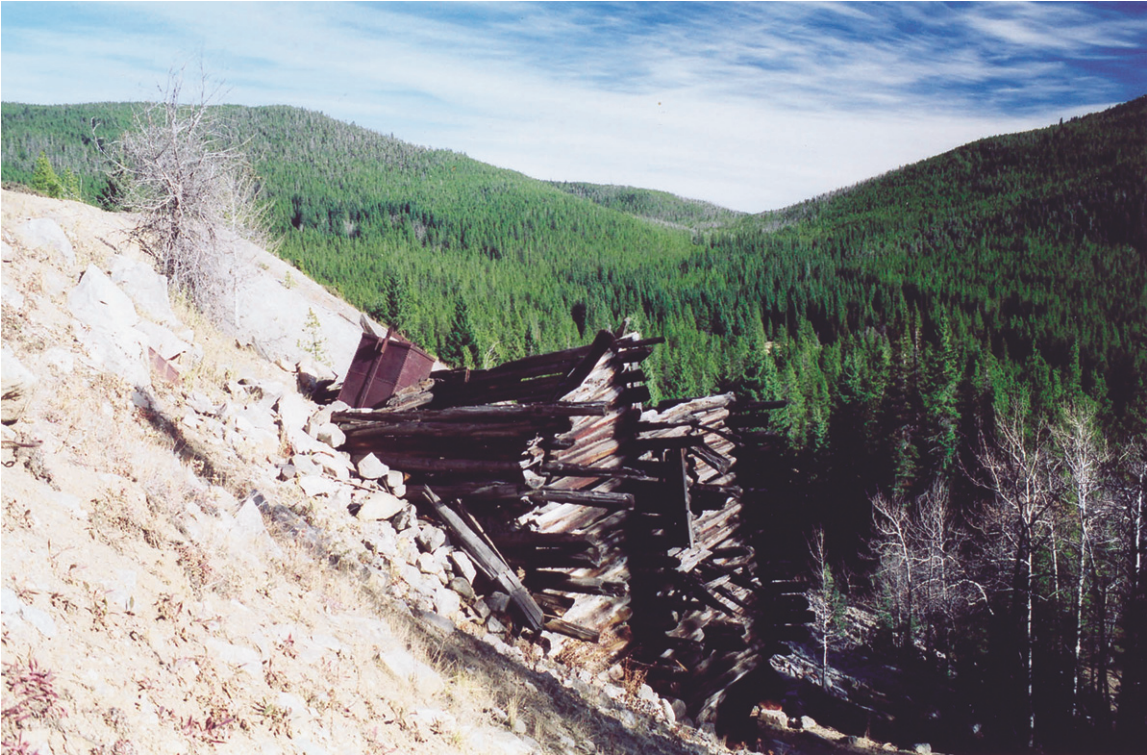
Figure 2. Eva May mine in Cataract Creek valley, September 1998. Photograph by D.A. Nimick.

The overall conclusion from our analysis of trace-element sources is that three large mines appear to be the most important sources of trace elements in the Boulder River watershed (Finger, Farag, and others, this volume, Chapter C). Smaller loadings occur from some other sites, such as the Buckeye mine and mill and Enterprise mine in upper Basin Creek and the Hattie Ferguson, Boulder Chief, Ida M., and Eva May mine sites along Cataract Creek.

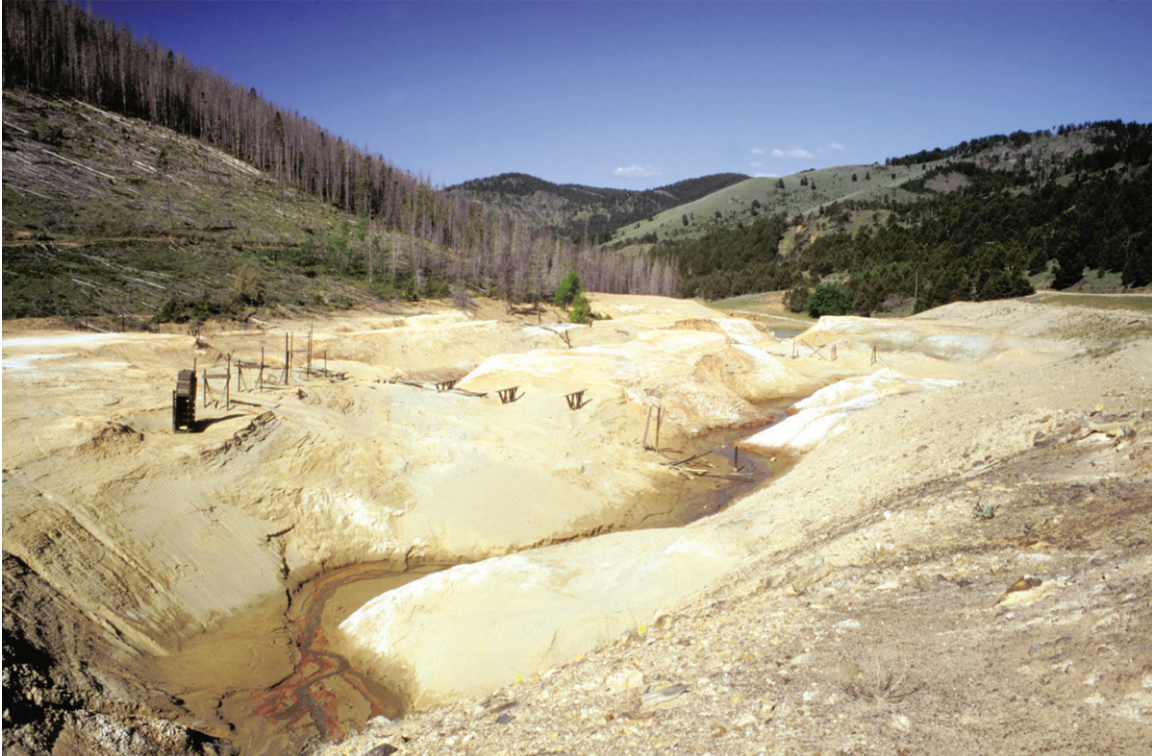
Figure 3. Mill tailings in High Ore Creek valley at Comet mine site, October 1996. Photograph by D.A. Nimick.

During historical mining, mine waste and mill tailings were discharged with little regard for any potential effect on the landscape or streams (fig. 3). Although most mining in the Boulder River watershed occurred nearly a century or more ago, effects on the environment are still present today. Physical manifestations of these effects were evident locally as land disturbances, unvegetated areas, and colorful mine drainage near mine and mill sites. At a watershed scale, these effects occurred primarily in streams, where aquatic organisms are affected downstream from the historical mine and mill sites.

Many of the mine sites identified as contributors of trace elements have been targeted for remediation by Federal land-management agencies. Large-scale remediation efforts began in 1997 at the Comet mine in High Ore Creek. The Montana Department of Environmental Quality removed the large quantity of mill tailings (about 500,000 yd³ or about 750,000 tons) that had been impounded in the valley (fig. 3). In 1999, the Bureau of Land Management began removal and in-place treatment of tailings that had been washed downstream by floods and deposited on the High Ore Creek flood plain. The United States Department of Agriculture (USDA) Forest Service began remediation efforts at the Buckeye and

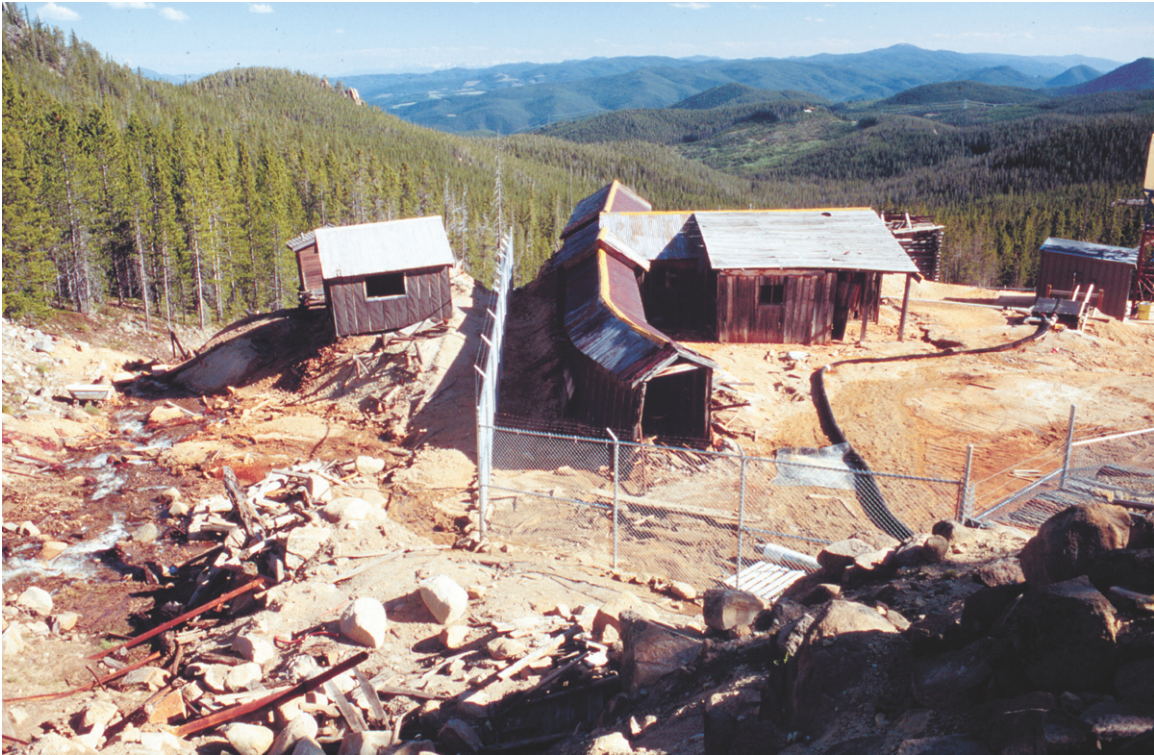
Figure 7. Crystal mine, June 1997. Acidic discharge drains from adit (out of view near lower right of photograph) to Uncle Sam Gulch on far left. Photograph by D.A. Nimick.

Land-management agencies are charged with the task of remediating inactive mines in the Boulder River watershed. Numerous inactive mine sites contribute trace elements to streams in the study area. Therefore, the challenge facing the agencies is one of source determination. The highest concentrations of cadmium, copper, lead, and zinc in water, streambed sediment, and aquatic organisms occur just downstream from the Crystal, Bullion, and Comet mines. Because the concentrations below these mine sites are so high, the three sites clearly are the major sources of trace elements in the watershed. However, the main delivery mechanism for trace elements is not the same at each mine site. Study of streambed sediment demonstrated that much of the contaminated sediment in the Boulder River came from High Ore Creek (Church, Unruh, and others, this volume). The dam holding the mill tailings deposited in the High Ore Creek valley from the Comet mill (fig. 3) has been breached and the tailings extensively eroded and transported downstream into the Boulder River (Gelinas and Tupling, this volume, Chapter E2). Study of water quality demonstrated that Cataract and Basin Creeks contributed more than 80 percent of the dissolved cadmium and more than 50 percent of the dissolved copper and zinc to the Boulder River (Nimick and Cleasby, this volume). These and other data indicated that the Crystal mine (fig. 7) in Uncle Sam Gulch and Bullion mine (fig. 8) in a tributary to Jack Creek were the largest contributors of dissolved trace elements in the watershed (Kimball and others, this volume, Chapter D6). Based on detailed metal-loading studies, discharge from one or two adits was by far the most significant source of trace elements at each of these mine sites.

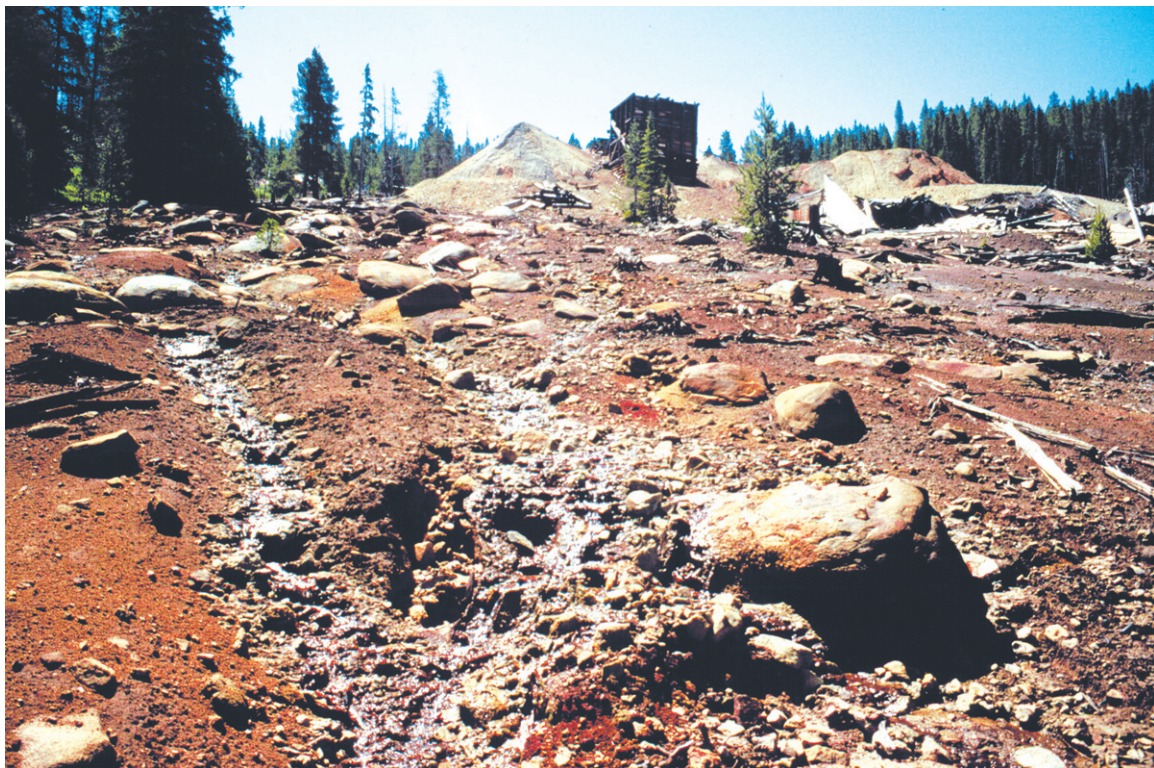
Figure 8. Bullion mine, August 1998. Acidic drainage flows downhill from mine adit behind mine-waste piles in top center of photograph. Photograph by D.A. Nimick.

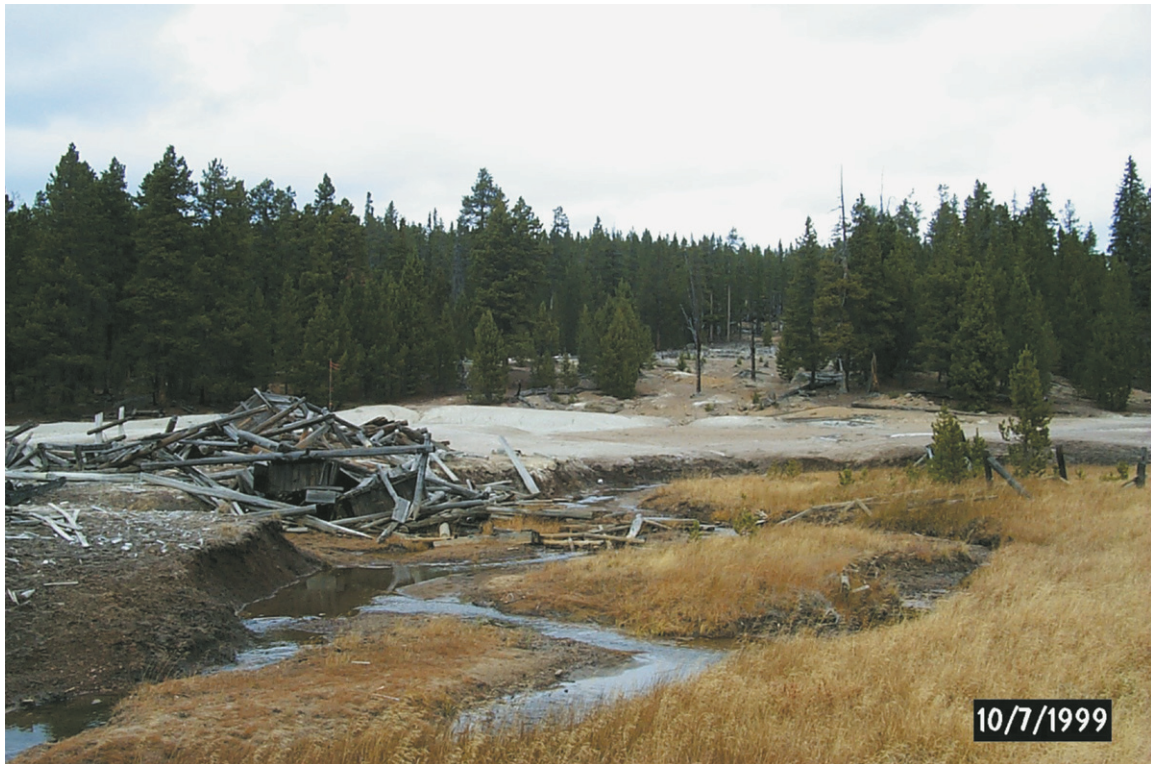
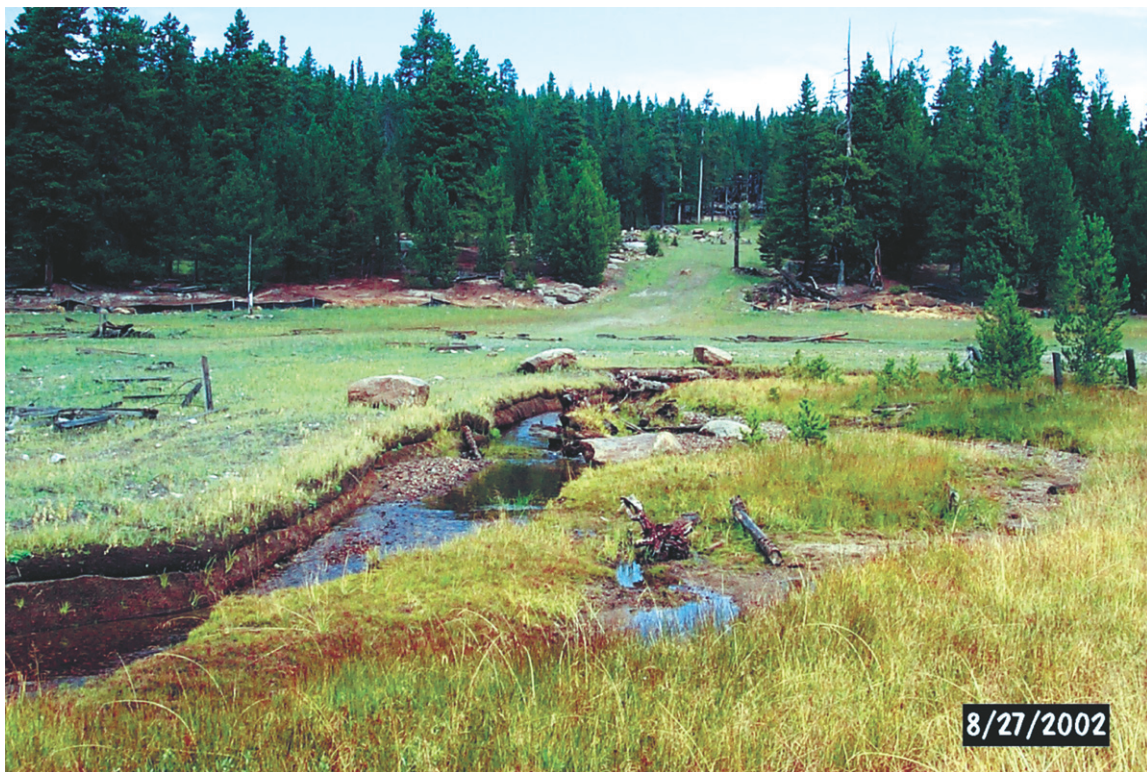
Figure 9. Buckeye flotation mill site, upper Basin Creek, before (top) and after (bottom) remediation. Photographs by Ray TeSoro.

Enterprise mine site in 2000 (fig. 9) and at the Bullion mine in 2002. Part of the earlier planning efforts by USDA Forest Service had been location of suitable repository sites for safe storage of mine waste and mill tailings removed from historical mine sites. The U.S. Environmental Protection Agency (USEPA) has recently taken over the open pit at the recently closed Basin Creek mine and converted it to a regional repository (Smith and others, this volume, Chapter E3) for mine wastes in the Boulder River and other neighboring watersheds. Basin and Cataract Creeks were added to the National Priority List (Superfund) in 1999. Soon afterwards, USEPA began removing mine and mill waste within the town of Basin, and in 2002, began cleanup work at the Crystal mine. However, to date (2003), no work has been initiated to remediate acid drainage coming from mine adits such as those at the Crystal, Bullion, or Enterprise mines.
