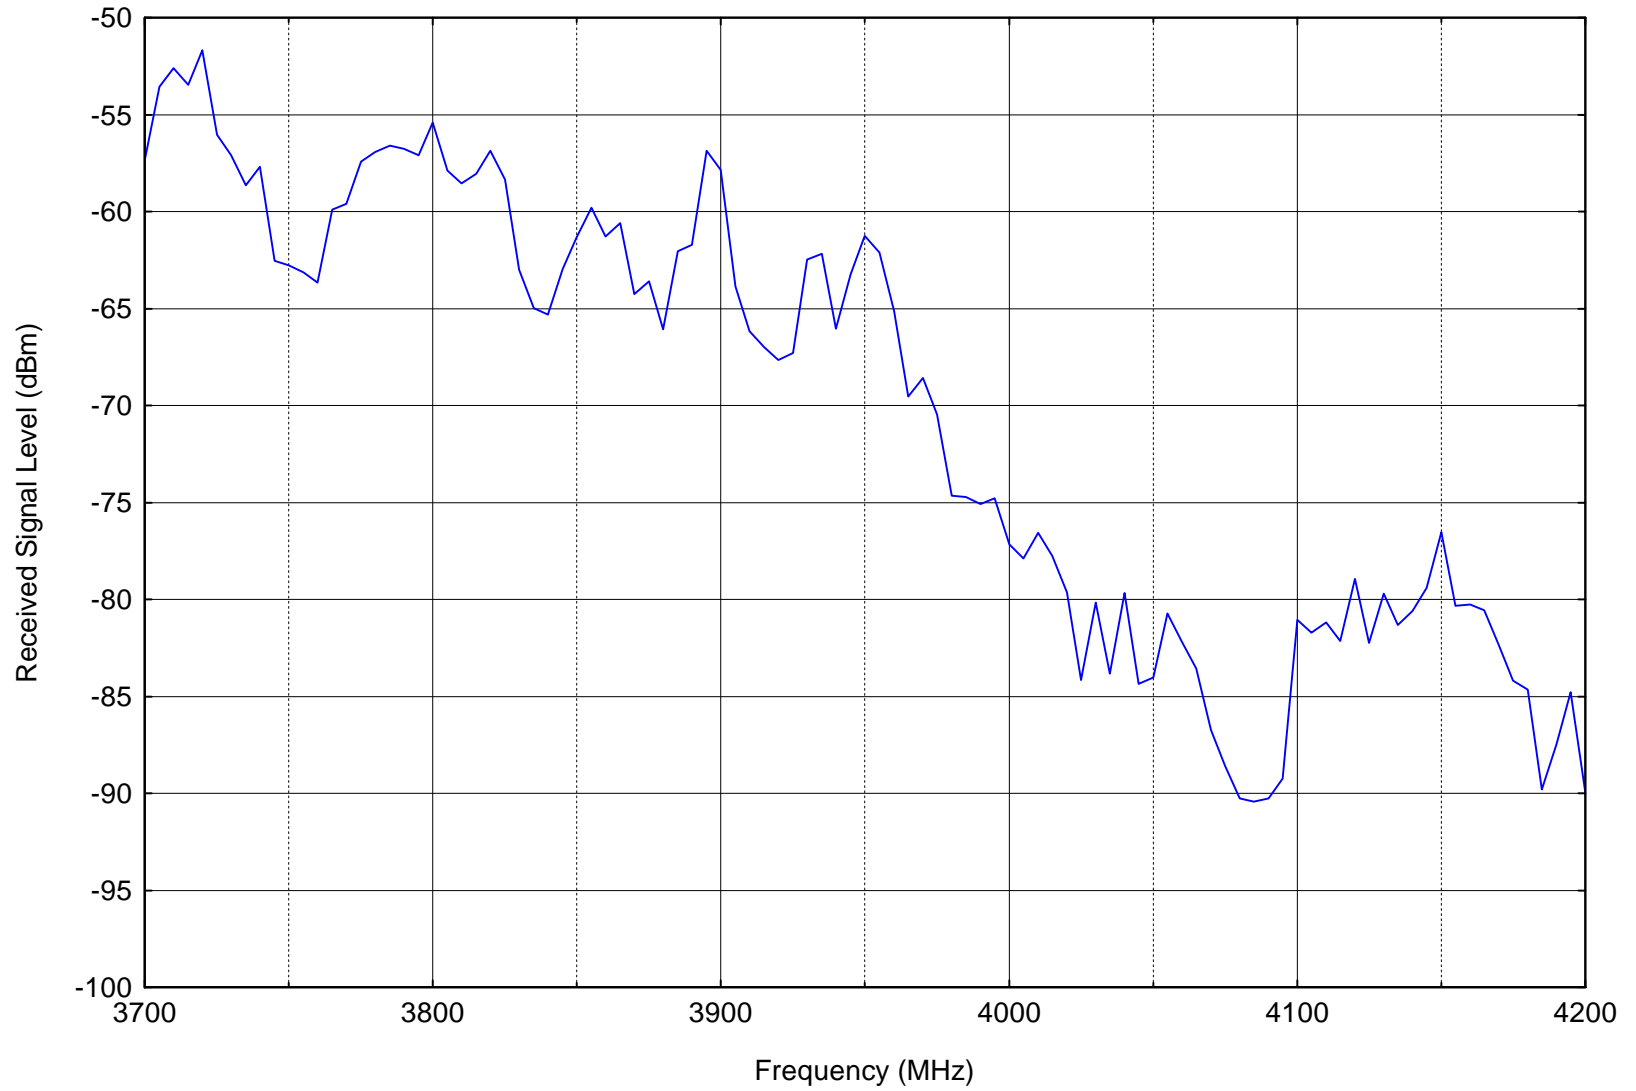
Figure 16. Radar emission spectrum measured in south parking lot
