Wind Turbine Generator System Duration Test Report

Bergey Excel-S/60

February 2003

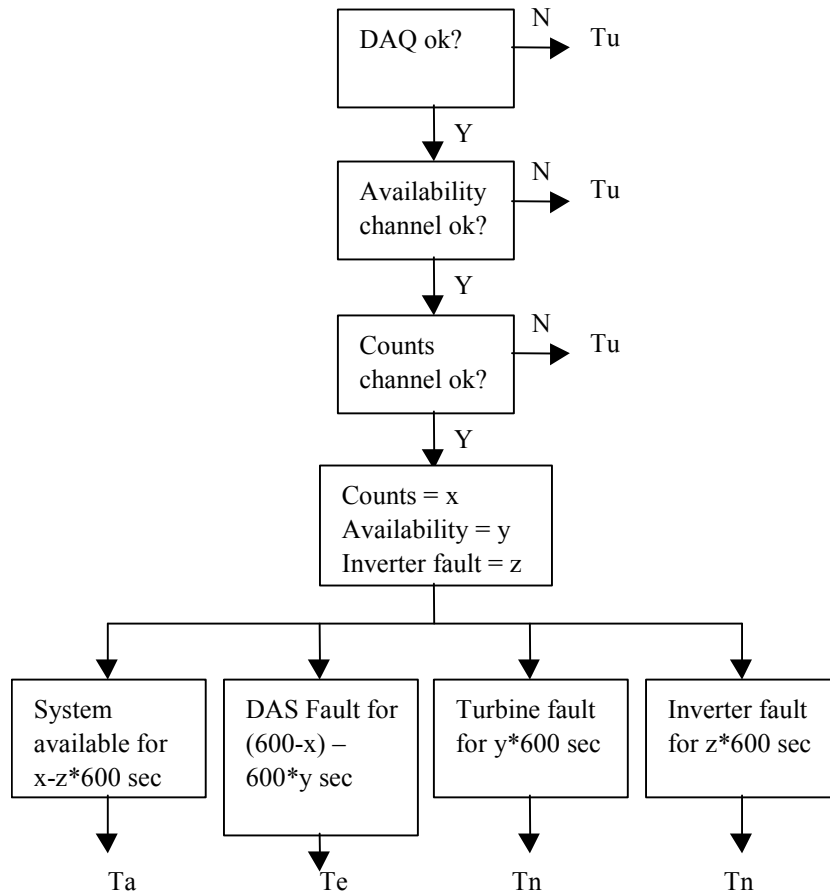
These channels are used in the combination given in Figure 5. After the spreadsheet has automatically applied the criteria from Figure 5, the analyst uses the logbook to override the spreadsheet if needed.

Figure 5. Classification of time for operational time fraction.

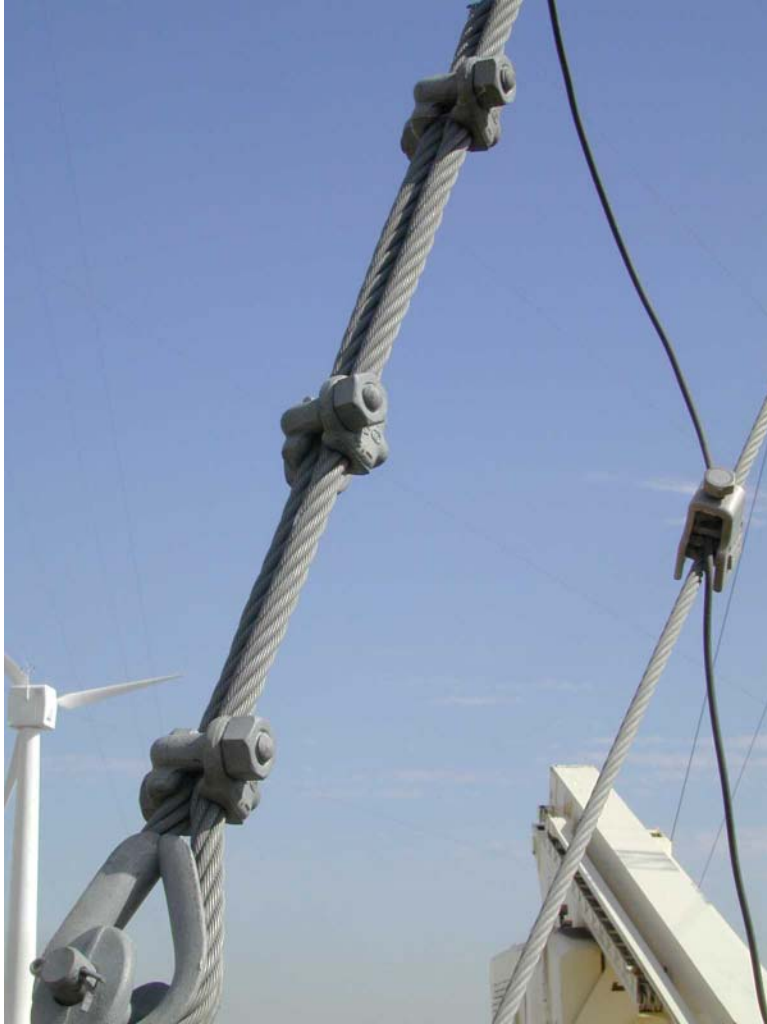
Figure 2. The wire clamps on the top west guy wire.

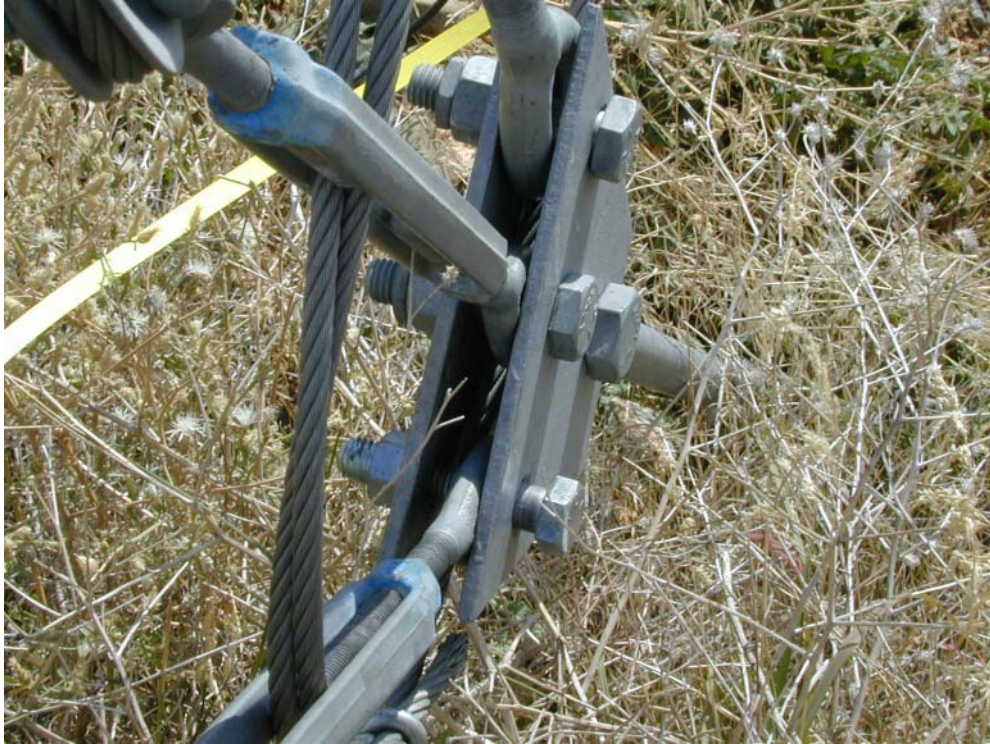
Figure 3. The southeast anchor point. Note that the bolt of the bottom guy wire does not have a lock nut on it and the nut is not tightened.

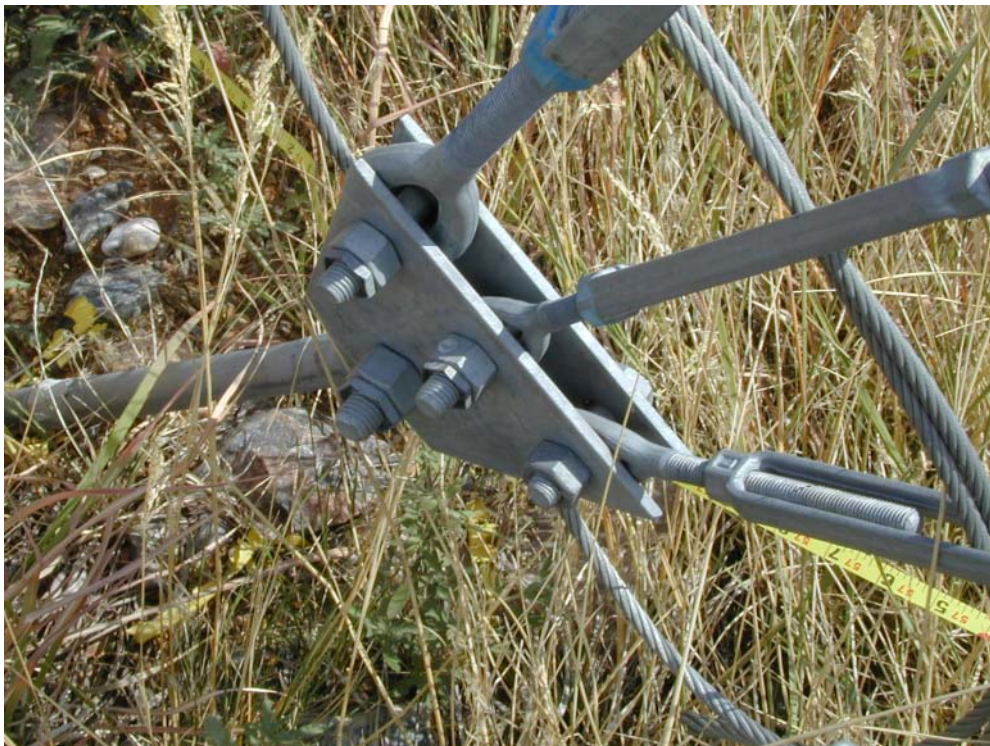
Figure 4. Close up of the equalizer plate on the north guy anchor. Note that the bottom guy wire does not have a lock nut.

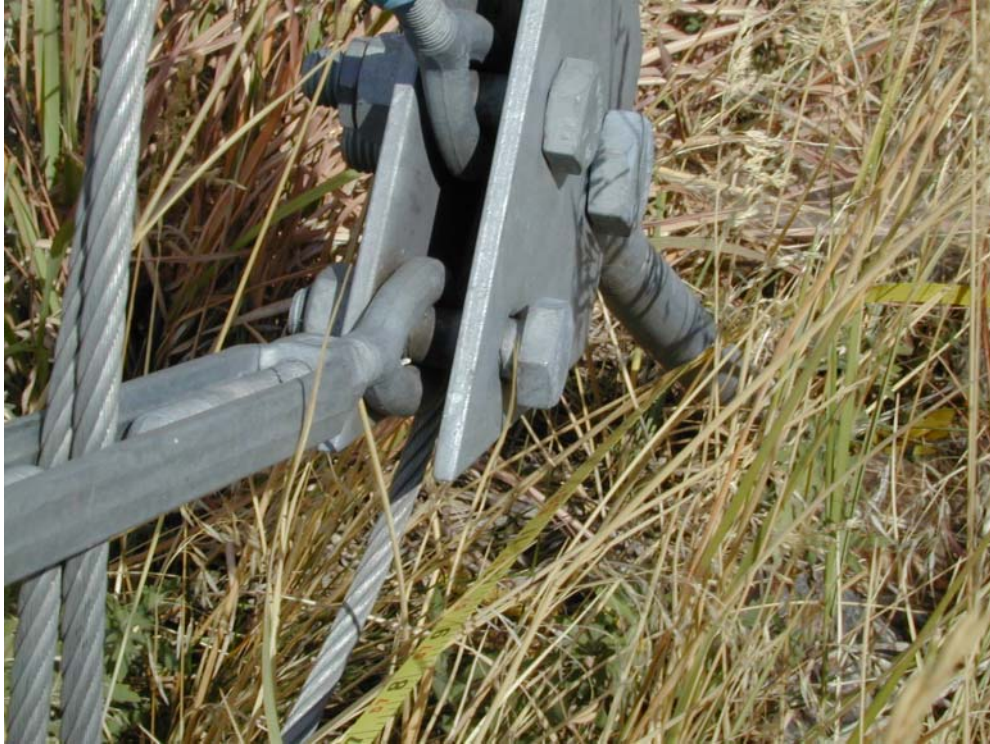
Figure 5. Equalizer plate on north guy anchor. Note that the bolt of the bottom guy wire is not secured all the way.

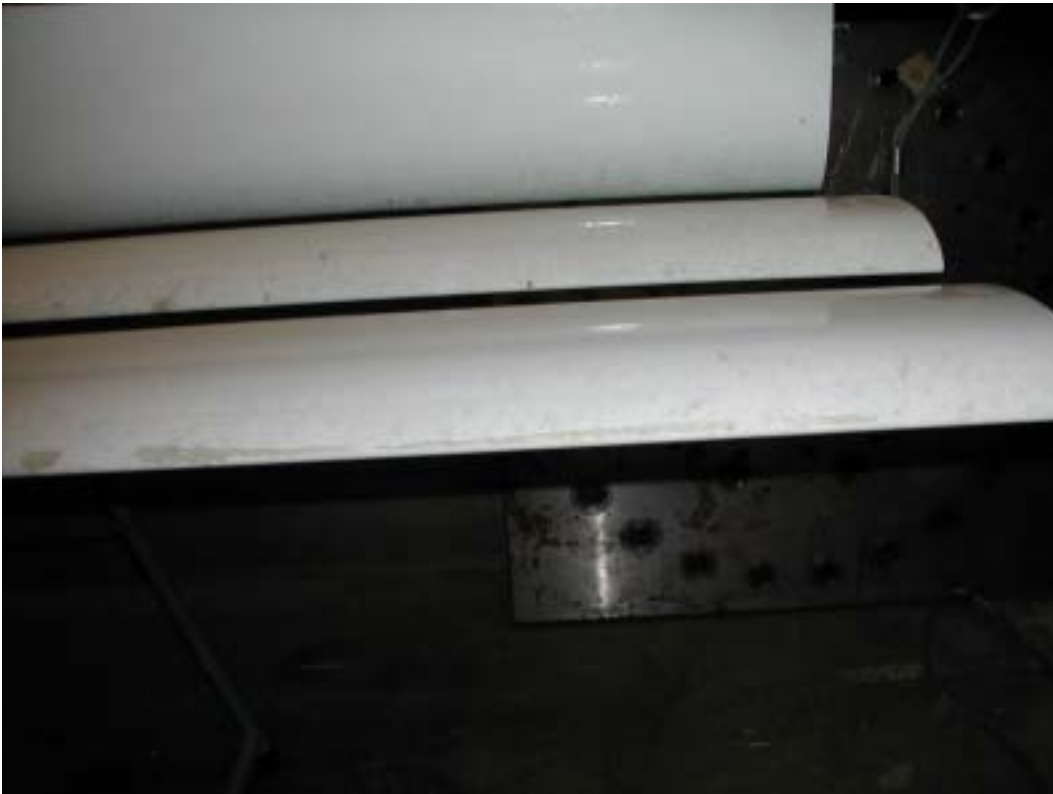
Figure D.3. Paint erosion on leading edge of blade 1.

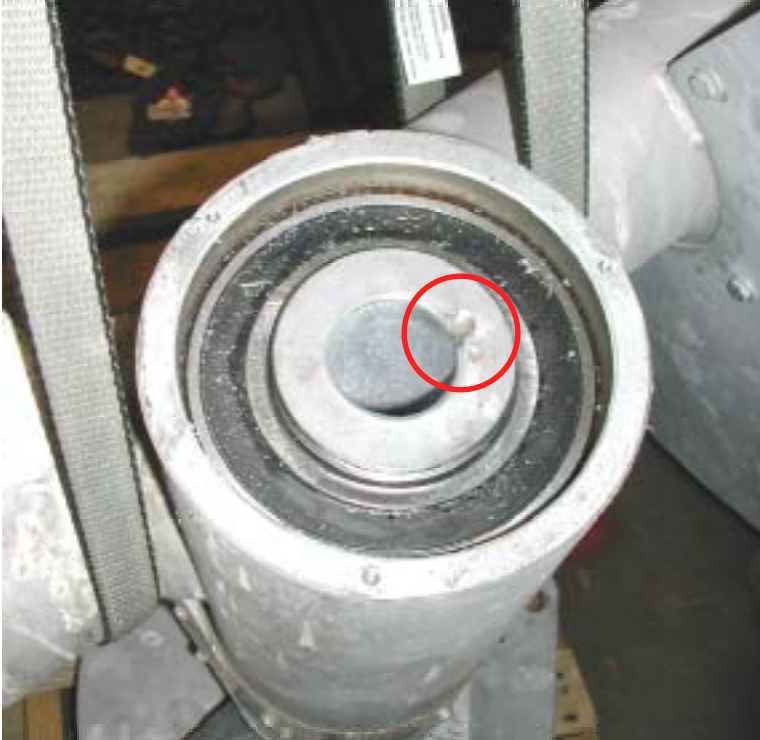
Figure D.4. Indentations on the top of the yaw shaft.

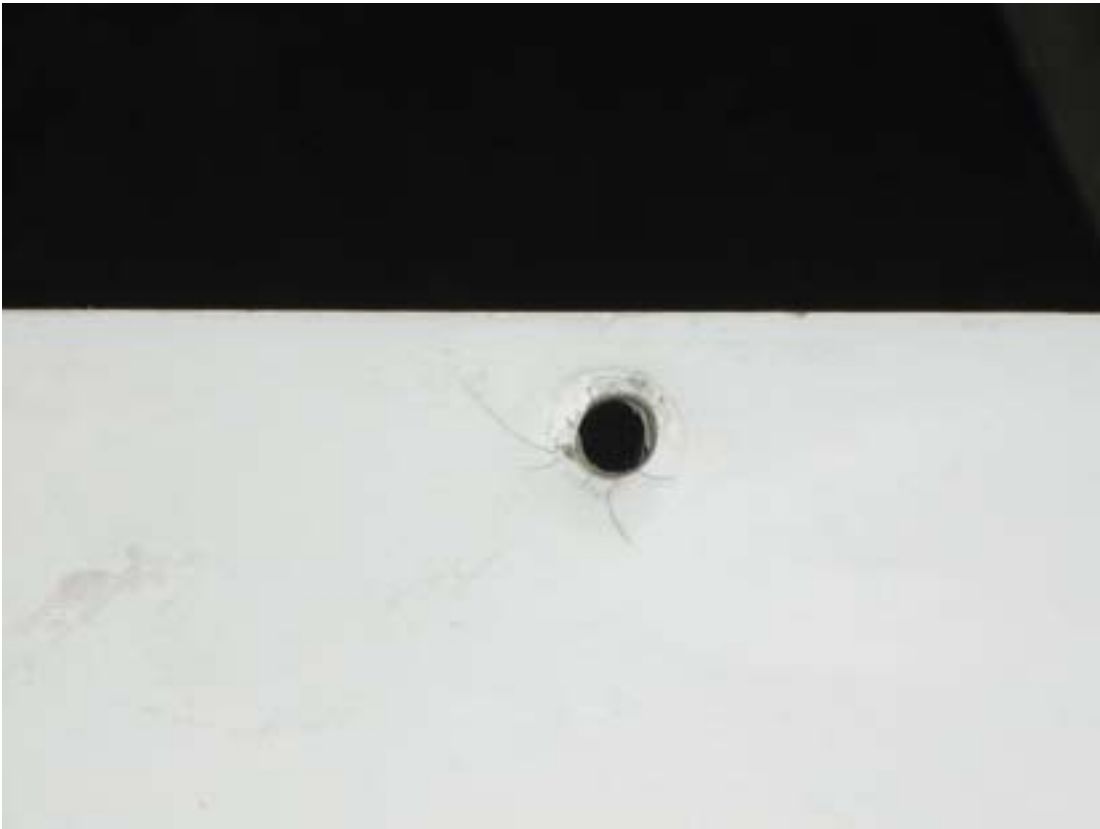
Figure D.5. Cracks near a bolt hole on the nacelle cover.

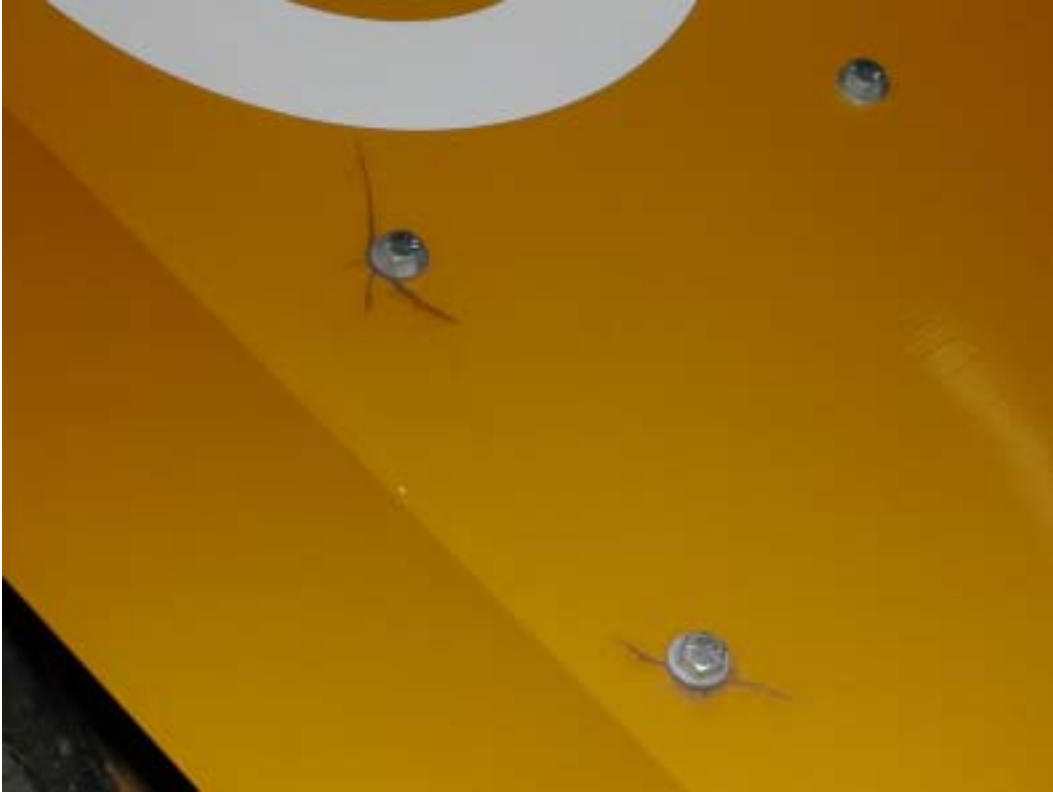
Figure D.6. Cracks near the downwind bolts on the tail vane.

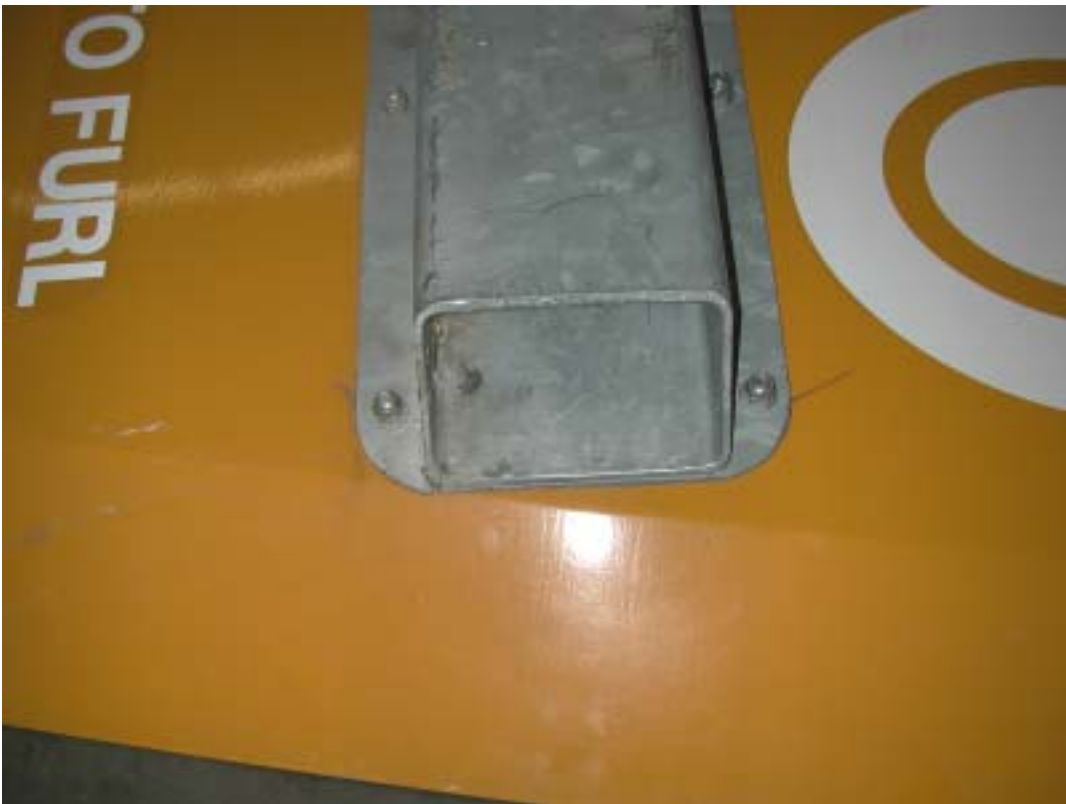
Figure D.7. Same cracks as in Figure 6, seen from other side.

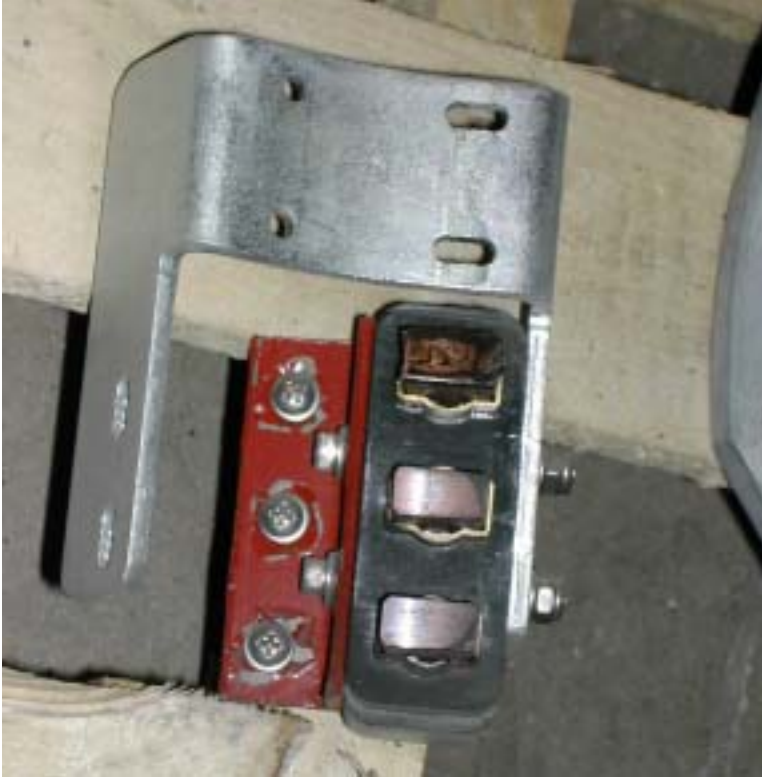
Figure D.12. The slip ring brushes. Note the grease on the top brush.

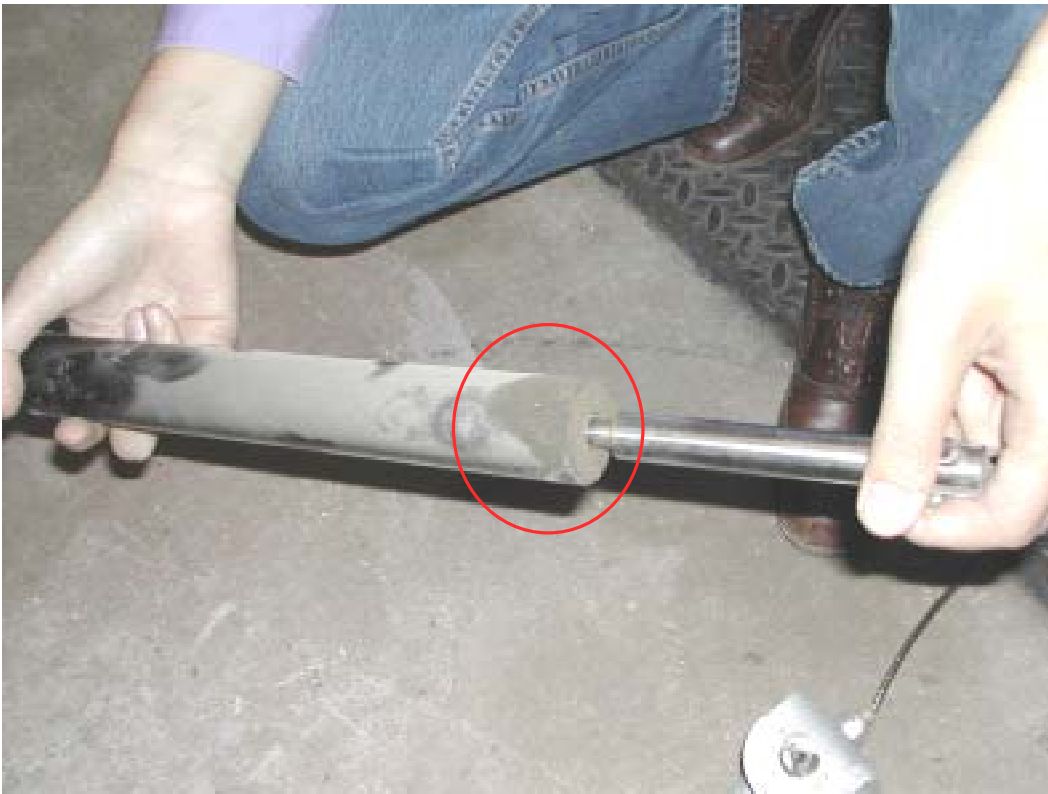
The furl damper shows some sign of leakage, which is considered normal according to the owner's manual (Figure D.13). Some damage was found on the plastic cover around the furl

Figure D.13. The furl damper with some signs of leakage on the right side.

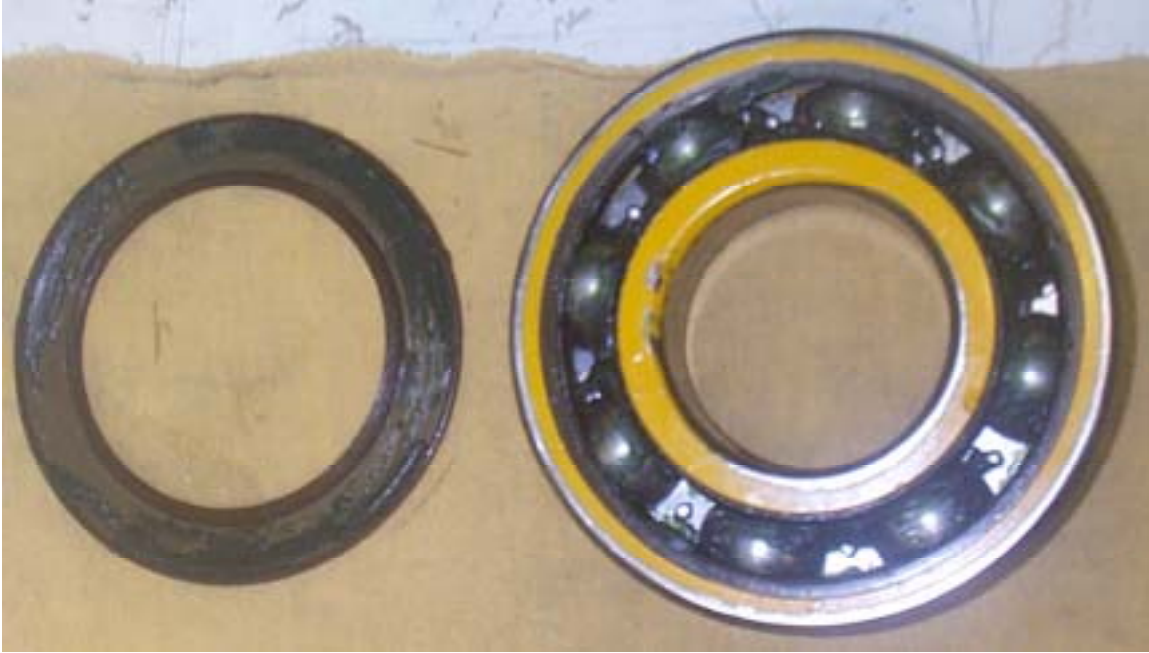
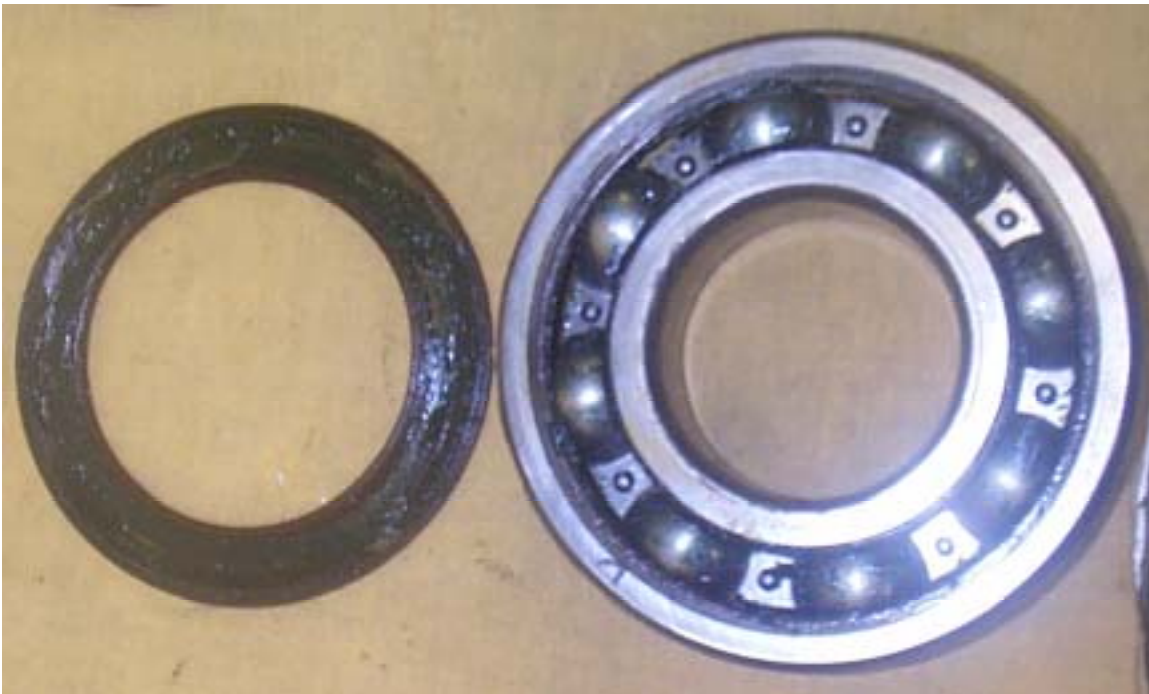
Rear Generator Bearing NTN 6215

The grease is in very good condition with light color and good consistency. A band of brown discolored grease is present on the outside part of the non-painted shield. The rest of the shield is covered with new-looking green grease. The discoloration is probably due to moisture. There is no evidence of corrosion. (The grease looks like Chevron SRI-2, but this was not confirmed). This bearing contains less grease than the other bearings. It is probable that this is the standard grease pack for this bearing.

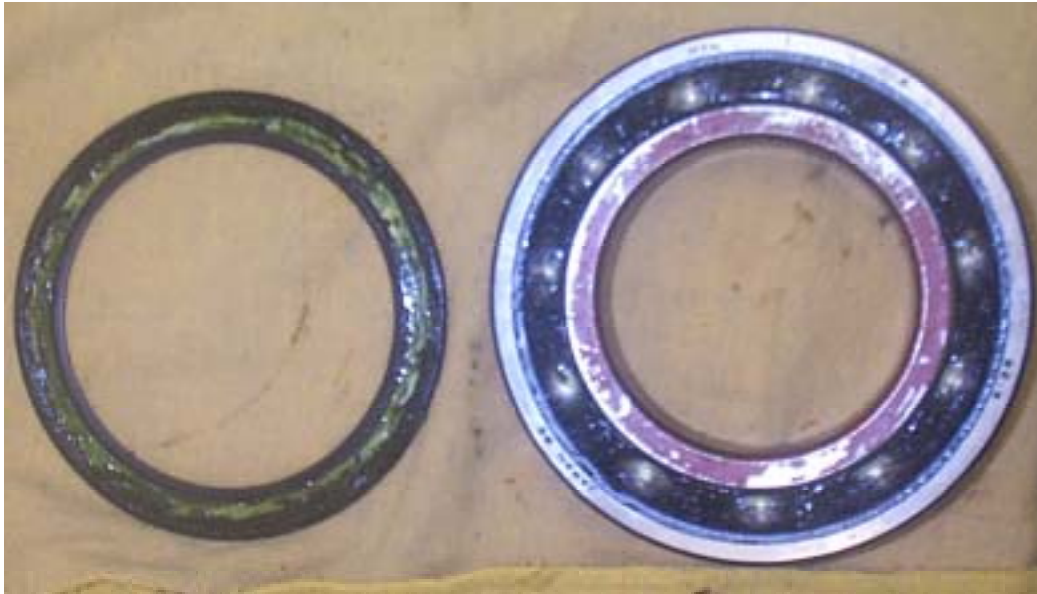
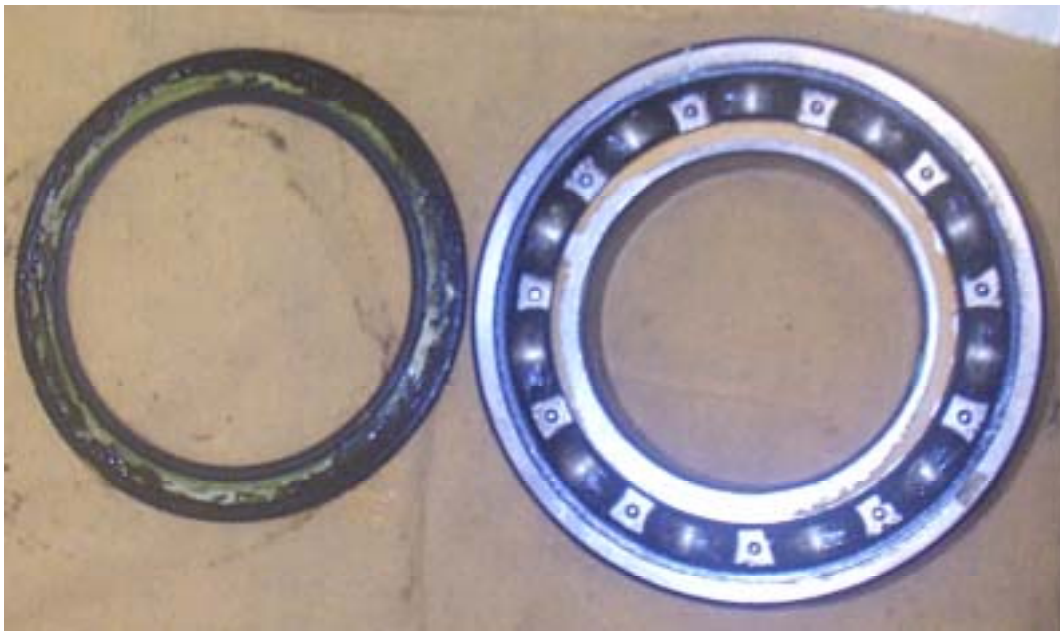
Front Generator Bearing
Nachi 6313NSE

The grease is in good condition. It is somewhat thicker and darker than new grease. Most of the grease present in the bearing is on the unpainted (red paint) side of the bearing.

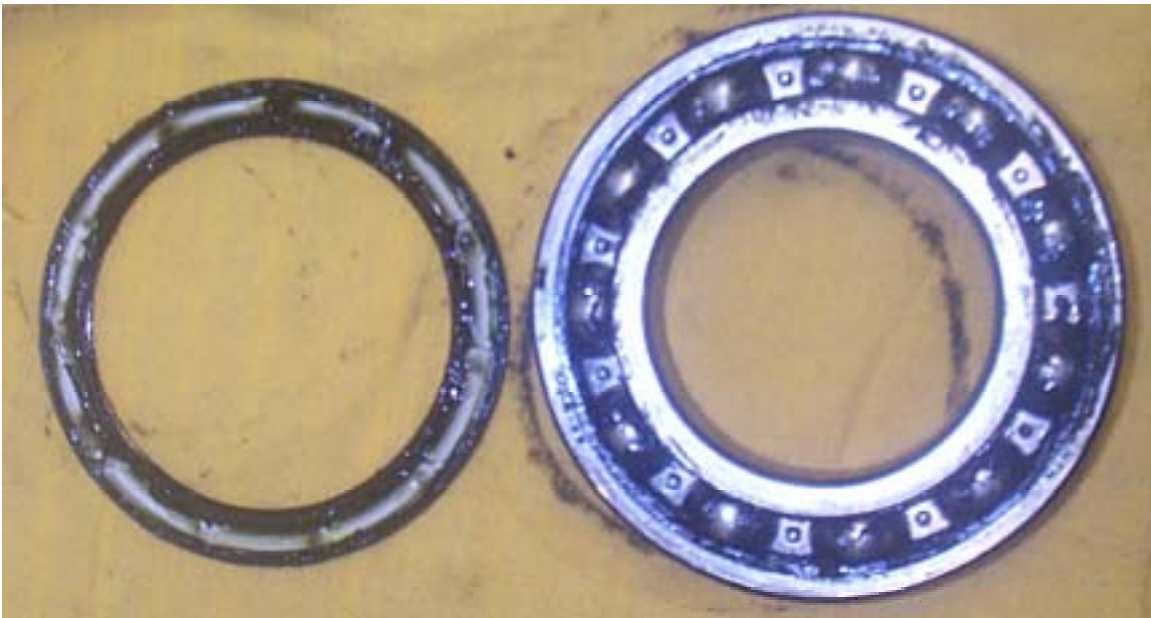
Lower Yaw Bearing
NTN 215L8

The grease present is dark in color but in very good condition.

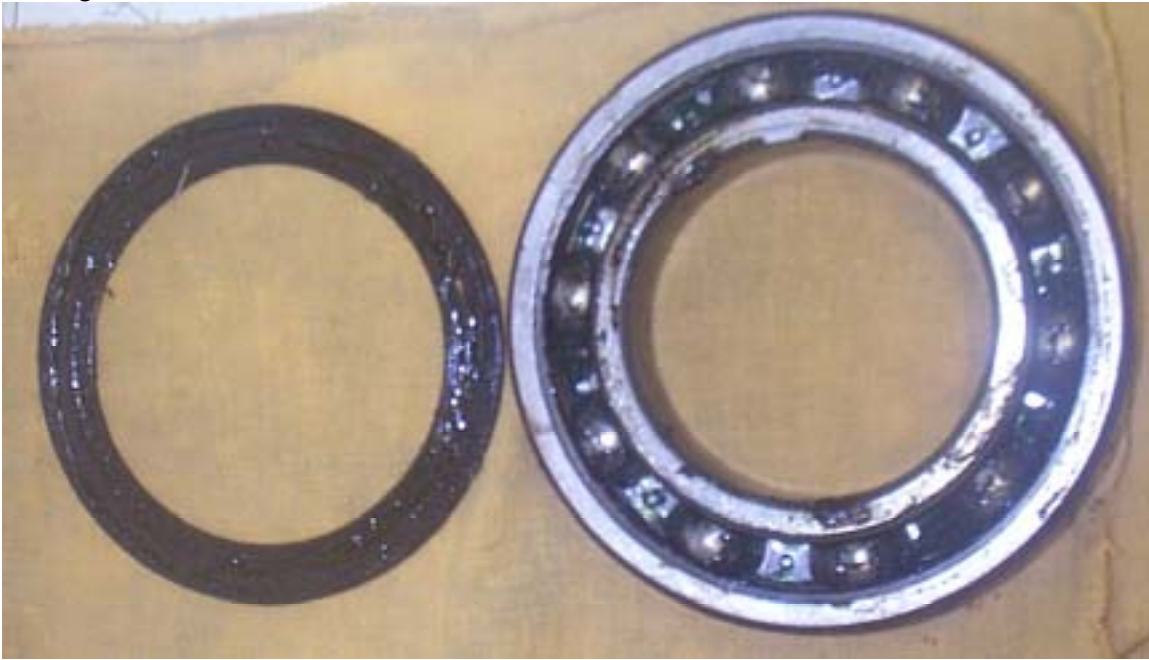
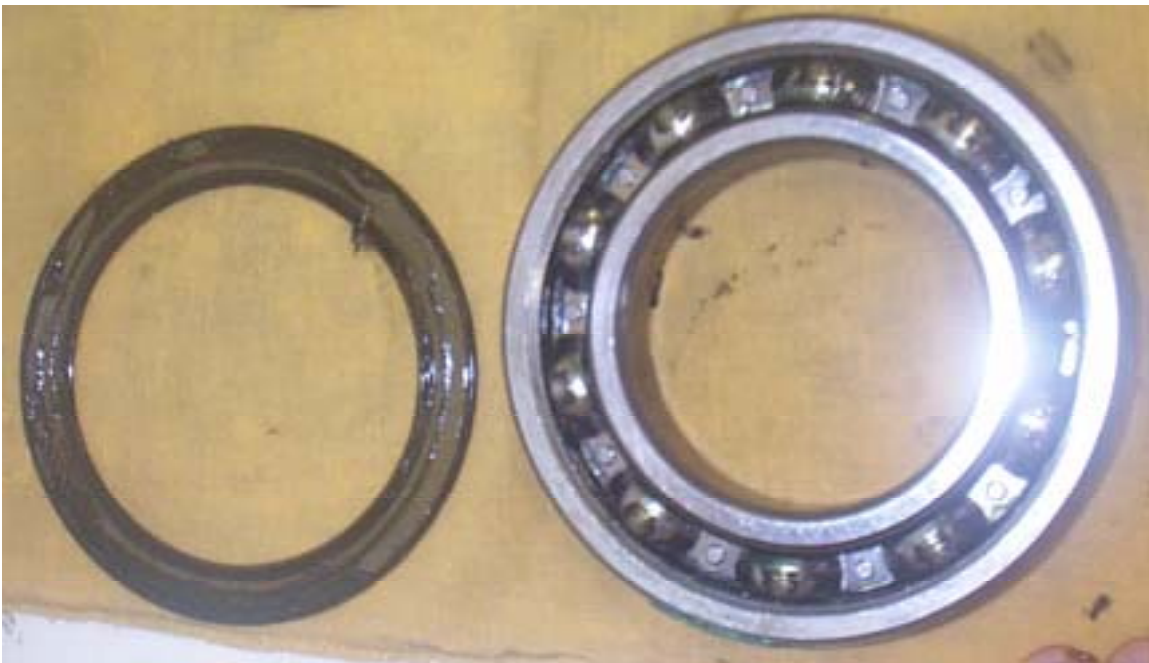
Upper Yaw Bearing
Nachi 6215NSL

The grease on the “damaged” shield is a little darker than the other side. (The shield was slightly damaged during bearing removal.)

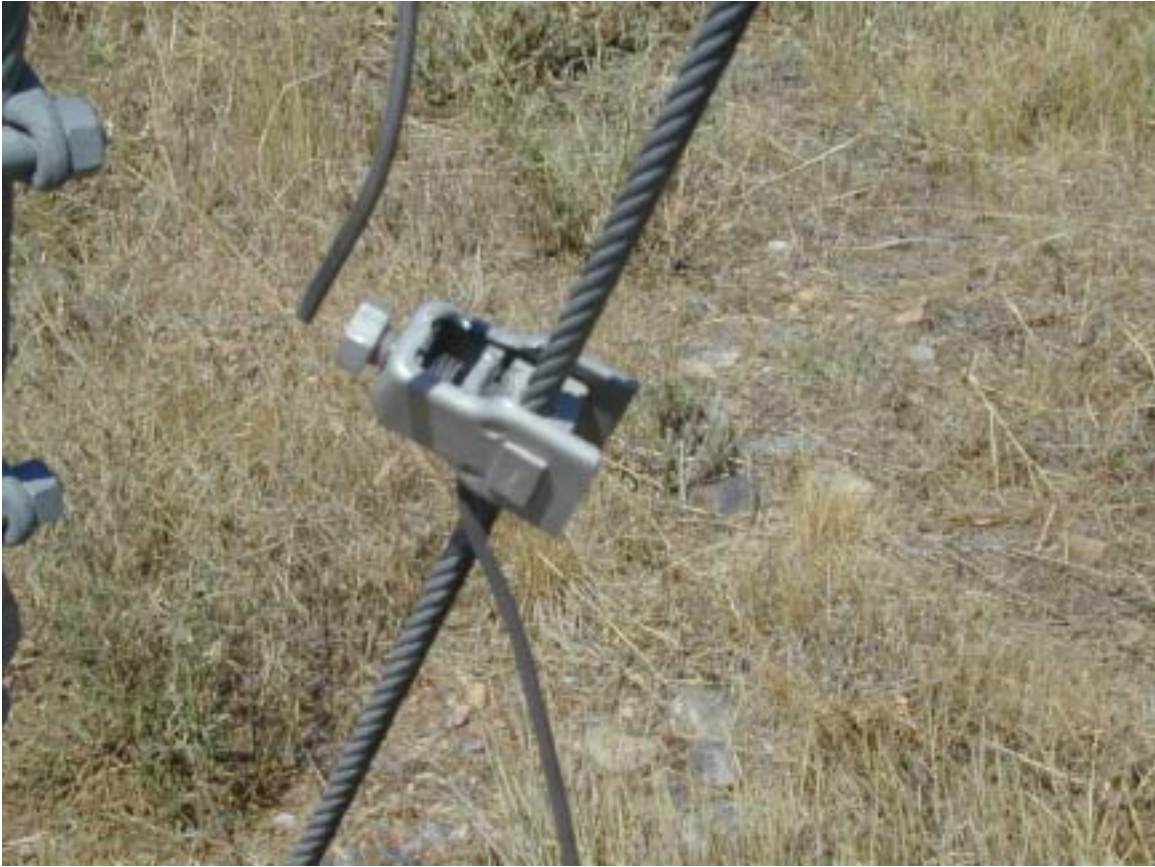
Figure 2. Broken ground wire at the top west guy wire.

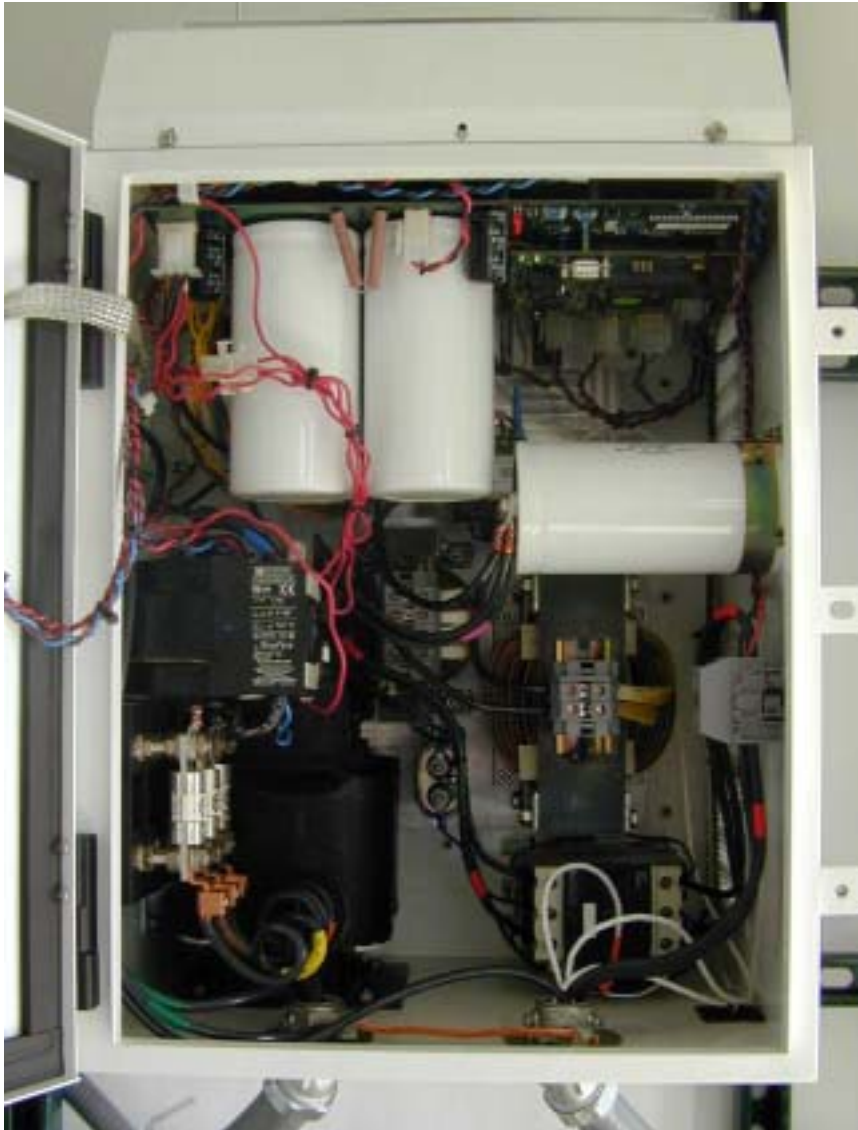
Figure 2 gives an overview of the inside of the inverter. A number of hot components were found inside the inverter:

Figure 2. Overview of the inside of the inverter.

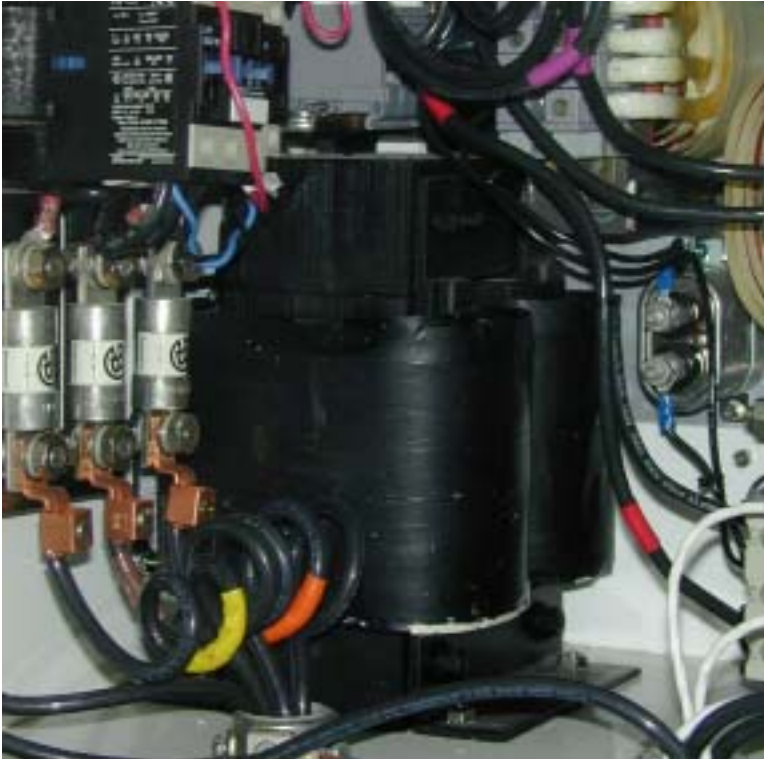
Figure 6. A close-up of the inductor on the bottom left of the cabinet.
