Wind Turbine Generator System Safety and Function Test Report

Bergey Excel-S with Gridtek-10 inverter

National Wind Technology Center
National Renewable Energy Laboratory
1617 Cole Boulevard
Golden, Colorado 80401

17 April 2003

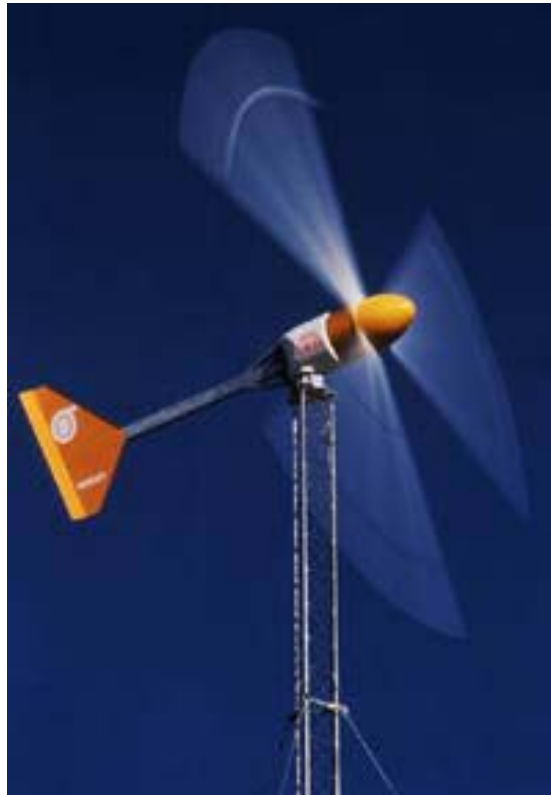
Figure 1: The Bergey Excel wind turbine.

The Bergey Excel-S is a three-bladed upwind wind turbine rated at 10 kW output at 13.0 m/s. It is connected to a Bergey Gridtek-10 inverter, which provides power to the NWTC public service electrical grid.

The Excel uses a permanent magnet alternator to produce three-phase variable frequency output at a nominal 240 volts. The three-phase output is rectified to DC power and then converted to single-phase, 240-volt, 60-Hz AC power in the Gridtek inverter.

The turbine blades are made from pultruded fiberglass. In high wind speeds (greater than about 15.6 m/s), the turbine will turn out of the wind (known as furling) to protect the turbine from overspeeding. Table 1 lists the basic turbine configuration and operational data.

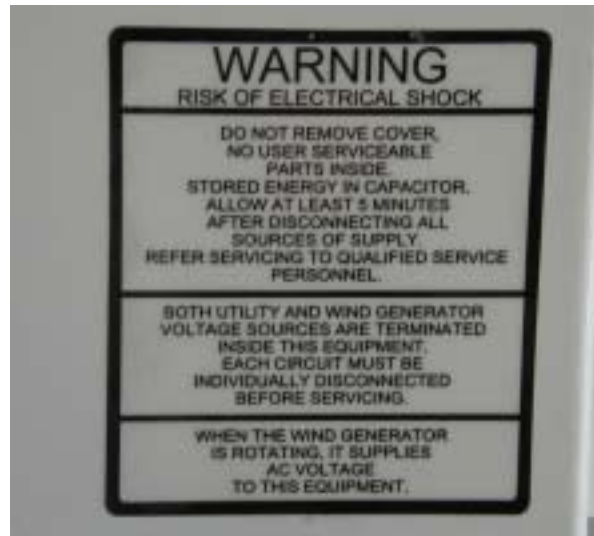
Figure 10: Warning sticker on the inverter.

All major electrical components are behind doors that can only be opened with a screwdriver. A sticker on the inverter (Figure 10) gives sufficient warnings for the multiple power sources and in specific capacitors.
