Wind Turbine Generator System

Duration Test Report

Atlantic Orient 15/50 Wind Turbine

National Wind Technology Center
National Renewable Energy Laboratory
1617 Cole Boulevard
Golden, Colorado 80401

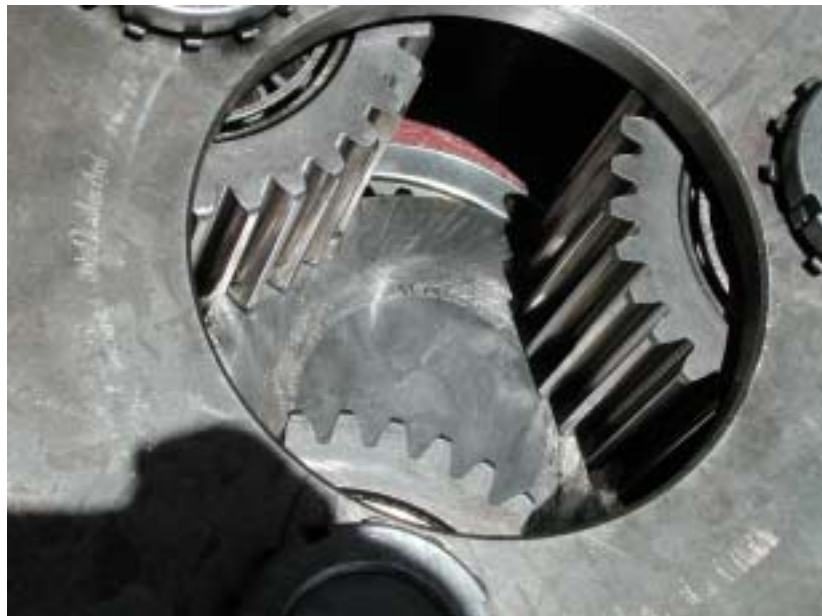
The plate in the LS Carrier exhibited wear from the dislocation of the plate from its counter bore. This dislocation reduced the depth of the counter bore such that the plate could be sandwiched between the gear and carrier.

Figure B.2. The low-speed carrier.

Small metal pieces were found in the bottom of the nacelle casting. These were traced back to the wear from the LS Carrier and wear on the end of the LS planetary gears. Metal shavings were

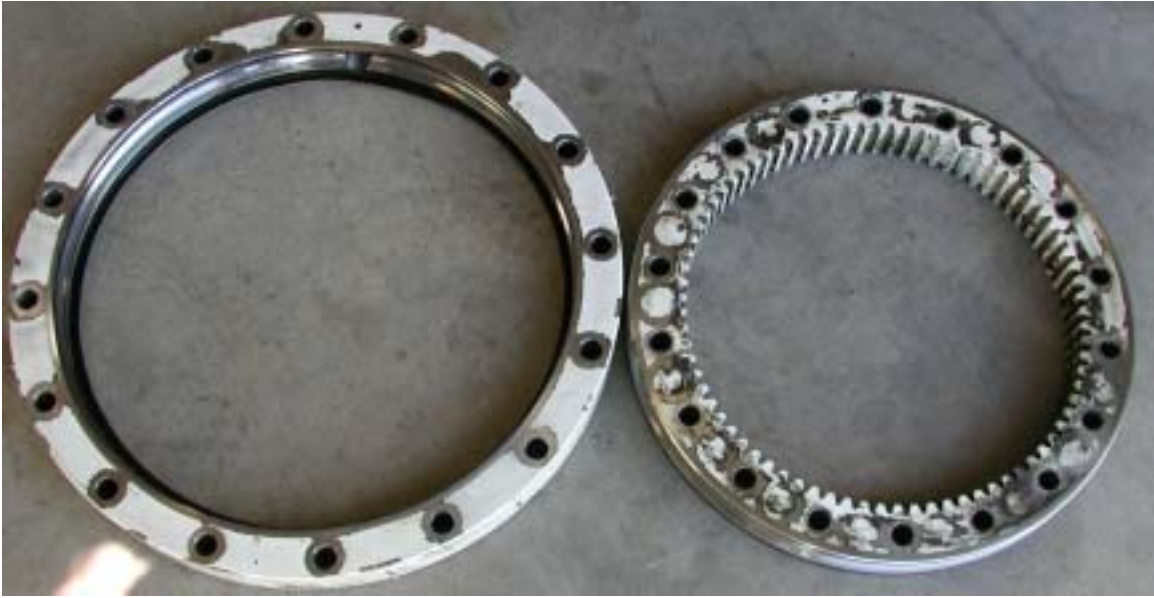
Figure B.4. The disassembled yaw bearing.

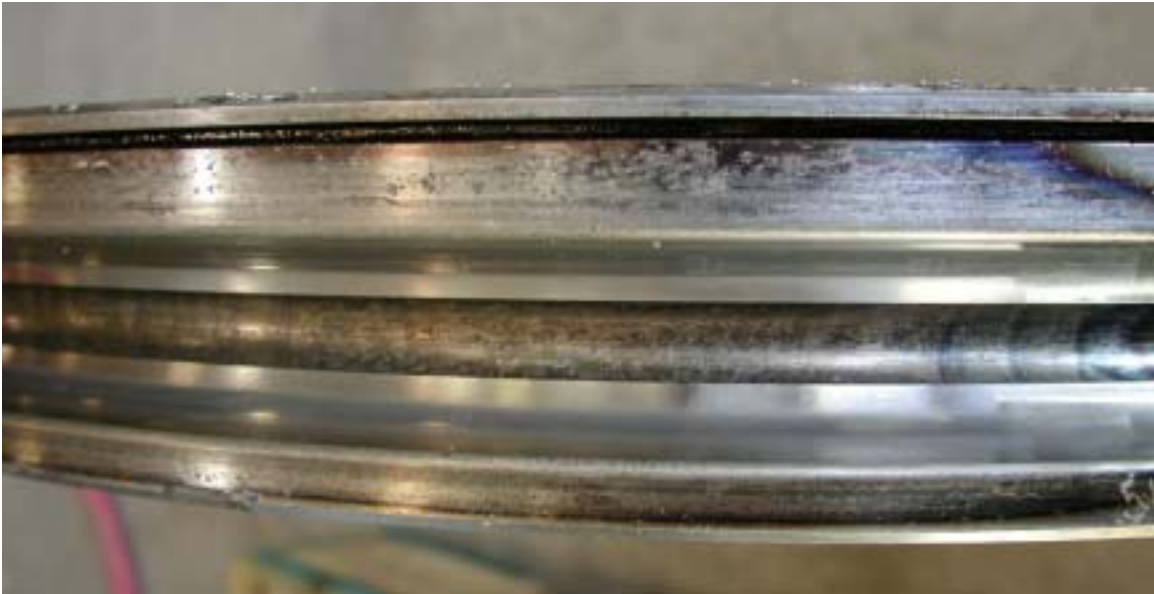
The inner and outer rings were found to have intermittent marks on both ball paths with spacing that corresponds to the ball spacing. We speculate that these marks were caused by a single event

such as an extreme load during installation or by a dithering load that may have occurred when shipping the turbine to the NWTC.

Figure B.5. Inner ring and intermittent marks.

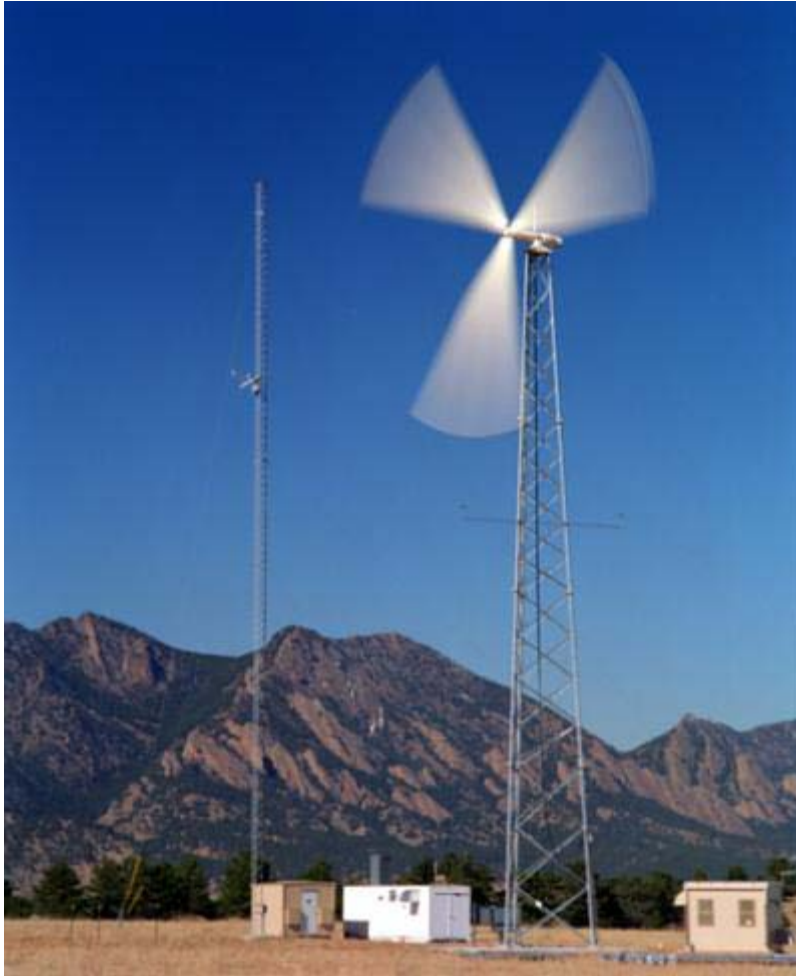
Figure 1. Overall configuration of the AOC 15/50 test turbine.

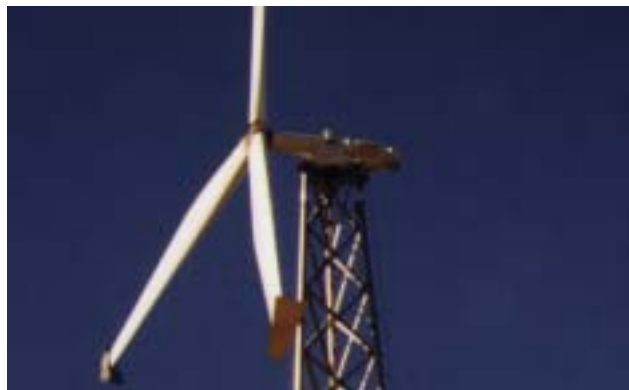
Figure 2. Nacelle configuration, AOC 15/50.

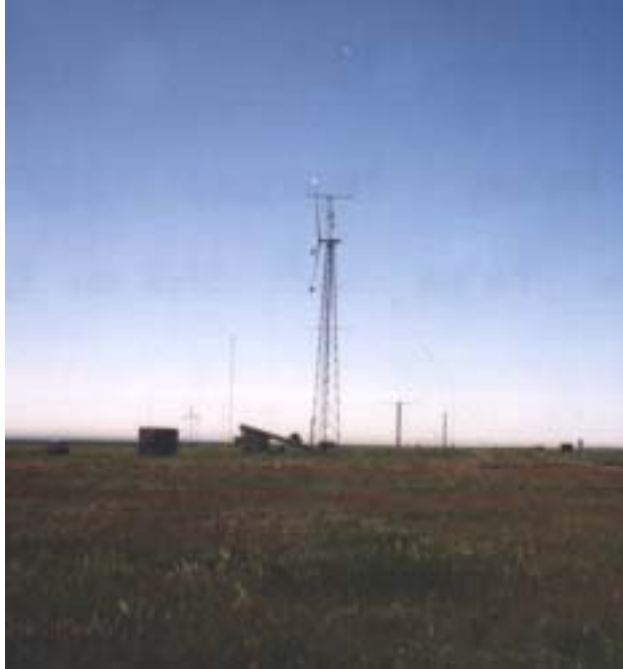
The meteorological tower is located 37.5 meters from the test turbine at a bearing of 292° true. Figure 4 shows the test turbine from the direction of the prevailing winds.

Figure 4. Test turbine through met tower from prevailing wind direction (292°).

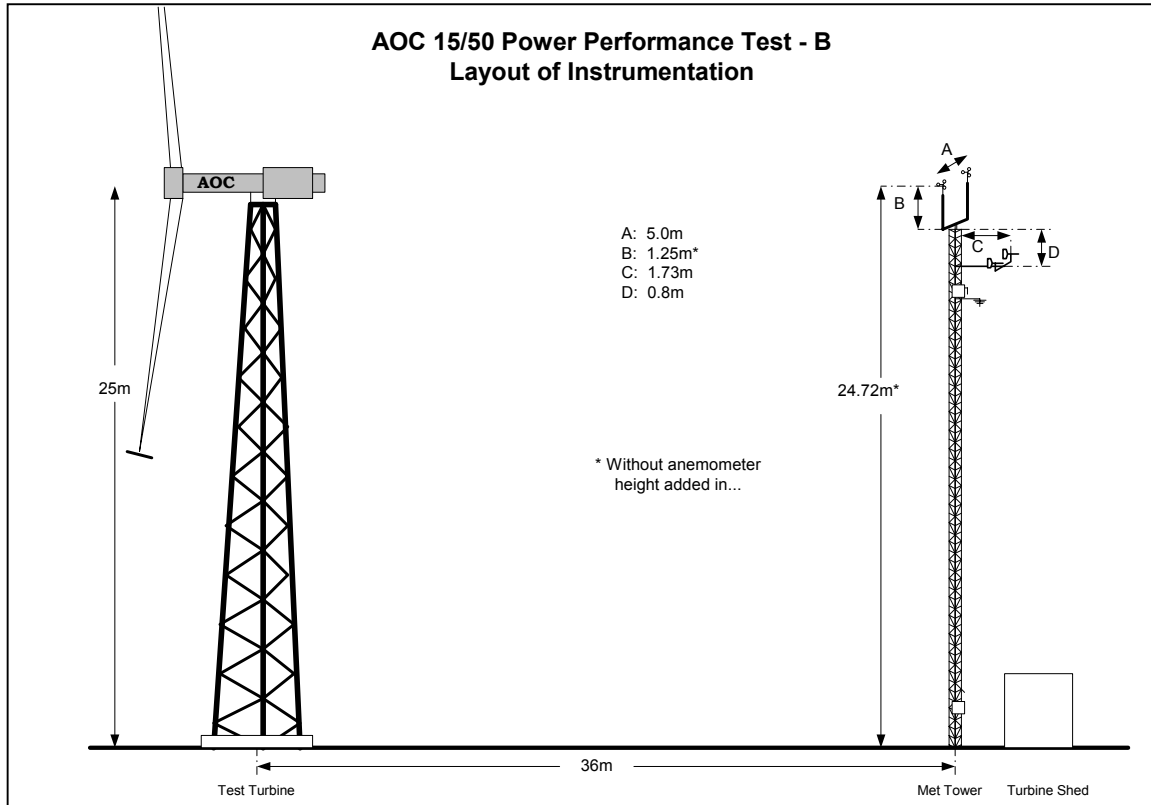
Figure 5. Layout of instrumentation.

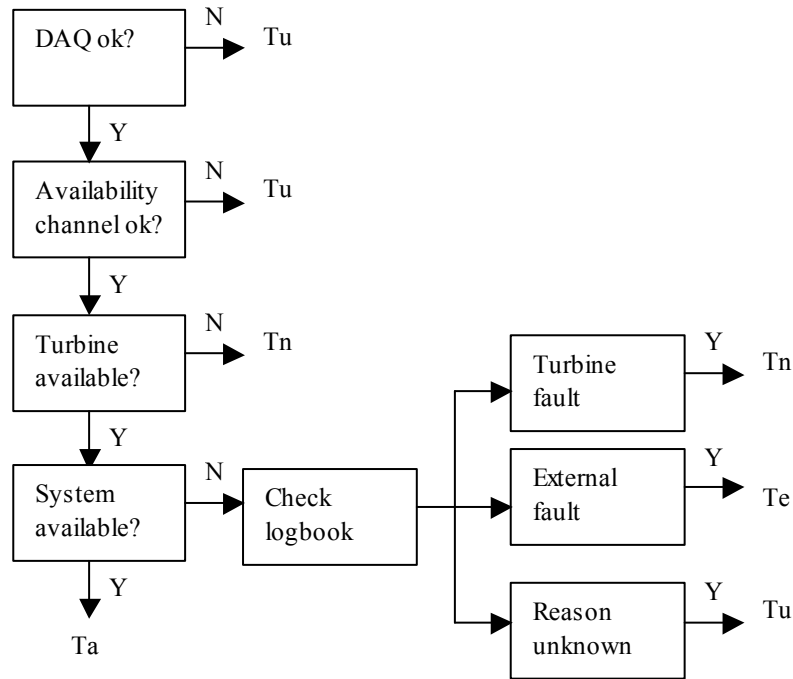
The system availability and turbine availability channels are used in the combination given in Figure 7. After the spreadsheet has automatically applied the criteria from Figure 7, the analyst uses the logbook to override the spreadsheet if needed.

Figure 7. Classification of time for operational time fraction.
