**Wind Turbine Generator System  
Duration Test Report, Revision 1**  
for the  
**Southwest Windpower H40 Wind Turbine**

**National Wind Technology Center  
National Renewable Energy Laboratory  
1617 Cole Boulevard  
Golden, Colorado 80401**

**December 24, 2002**

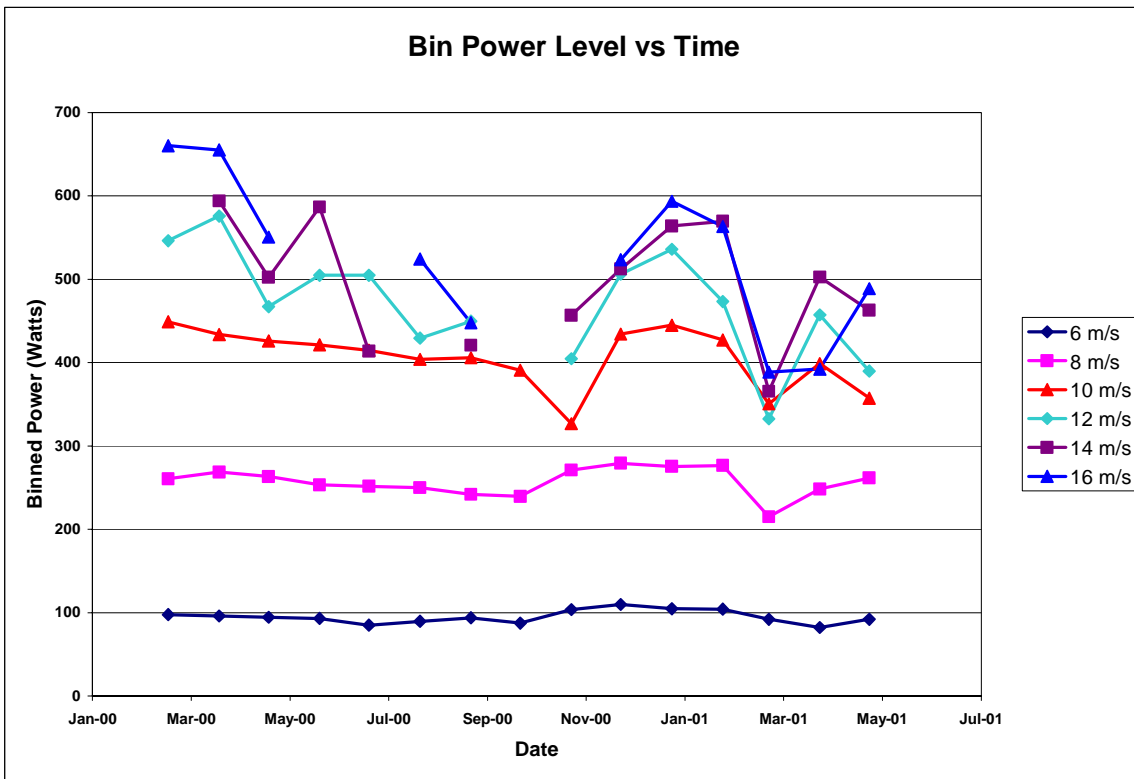
Figure 3. Binned power level at several wind speeds for each month

The comparison of power levels indicates similar behavior. Figure 3 shows significant dips in the 10 m/s power level during November 2000, and March 2001. The 8 m/s power level shows a dip only in March. This could be due to the furling problem becoming worse or some other, unknown problem affecting the turbine in November. There are relatively few data that may have had an effect, but otherwise NREL did not identify the cause for the apparent cyclic variation of 12, 14, and 16 m/s curves.

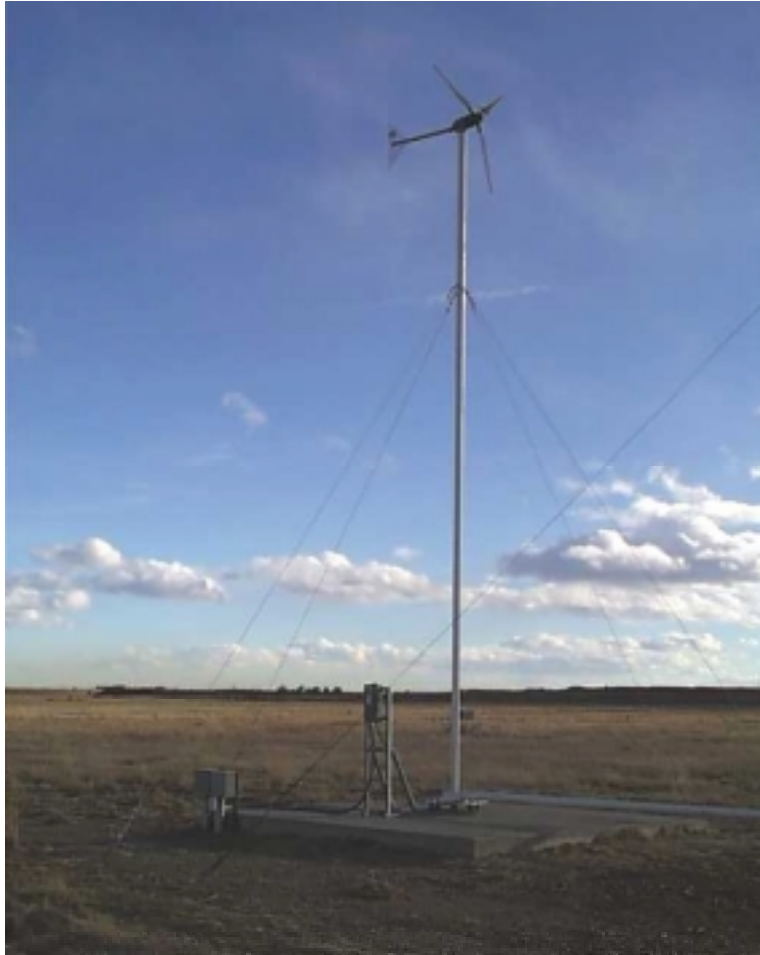
Figure 1. Overall Configuration of the Test Turbine, the Whisper H40

The configuration of the Whisper H40 wind turbine is shown in Figure 1. The turbine is a three-bladed upwind, variable-speed, furling for turbine overspeed control. Rotational energy is converted to electrical power in the nacelle, which contains the permanent magnet alternator, and a brake which shorts one of the electrical wires that runs down the tower.

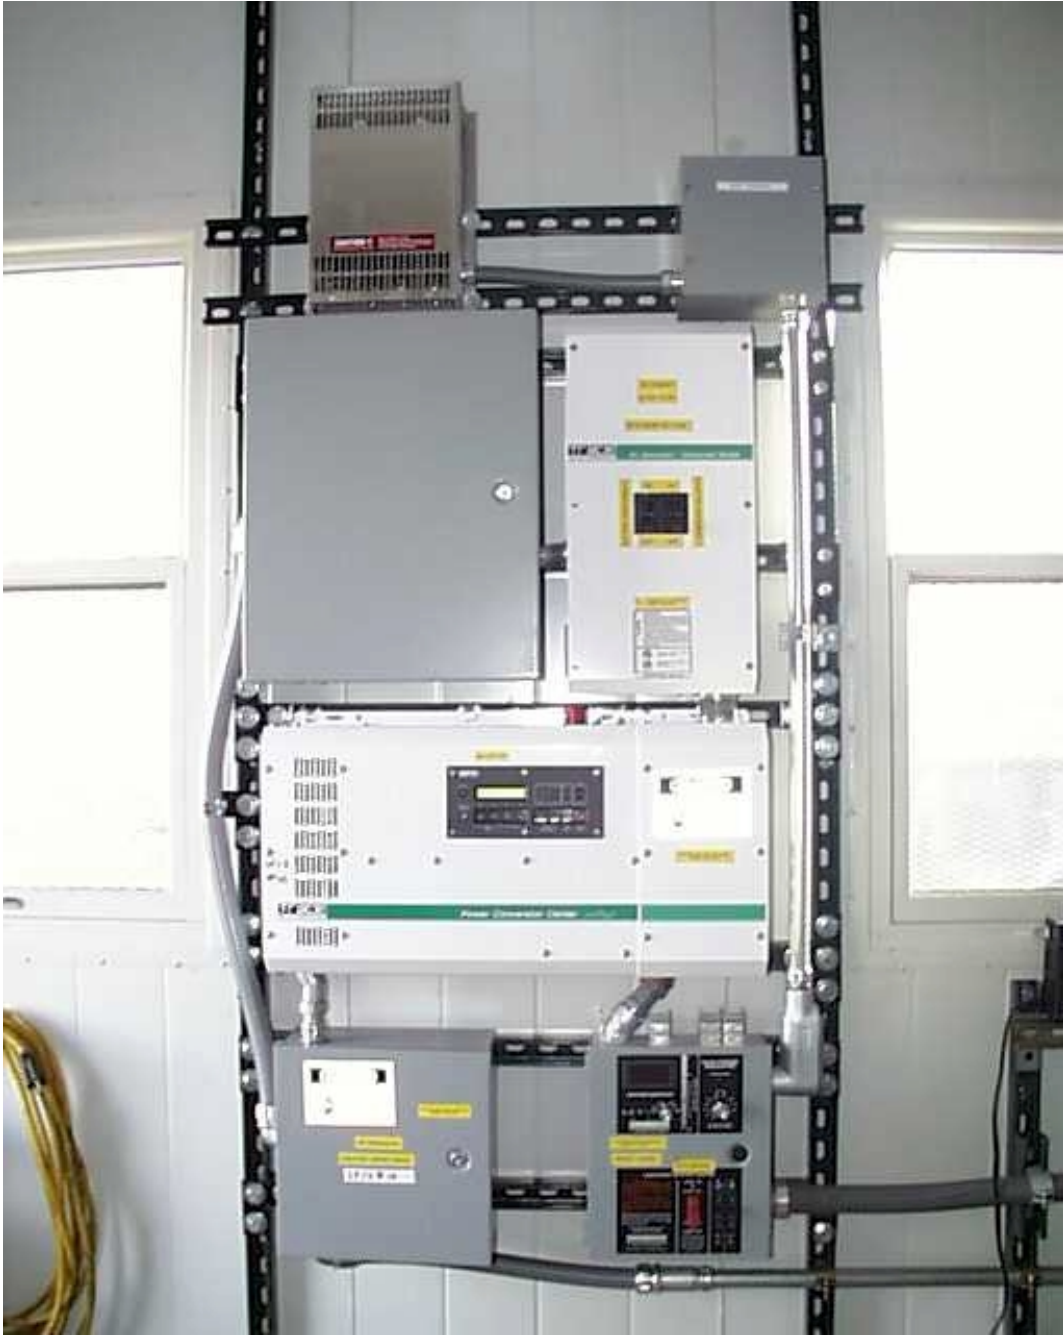
Figure 4. Photograph of Site 1.3 Electrical Installation

Figure 4 shows a photograph of the actual installation within the Site 1.3 shed.

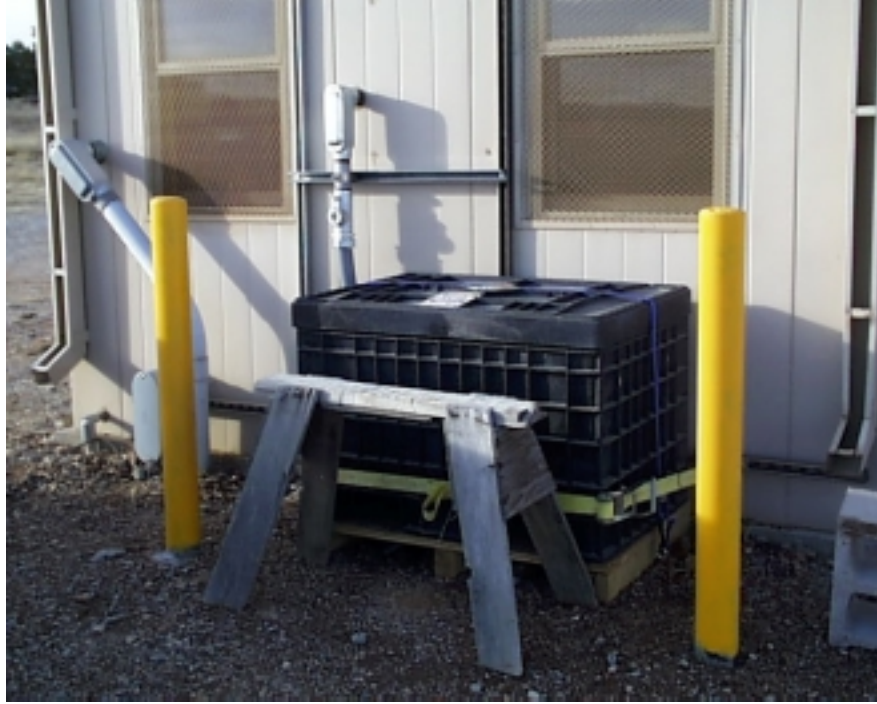
Figure 5. Detail of Battery Box Installation

Note that the system batteries are located outside of the shed and within their own containment box for safety reasons. Figure 5 show the battery box (located along the south wall of the Site 1.3 shed) and the provisions made to secure the box in the event of high wind speeds.

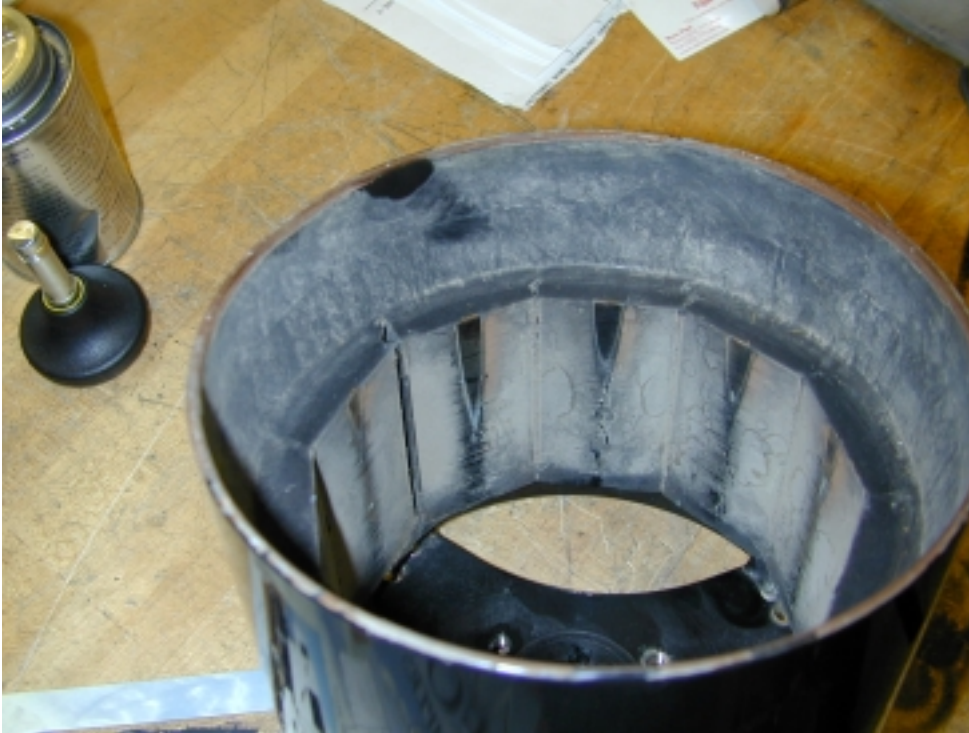
Figure 1: Signs of wear on the magnet can

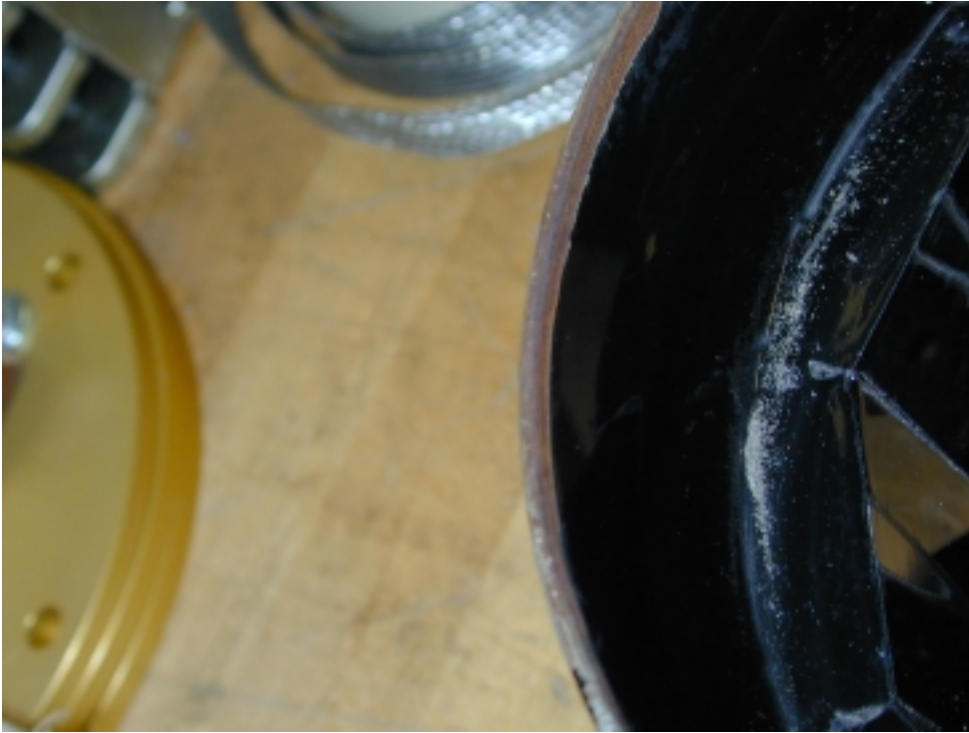
Figure 3: Wear on the edge of the magnet can

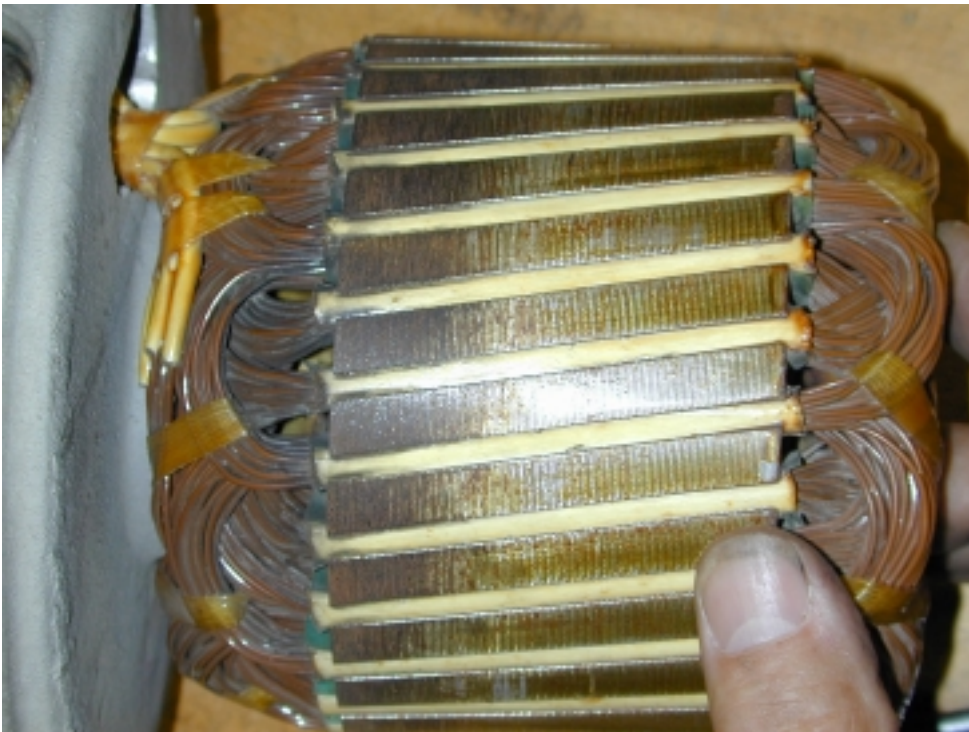
Figure 4: Windings on the downwind side (left) seem slightly decolorized compared to the windings on the up wind side (right). Further the brown areas on the left show where the magnets have been rubbing the stator lamination.

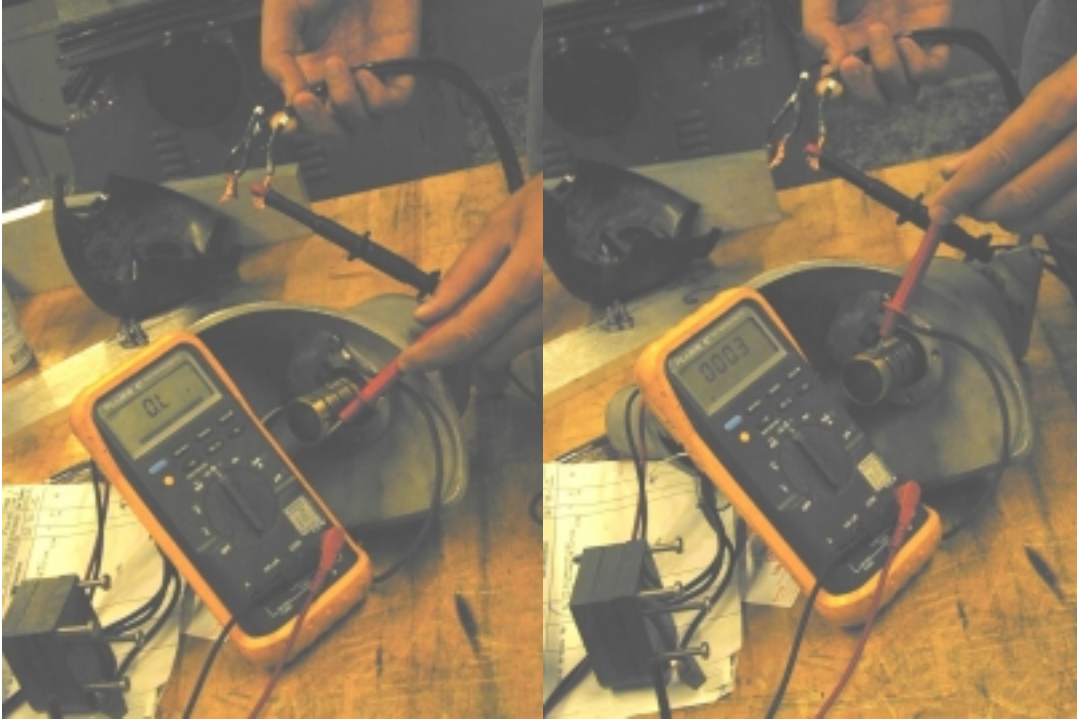
Figure 5: Left: measuring resistance between the slip ring race and the end of the wire, no contact. Right: Measuring resistance between one end of the wire and the wire end in the slip ring hole, connection.

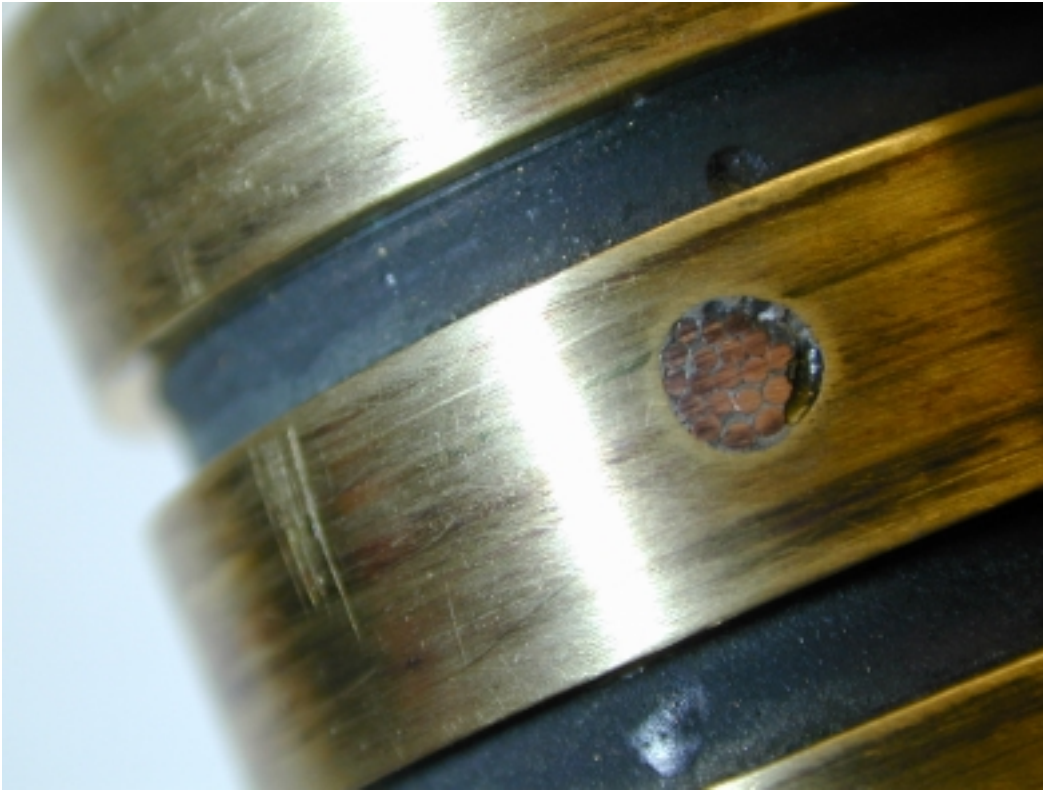
Figure 7: As a comparison a good connection on one of the other slip ring channels.

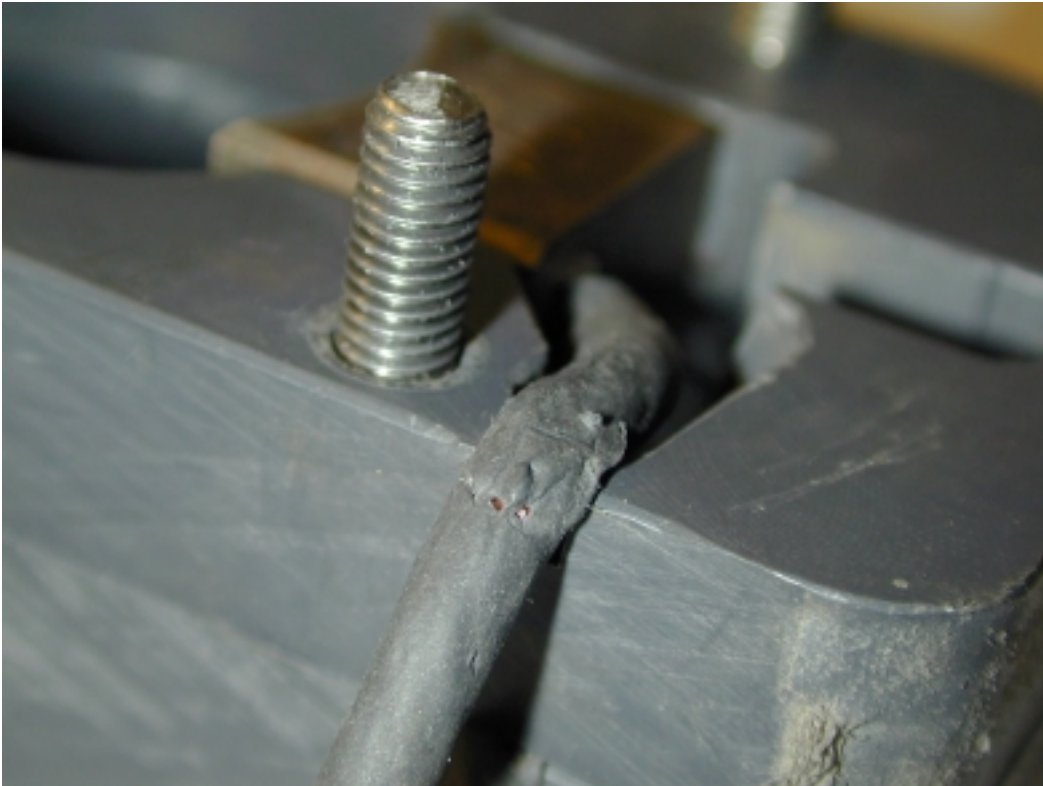
Figure 8: Damaged insulation on one of the wires coming out of the slip ring assembly.

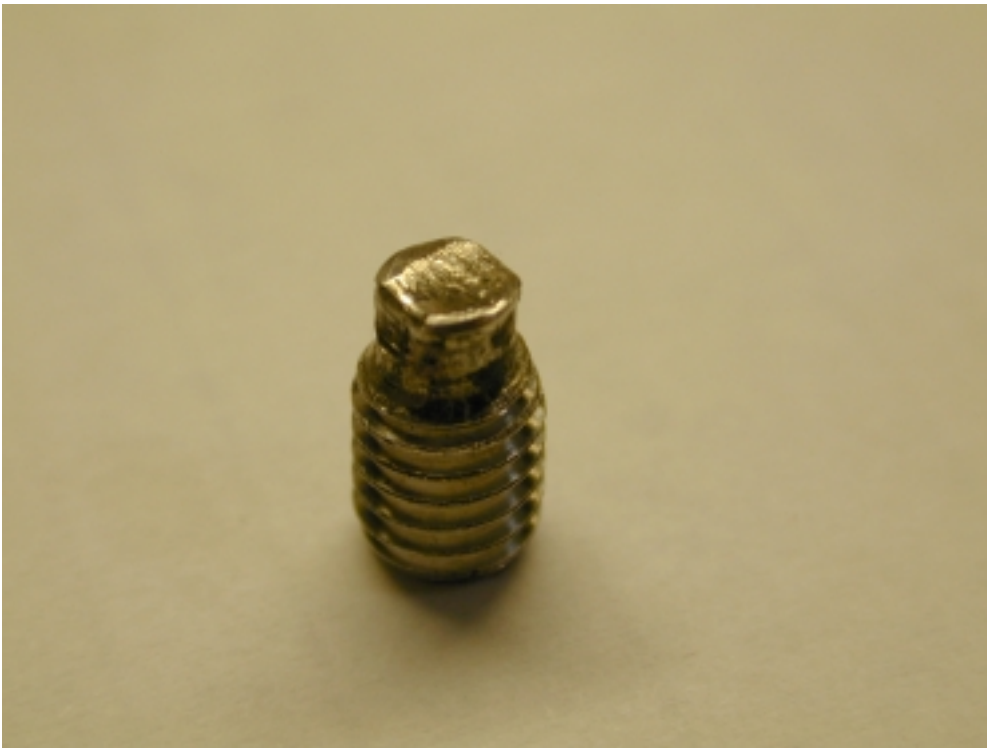
Figure 12: The setscrew. Note the wear on the top of the setscrew.

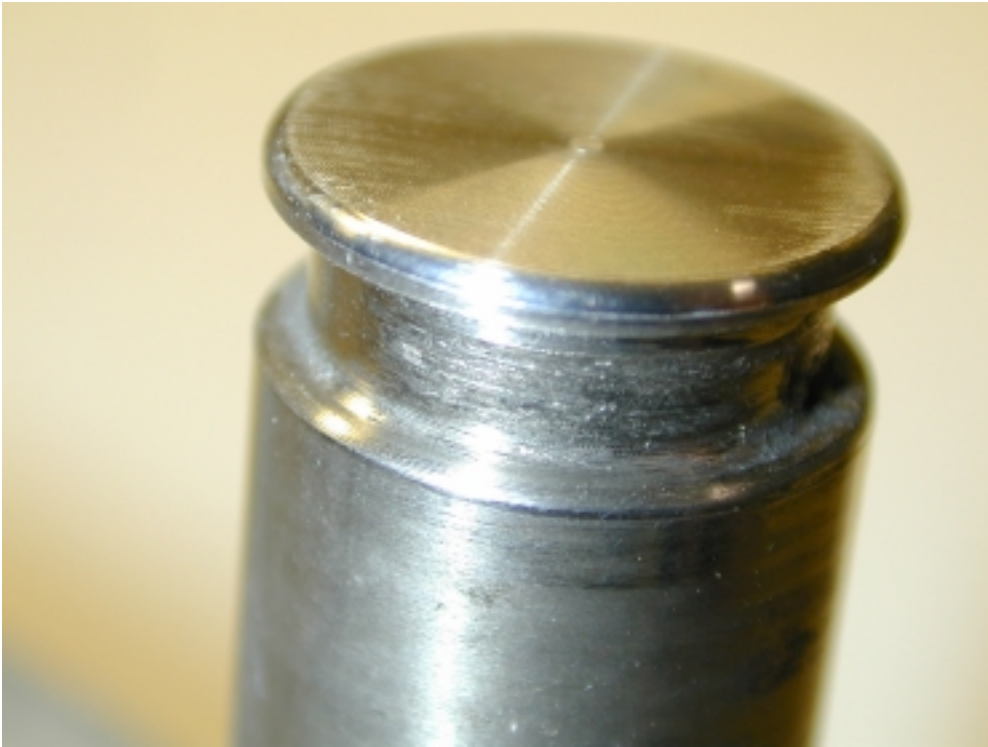
Figure 13: Close up of the groove in the pivot pin. Some wear caused by the setscrew is present.

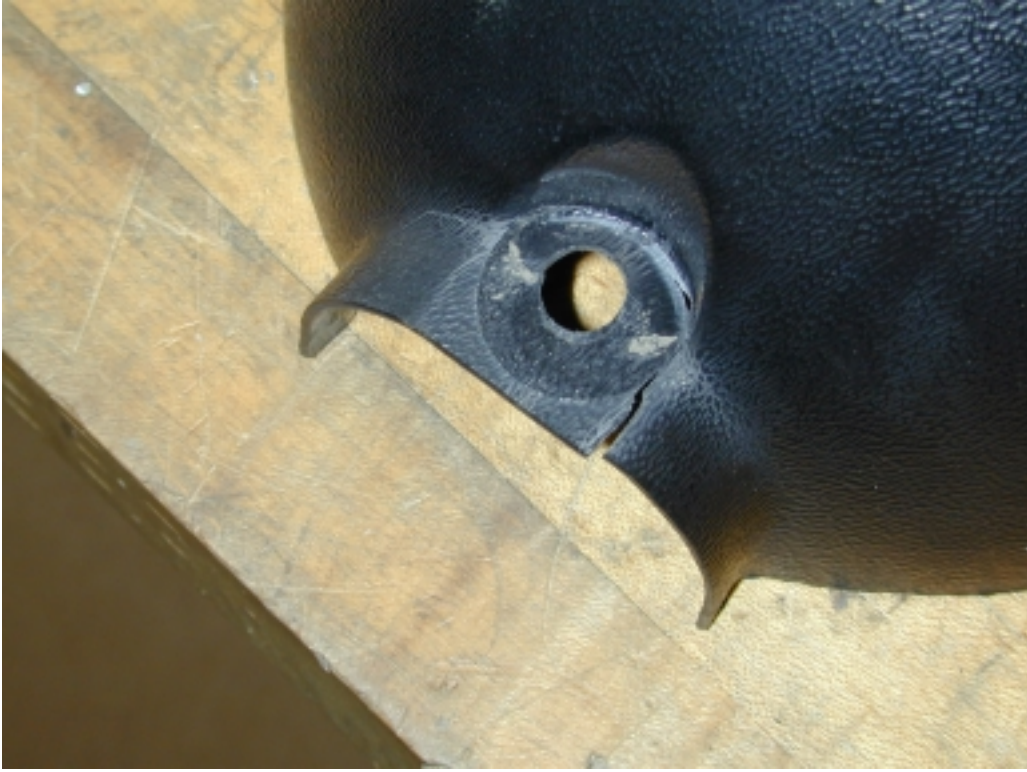
NREL also noted that the nose cone was cracked and needs to be replaced.

<p><b>7. Yaw bearing</b> Dismount he bearings from the turbine and check for abnormal wear, signs of pitting or excessive play in the bearings.</p>	<p>The yaw bearing has some play in it, but no more then can be expected from a double row of the type of ball bearings used. The bearings itself seem fine. There is some minor wear found on the yaw axis caused by the bearing seal (Figure 14)</p>
<p><b>8. Other findings:</b> Check any other components (tail, nacelle body, nose cone, tower insert etc.) for wear, cracks, corrosion, deformation, etc.</p>	<p>As reported earlier the nose cone is cracked and will need replacement. (see Figure 15)</p>

Figure 15: Close up of the nose cone. The holes are use by the fasteners connecting the nose cone to the hub.
