FLEXIBLE GAS CONNECTORS
CHRONOLOGY OF COMMISSION INVOLVEMENT

Failure of Flexible Brass Gas- Appliance Connectors

Failure Analysis Report

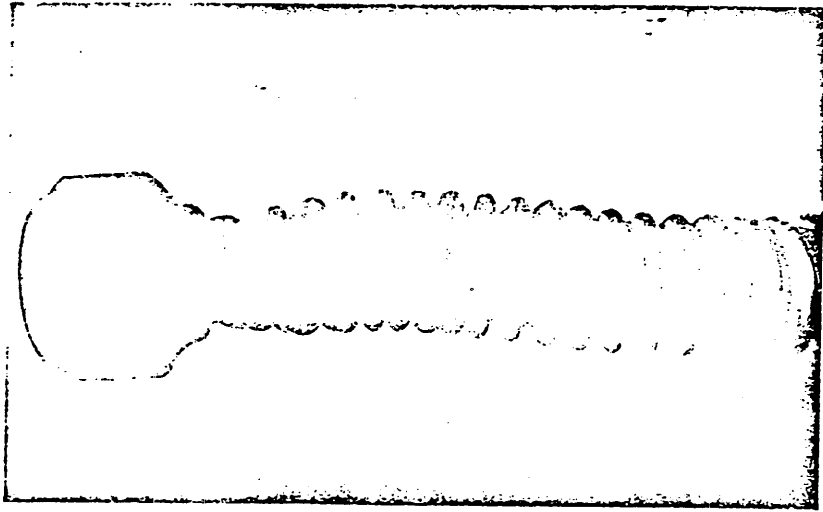
Visual examination of the specimens revealed discoloration and blue and white residue in the area located near the extremities of the tubing sections, where couplings were attached (Fig. 2a). In addition to this,

Fig. 2a Close-up view of an end of one tubing, showing where the corrosion attack was located.

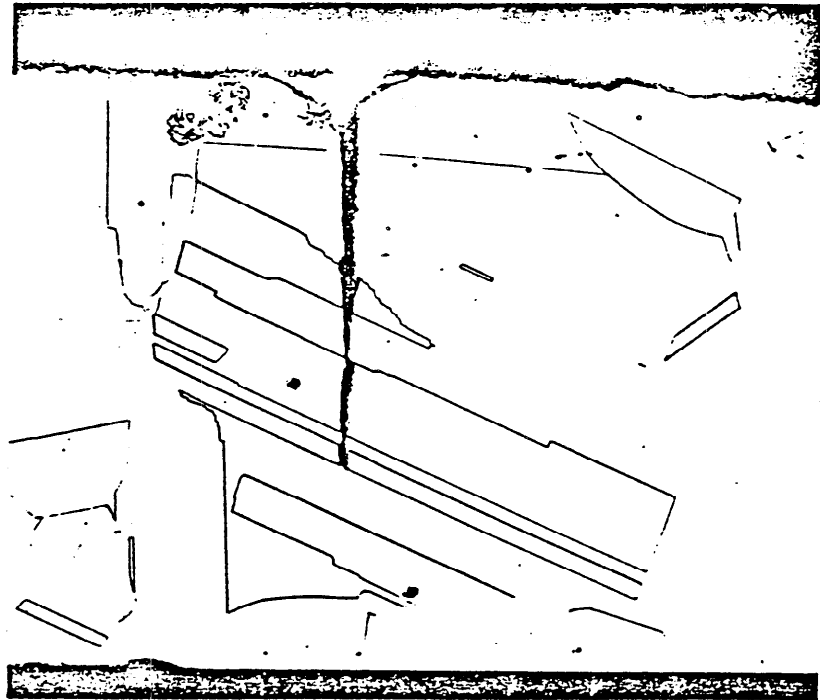
Optical micrographs were made of a specimen which was sectioned from the flexible tubing in an area near one of the major fracture sites. Cracks can be observed throughout the body of the material and are highly branched (Fig. 4). When the specimen surface was chemically etched two important observations can be made: (1) the metal microstructure is of rather large grain size, and (2) the cracks are largely transgranular in nature, propagating through grains rather than through grain boundaries (Fig. 5).

A comparison of the optical micrographs taken of cracks in this material (Fig. 5) with those observed for stress corrosion cracking of 70-30 brass in non-tarnishing aqueous ammonia solution show the morphology of cracking to be quite similar (Fig. 7, from (4)). Furthermore, the particular heat treatment of this brass which resulted in the large grain size (Fig. 5)

Fig. 5 Optical Micrograph (x200) of a cross section of the flexible brass tubing, etched in 1 part water (H_2O), 1 part hydrogen peroxide (H_2O_2), and 1 part concentrated ammonium hydroxide (NH_4OH), showing the metal microstructure. Cracks are predominantly transgranular.

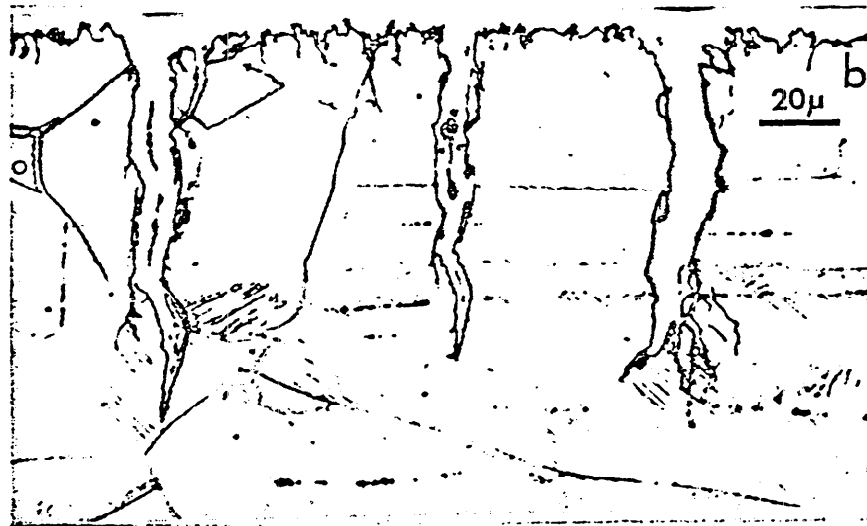
Fig. 7 Optical Micrograph showing stress corrosion cracks in 70-30 brass exposed to aqueous ammonia solution (from (3)).

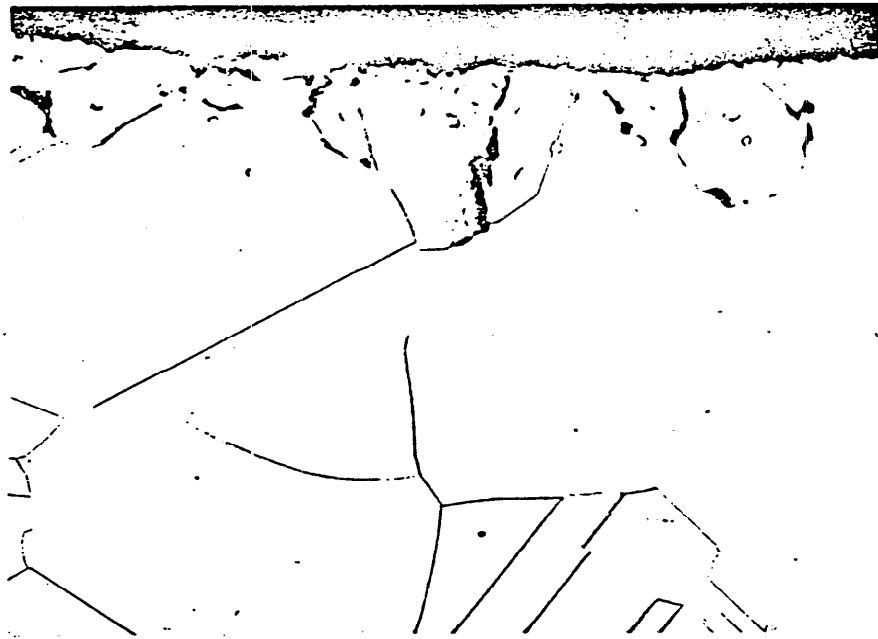
Finally, a test specimen was cut from a section of the brass tubing, bent once to simulate treatment during installation of the coupling unit, dipped into a sample of the leak detector solution, then placed into a sealed glass container. The test exposure was allowed to proceed for two weeks, after which the specimen was removed, sectioned, and mounted for metallographic examination. Although the extent of crack propagation is less than that in the failed specimens, the initial stages of cracking are evident in Fig. 8. It should be remembered that service failures were reported to have taken from 3 to 6 weeks to occur, while the short term laboratory test was all that was possible, within the time limitations set to prepare this report.

Fig. 8 Optical Micrograph (x500) of the cross section of a 5 cm specimen of brass tubing exposed for two weeks to the leak detector solution, then etched as in Fig. 5, showing initiation of cracking at the metal surface.
