Parabolic Trough Receiver Thermal Performance

Parabolic Trough Workshop

March 9, 2007

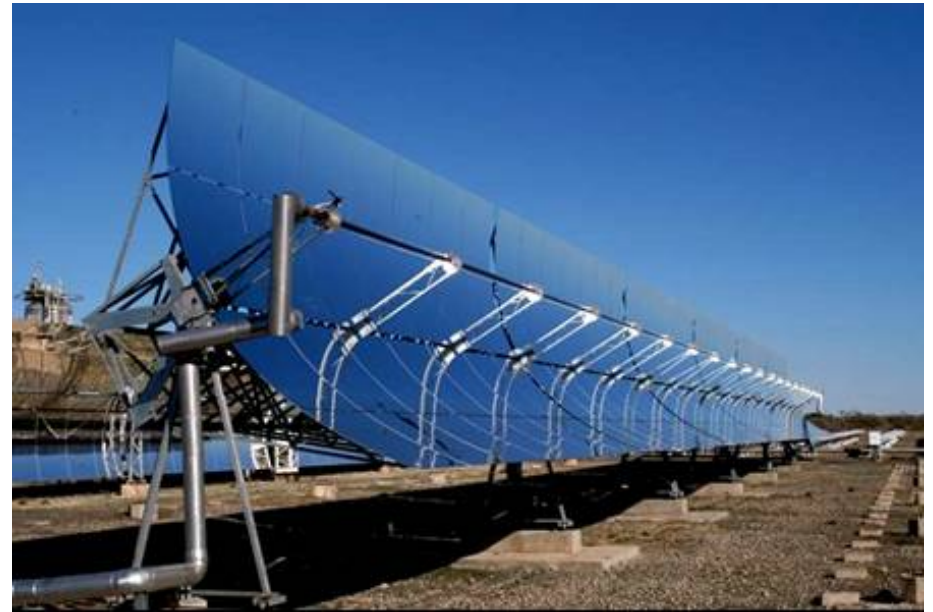
- Receiver testing on EuroTrough Prototype @ Plataforma Solar de Almería
 - Solel UVAC
 - Schott Cermet
- Advantages
 - Full collector tested (more receivers)
 - Better precision
- Disadvantages
 - Single E/W axis tracking
 - Reduced test flexibility

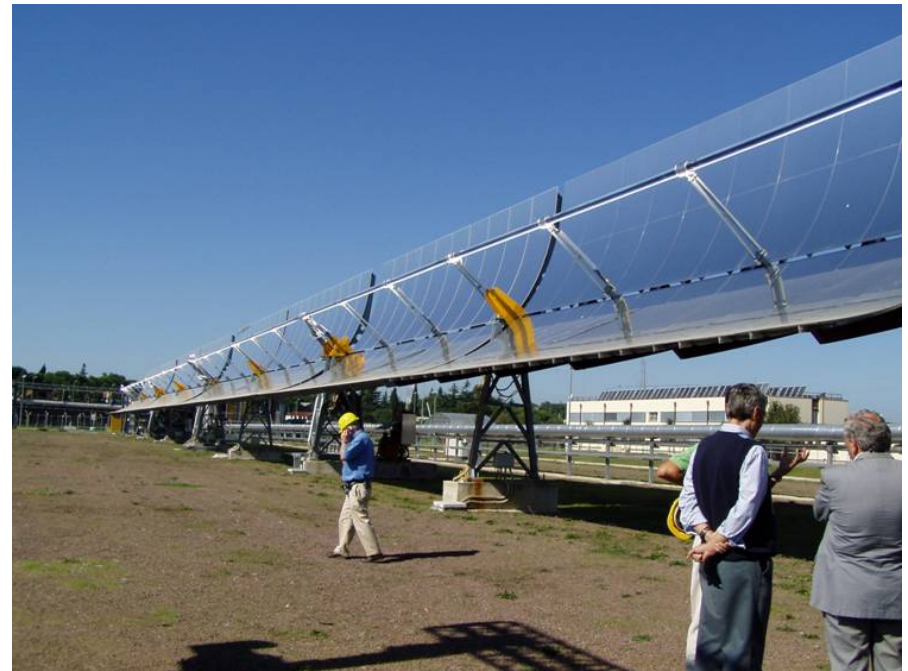
- Receiver testing on ENEA Loop
 - Schott Receiver
 - ENEA Receiver (Summer 2007)
- Advantages
 - Molten Salt Test
 - Higher Temperatures
 - Two Collectors

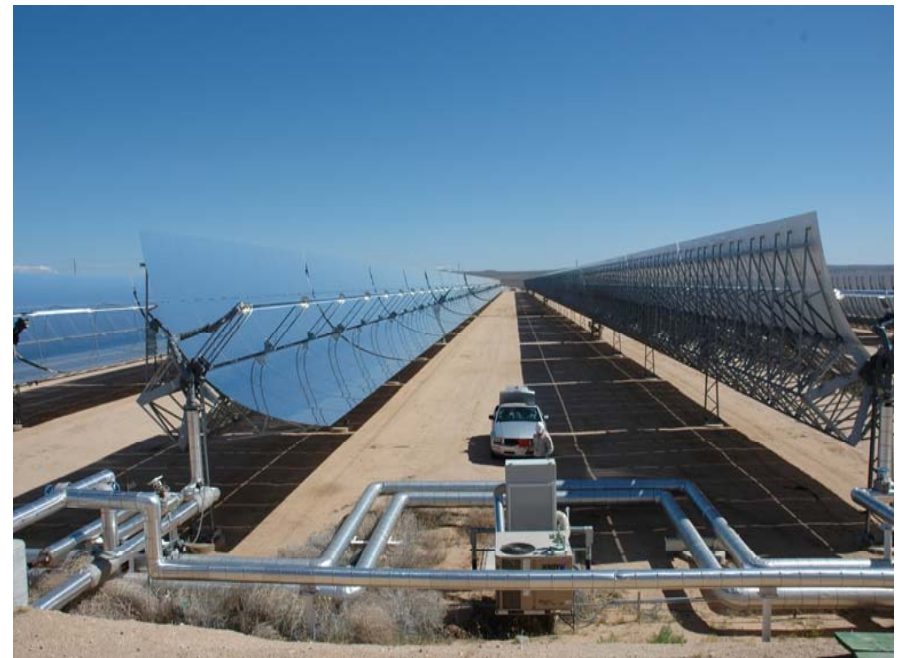
- **Loop Testing at the SEGS**
 - Solel UVAC (SEGS VI)
 - Schott Cermet (SKAL-ET, SEGS V)
- **Advantages**
 - Field testing in normal operation
 - Full loop tested
 - Comparison to other loops
- **Disadvantages**
 - Many factors affect results
 - Limited control of test

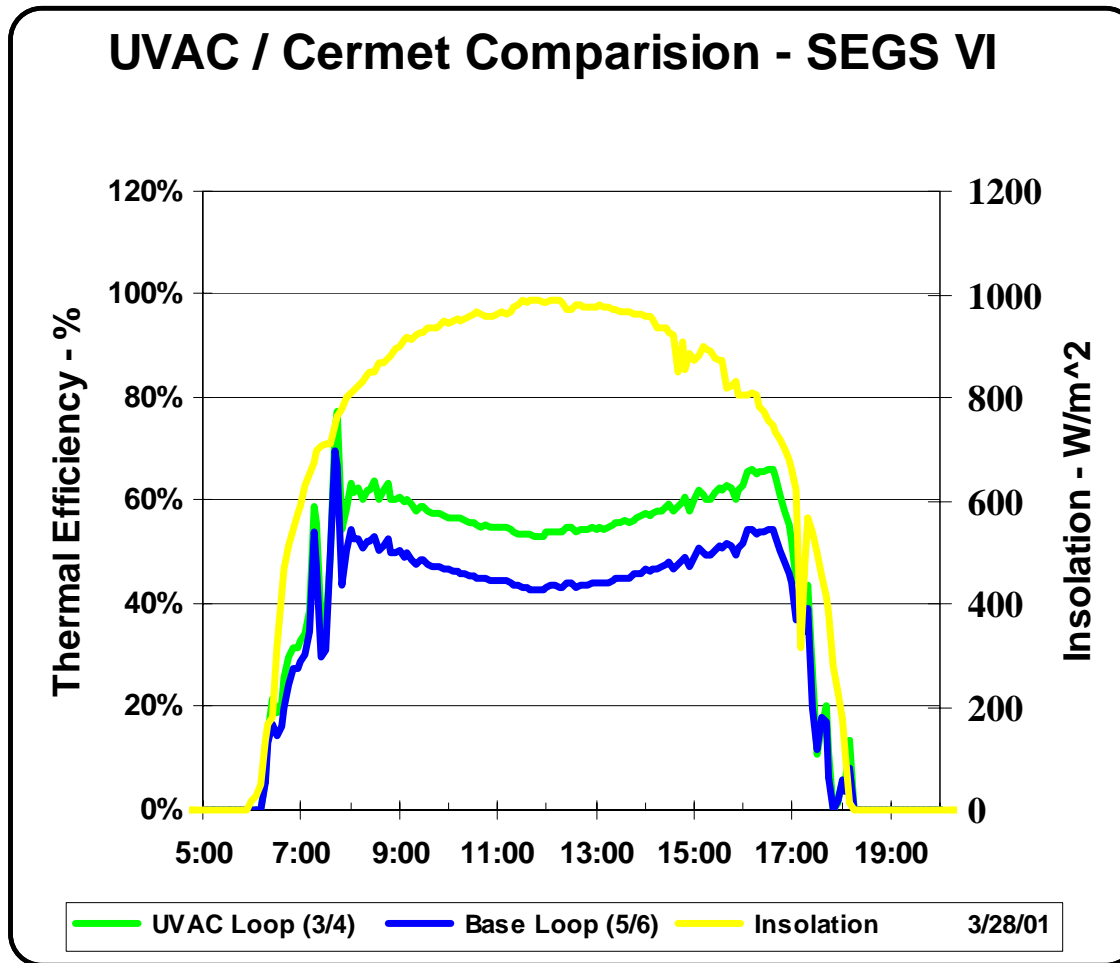
UVAC Test Loop Results @ SEGS VI Performance or 192 HCEs

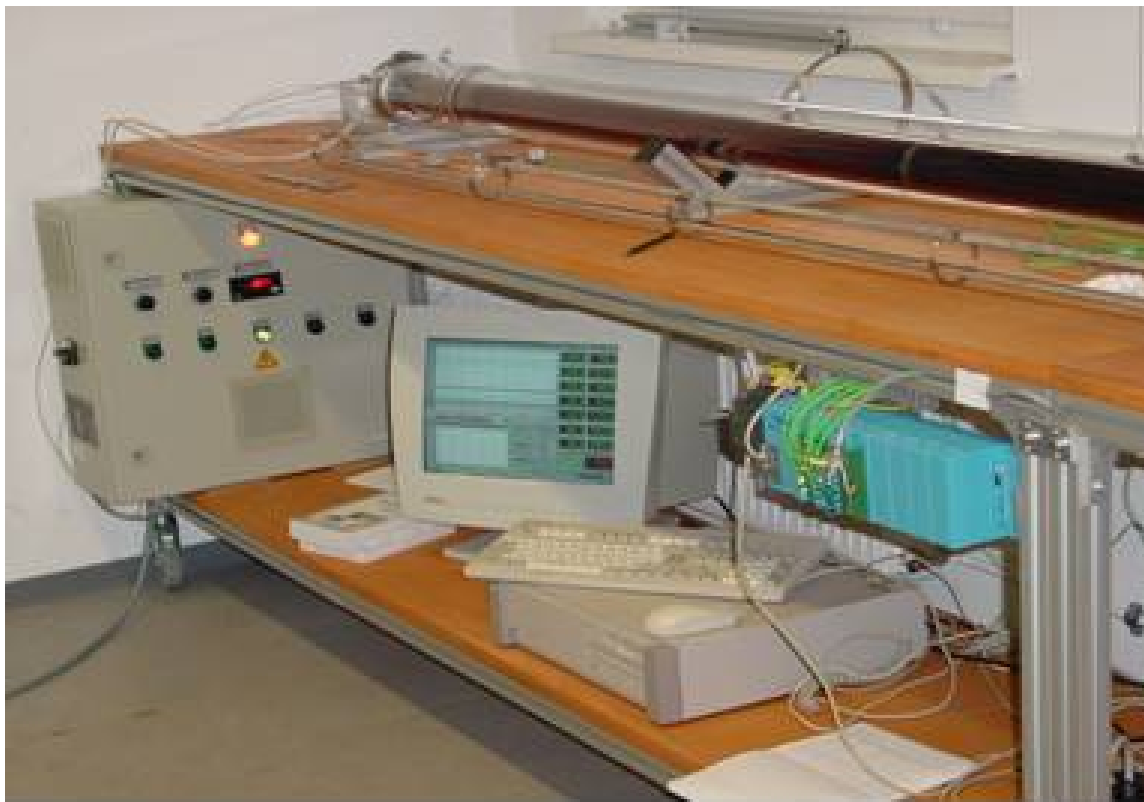
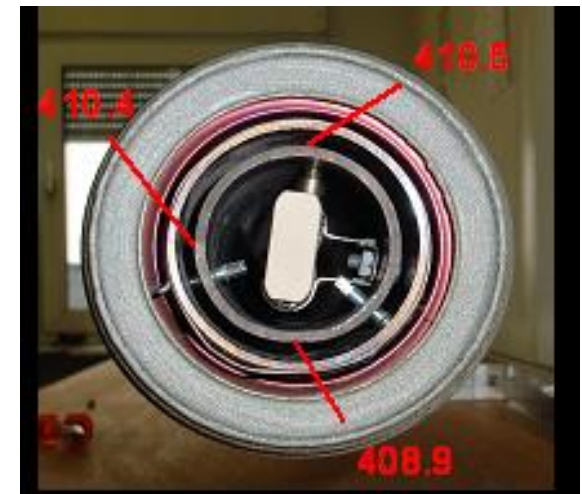
DLR Receiver Test Lab

- Electric resistance heating
- At steady state power consumption is equal to thermal losses

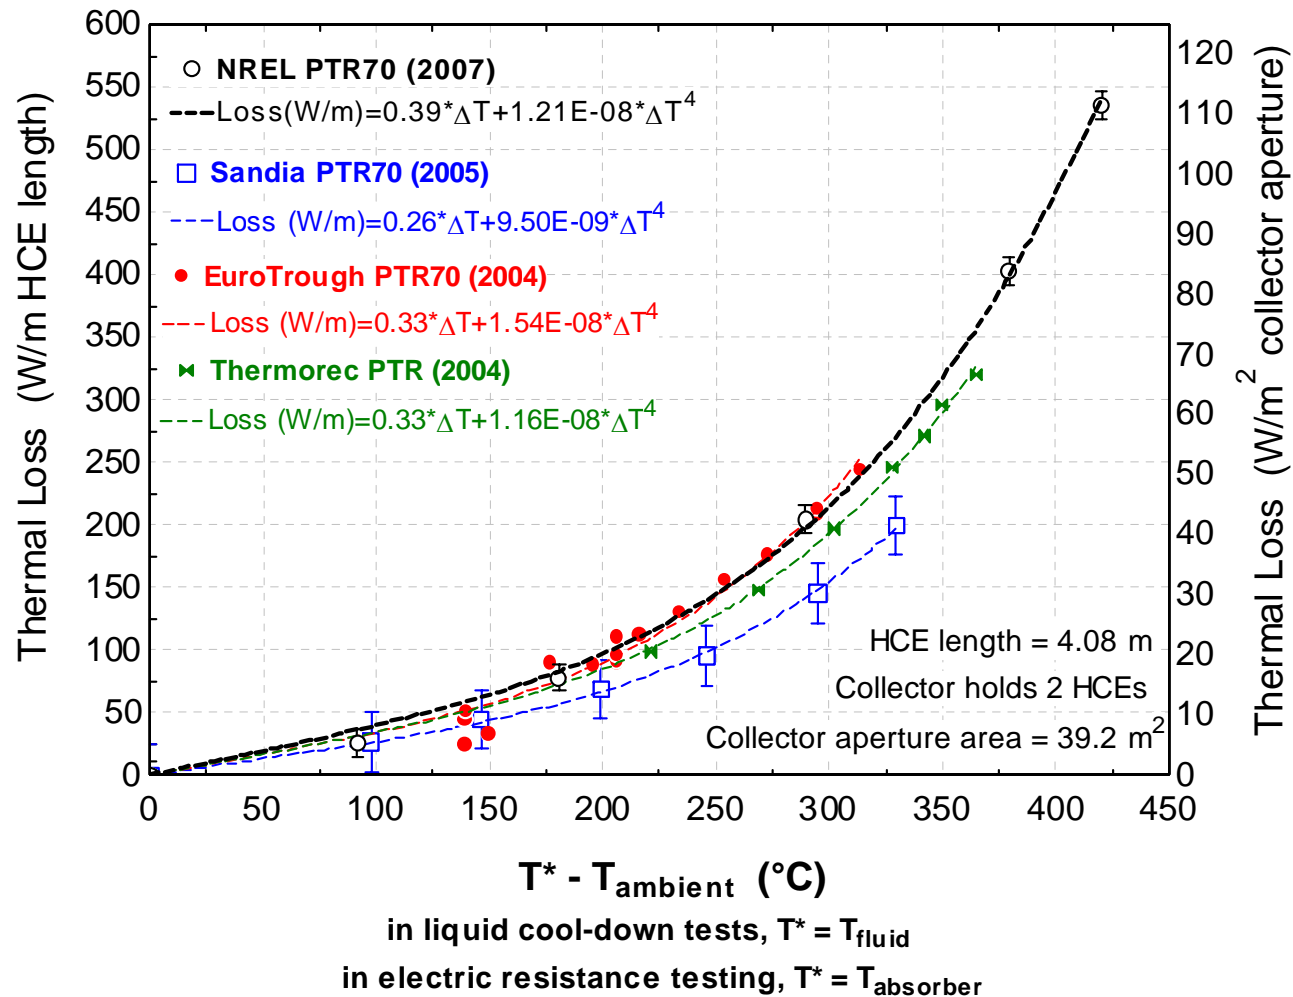
Receiver Test Results Schott PTR70

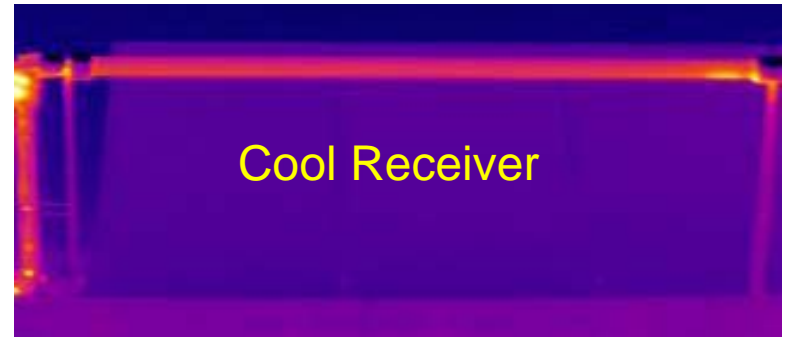
Receiver Field Survey With Infrared Camera

- IR camera provided a good approach for evaluating condition of a large number of receivers in the solar field.
 - A highly automated approach for imaging receiver and analyzing data developed
 - Good agreement between IR camera and thermocouple measurements
 - Able to take measurement while collectors tracking
 - Approximately 12,000 images of receivers taken (out of ~90,000 receivers)
- Results from testing:
 - Able to evaluate performance of various generations of original and replacement receivers.
 - Getter dust, dirt on glass, or fluorescent coating failure cause increased glass temperatures.
 - **Results indicate a potential hydrogen build-up in receivers in solar field**

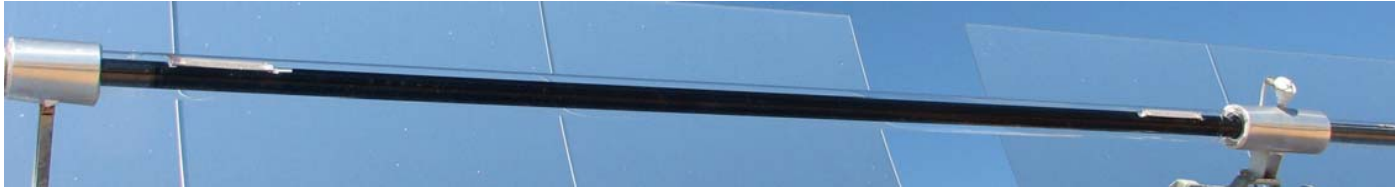
Solel UVAC2 (2 years old) with Vacuum

Visible Image of Receiver – Not Tracking

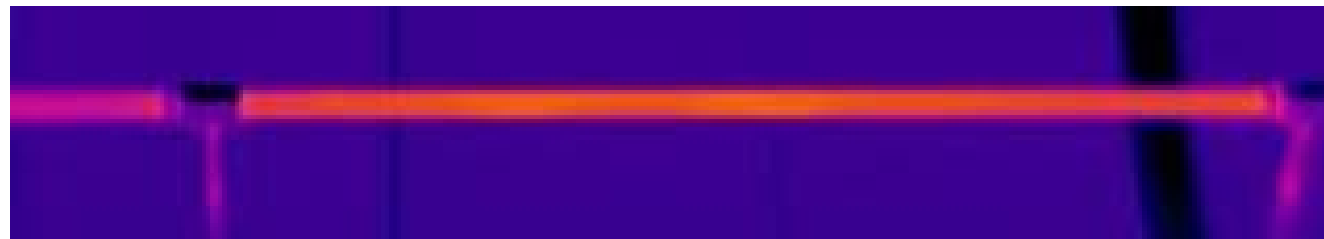
Infrared Image – Not Tracking (Glass Temp. 124°C-141°C)

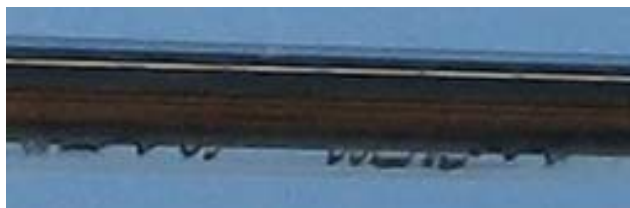
Getter dust is causing hot spots on the glass

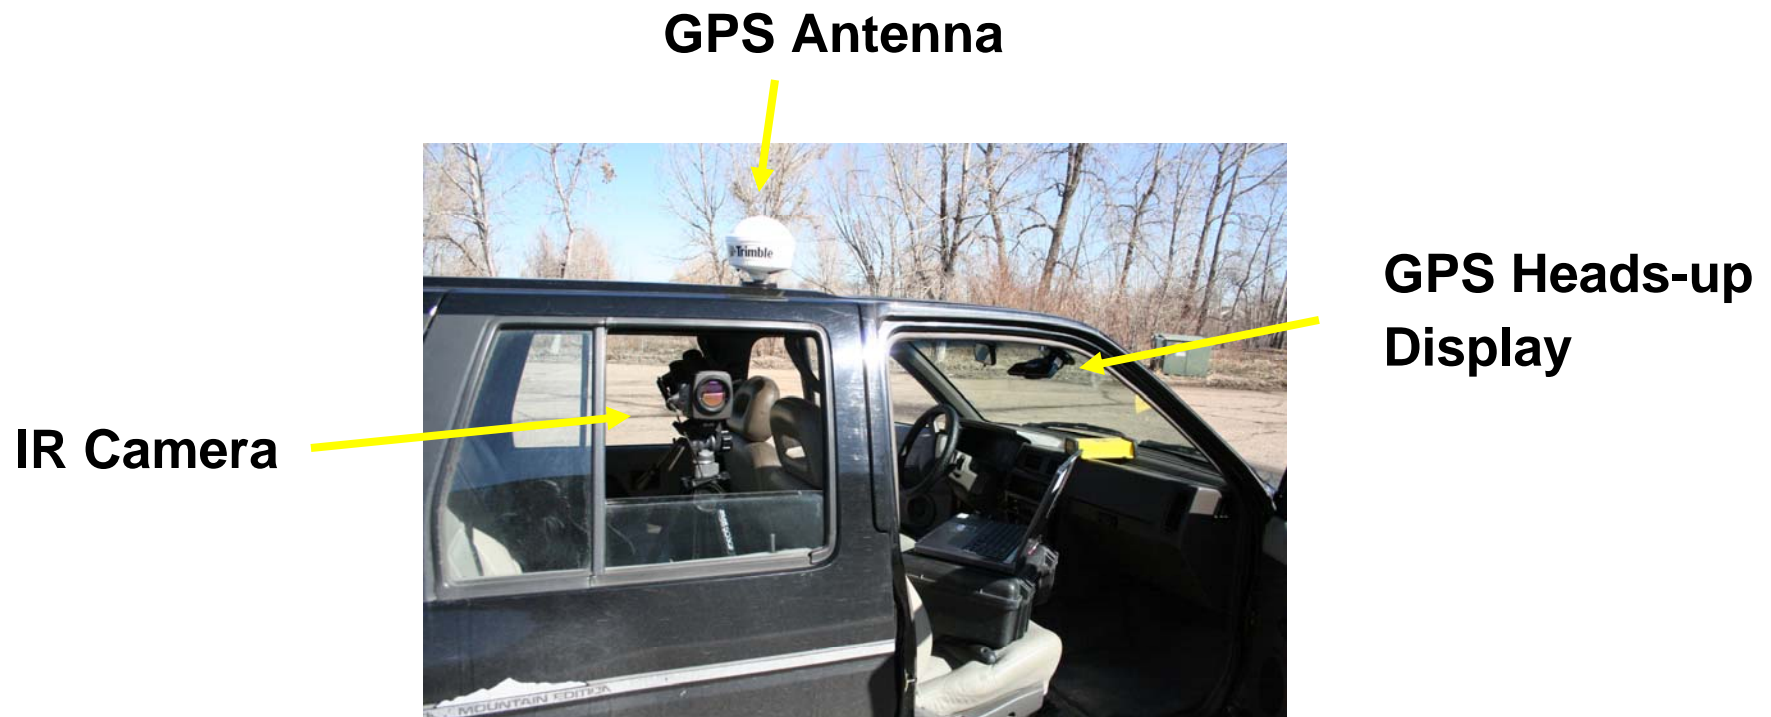
- Improved automation of image acquisition
 - Integration of GPS for automated acquisition of images.

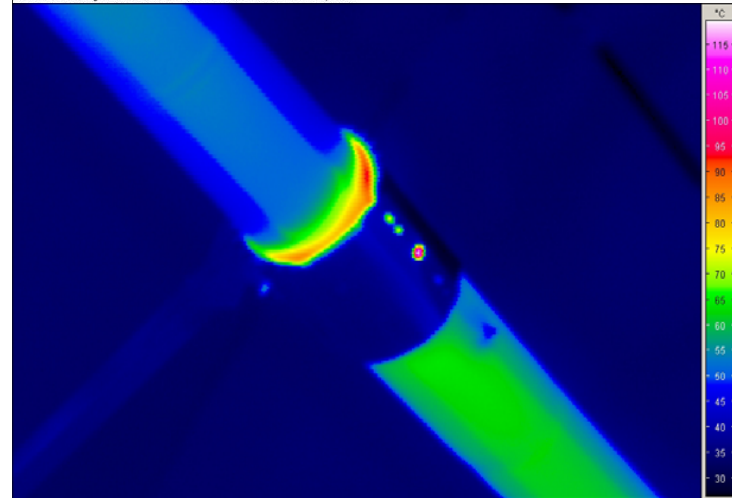
Infrared Camera Measurements through Glass

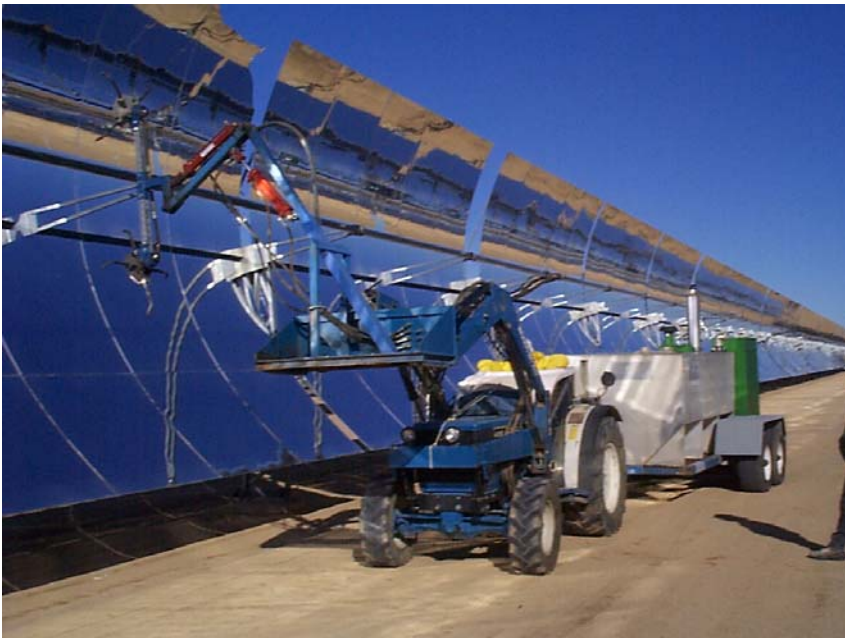
**High Pressure Spray with
Demineralized water**

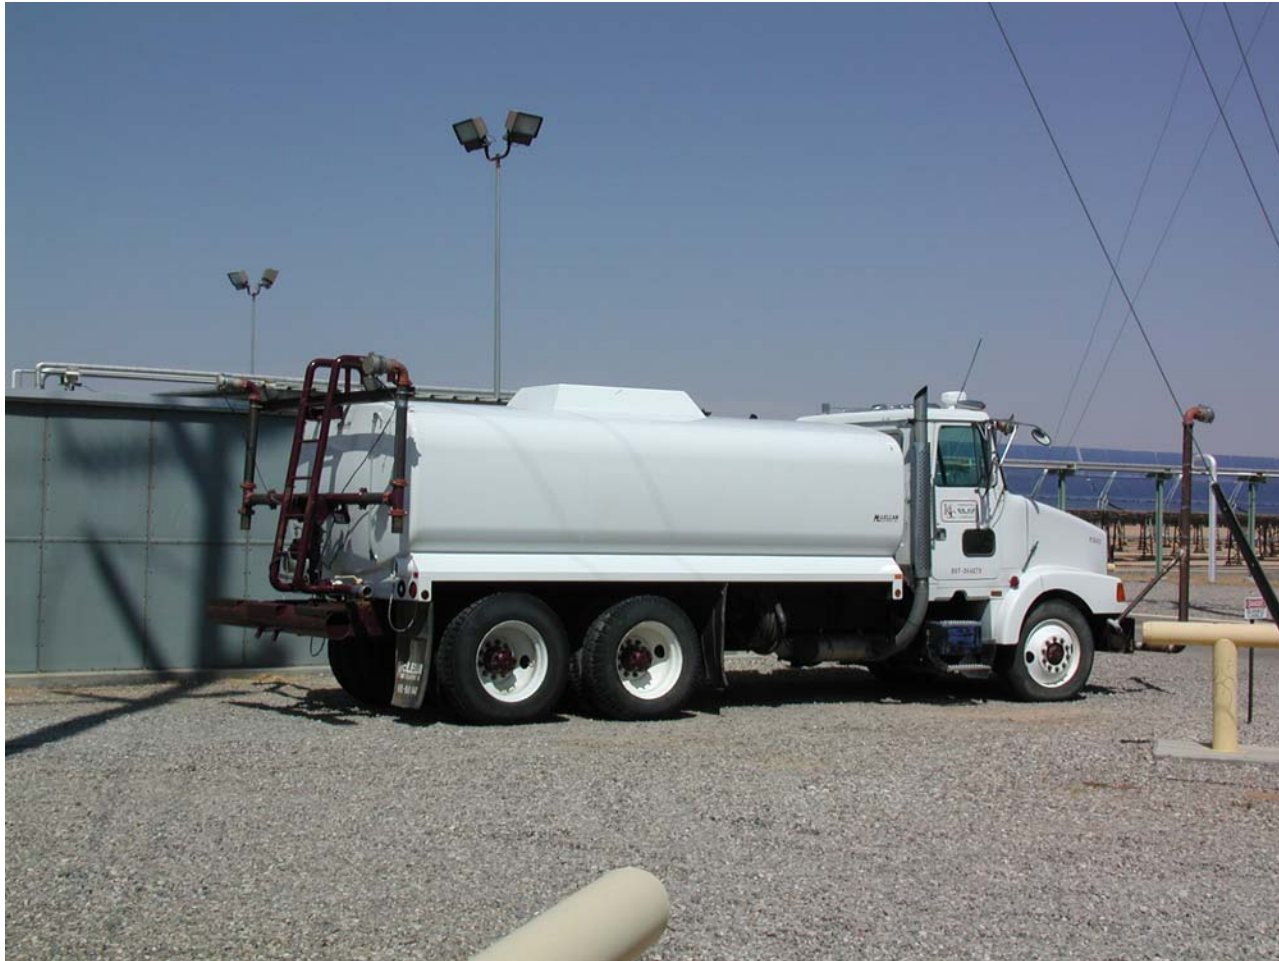
Deluge wash with Demineralized water
