U.S. Department
of Transportation
**Federal Railroad
Administration**

Thermal Insulation Systems Study for the Chlorine Tank Car

1. Report No. FRA/ORD-85-10		2. Government Accession No.		3. Recipient's Catalog No.	
4. Title and Subtitle THERMAL INSULATION SYSTEMS STUDY FOR THE CHLORINE TANK CAR				5. Report Date APRIL 1985

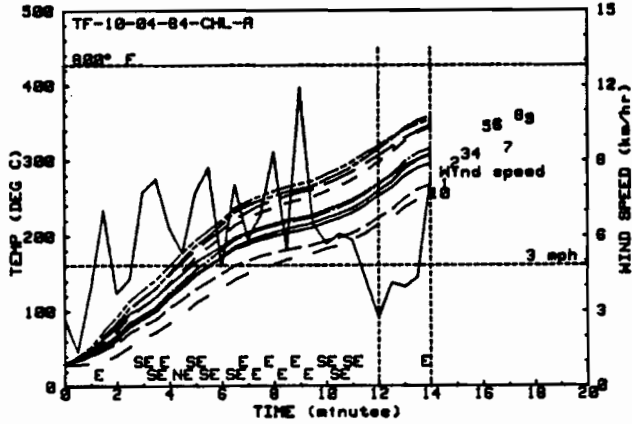
The next six tests listed in Table 5 were conducted following the Kaowool pool fire tests and in preparation for testing the Fiberfrax-Fiberglass Insulation System. The wind caused the first five to fail (Figures 25 through 29). The sixth test (Figure 30) was successful since the wind was calm. However, the Fiberfrax System could not be tested because the wind was too unfavorable to attempt a 100 minute test.
