Status and Monitoring of Southwestern Willow Flycatchers within Elephant Butte Reservoir, New Mexico

**U.S. Department of the Interior
Bureau of Reclamation
Ecological Planning and Assessment
Denver, Colorado**

December 2005

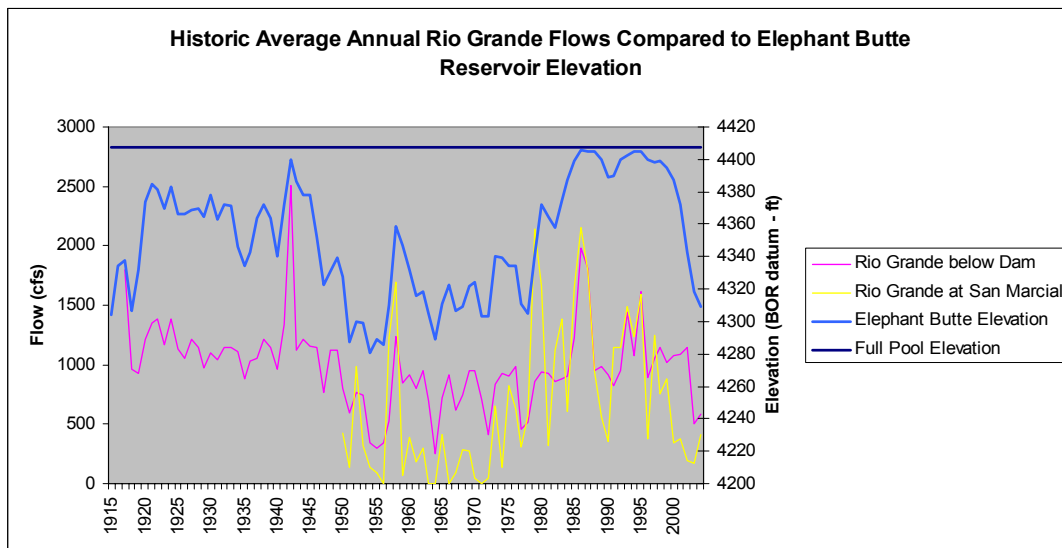
Figure 1. Average annual flow in the Rio Grande compared to Elephant Butte Reservoir elevations from 1915 to 2004. The San Marcial station was not installed until 1950.

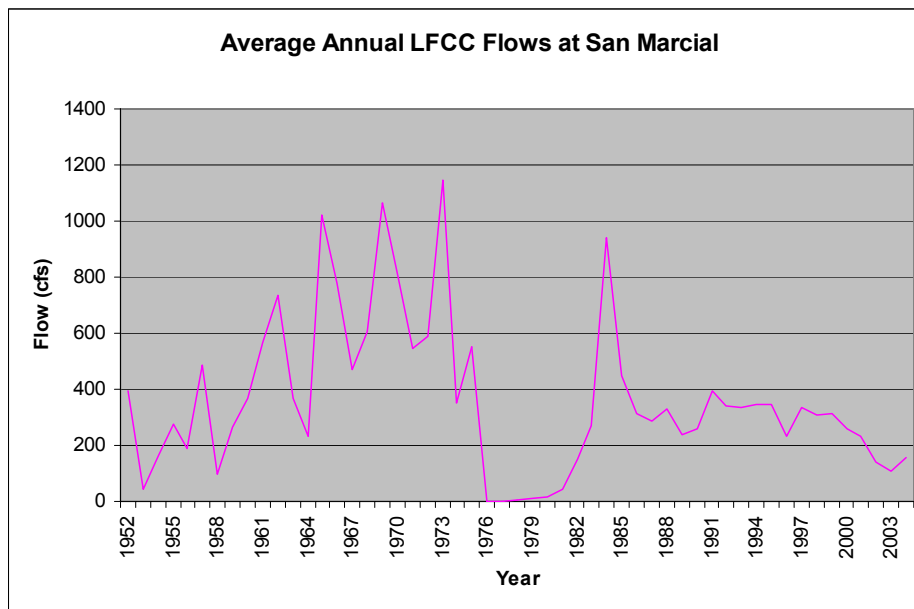
Figure 2. Average annual flow in the Low Flow Conveyance Channel at San Marcial from construction to present.

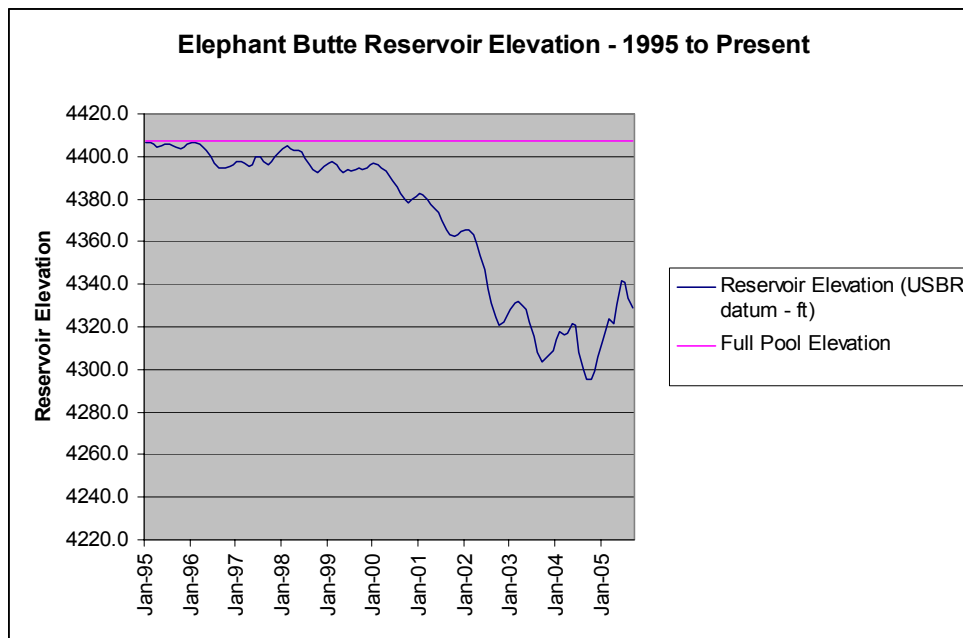
Figure 5. Elephant Butte Reservoir surface elevation – 1995 to present.

As of September 27, 2005, Elephant Butte Reservoir elevation was 4,327 ft; 80 ft below the full pool elevation of 4,407 ft. Reservoir storage at this elevation is 350,950 ac-ft, approximately 17 percent of full pool storage. Due to low Rio Grande flows, reservoir levels have dropped from nearly full pool elevation in the mid- to late-90s to the current level (Figure 5). This recession of the reservoir pool, in combination

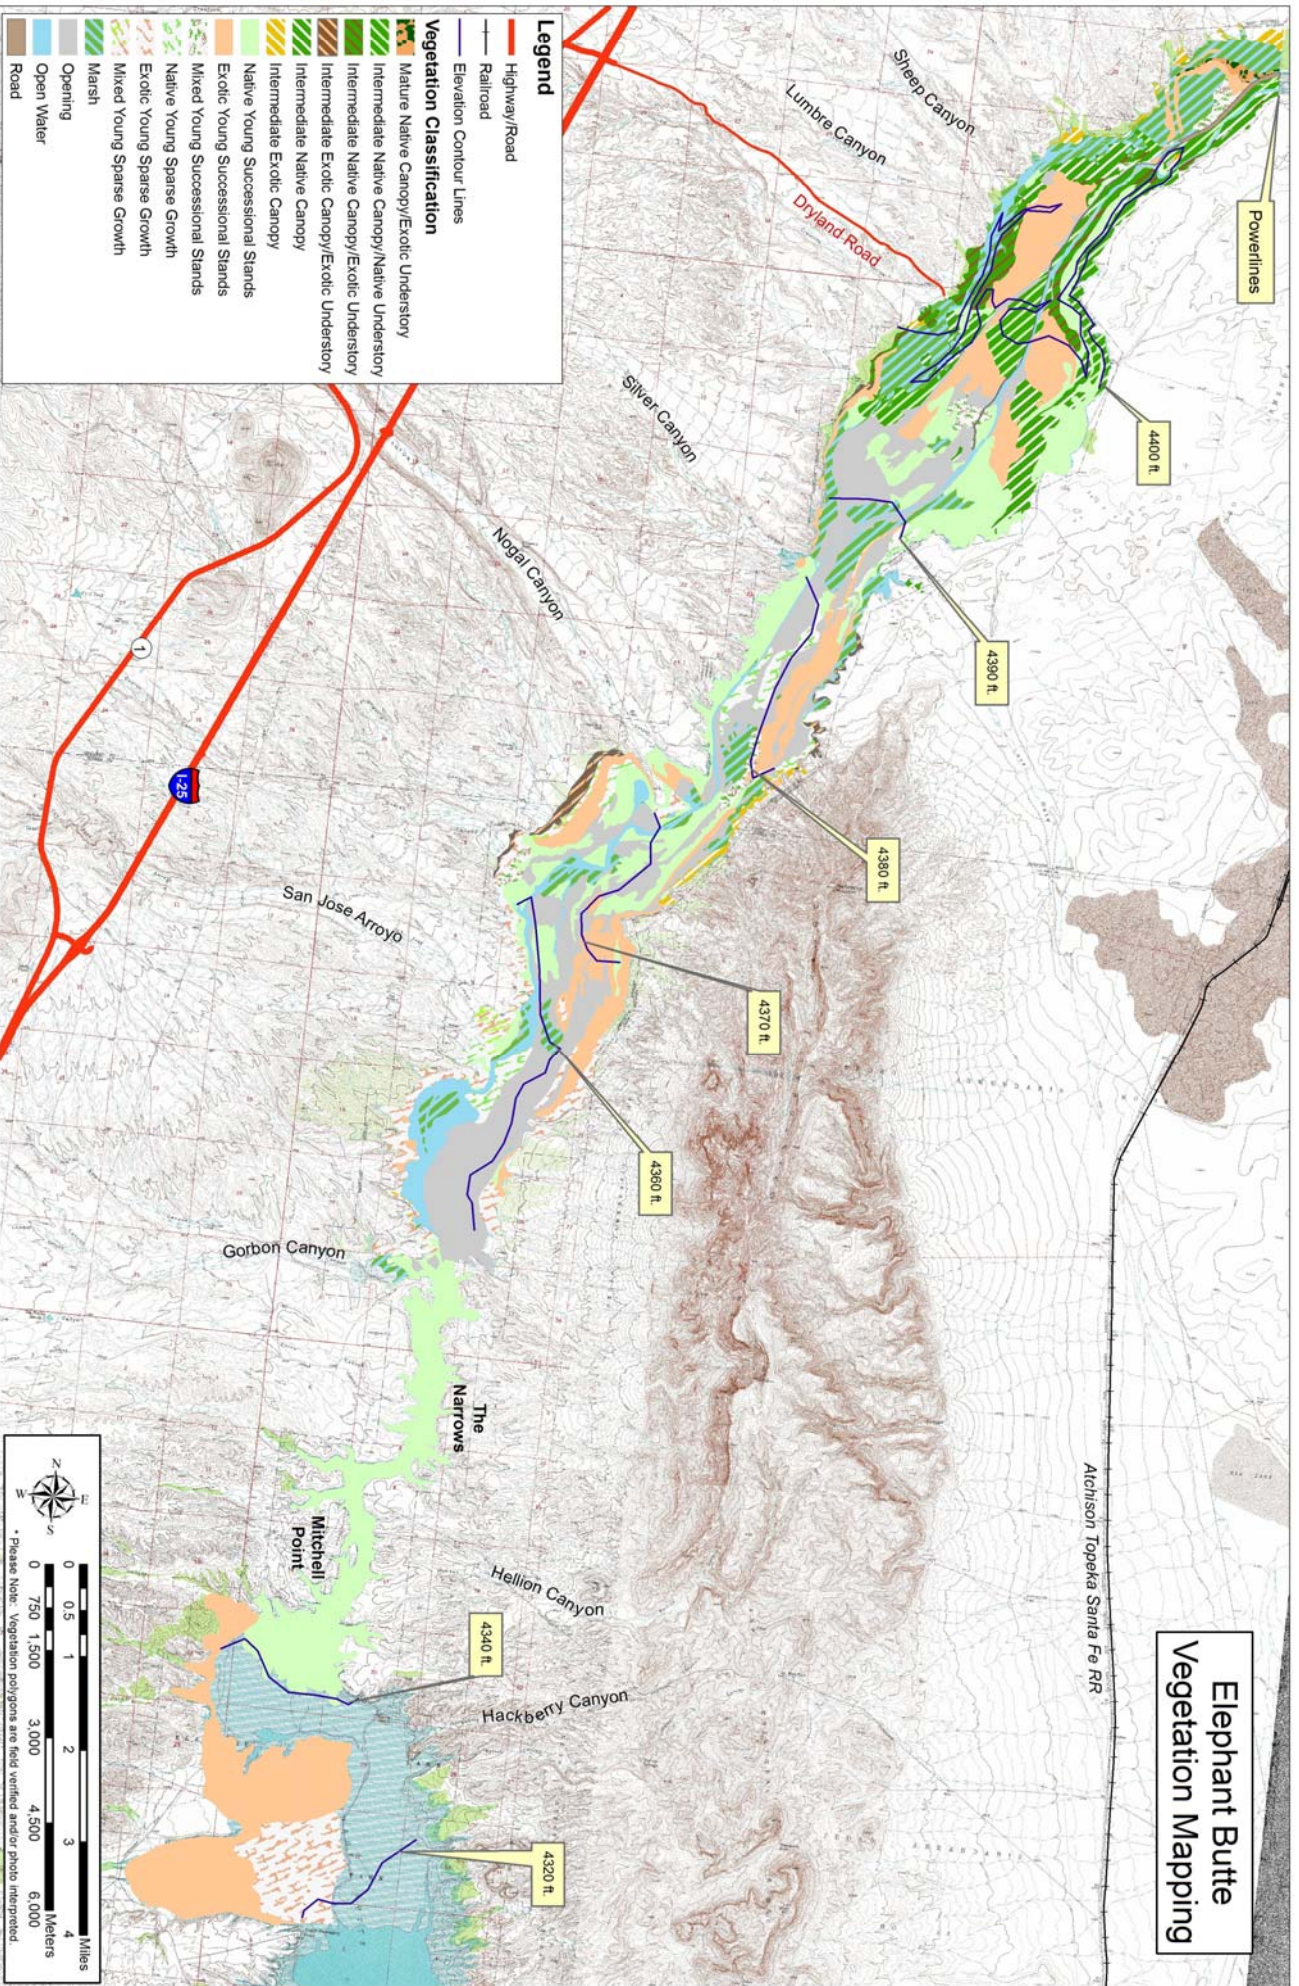
Fig. 6. Vegetation development within the pool of Elephant Butte Reservoir.

Table 1. Area covered by various habitat classes within the upper reaches of Elephant Butte Reservoir (corresponding to Figure 6), based on 2002 aerial data

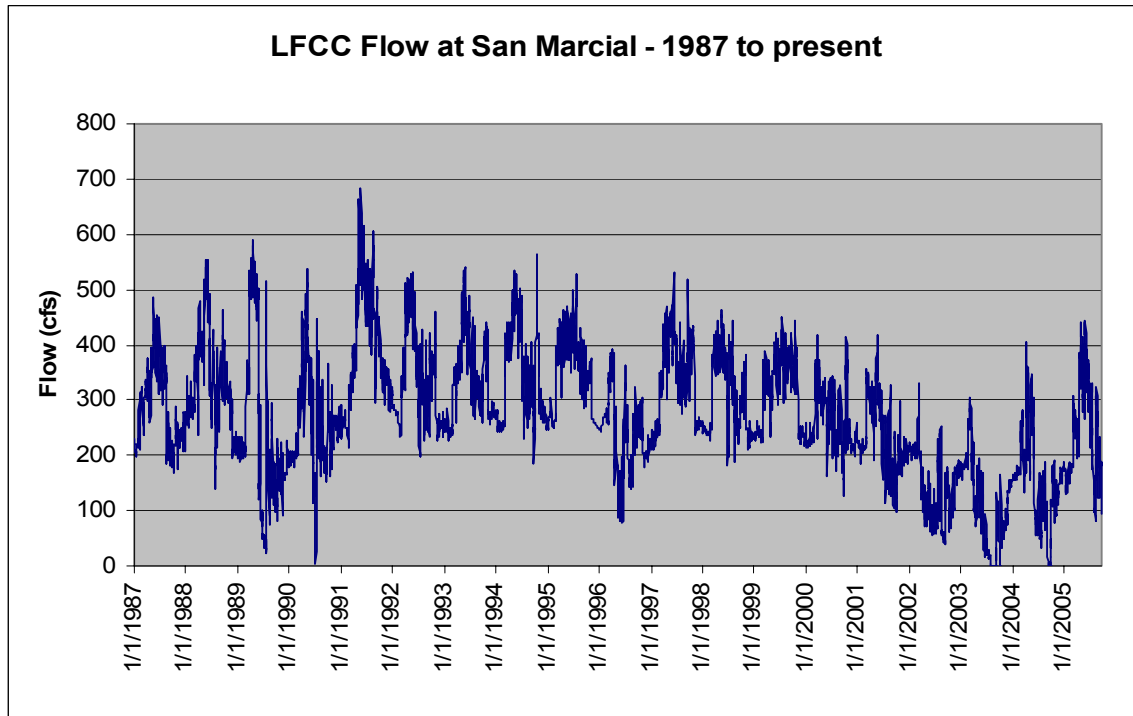
Figure 7. Average daily flow within the Low Flow Conveyance Channel, 1987 to present.

Channelization of the Rio Grande below San Marcial has effectively disconnected the western flood plain from the river. Thus, groundwater and irrigation returns within the LFCC have supplied the only water to the west side of the flood plain below the LFCC outfall since 1987. LFCC flows during this time typically fluctuated between 100 and 500 cfs, however there have been periods when flows were much greater and conversely, when the LFCC was totally dry (Figure 7). In order to determine flows that would

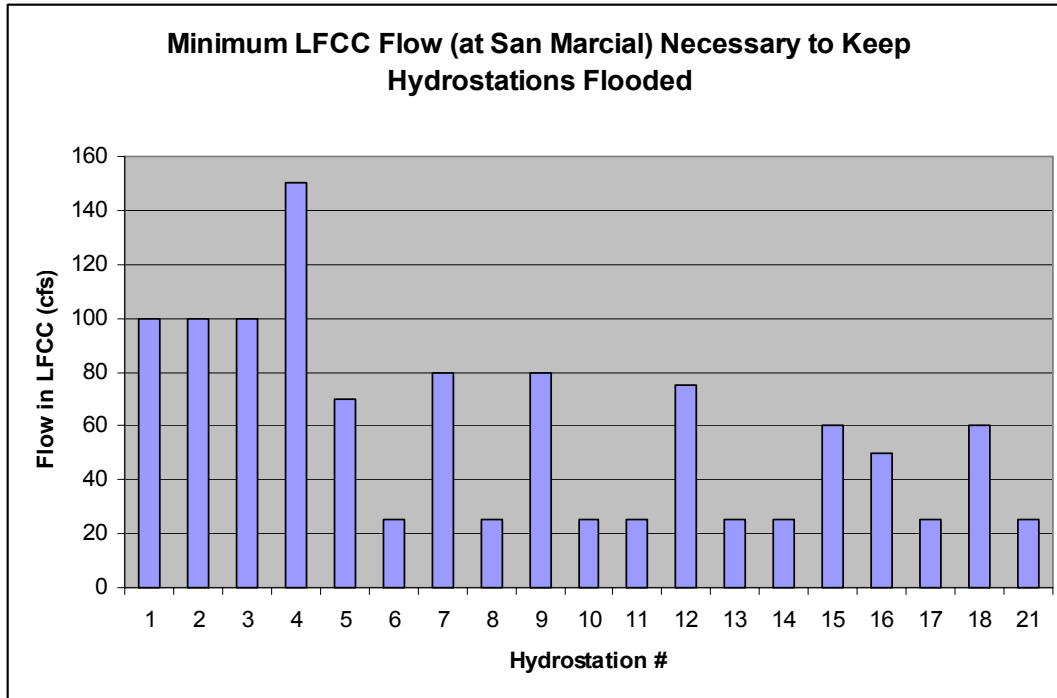
Figure 10. Minimum LFCC flows needed to keep hydrostations flooded during the 2004 and 2005 SWFL breeding seasons. Many hydrostations never dried out during the 2004 and 2005 seasons and the minimum flow during those years was 45 cfs, therefore stations were assigned a minimum flow of 25 cfs.

As shown in Figure 10, all but one hydrostation (HS 4) were flooded when LFCC flows reached 100 cfs during 2004 and 2005. Thirteen of 19 hydrostations were flooded when flows were at least 75 cfs. Stations that dried out at the highest flows were those stations located in survey site LF-17a. These stations are the first downstream of the LFCC breach where the LFCC begins to branch out over a larger flood plain, resulting in slower water velocities. These sites have likely aggraded during the past several years of sediment deposition, making them slightly higher in elevation (and, thus, the first to dry out) than downstream sites that receive less sediment deposition. Consequently, it is likely that site LF-17a will continue to aggrade at a much faster rate than downstream sites.

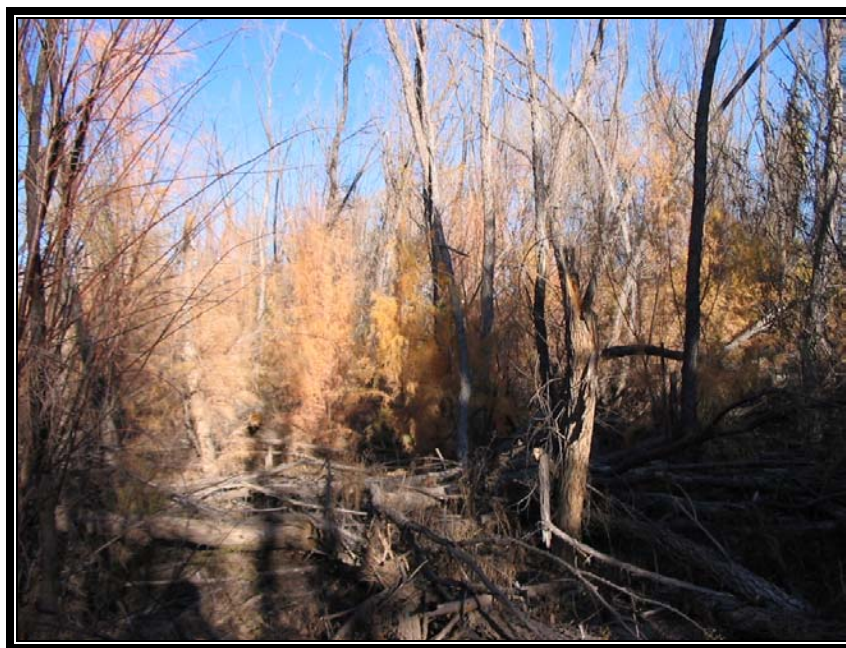
Figure 11. Native vegetation in the reservoir pool killed by salt accumulation and lack of “flushing” flows.

A prime example of this occurrence took place in SWFL survey site LF-14, which is located immediately downstream of the powerline crossing at River Mile 62. Although outside the reservoir pool, this site became suitable flycatcher breeding habitat and was occupied by SWFLs between 1997 and 2002. Reduced Rio Grande flows beginning in

1998 prevented overbank flooding from flushing salts from the soil in this site. Between 1998 and 2002 suspected salt accumulation killed the native vegetation, rendering the site unsuitable for breeding SWFLs. Although no soil testing has been conducted, salt accumulation is a key factor in mortality of willows in areas with reduced flood frequency (J. Taylor, pers. comm. 2002) Figure 11 shows the result of salt accumulation on native willows in the headwaters of Elephant Butte Reservoir. Notice the dead and downed Goodding's willow (*Salix gooddingii*) and the encroaching saltcedar.

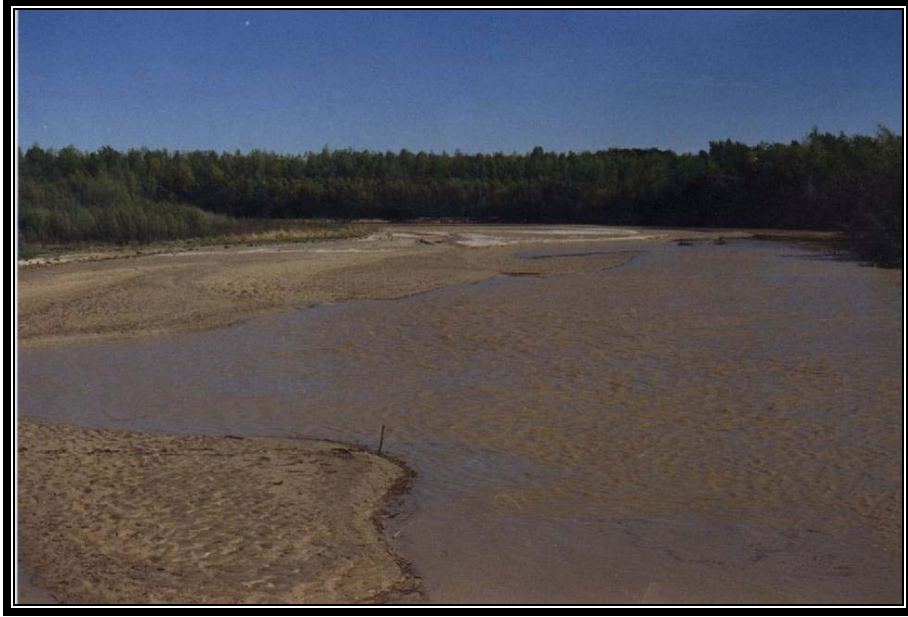
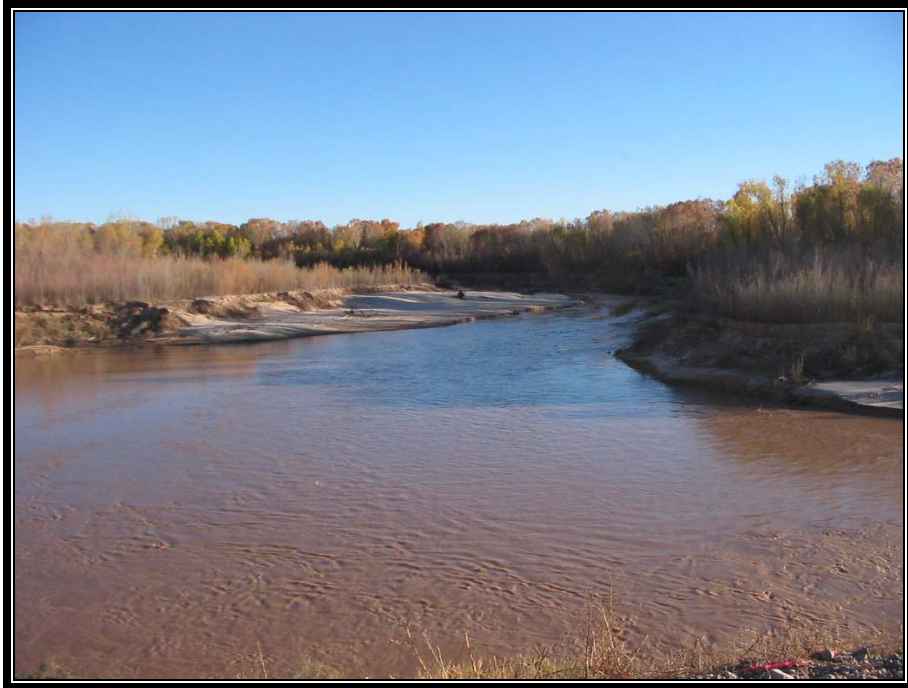
Figures 12.1 and 12.2. River channel below San Marcial before and after high flow degradation event of 2005.

Starting in the early 1990s, Reclamation and the New Mexico Interstate Stream Commission built temporary channels through the Elephant Butte Reservoir delta to maintain the connection between the Rio Grande to the reservoir pool. This ‘temporary’ channel construction created a series of ‘headcuts’ as the base level continued to be lowered to the ever decreasing reservoir pool elevation. With the larger-than-average spring flows in 2005, several of the ‘headcuts’ migrated upstream to the San Marcial railroad bridge crossing, creating an incised channel. The current bed elevation at San Marcial is estimated to be as much as 5 ft lower than in 2004 (T. Massong, pers. comm. 2005). This process will likely contribute to lowering of the water table adjacent to the river and reducing available water to the root zone of many of the native vegetation

patches. It is possible that these patches will suffer significant mortality, reducing their suitability to nesting SWFLs. Figures 12.1 and 12.2 show the Rio Grande channel at San Marcial before and after the degradation even in 2005. Although incision was rampant in 2005, and may continue for the next few years as other ‘headcuts’ migrate into the San Marcial area, this reach is still an aggrading reach and will likely begin aggrading again in the next 5 to 10 years (T. Massong, pers. comm. 2005).

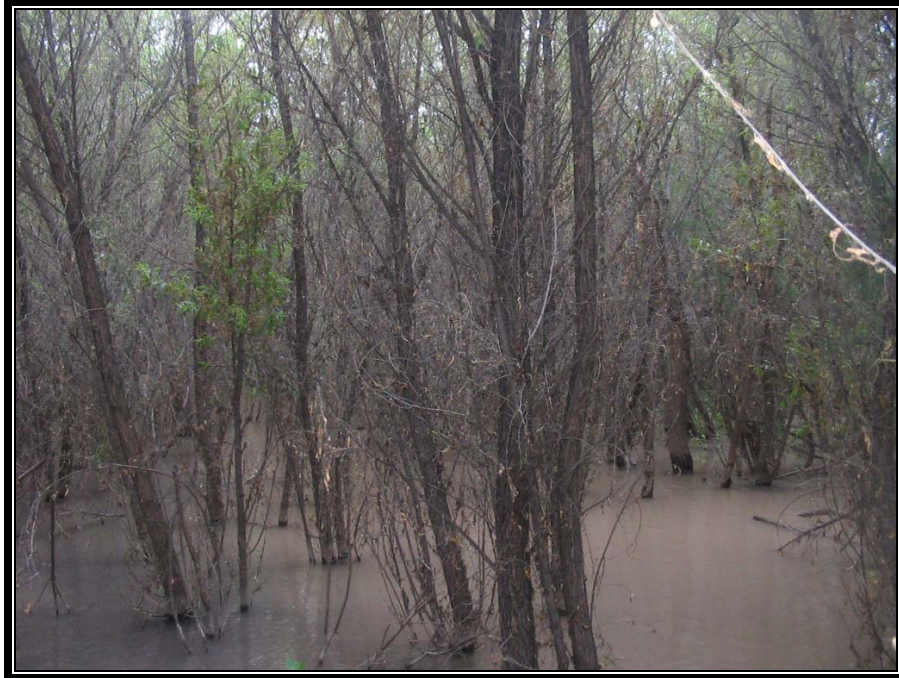
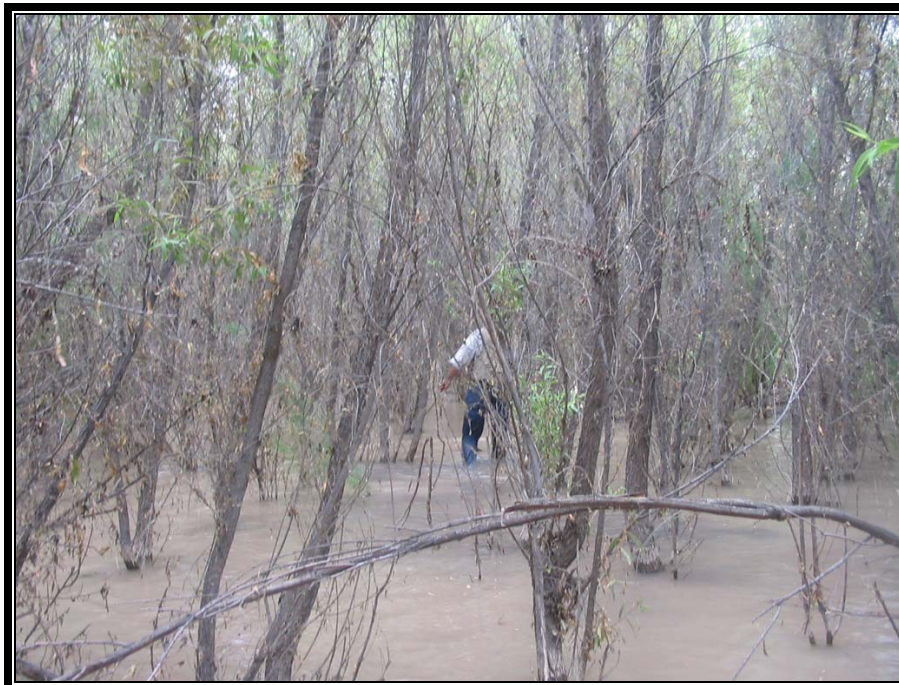
Figures 13.1 and 13.2. Photos of cottonwood leaf beetle defoliation in the headwaters of Elephant Butte Reservoir – spring 2005.

Lastly, in the spring of 2005, an outbreak of cottonwood leaf beetles (*Chrysomela scripta*) was noted in the headwaters of Elephant Butte Reservoir. It was the first time in 10 years of surveying in the San Marcial area that these beetles were documented by Reclamation personnel. The beetles’ population can be somewhat cyclical in nature, flourishing when conditions are right (M. Nelson, pers. comm. 2005). Their host plant is typically cottonwood (*Populus* spp.). However, in the spring of 2005, these beetles were prolific on the Goodding’s willow in certain areas of the reservoir headwaters. Defoliation occurred on a broad scale in several areas (Figures 13.1 and 13.2) and SWFL territories in one severely impacted area dropped from four in 2004 to two in 2005.

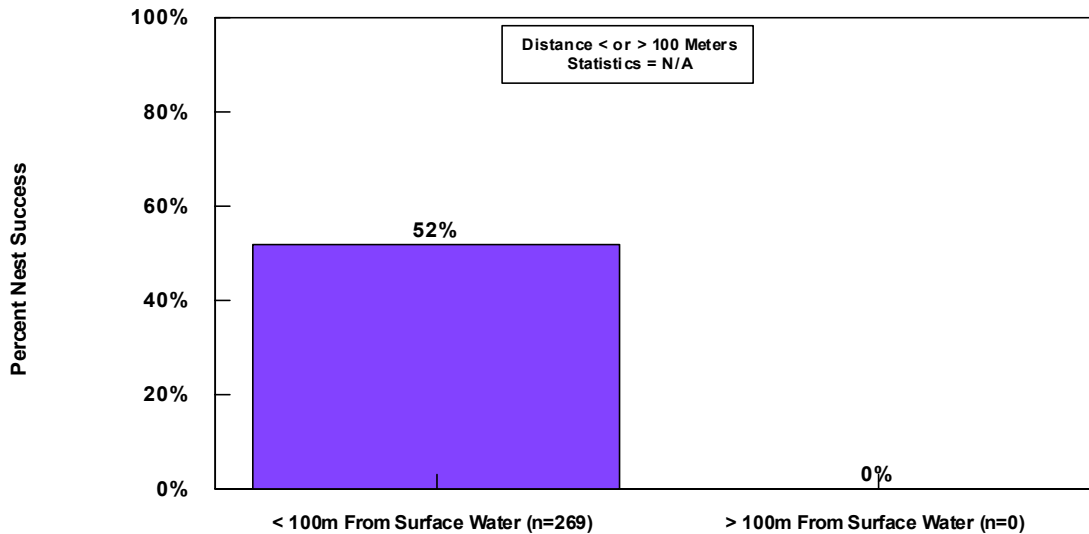
Percent Nest Success vs. Distance to Surface Water

(All Nesting Attempts)

Reservoir Only - 2004-2005

Distance < or > 100 Meters
Statistics = N/A

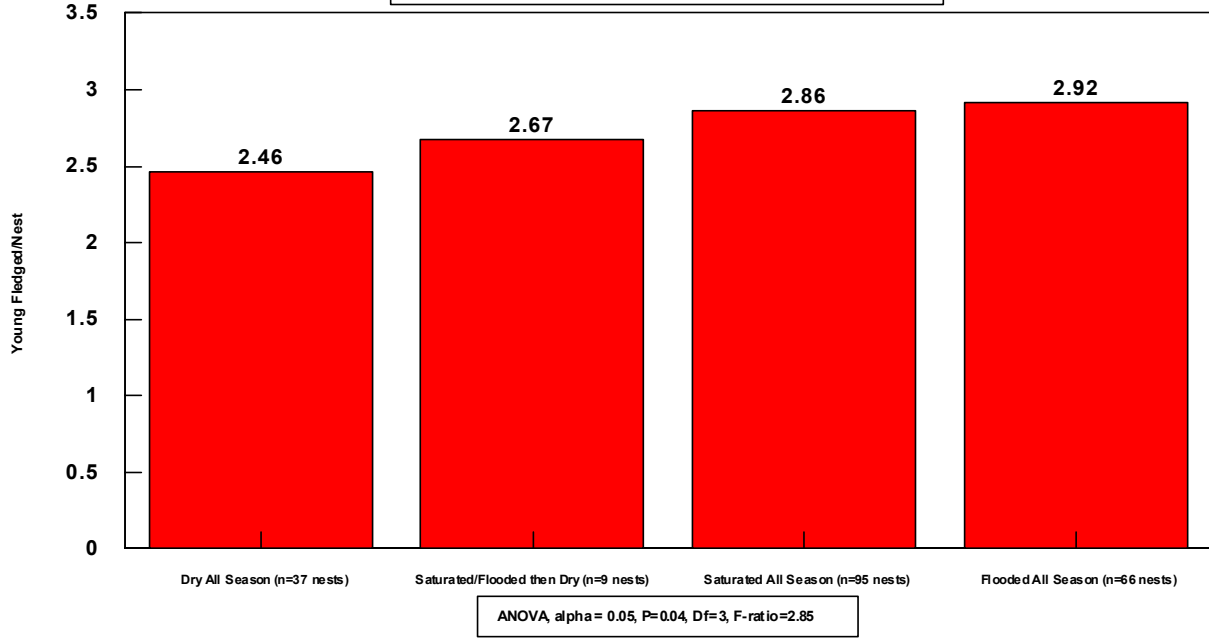
**Productivity of Successful Nests
Based on Hydrology Immediately Under Nest
Reservoir Only - 2004-2005, All Nest Attempts**

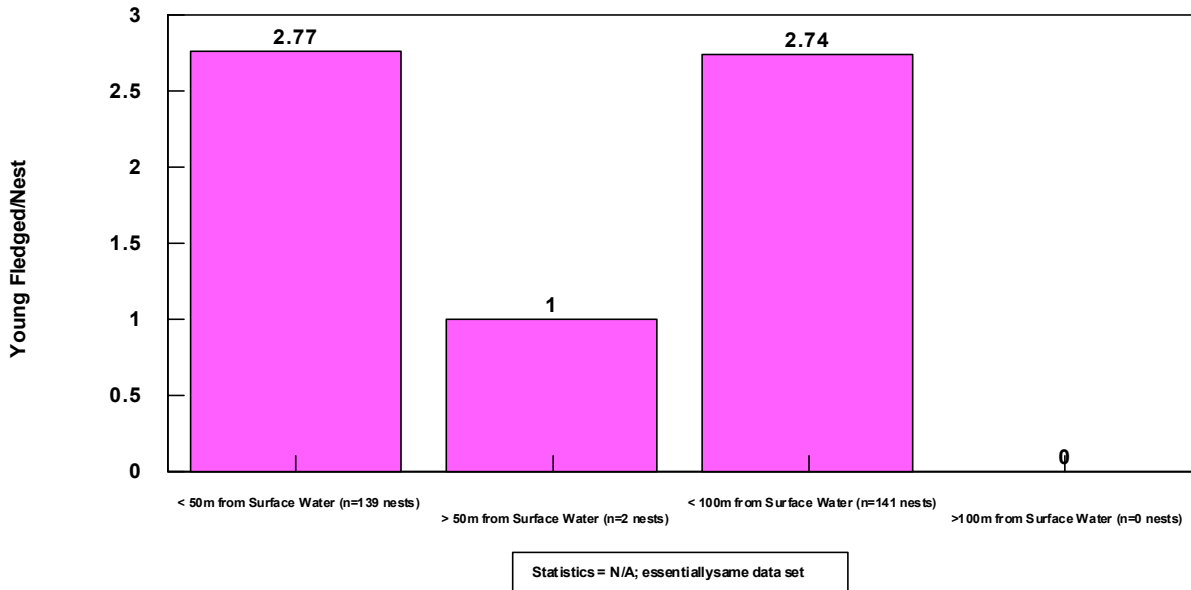
**Productivity of Successful Nests
Based on Distance to Surface Water
Reservoir Only - 2004-2005, All Nest Attempts**

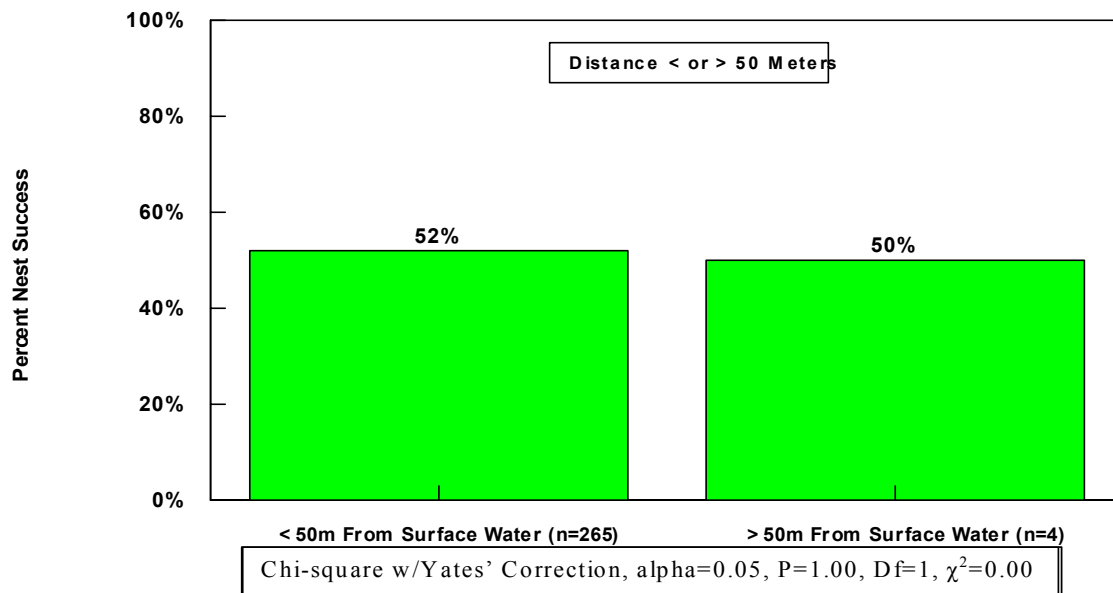
Percent Nest Success vs. Distance to Surface Water
 (All Attempts)
 Reservoir Only - 2004-2005

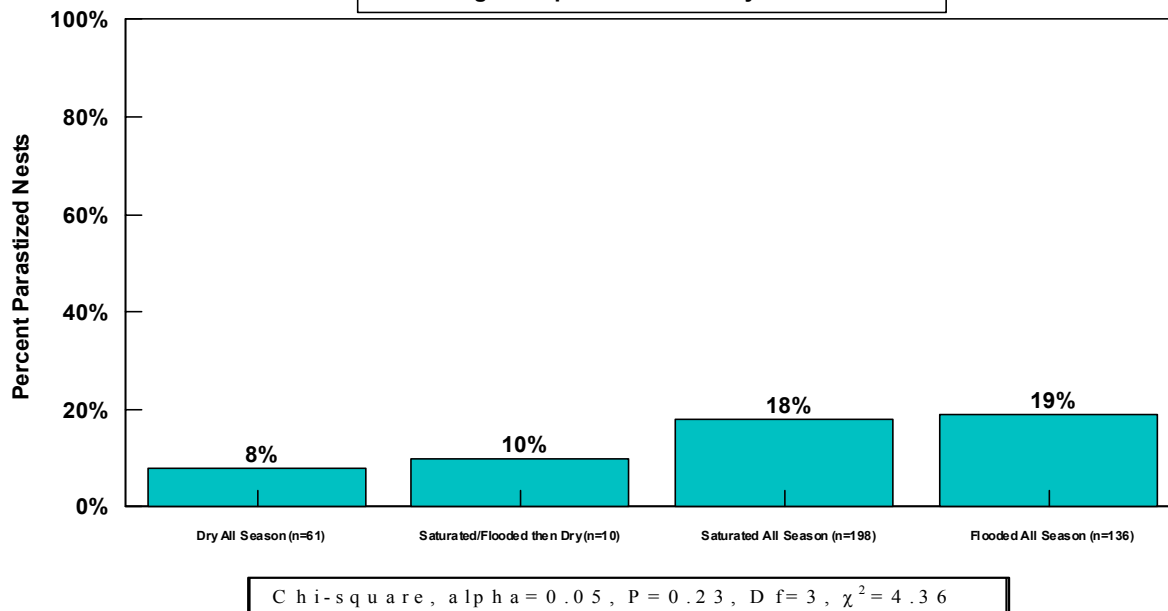
Parasitism Rates
 Based On Hydrology Immediately Under Nest
 All Nesting Attempts - Reservoir Only - 2004-2005
