I-68 Reduced Visibility Fog Detection and Warning System: Evaluation Report

I. INTRODUCTION

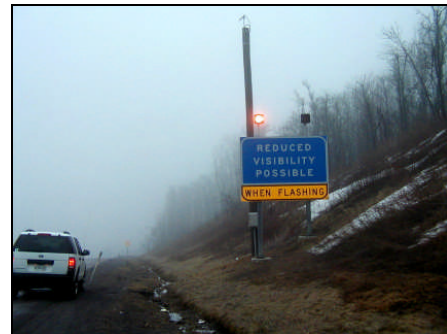
Figure 1. Typical “Reduced Visibility” Warning Sign

This report describes the evaluation of the “Reduced Visibility” warning system on I-68 in Garrett and Allegany Counties in western Maryland. The system uses “Reduced Visibility Possible” signs located in two fog-prone areas, one near Big Savage Mountain and the other near Keyzers Ridge. These locations were selected because of the prevalence of fog and to make effective use of existing Roadway Weather Information Stations (RWIS) infrastructure to detect conditions of reduced visibility. There is one warning sign for each direction (see figure 1 for illustration) for each of the two locations for a total of four signs.

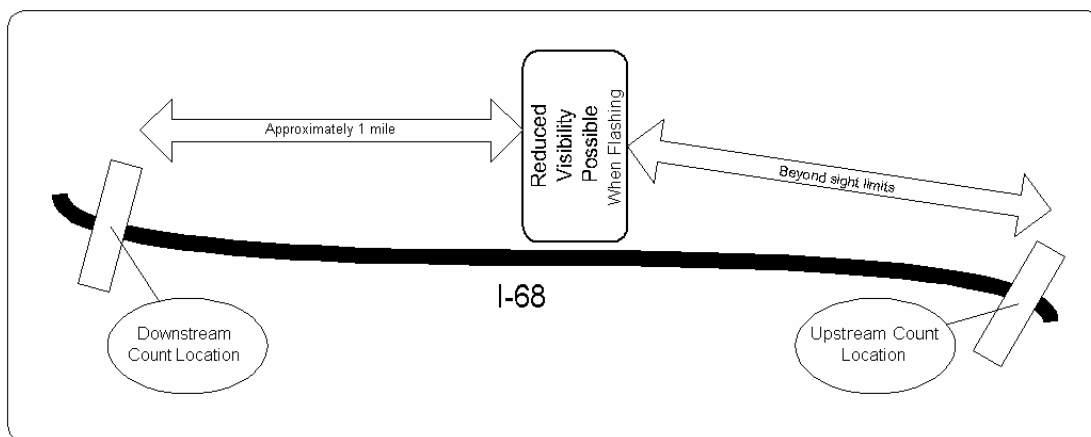
This part of the evaluation seeks to answer the question; does the driver behavior change as a result of the system? In other words, if the system is effective, then there should be a measurable change in the traffic flow after the drivers see the sign as compared to the traffic flow before they see the sign. This is shown graphically in figure 2.

Figure 2. Traffic Measurement Stations.

The basic observation is a 15-minute count and average speed measure of all vehicles driving past the two observation points. Road-tube counters are used to collect the count and speed measures. During periods when the sign is "Off", no significant difference in volume or speed is expected between the two stations. During periods when the sign is "On", no difference in

Location 1 is upstream from the sign far enough such that the drivers can not see the sign. Location 2 is downstream from the sign approximately 3,000 feet, enough distance to allow drivers to react to the sign message.

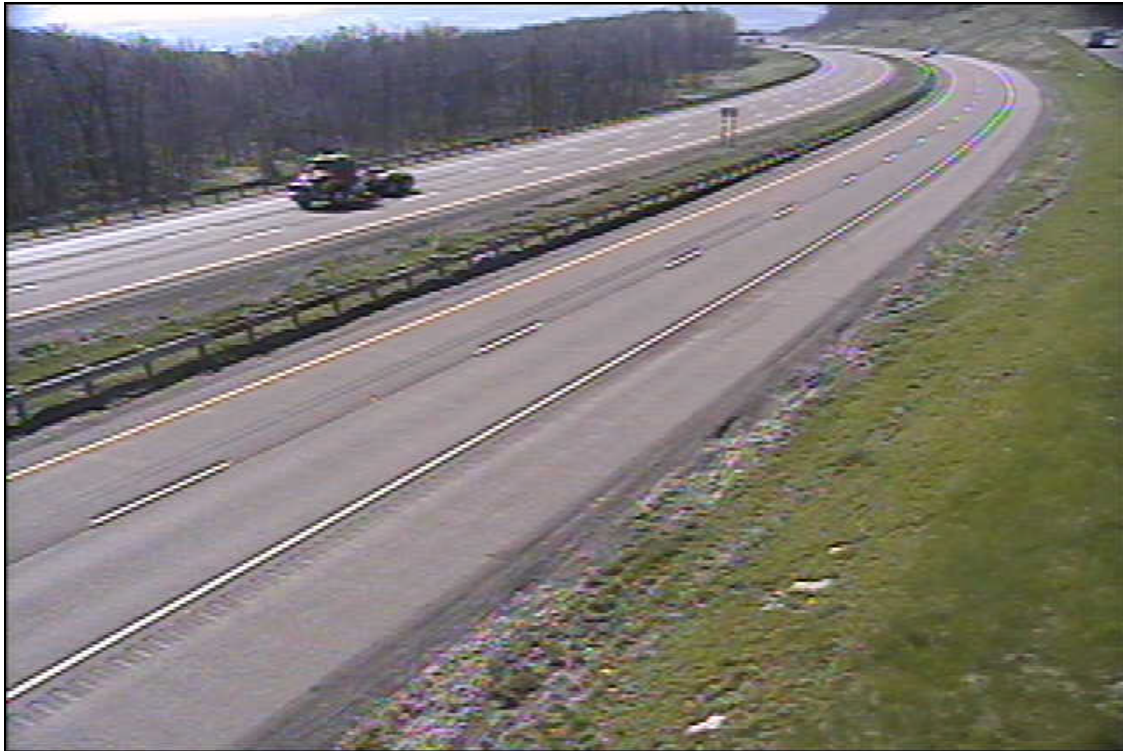
To determine the actual condition, however, the actual conditions at the site were observed. Real-time images from the CCTV camera at the Big Savage Mountain RWIS site were recorded as shown on Figure 4, a clear day. It is important to note that the image is clear at night as well, as shown on Figure 5.

Figure 4. Daytime view from the RWIS CCTV Camera at Big Savage Mountain.

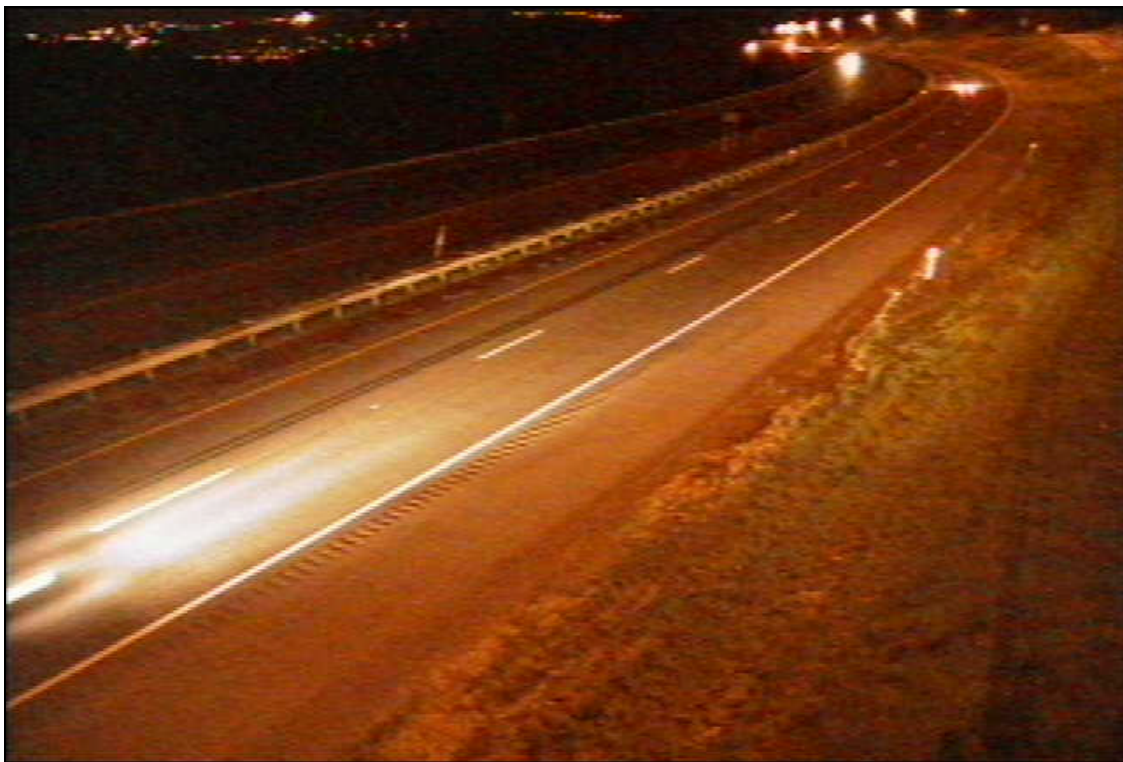
Figure 5. Clear night view.

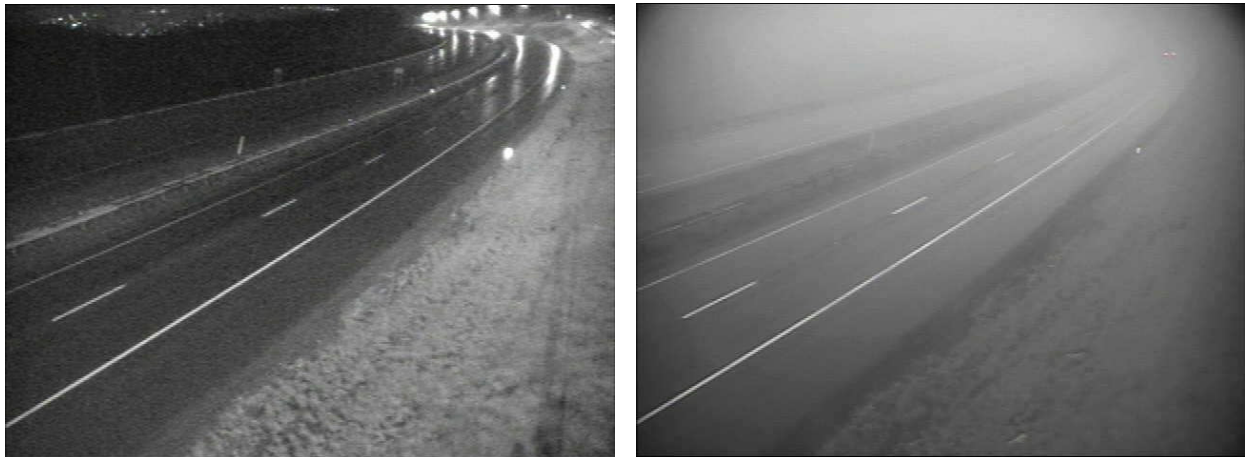
The visibility situation changes very fast on the mountain. The image to the left in Figure 6 was captured at 9:33 AM, the image to the right was captured 39 minutes later at 10:12 AM.

Figure 6. Left before fog; right typical fog condition 39 minutes later.

Notice that there are approximately four skip lines visible in the image on the right. This indicates a moderately foggy condition, one in which drivers have sufficient sight distance to continue driving at the speed limit.

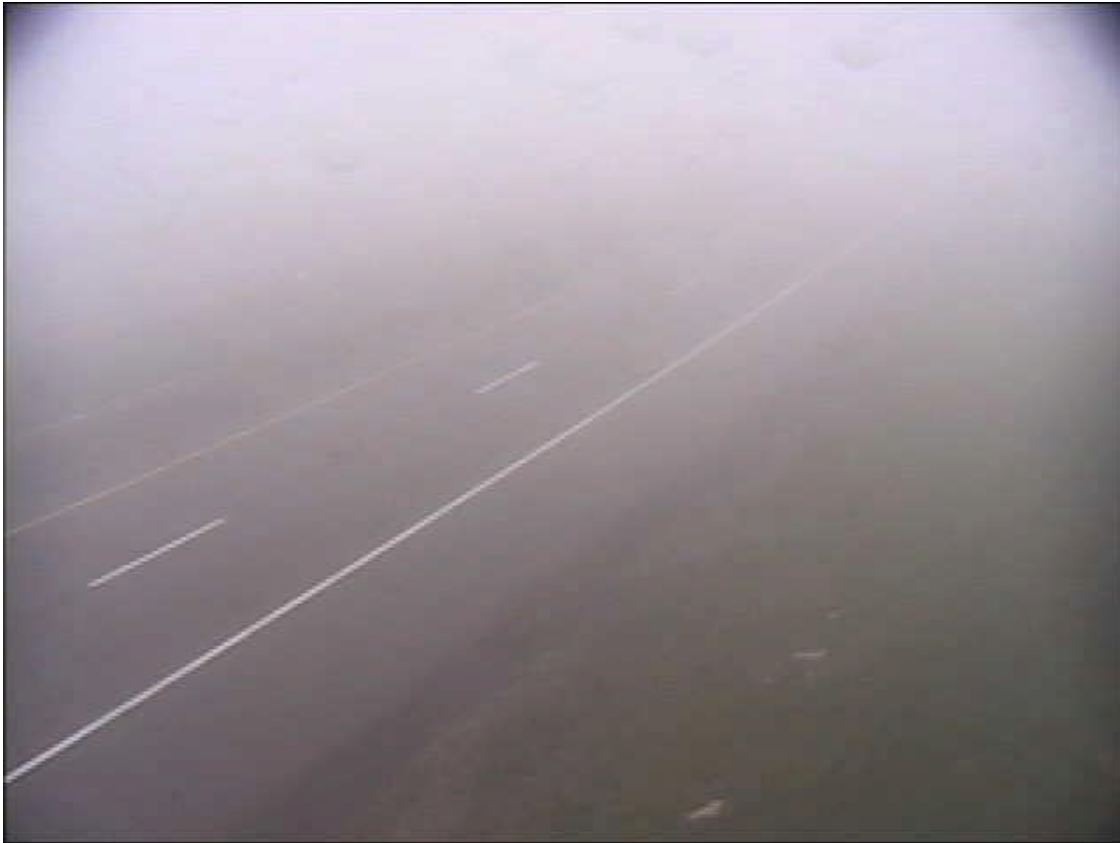
This was a relatively long event of approximately ten hours. As shown in Figure 7, the visibility was reduced more than that shown in Fog Event 1.

Figure 7. Intense fog during Fog Event 2.

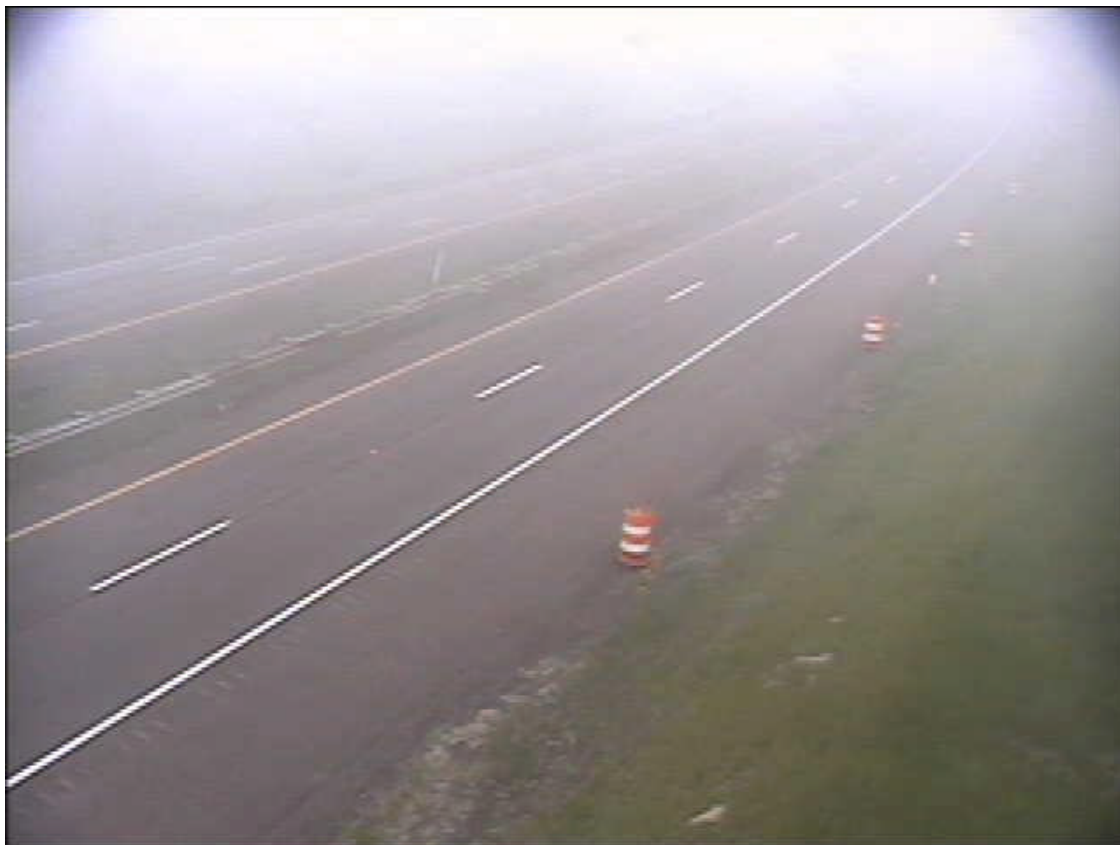
This was a minor fog event, not as foggy as Fog Event 2. Visibility was not reduced enough to justify turning on the system. As can be seen in Figure 8, more than six skip lines are visible in the image.

Figure 8. Fog Event 3.

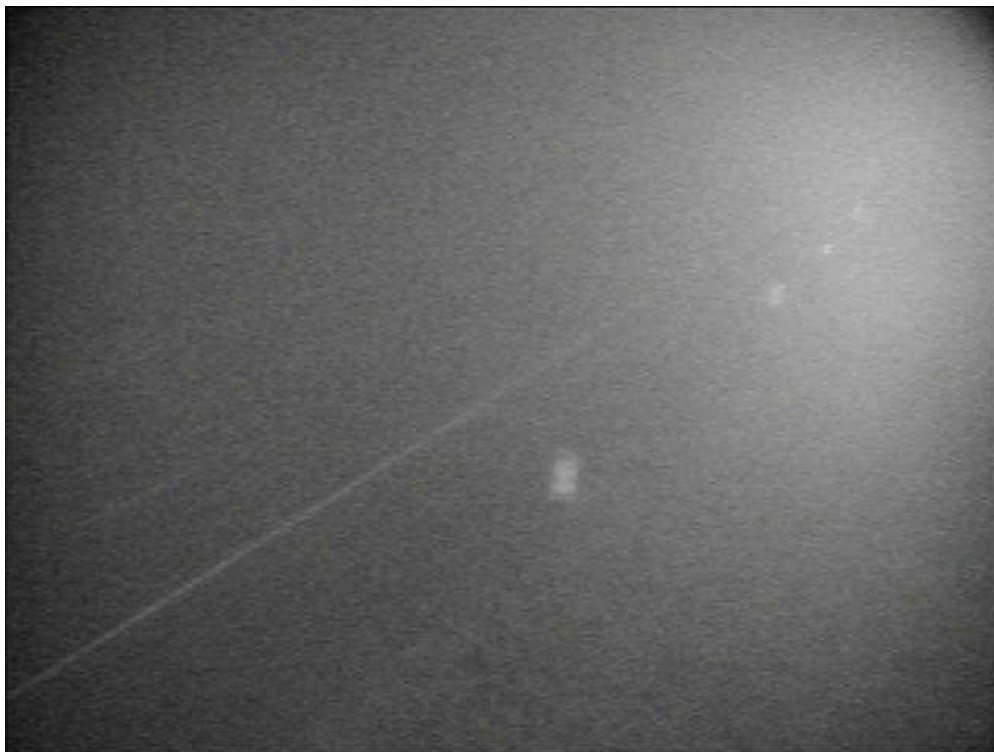
Figure 9. Fog Event 4.

Figure 9 and Table 8 indicate the conditions for Fog Event 4. This was one on the foggiest situations encountered during the study.

With respect to the system operation during the 13 fog events, only two (Fog Events 4 and 5) could be classified as intense as indicated by being able to barely see one or two skip lines. Six events (Fog Events 2, 7, 8, 9, 11, and 13) could be classified as moderate, and the remaining five events are minor with no significant reduction in sight distance. In each case, the system performed as designed.

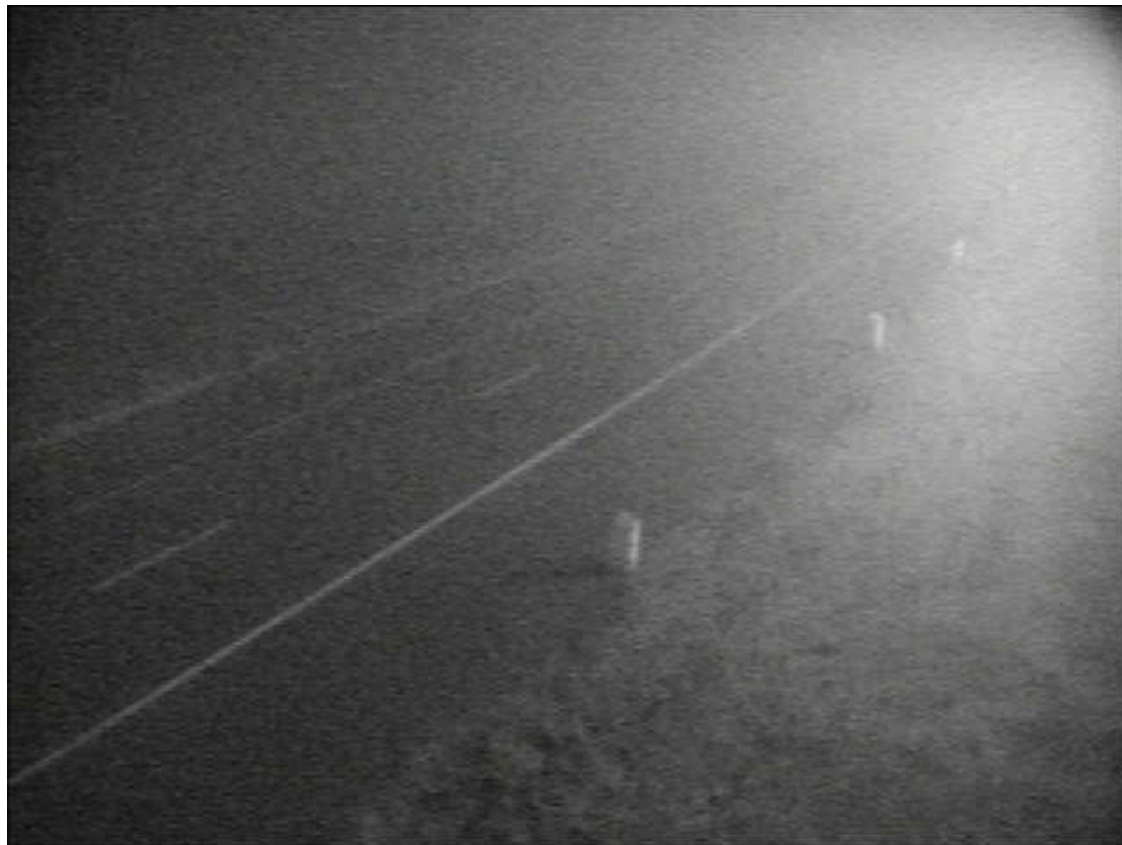
Figure 10. Fog Event 5.

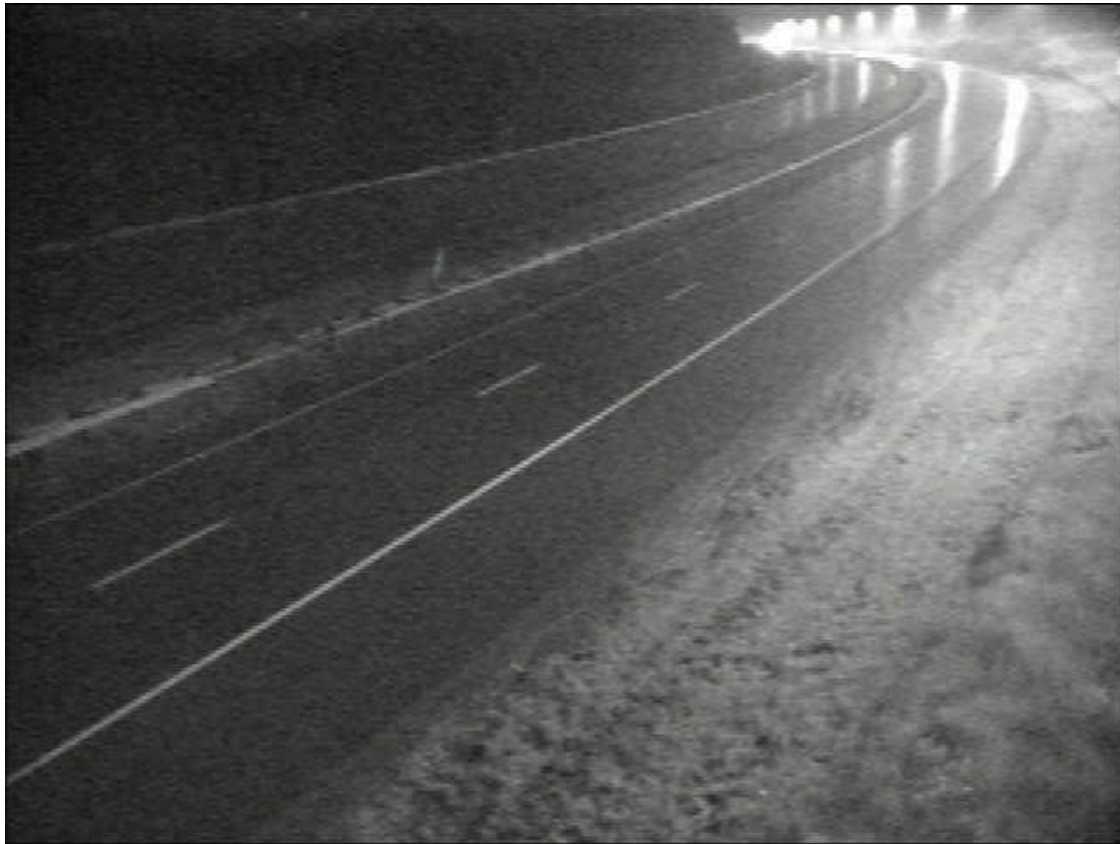
This was a very short event lasting less than one-half hour. The reduced visibility was probably triggered more by heavy rain than by fog.

Figure 11. Fog Event 6.

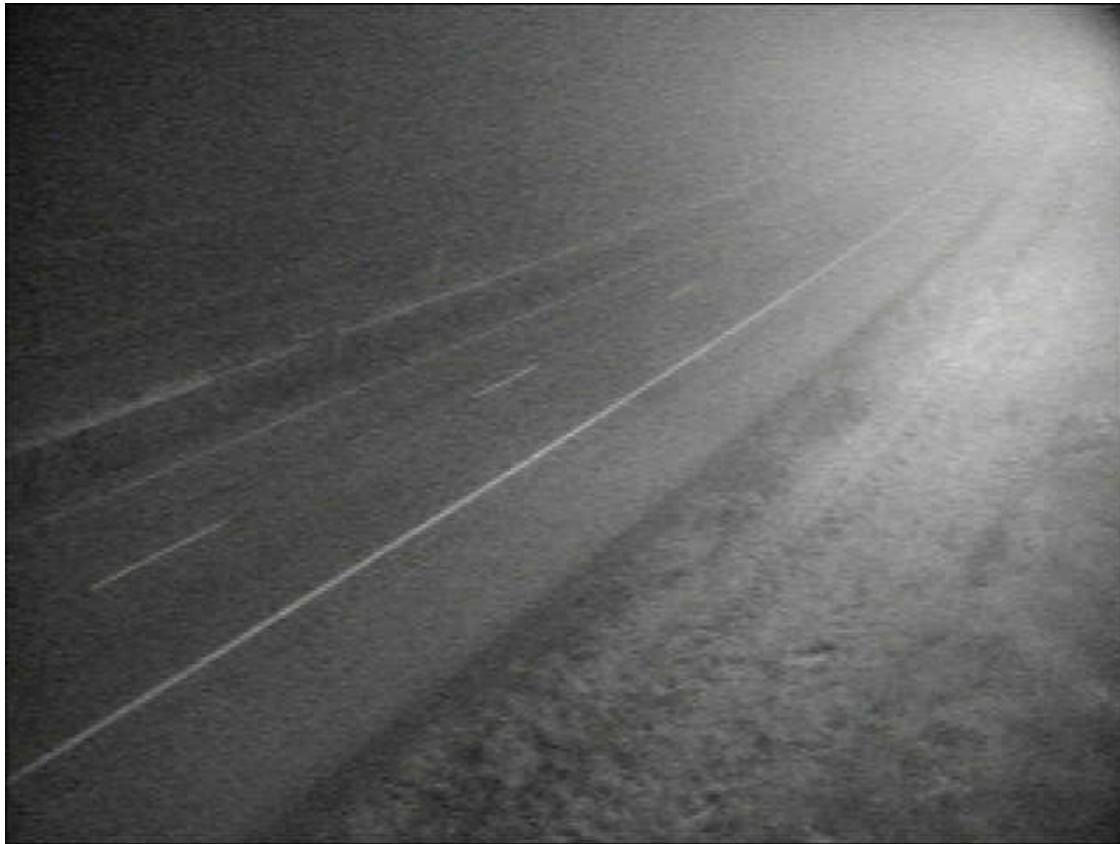
Figure 12 shows the moderate fog conditions exhibited in Fog Event 7.

Figure 12. Fog Event 7.

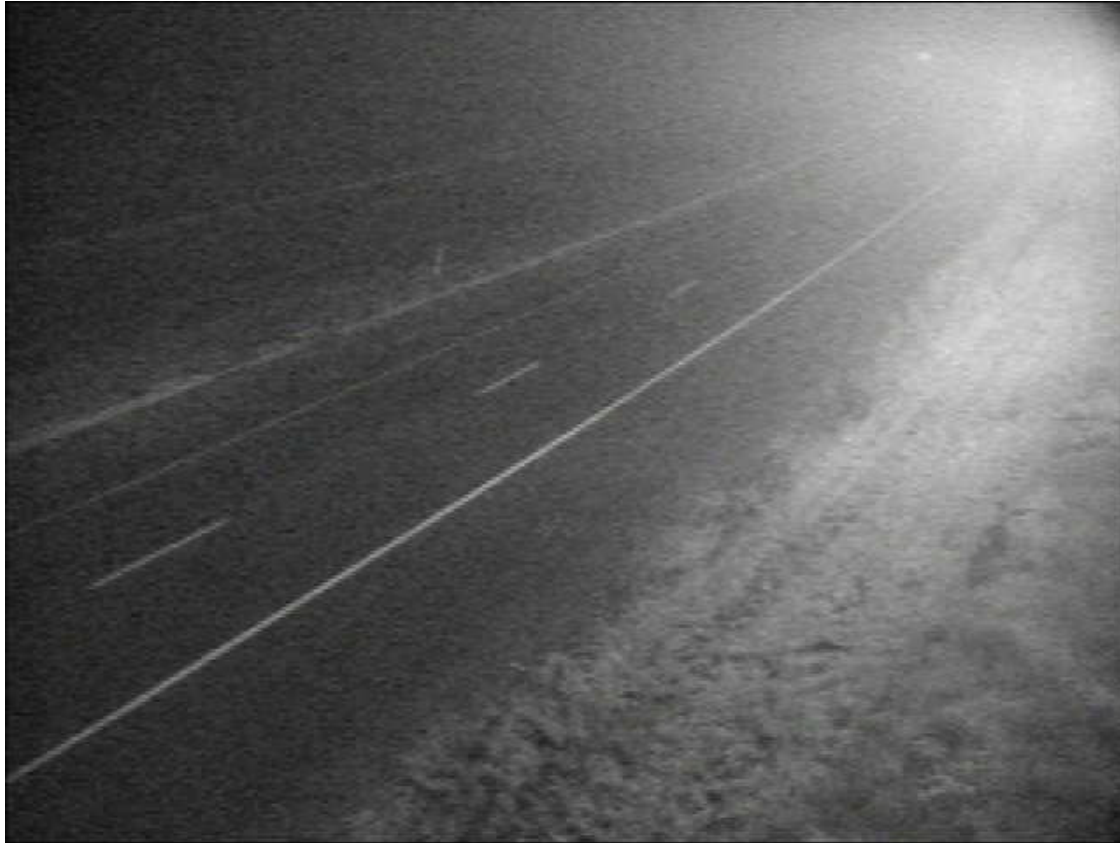
out settings may be too short. As shown in Figure 13, this weather event is a continuation of that depicted in Fog Event 7 with a moderate reduction in visibility.

Figure 13. Fog Event 8 (6-26-04-51)

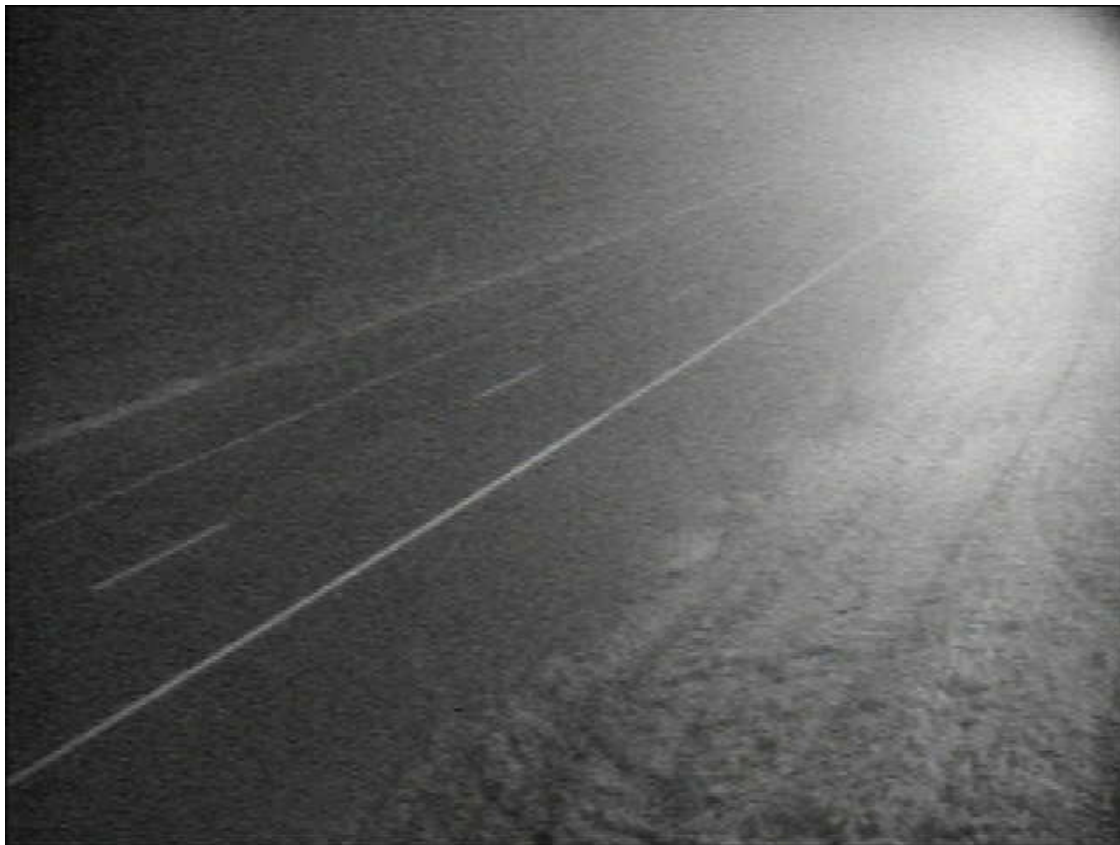
The moderate fog situation is depicted in Figure 16.

Figure 16. Fog Event 11 (06-28-01-52)

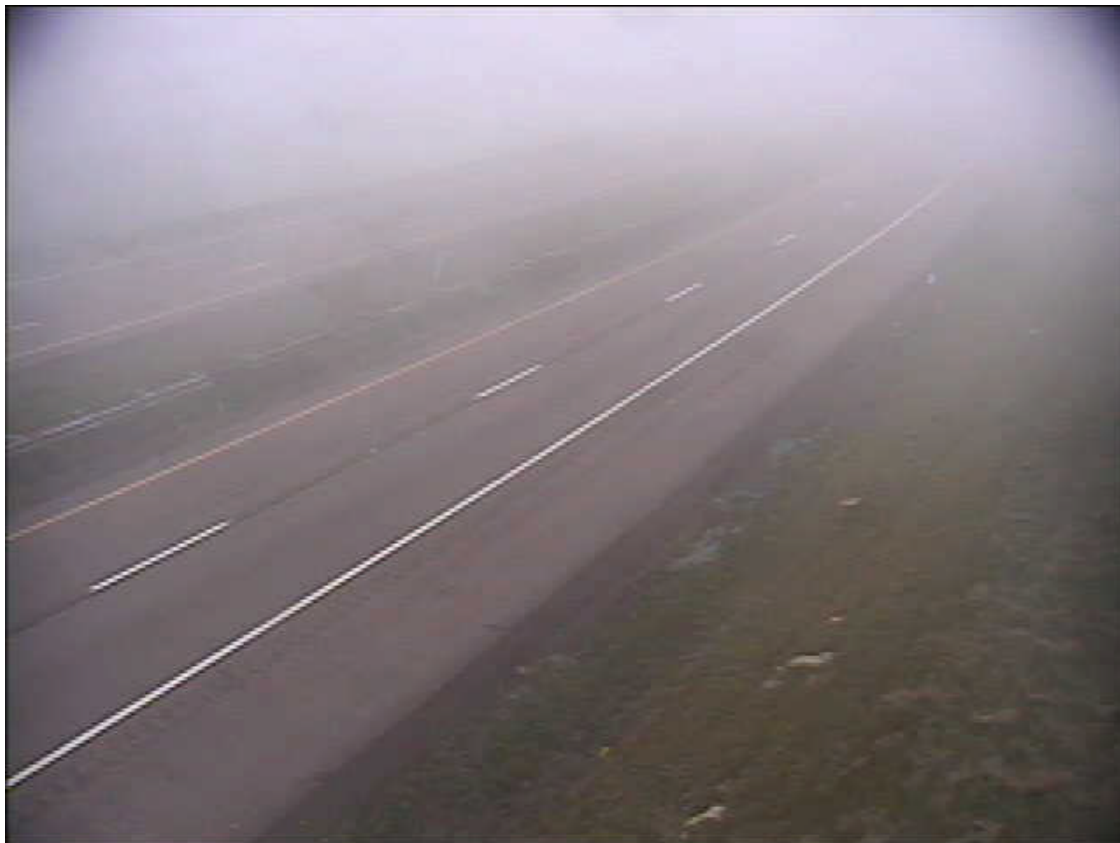
Each “System Log” entry indicated a system change of state, the six extra state changes indicate that a time lock-out is needed to prevent the rapid switching from Off to On to Off.

Figure 17. Fog Event 12. (07-14-10-53)

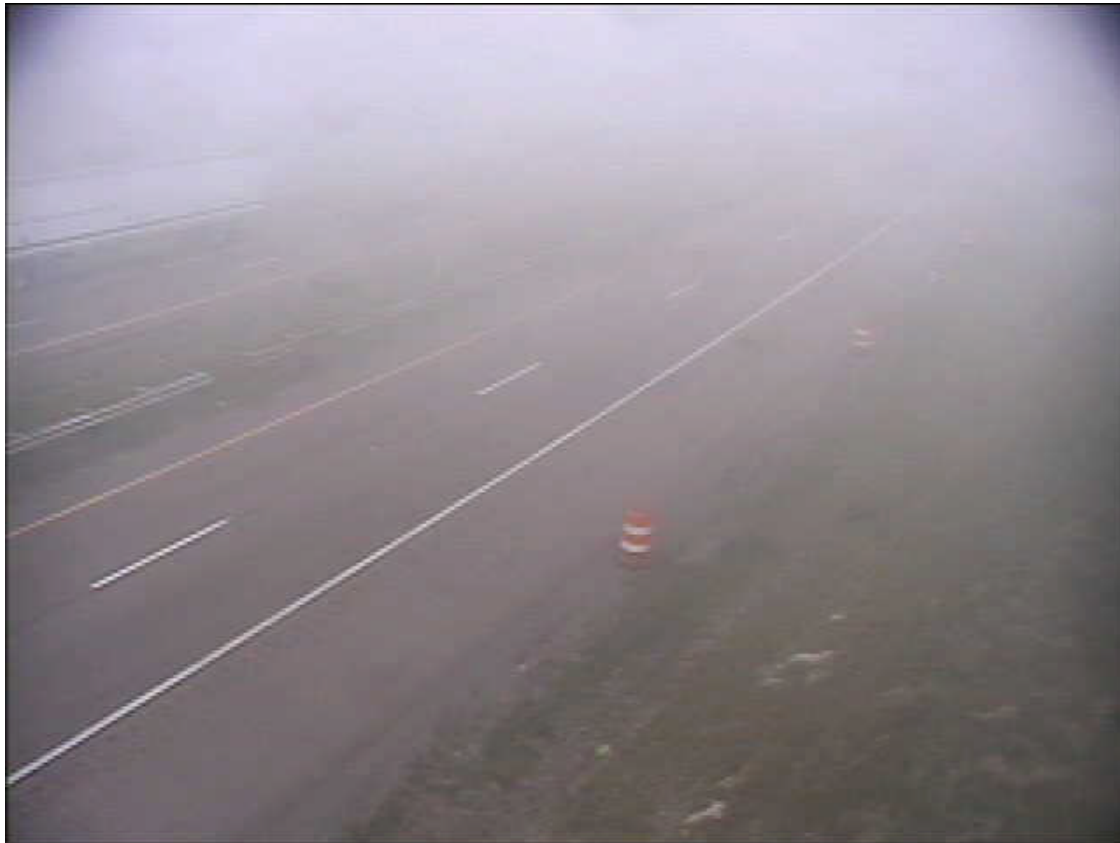
The moderate fog situation for this event is depicted in Figure 18.

Figure 18. Fog event 13. (07-20-11-14)
