# EVALUATION OF A FIXED ANTI-ICING SPRAY TECHNOLOGY (FAST) SYSTEM

Prepared by: Brandon L. Ward, Project Manager  
New York City Department of Transportation, Division of Bridges

This paper describes the in-house development (Phase I) of the Fixed Anti-Icing Spray Technology (FAST) systems to apply less corrosive liquid chemical freezing - point depressants on portions of the south-wardway (Manhattan-side span) of the Brooklyn Bridge. During the first phase of the project, several operational parameters were investigated, including spray pattern, spray angle and spray pressure. Two homegrown FAST systems were installed. The first system consisted of the installation of pipes on both sides of the roadway, with spraying activated simultaneously through nozzles spaced 20 feet apart and 6-8 inches above the roadway surface. The second system – which was installed on only one side of the roadway – was intended to achieve sequential spraying. During this phase, the FAST systems were manually activated. Phase II of this project describes the proposed extension of the FAST system and integration of a road weather information system (RWIS).

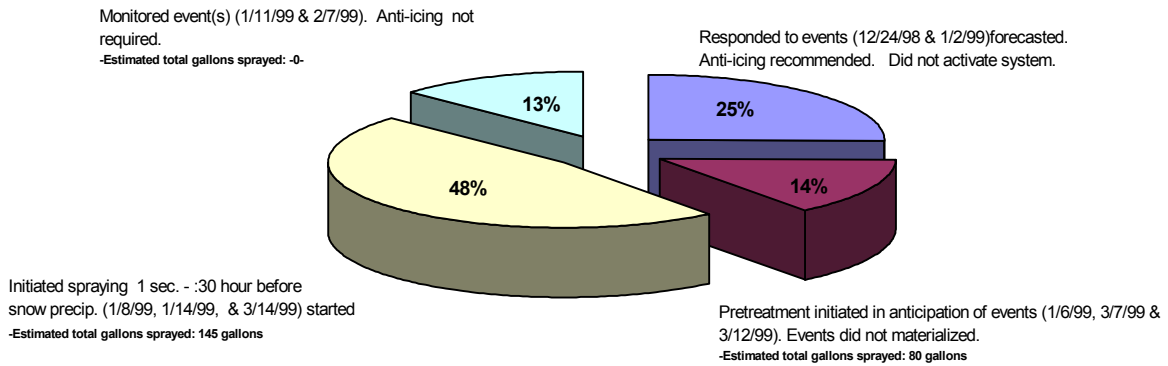
Chart 2: 1998/99 Event-Response Categories

An operation team consisting of two workers responded to ten separate weather events during the '98/'99 season. These events were categorized (see Chart 2) as follows:

Note: Percentages are based on operation cost .

A site-specific weather forecast information system was not utilized in determining whether to initiate a treatment, and when to start. Overall, a total of seven events (52%) were classified as follows: delayed responses; events that did not materialized, and events not requiring anti-icing. This inability to accurately predict storm and pavement temperature and to communicate rapidly changing conditions before treatments were initiated resulted in unnecessary expenditures. The decision to pretreatment the roadway and average of thirty-two (32) hours before an event materialized occurred on three (14%) occasions during the season. However, these actions aided the evaluation by providing some critical information pertaining to the residual effects of a treatment on the roadway. As anticipated, the chemical (potassium acetate) was not as effective after this lapse of time before the event started. Based solely on observation, traffic volume was considered to be a major factor in "removing" the chemical from the roadway. In fact, treatment made >1hour before an event invariably required retreating. The

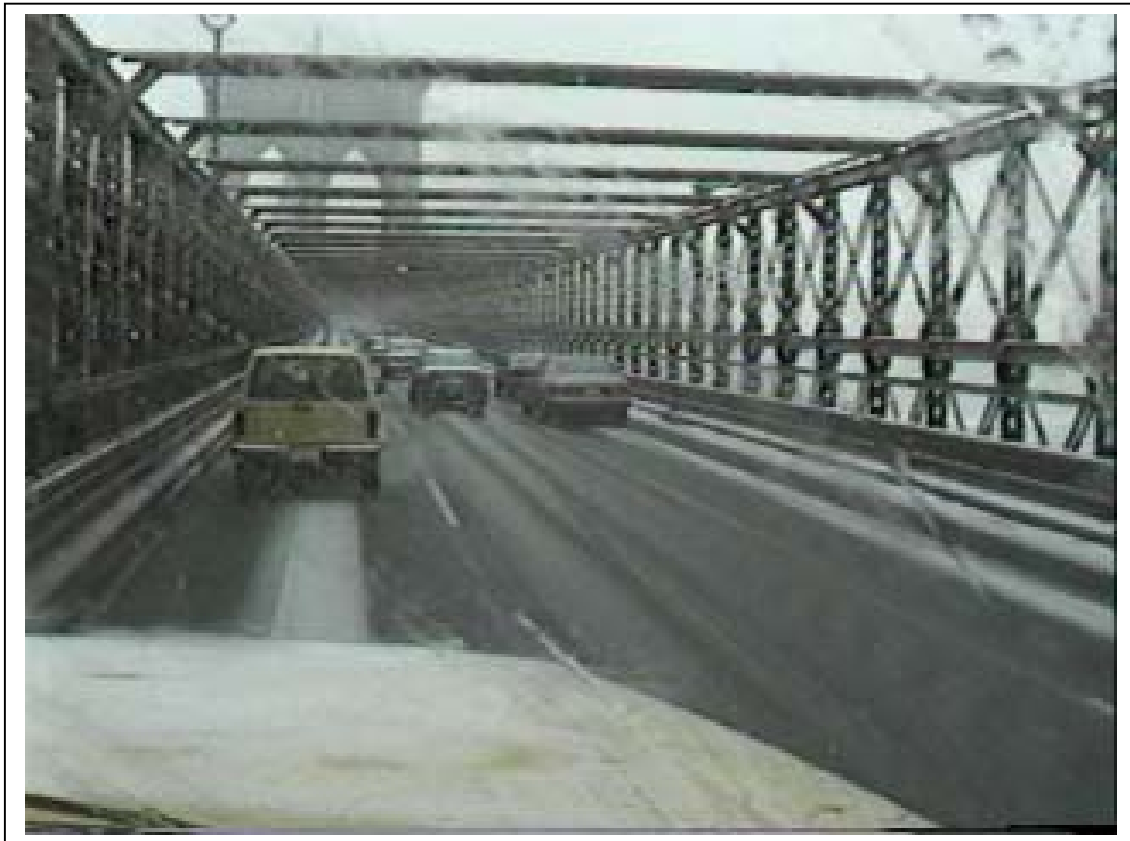
Photo Exhibit A: Pavement condition of roadway section sprayed with FAST system (3/14/99)

The forecast certainty (> 90% chance of precipitation) of the 1/8/99, 1/14/99 and 3/14/99 events resulted in spraying being initiated literally seconds before the events started. An analysis of these events and the treatments initiated indicate that the roadway section treated via the AISDS provided a higher level-of-service in comparison to the adjacent roadway sections treated with an over-the-road method utilizing truck mounted spray units. Photo exhibits A-G below illustrate the various pavement conditions observed during the events.

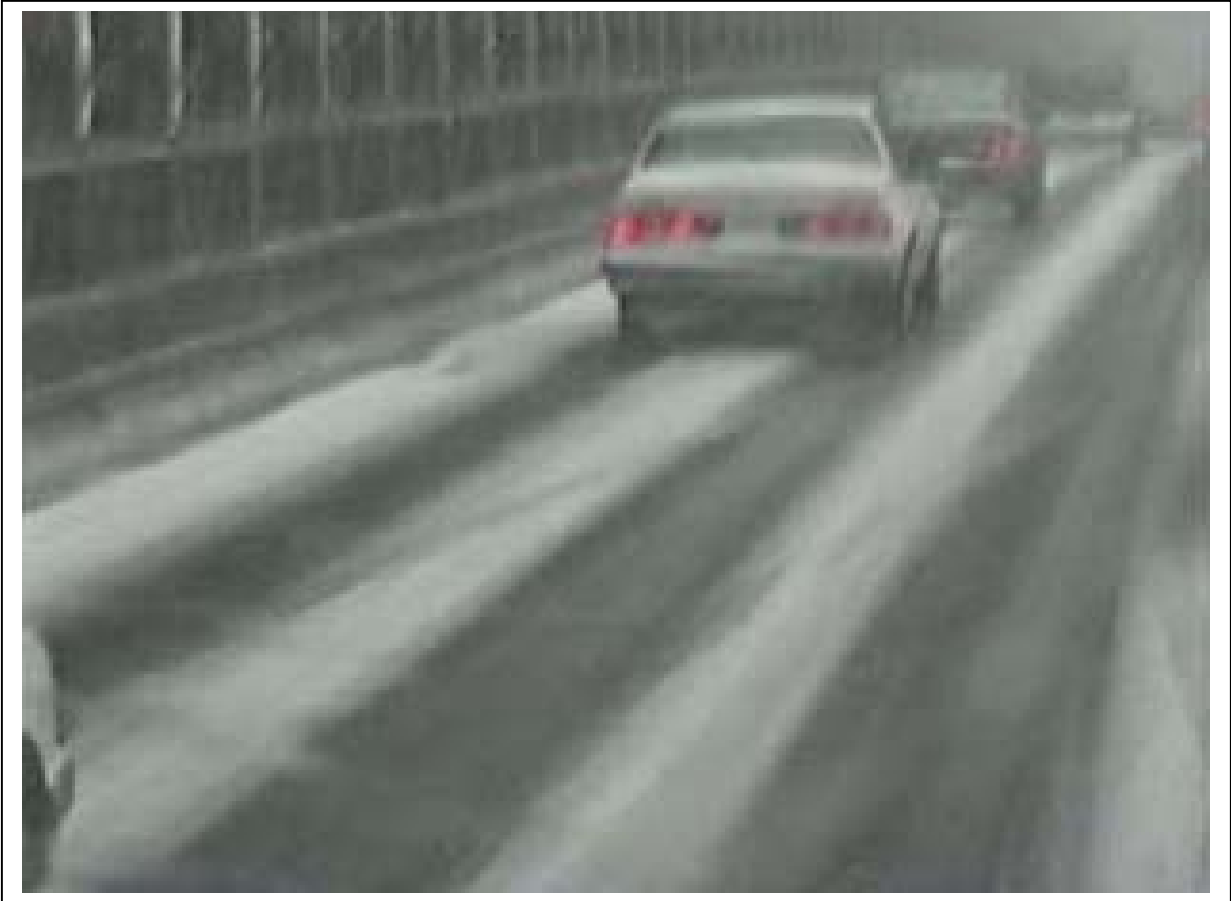
Photo Exhibit B: Location sprayed with Truck mounted spray unit (3/14/99)

Initially, the decision to initiate anti-icing during the March 14, 1999 event was marginal. This was partly due to the weather forecast prediction that temperature would be steadily increasing during the course of the event. Under these conditions, icing of the roadway was unlikely. However, snow precipitation was predicted to be moderate to heavy, with accumulations totaling 4.5 inches. In addition, the snow was of a wet<sup>2</sup> consistency. Nevertheless, a treatment was initiated second after the event started. Photo Exhibit A and B illustrates the pavement condition between the hours of 8am-10am. It is critical to note, that plowing is recommended for this type of event and accumulation total. However, none was observed during this period. A key consideration in the decision to spray the roadway under these conditions was an attempt to discourage the DOS's crews from salting the roadway by default. However, despite bare "black" pavement conditions, a DOS truck was observed salting the roadway (see photo exhibit C) despite the pavement condition.

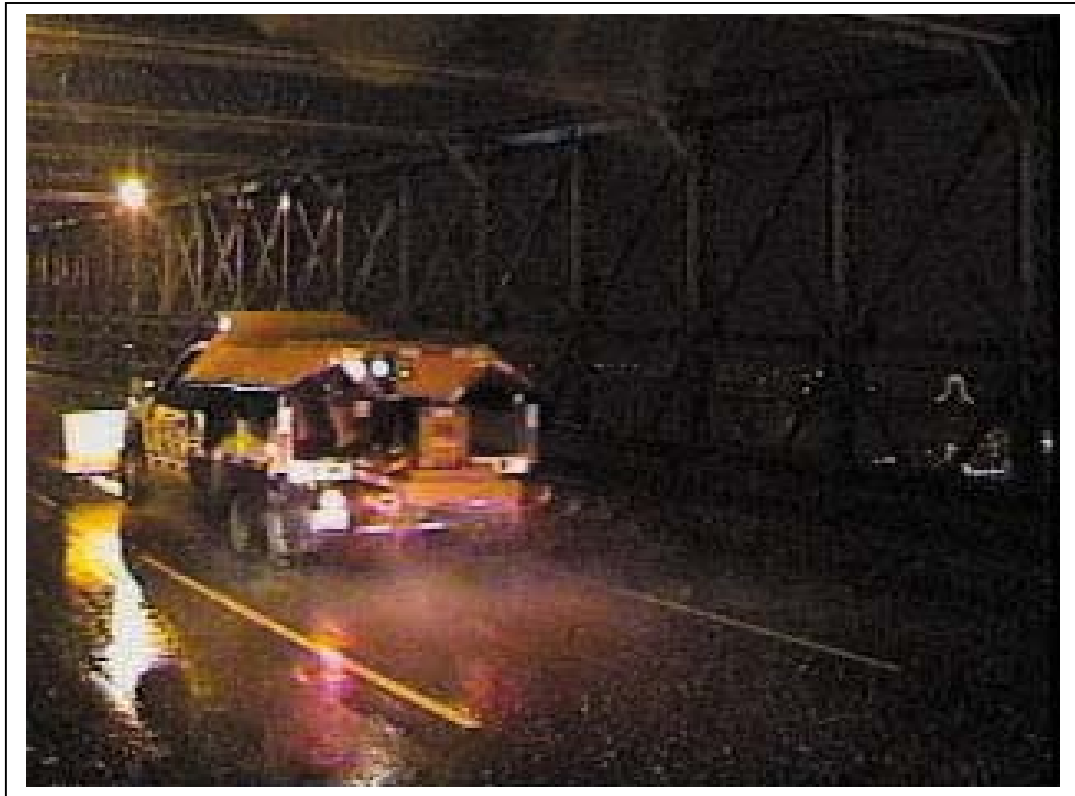
The photo exhibit below depicts an event on March 7, 1999 where a DOS salt truck was observed salting the pavement (black pavement conditions). This event did not materialized.

Photo Exhibit C: NYCDOS salt truck salting the Brooklyn bridge south roadway (3/7/99)

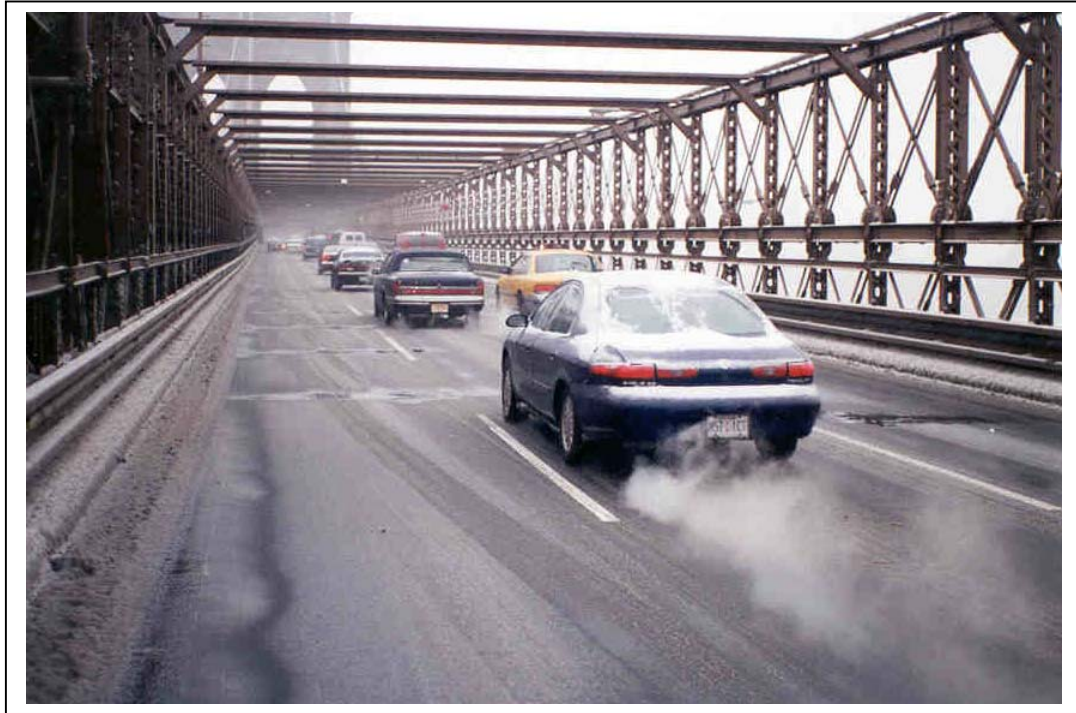
Photo Exhibit D: Pavement condition before re-treating (1/14/99)

While the rationale for the treatments is unexplained for the conditions reported, a similar action was also observed during the January 14, 1999 event. Based upon the evaluation of the event, maintaining a bare “black” pavement condition required minimal snow removal. The information recorded indicated that the pavement temperature was estimated to be ~23°F; the ambient temperature was 27°F and snow precipitation was dry with accumulations totaling >2 inches. The pavement section treated with the FAST system achieved the best pavement conditions (“black conditions”) compared to the other section treated by the spray truck (see Photo Exhibits D and E). As photo exhibit D illustrates, a dry slush-like residue (<<1 inch) remained on the roadway in comparison to the section treated with the spray truck (see Photo Exhibit E). A subsequent treatment was initiated during the event in an attempt to achieve black pavement conditions. However, the slush-like residue remained on the pavement as illustrated. DOS salt trucks were witnessed salting the roadway later into the event-day. Photo Exhibit G illustrates the pavement after the salting occurred.

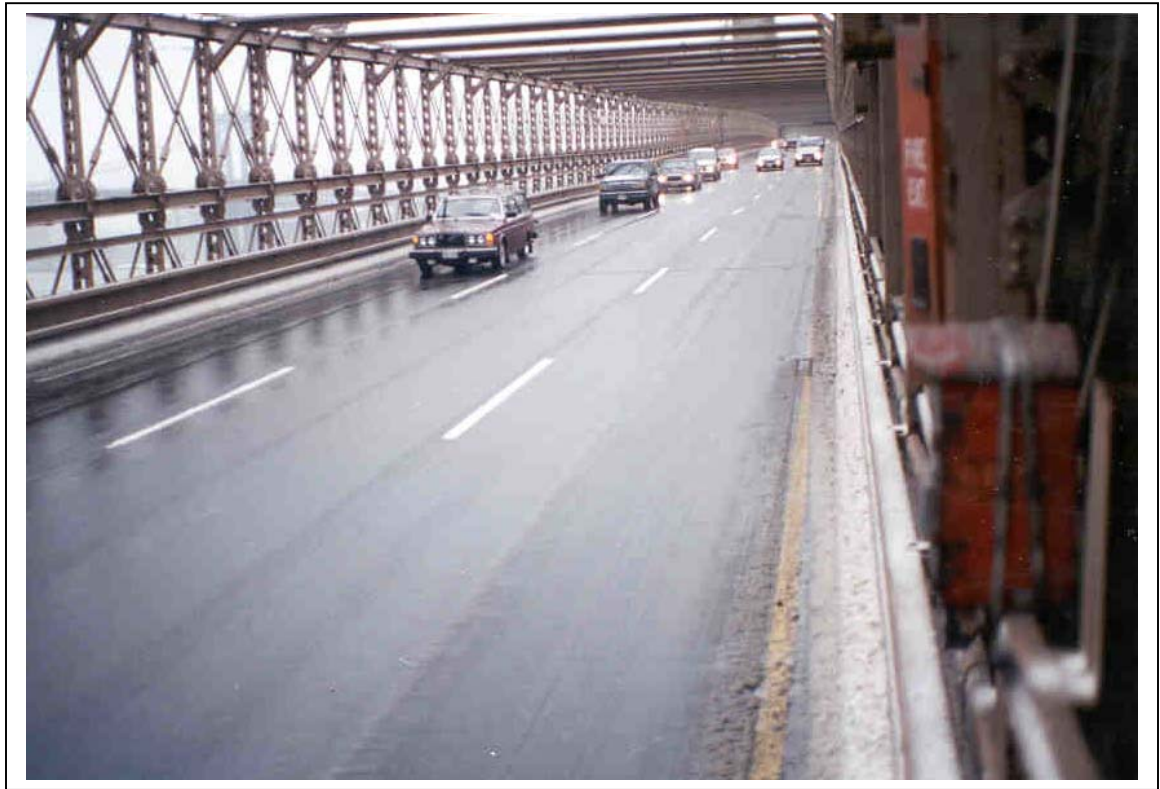
Photo Exhibit F: North roadway pavement after >4 passes of DOS salt trucks (1/14/99)

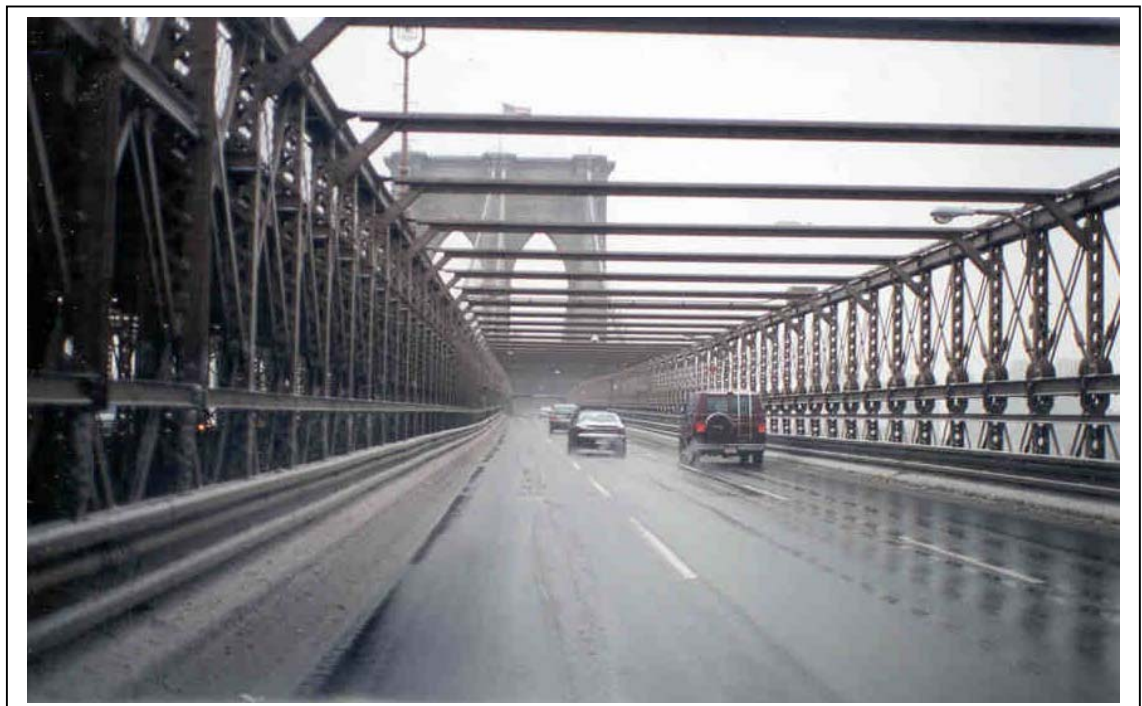
Photo Exhibit G: Pavement condition after DOS applied salt. (Note: Photo D illustrates the pavement condition before salting occurred (1/14/99).

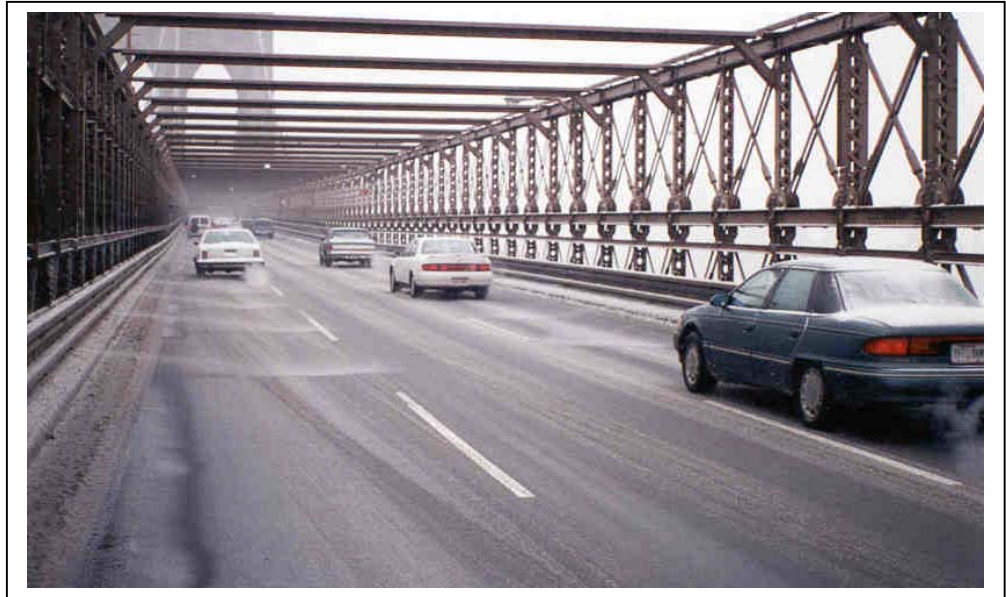
- **FLUID DELIVERY:** In order to spray the recommended quantity (0.5 gallons per 1000 sq. ft.), of potassium acetate (CF7) required for the initial application, a spraying time of 2-3 seconds was required. The spray time duration is based on the capacity of each nozzle (3-GPM) and the total number (50) of nozzles utilized. Photo Exhibit H provides an illustration of the FAST system spraying in progress.

Photo Exhibit H: FAST system spraying (1/14/99)

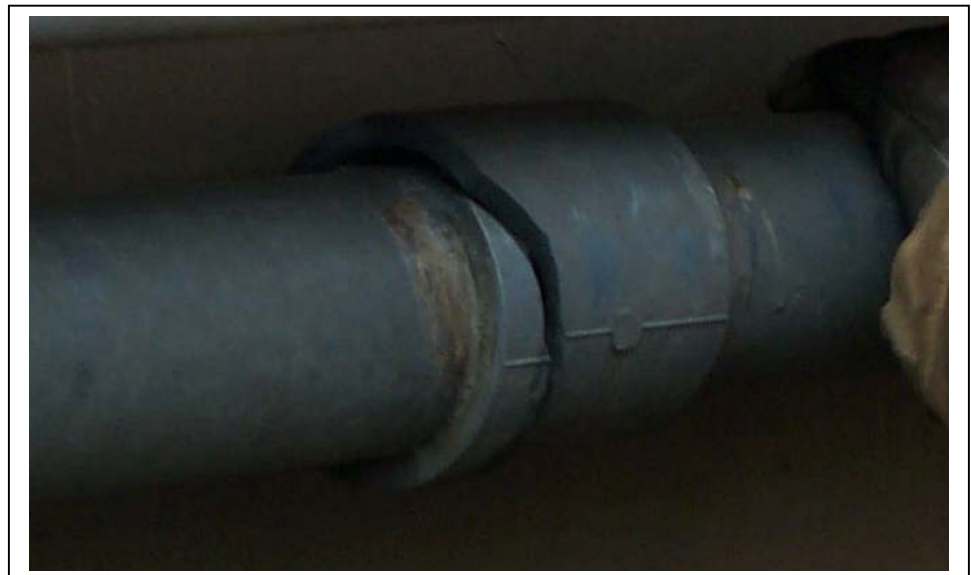
- **PVC Piping:** Schedule 80 PVC pipe was installed on the south roadway barrier. A major concern has been the durability of this pipe exposed to the elements. The concern was would it become brittle and break as a result of extreme ambient weather conditions, and when: year-one, year-two or year five. This did not occur during the '98/'99 winter season- the second year of the system's installation- but it was observed that some of the joints were discolored and moist. The discoloration can be attributed to airborne dust and debris. The moisture at some of the joints was as a result of the glue's failure. Commercial PVC pipe glue was used. During subsequent winter seasons –'99/'00 and '00/'01- failure of the PVC pipe joints occurred.

Photo Exhibit I: Typical joint failure

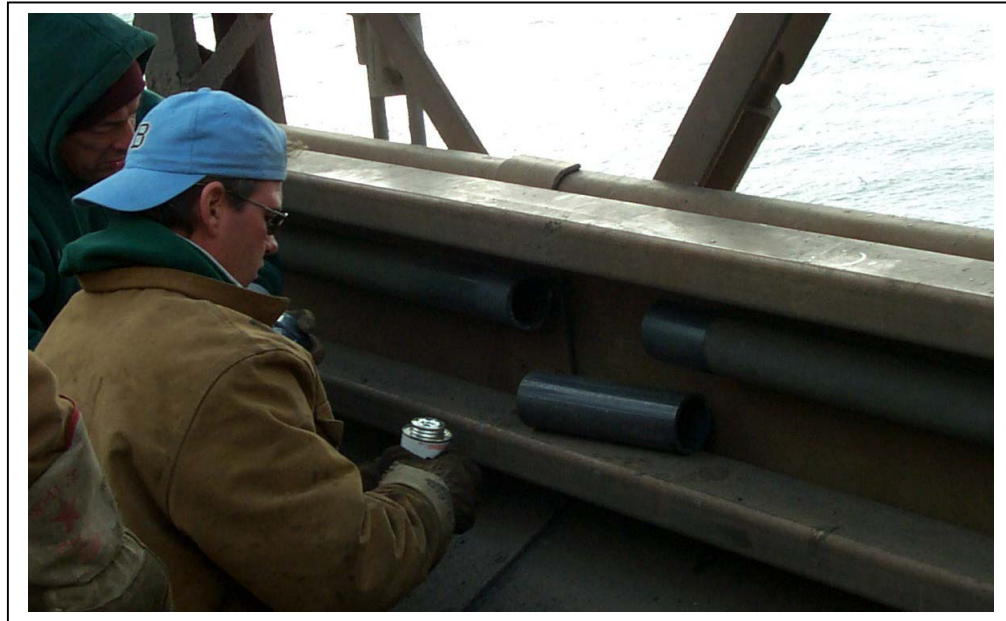
Maintenance consisted primarily of scheduled and periodic cleaning of check valves. Repair of broken and leaky joints is accomplished by a worker easily saw cutting PVC pipe and using couplings, reconnect the joint.

Photo Exhibit J: Typical joint repair

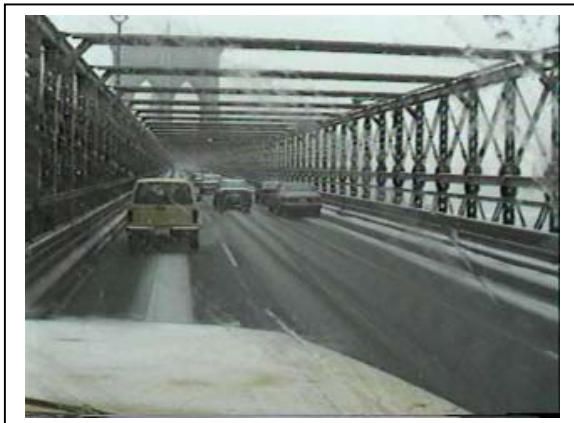
It is important to note that a qualitative comparison of pavement conditions indicate that the level of service of the roadway treated with the FAST system had significantly less accumulated snow that the section tread via conventional methods utilizing a spray truck (see photo 1 and 2 for illustration).

Photo 1: Road section sprayed by the FAST system

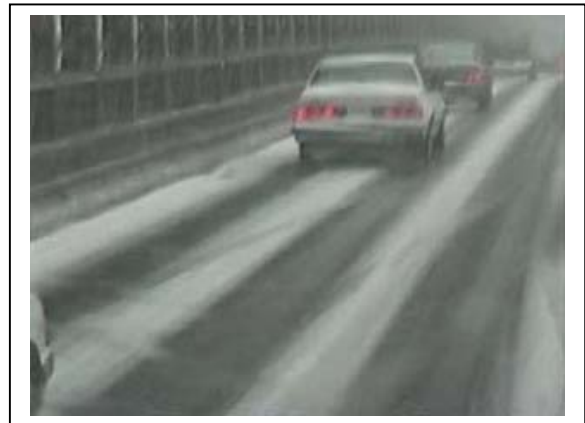
Photo 2: Road section sprayed with truck mounted spray unit

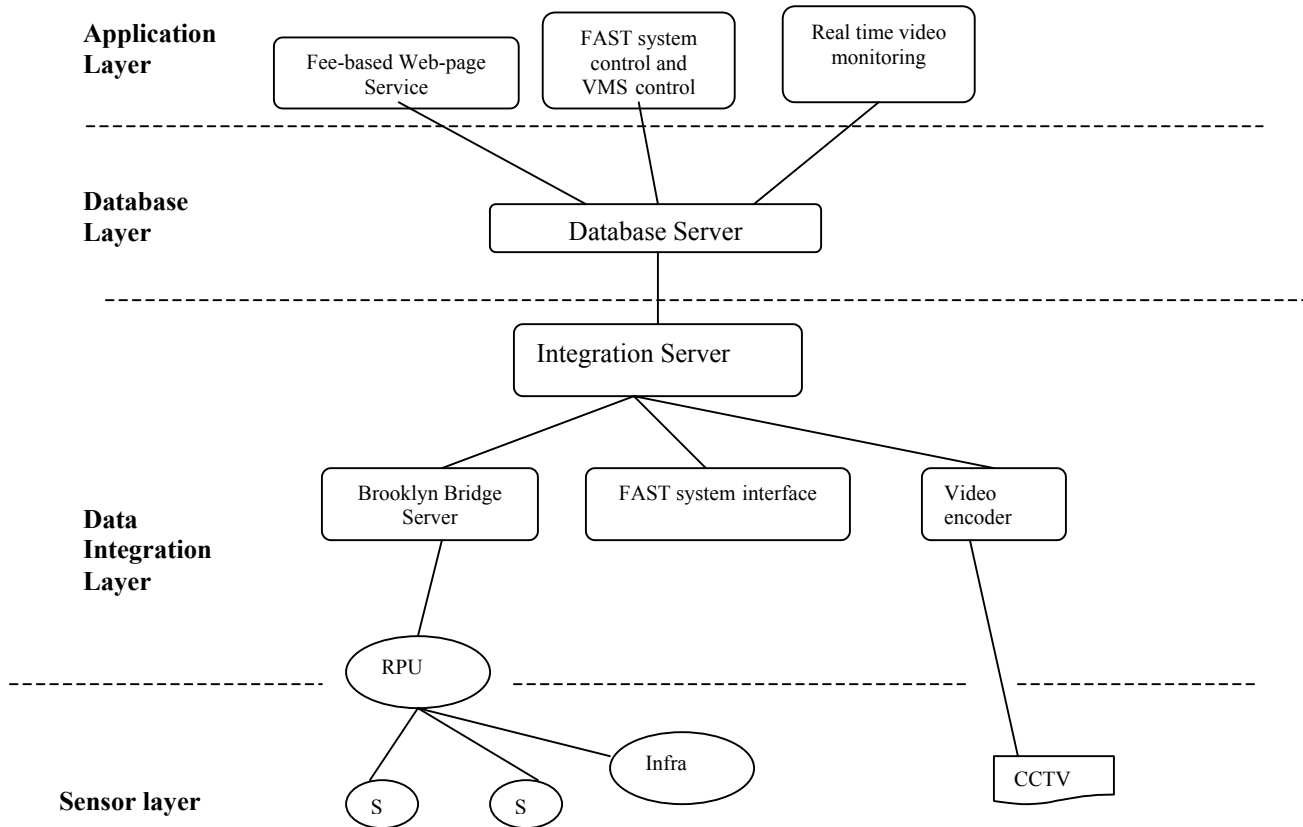
This phase of the project (phase II) describes extension of the FAST system and integration the following road weather information system's next generation (RWIS) architecture [2] model.

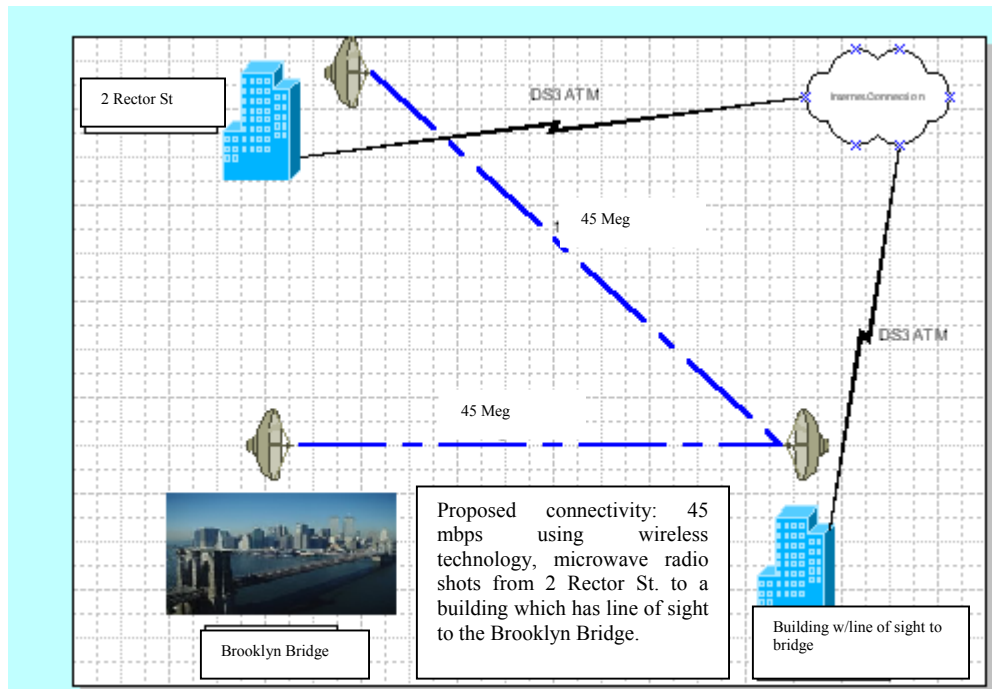
The demonstration phase of the phase II project shall provide for the development of proven wireless high-speed connectivity of a road weather information system's (RWIS) sensors data and distribution of real time high quality video across a virtual private IP network and IP-applications utilizing the Internet. By combining wireless technologies with a fiber infrastructure, the Division will cost-effectively link pavement sensors, non-destructive structural stress-stain sensors' data and distribute high quality live video across a Virtual Private IP network which can handle 30 JPEG images per second over the LAN and internet.

Utilizing 45 Mbps RF wireless microwave communication technologies and radio shots between two sites- Brooklyn Bridge Manhattan Tower to New York City Department of Transportation's Division of Bridges office located at 2 Rector Street in lower Manhattan- this can be accomplished.
