**EXPEDITED CONCRETE BOX GIRDER BRIDGE
REMOVALS OVER THE INTERSTATE
IN ONE-NIGHT INTERSTATE CLOSURES**

AUGUST 5, 2002

**ANTHONY BOWER
FHWA – IOWA DIVISION**

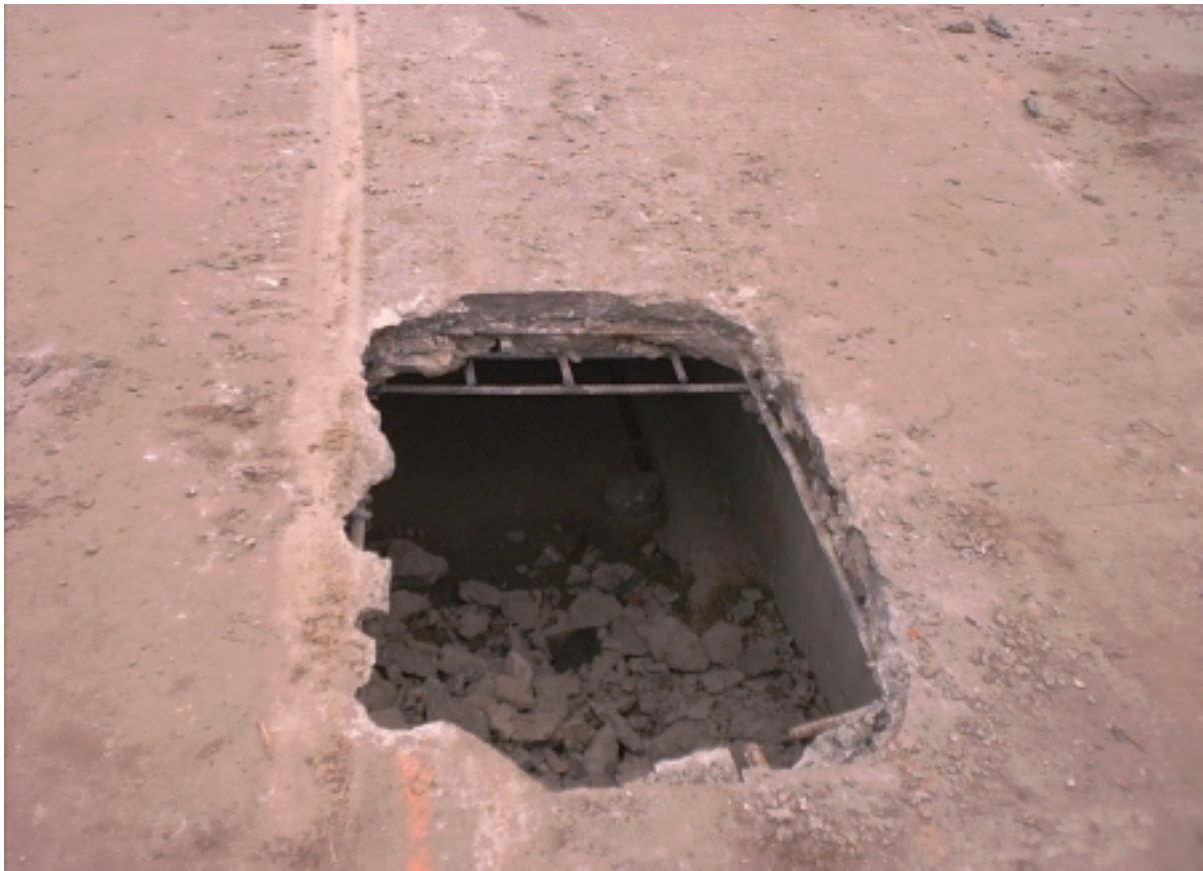
Attachment 2 – Access Holes On Deck To Remove Wooden Forms

The contractor began working on the bridge a few days before the actual removal. This work was done on the bridge while traffic was still allowed on the Interstate below. Two-foot square openings were cut in the deck to allow access into the box girders to remove wooden forms that were left in place during construction (Attachments 1 and 2). These holes also provided an opportunity for the contractor to locate the girders and diaphragms to make sure the initial slotting of the top deck did not damage these elements. The metal handrail was also removed.

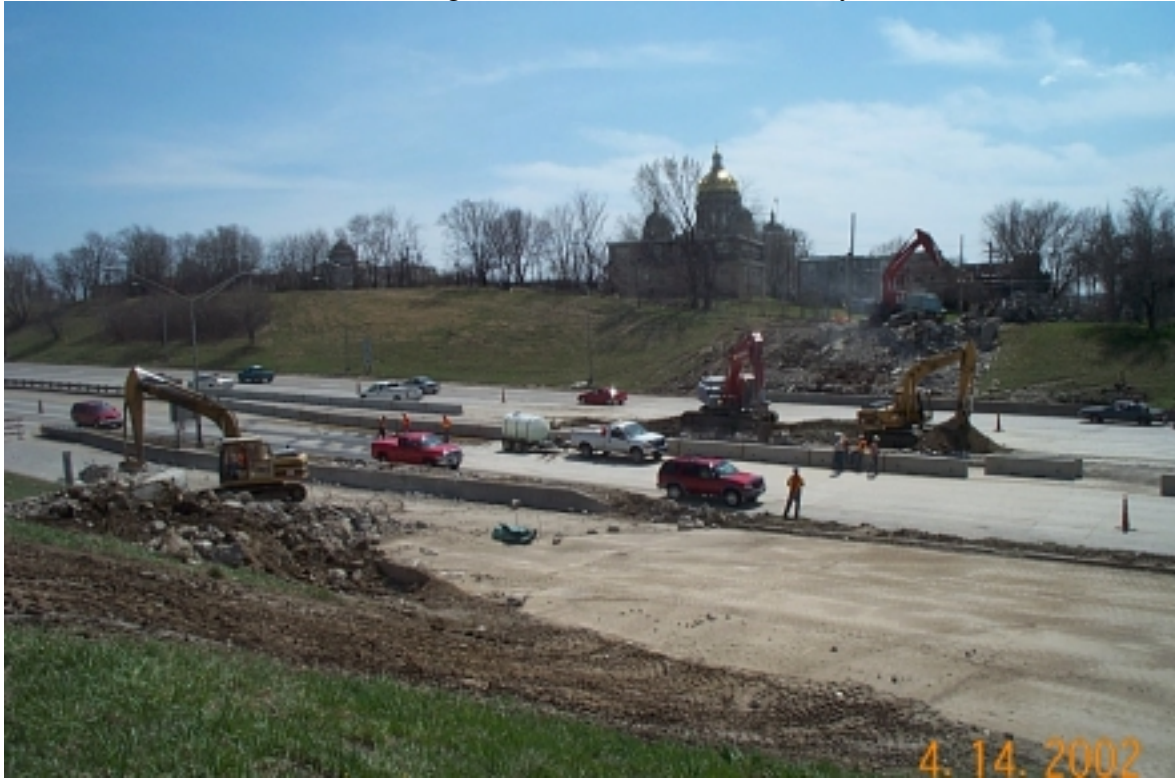
Attachment 3 – View of E 9th Bridge Removal at 1:00 PM Sunday afternoon

The deadlines were met. One lane of traffic in each direction was re-opened by 11 a.m. Sunday. Attachment 3 is a view, looking north, of the construction site at approximately 1

p.m. Sunday afternoon. This photo shows the traffic passing through the single open lane in each direction through the work zone. Traffic was slightly backed up at this point in time, but moving reasonably quickly through the work zone.

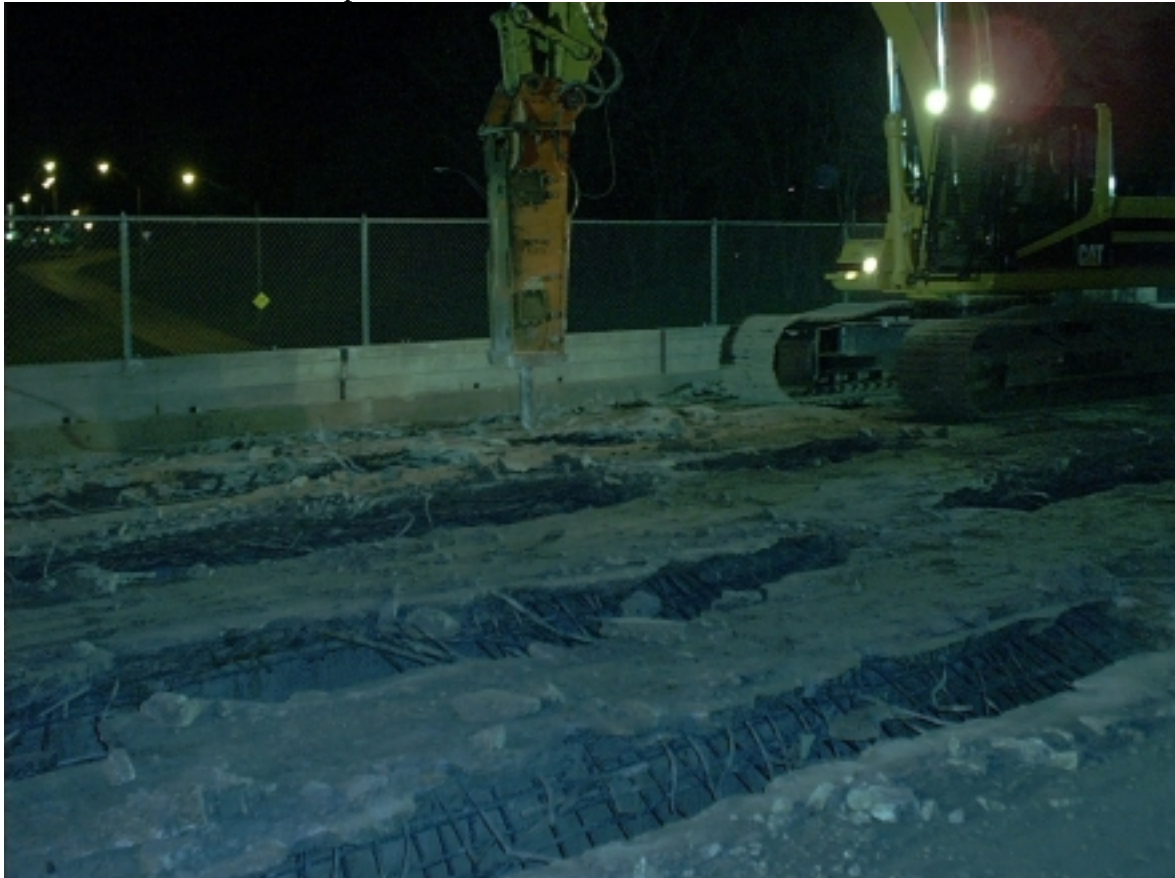
Attachment 4 – Slotted Top Deck

Two of the smaller excavators began by slotting the center span of the top deck as shown in Attachment 4. They cut openings as wide as 3.5 feet longitudinally between the girders. The excavators removed the chain-link fence, barrier rail, light pole, and metal Interstate signs at this time. Attachment 5 shows one of the excavators hammering at the barrier rail. The contractor's removal plan indicated that the tracks of the excavators needed to be kept on a girder during removal, and that no two tracks could be on the same girder line for the entire length of the bridge. It was noted that the excavators were on the same girder line on different spans for extended periods of time during the demolition with no adverse consequence. Attachment B is a typical cross-section of a concrete box girder showing the tracks of the excavator remaining over the girders.

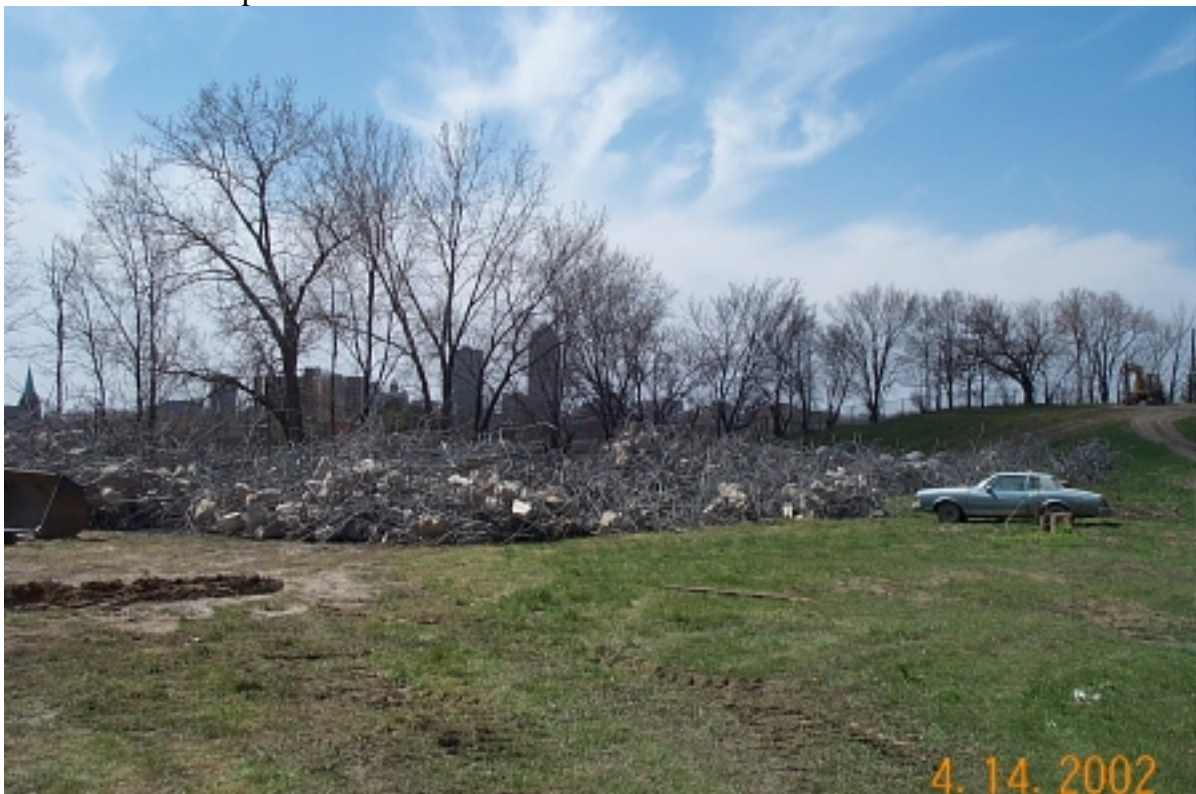
Attachment 6 – Separate Debris Pile for Steel Rebar

The excavators were able to separate most of the rebar while breaking up the concrete. As much of the steel as possible was hauled to a separate rubble pile as shown in Attachment 6. The end loaders loaded the concrete rubble onto the dump trucks that hauled it away. The operators of the end loaders appeared to clear enough of the rubble to keep the site workable without removing an excessive amount of the gravel protection.

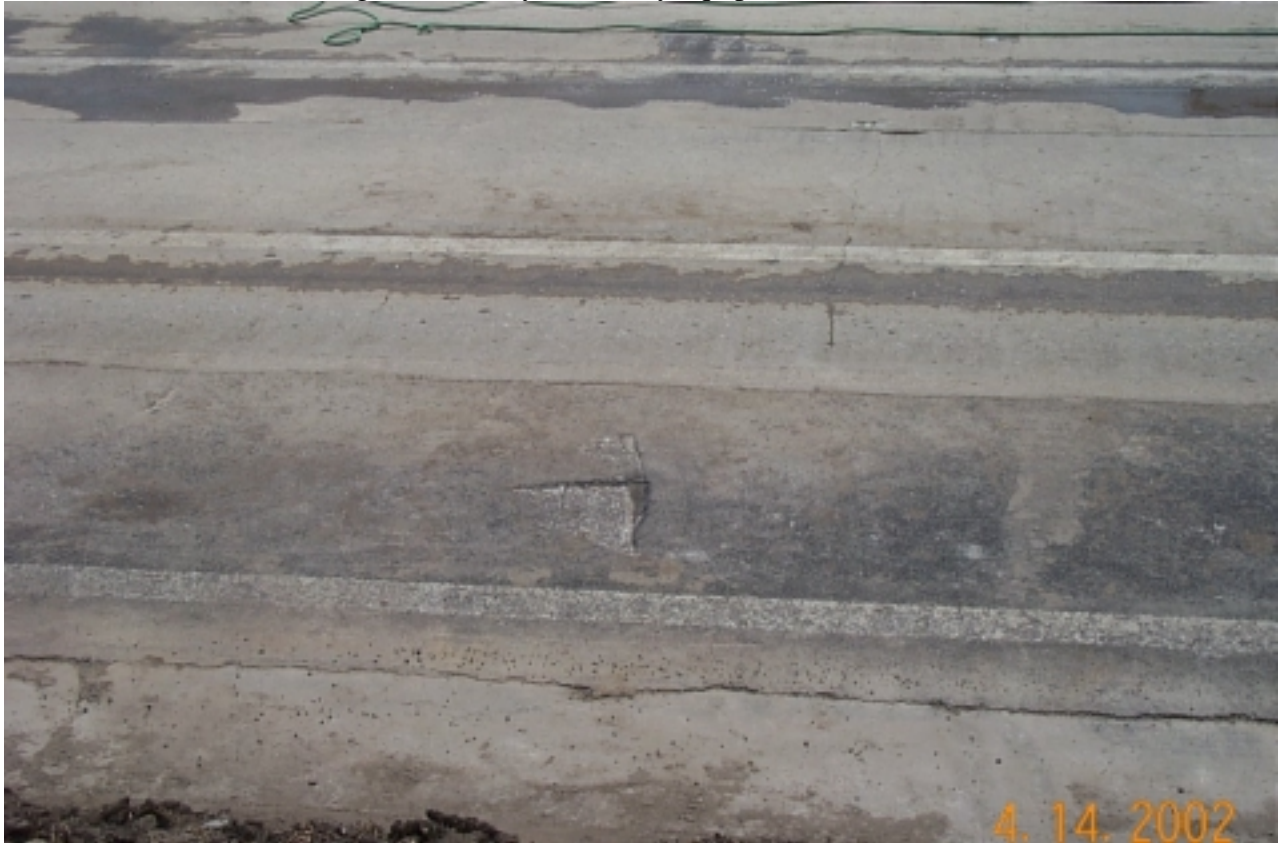
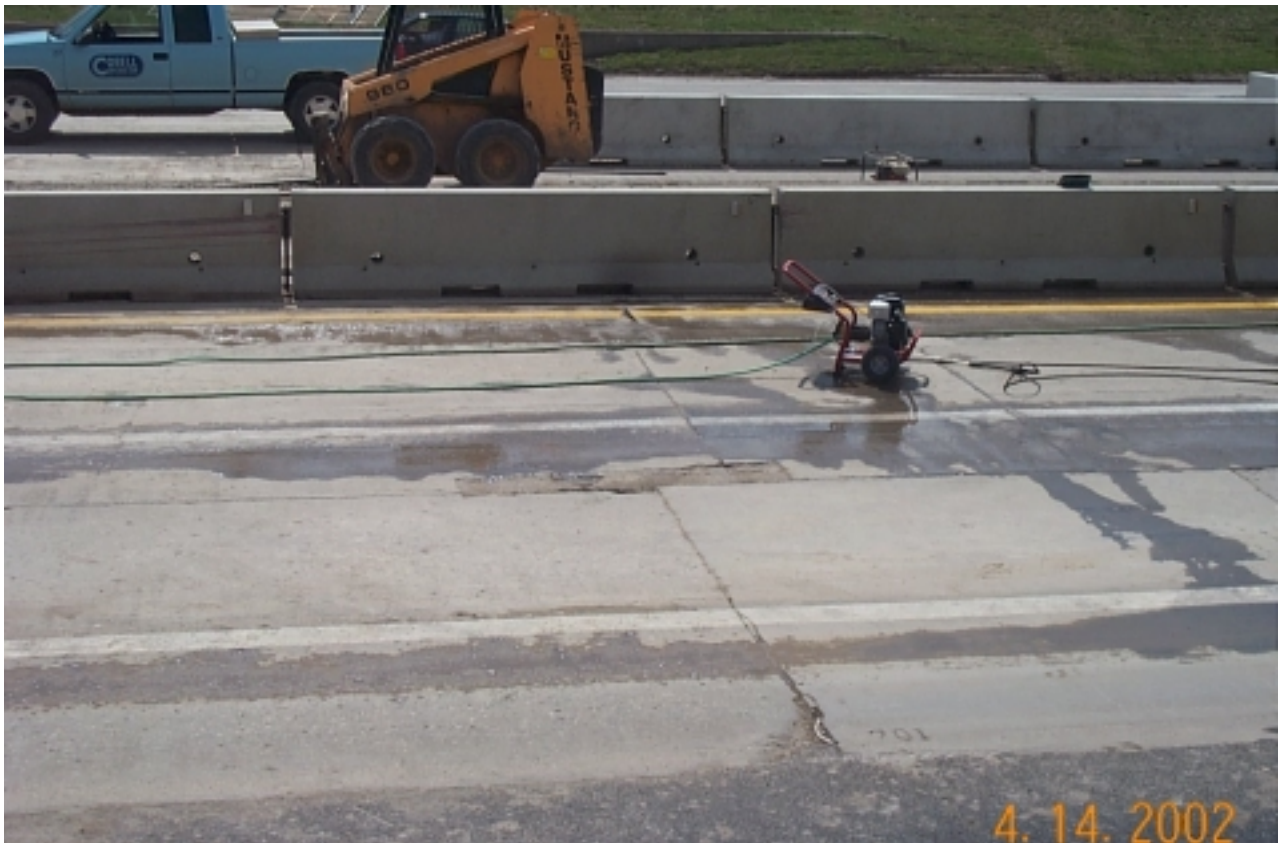
Attachments 7 & 8 – Damage to roadway caused by equipment

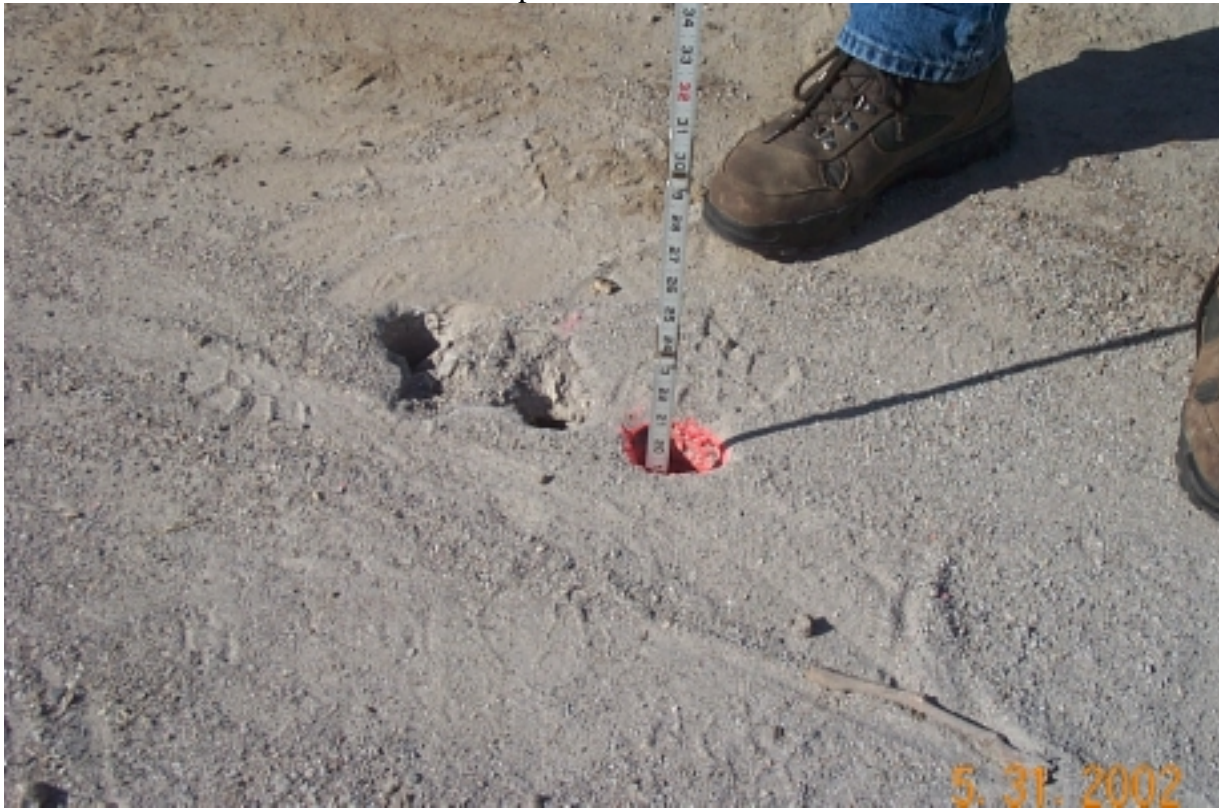
Attachment 9 – Pre-drilled Holes for Explosives

Approximately 800 holes were drilled into the top deck of the first bridge beginning one week before the demolition. These holes were about 2 inches in diameter and extended 20 inches down into the center of the girders as shown in Attachment 9. These holes were plugged with tar and a piece of geotextile to prevent debris from entering them. They were later filled with explosives on the day of the demolition.

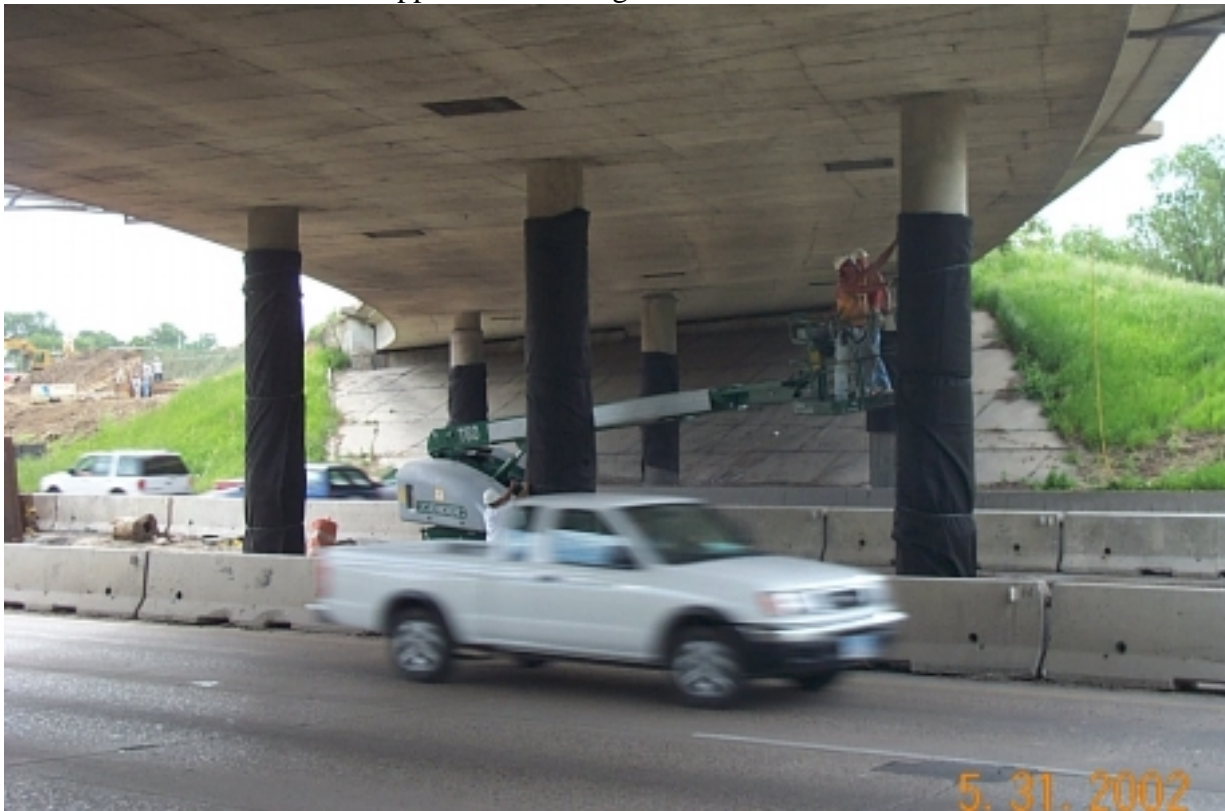
Attachment 10 – Columns wrapped with fencing and fabric

The structure needed to be wrapped with a geotextile fabric and chain link fencing to help prevent debris from the implosion from leaving the project site. The top deck was covered and the columns were wrapped during the days leading up to the implosion (Attachment 10).

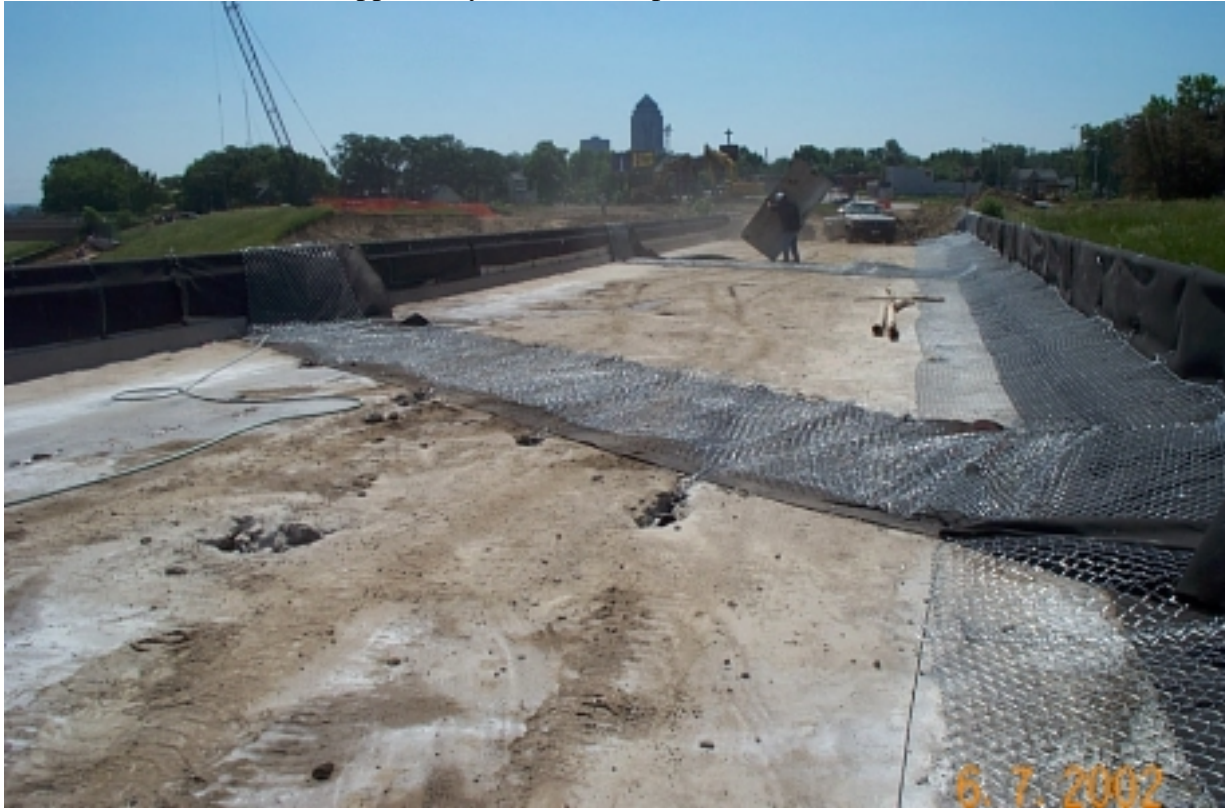
Attachment 11 – Deck Wrapped only over Pier Caps and Sidewalk

The information gathered from the first implosion was adapted for use on the second bridge, which was removed one week later. The only parts of the second bridge to be loaded were over the pier diaphragms and along the sidewalk. The bridge was only wrapped with the fabric and fencing where charges were placed, Attachment 11. Longitudinal cuts were made along the top deck. These cuts, shown in Attachment 12, are intended to help the bridge break apart when it hits the ground. This was also in the plan for the first bridge, but the contractor did not have enough time to perform the saw cuts.

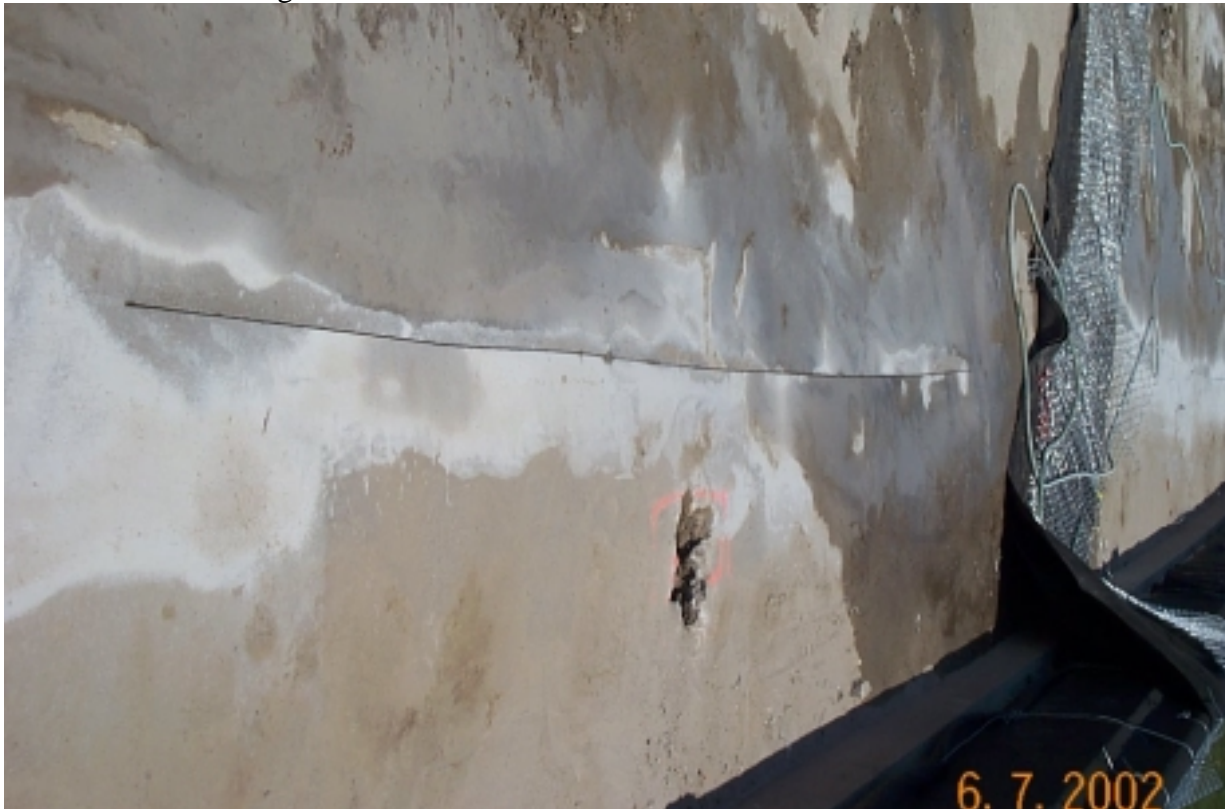
Attachment 12 – Longitudinal saw cuts in the deck

More preparation was done before the actual closure of the Interstate for the second bridge. The implosion was scheduled to occur at 2 a.m., one hour earlier than the first bridge. The top deck was longitudinally saw cut. More attention was given by the explosives contractor to the pier caps and abutments to make sure they were sufficiently broken apart. The deck did not have any explosives in it. The deck was slightly broken up by the impact of it hitting the ground, but for the most part hydraulic excavators were used to break it apart once it was on the ground.

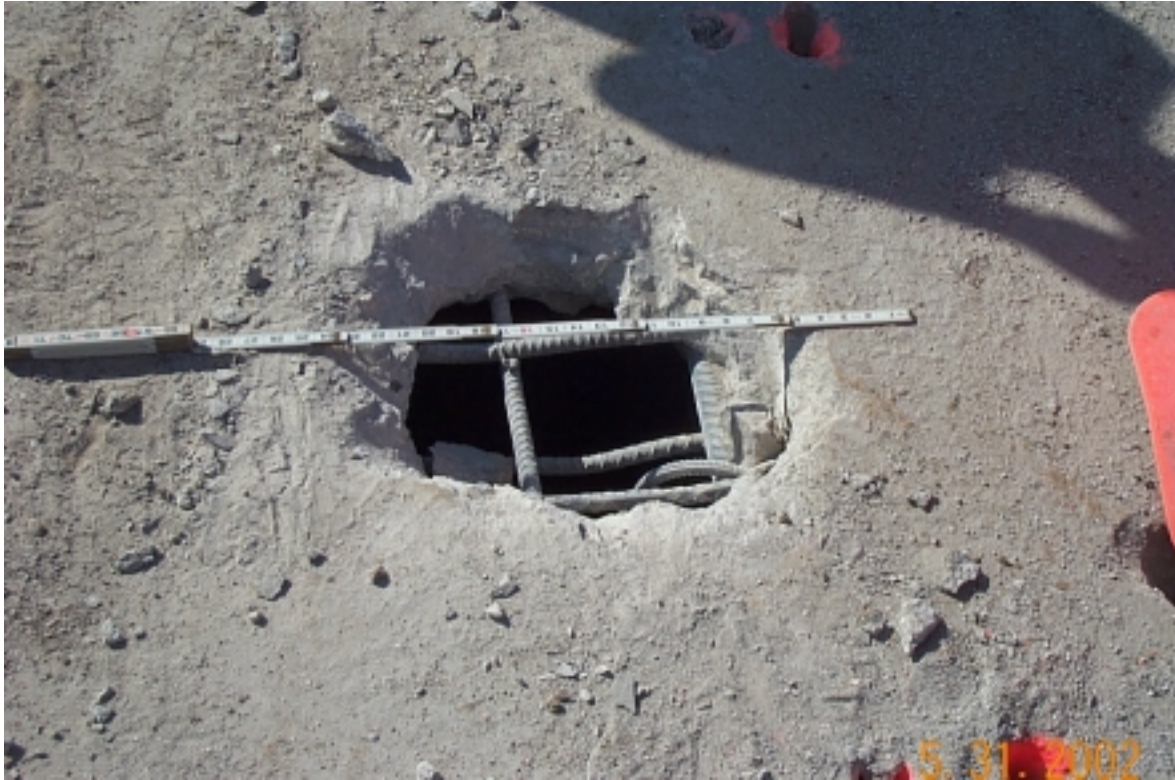
Attachment 13 – 18” Holes drilled into the Deck

On the first Cottage Grove Bridge, explosives were placed in each concrete girder every 4 feet for the length of bridge. Approximately 800 holes were vertically drilled down into the girders through the top deck. Eighteen-inch diameter holes were cut as necessary into the top deck to check the location of the girders as shown in Attachment 13. They were smaller than the holes in the deck of the E 9th Bridge. These holes did not cause any damage to the structural integrity of the bridge. For the second Cottage Grove Bridge, only approximately 300 holes were loaded with explosives near the pier diaphragms and sidewalk.

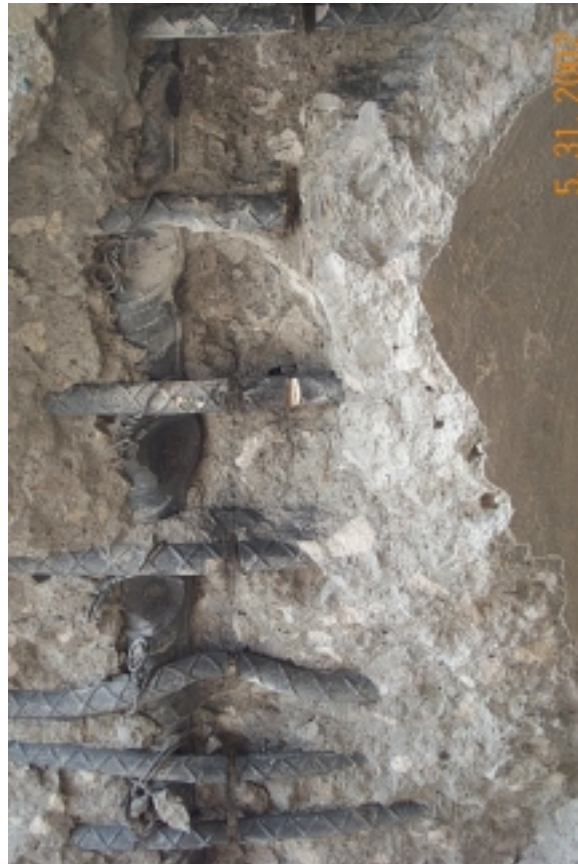
Attachment 15 – Cut Horizontal Rebar

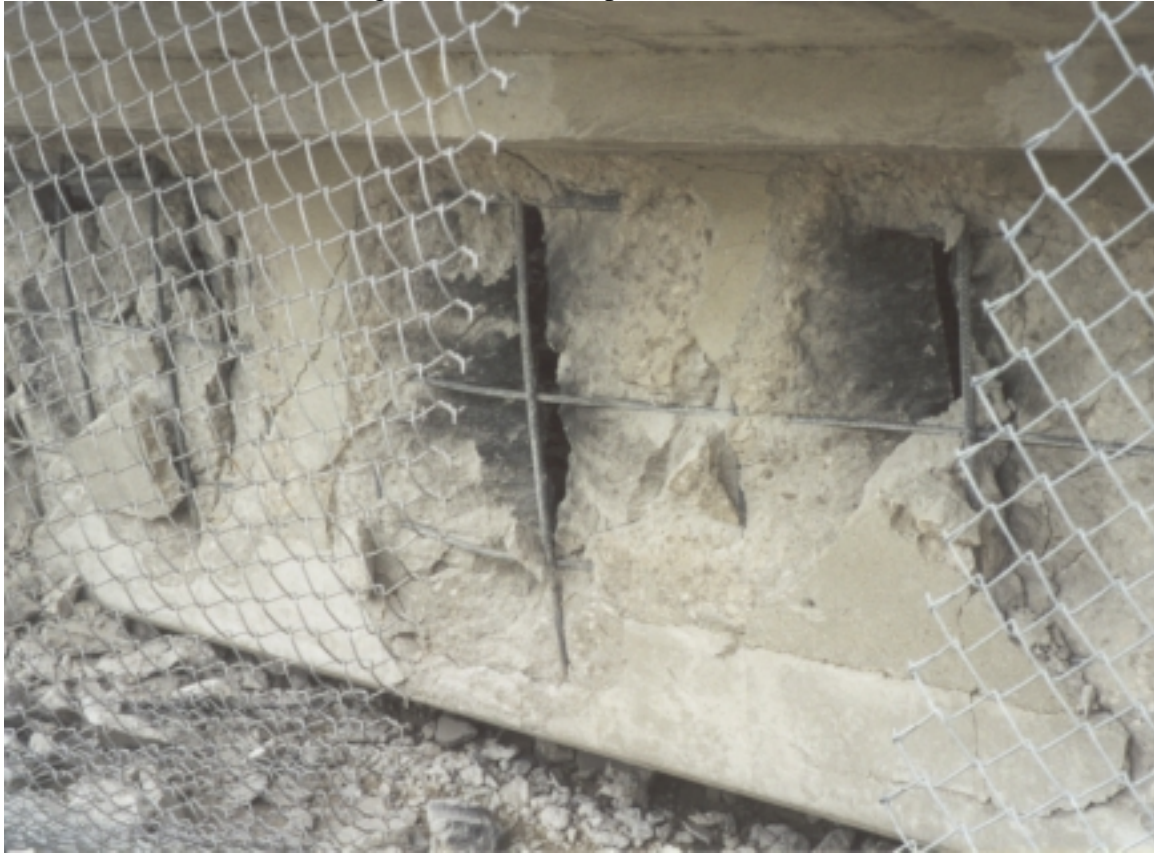
Attachment 16 – An outside girder after the implosion

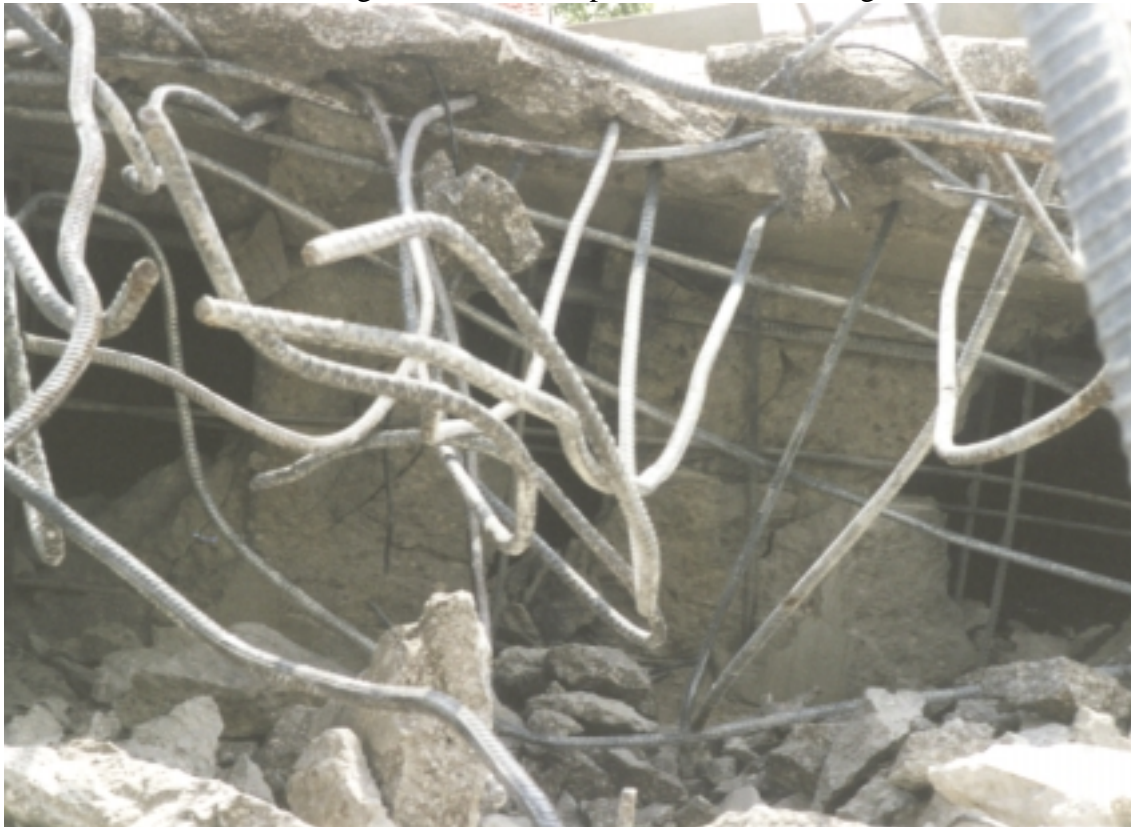
Attachment 17 – An inside girder after the implosion once outside girder was removed
