# **Preliminary Assessment of Landslides Along the Florida River Downstream From Lemon Reservoir, La Plata County, Colorado**

Open-File Report 2006-1343

By William H. Schulz, Jeffrey A. Coe, William L. Ellis, and John D. Kibler

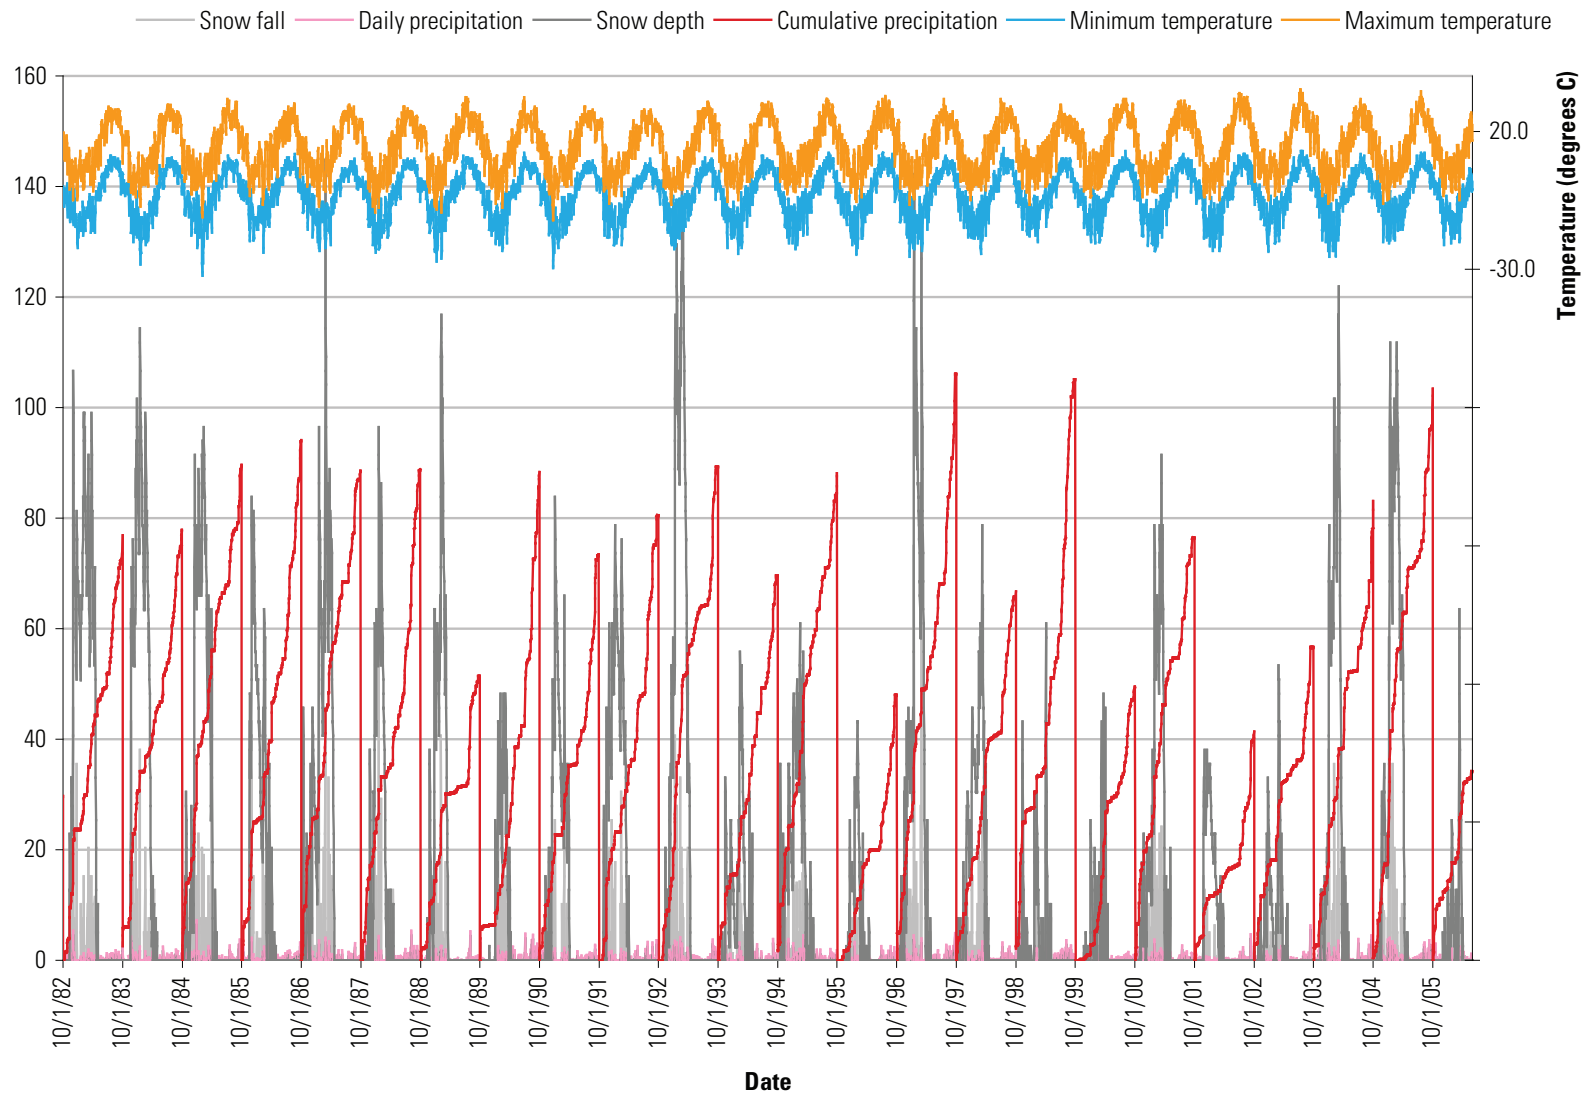
**Figure 2.** Climate data measured at Lemon Dam, October 1, 1982 – May 31, 2006. Data obtained from the Western Regional Climate Center, Desert Research Institute.

The FWCD operates a weather station near Lemon Dam, less than a kilometer from the landslide complex. Figure 2 shows climate data measured at Lemon Dam since 1982, with cumulative precipitation calculated for each water year. A water year is defined as October 1 through September 30, with the water-year name corresponding with the year the water year began. Snowmelt that occurred prior to spring 2005 landslide activity within the complex was above average, but not extreme. Cumulative precipitation for the Lemon Dam period of record was greater for complete water years 1996 and 1998 than for 2004, although cumulative precipitation until April 30 was greatest for water year 2004 (fig. 3). Figure 4 shows the percentage of average precipitation that fell each water year by the end of April measured in Durango, approximately 22 km southeast from the landslide complex. Durango data provide a longer period of record (1900-2004) than Lemon Dam data. Although Durango data (fig. 4) do not directly correlate with measurements made at Lemon Dam (for example, 2004 precipitation in Durango was less than that of three other years during the Lemon Dam period of record whereas precipitation was greatest at Lemon Dam during 2004), general trends are consistent. Since 1900 in Durango, 14 years experienced significantly more water-year precipitation through April than water year 2004 (fig. 4).

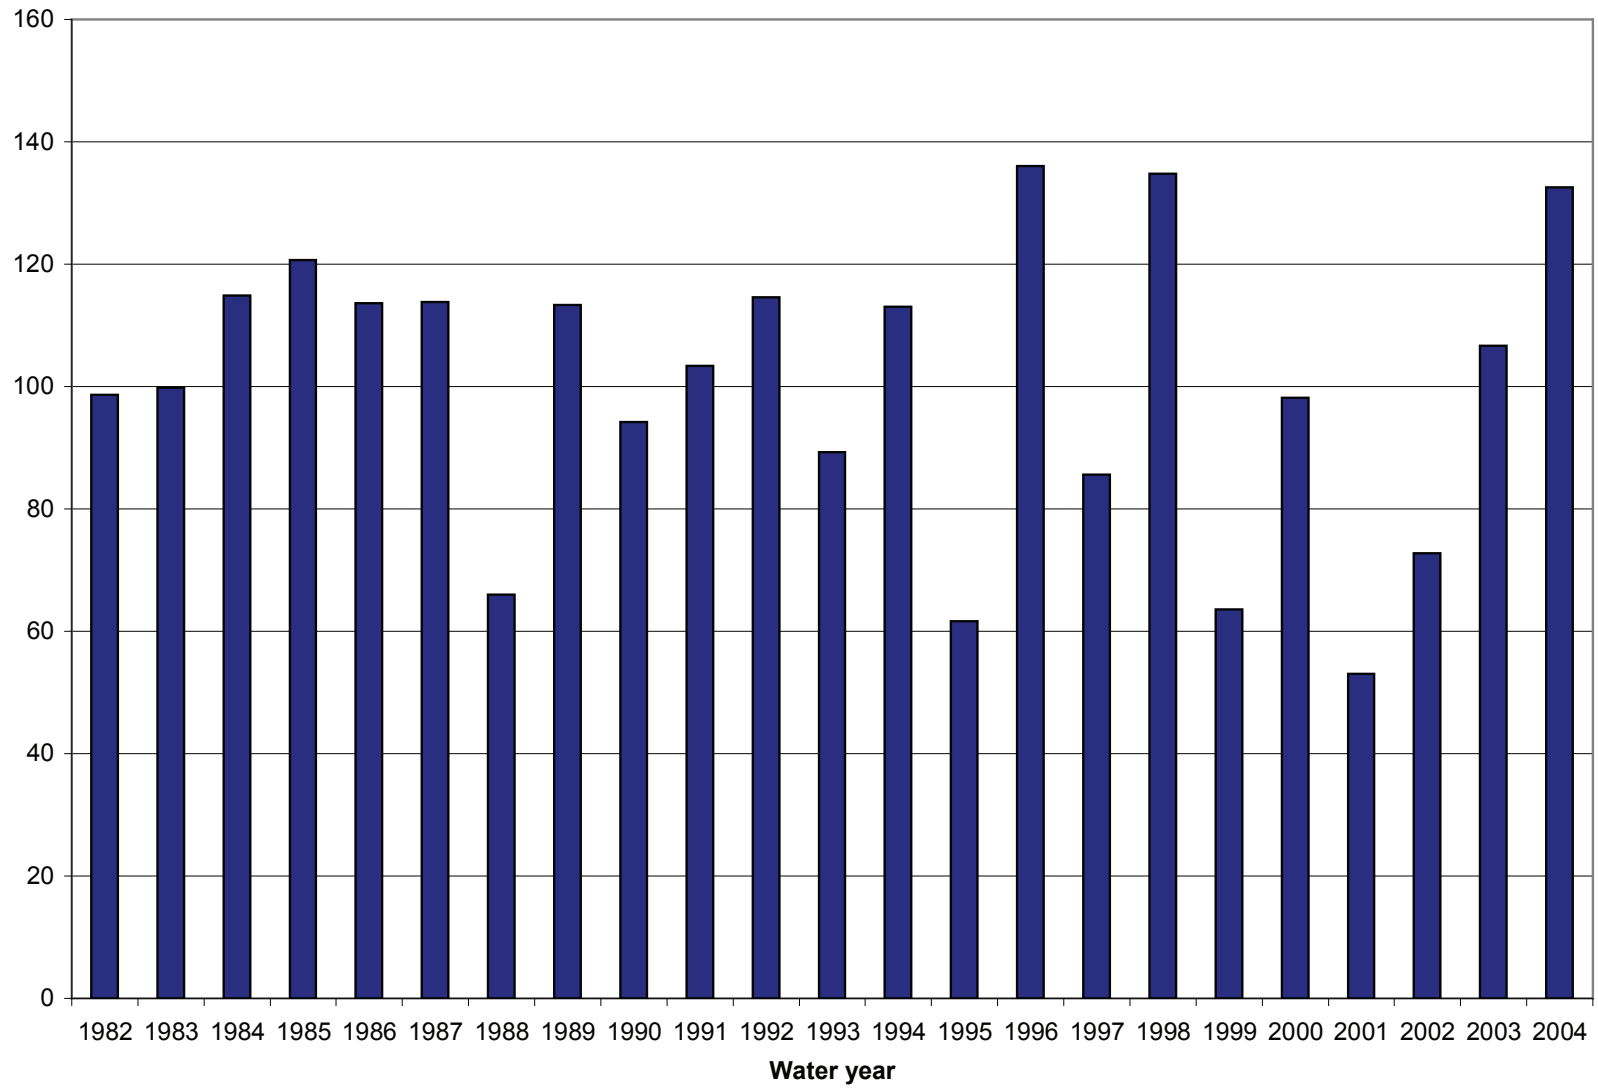
**Figure 3.** Percentage of average precipitation measured at Lemon Dam for the period of October 1 – April 30 of water years 1982 – 2005. Climate data obtained from the Western Regional Climate Center, Desert Research Institute.

Figure 6 shows precipitation data for water year 1983, which, by comparison with the other water years during the period of record (fig. 3, 1982-2005), approximately represents average conditions through April. During this typical year, about 29 cm of precipitation fell as snow by the time the snow pack began its final melt off beginning in the middle of February, compared to over 44 cm that fell during this period of water year 2004. Final melting of the snow pack during water year 1983 occurred gradually from the middle of February through the end of March (fig. 6).

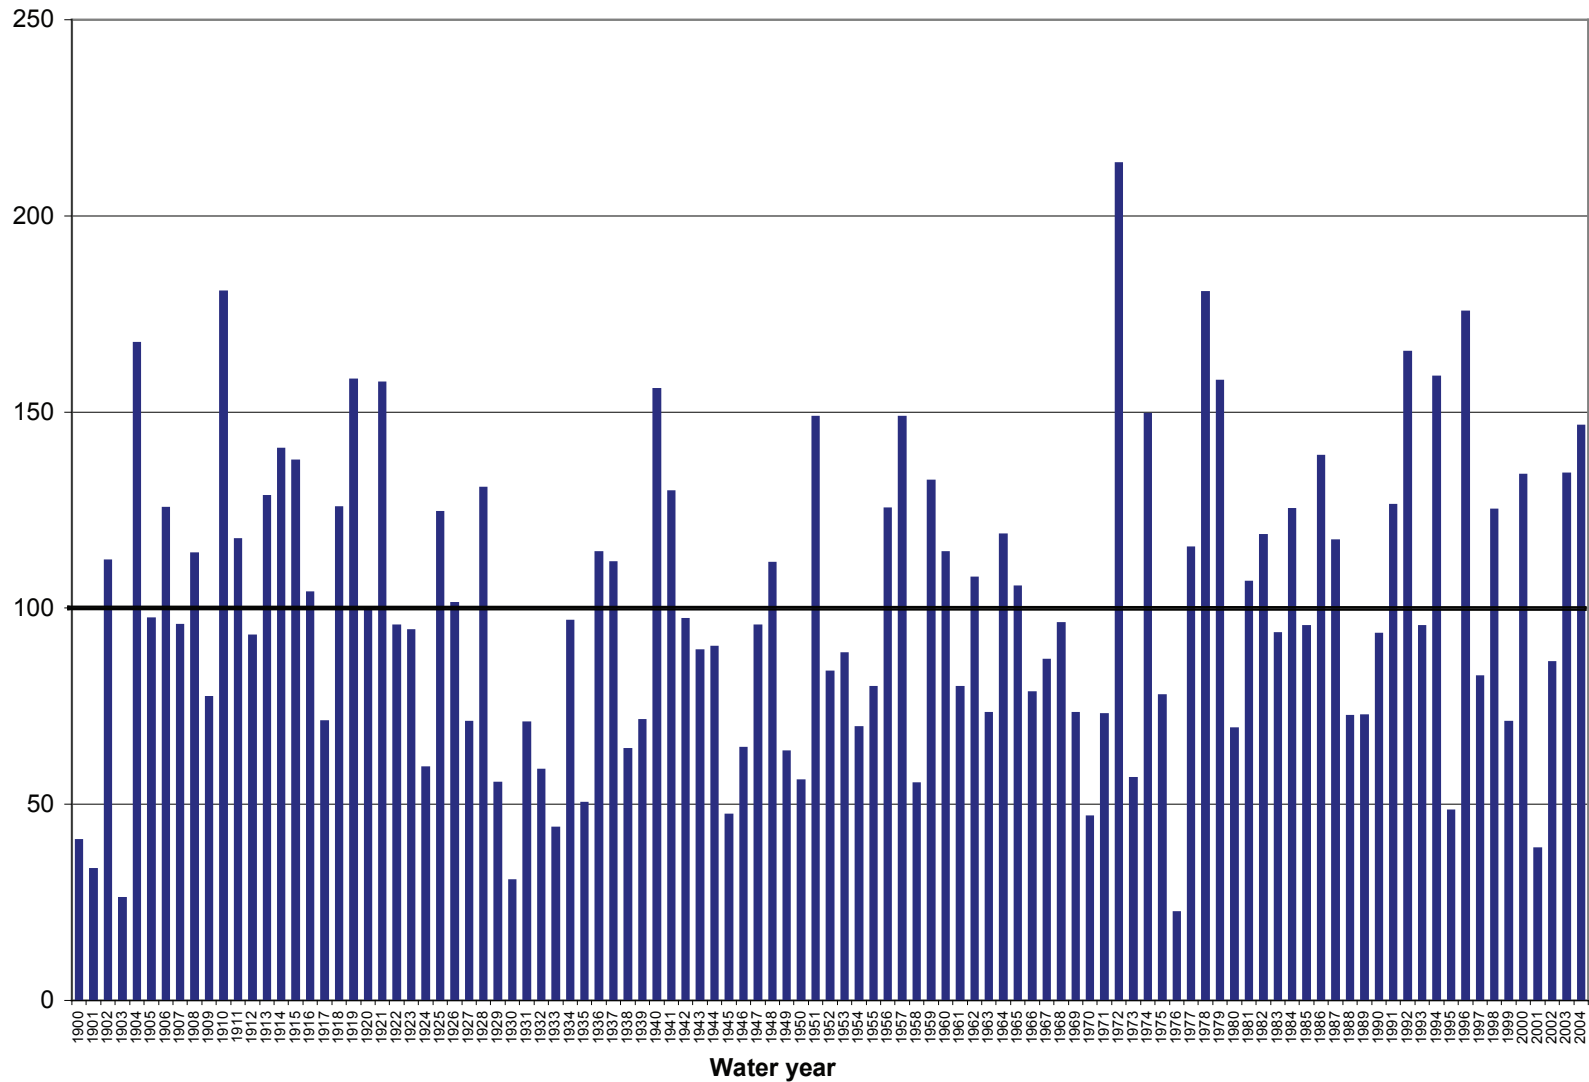
**Figure 4.** Percentage of average precipitation measured at Durango for the period of October 1 – April 30 of water years 1900 – 2004. Climate data obtained from the Western Regional Climate Center, Desert Research Institute.

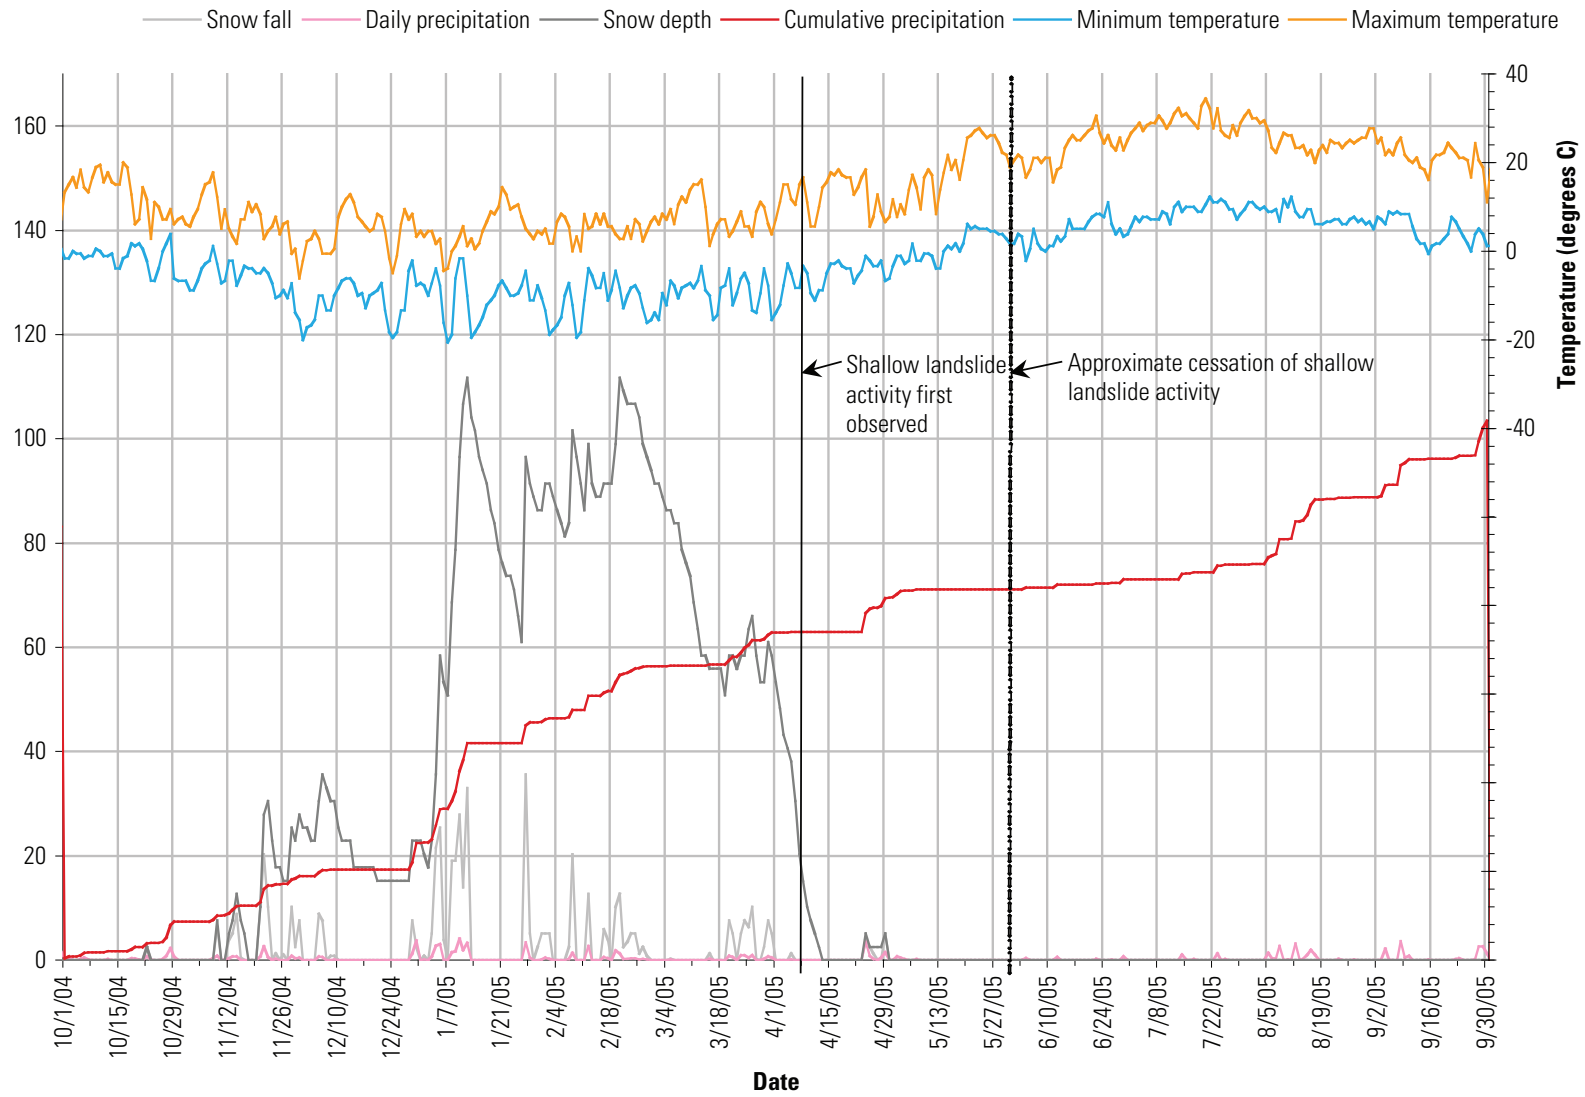
**Figure 5.** Climate data measured at Lemon Dam, October 1, 2004 – September 30, 2005. Data obtained from the Western Regional Climate Center, Desert Research Institute.

Landslide activity observed during April and May 2005 correlated temporally with rapid melting of a deep, wet snow pack. Figure 5 shows Lemon Dam climate data for water year 2004, which includes the April and May 2005 period of landslide activity. The amount of water accumulated as snowfall can be estimated for a given period by subtracting the cumulative precipitation value corresponding to the beginning of the period (fig. 5) from the value corresponding to the end of the period, assuming that no snowmelt occurred during the period. Using this method, over 44 cm of water accumulated as snow by the time the snow pack began its final melt off on February 20 (fig. 5). About seven additional centimeters of precipitation fell as snow during the last two weeks of March. The snow pack completely melted by April 13.

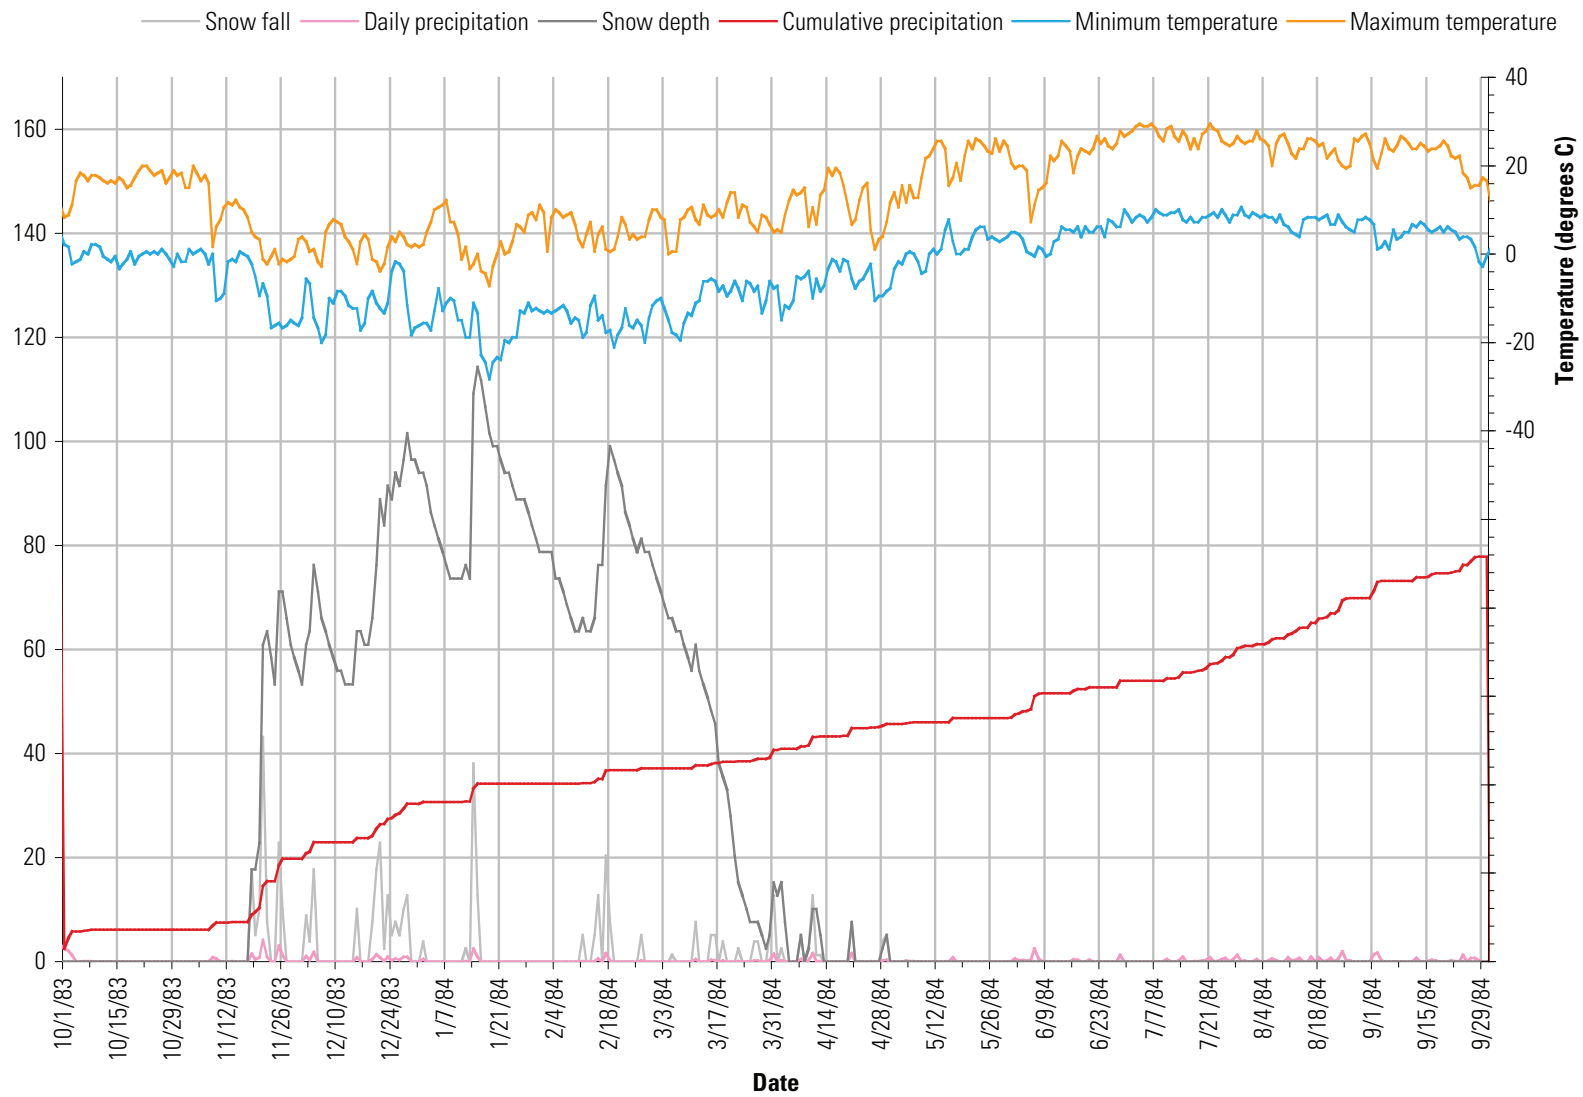
**Figure 6.** Climate data measured at Lemon Dam, October 1, 1983 – September 30, 1984. Data obtained from the Western Regional Climate Center, Desert Research Institute.

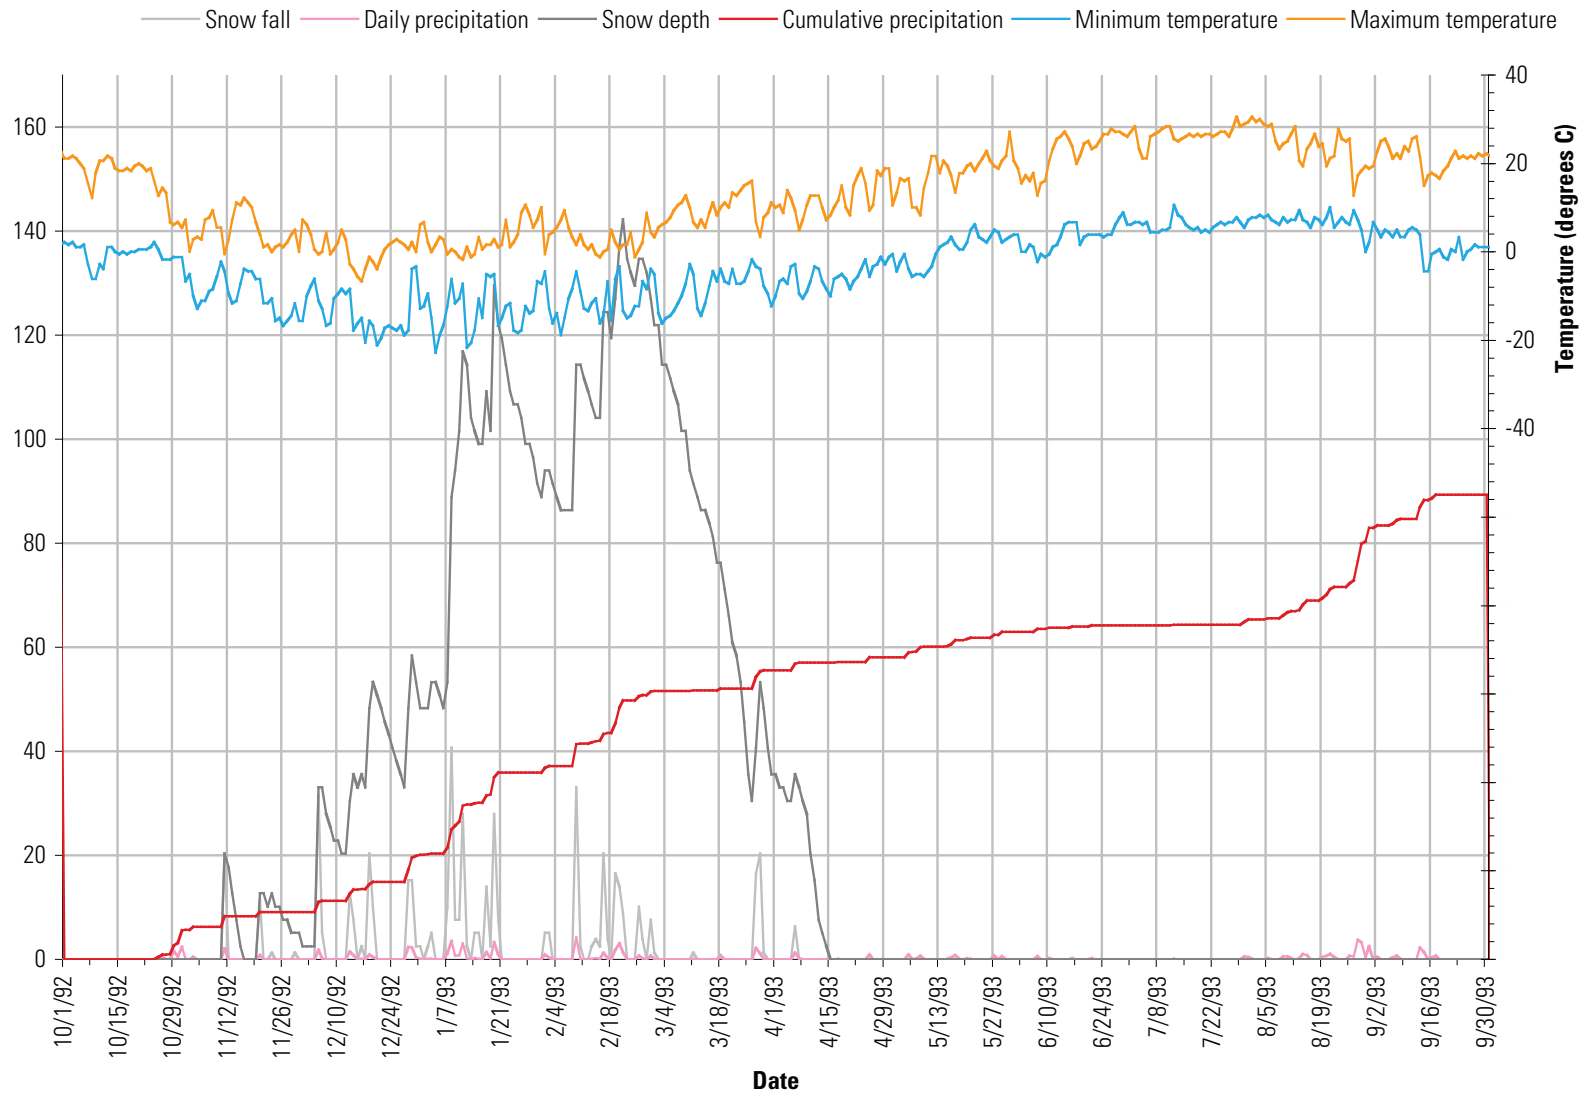
**Figure 7.** Climate data measured at Lemon Dam, October 1, 1992 – September 30, 1993. Data obtained from the Western Regional Climate Center, Desert Research Institute.

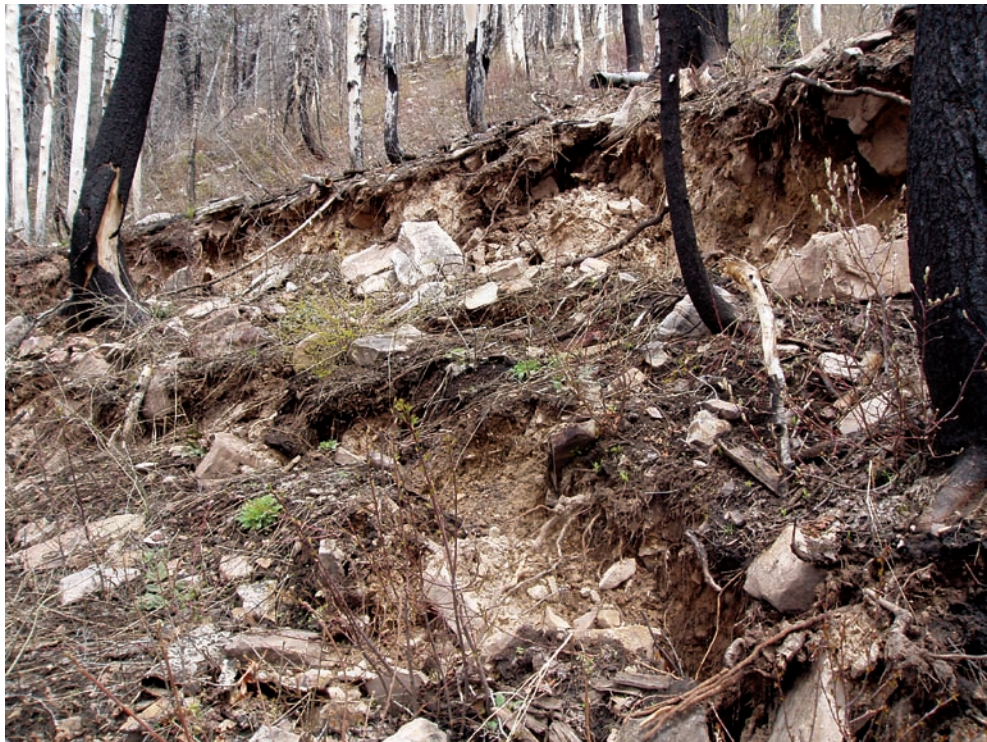
**Figure 8.** Head of a translational landslide that was active during spring 2005 within the Florida River landslide complex. Headscarp in upper part of photograph is 3.2 m high.

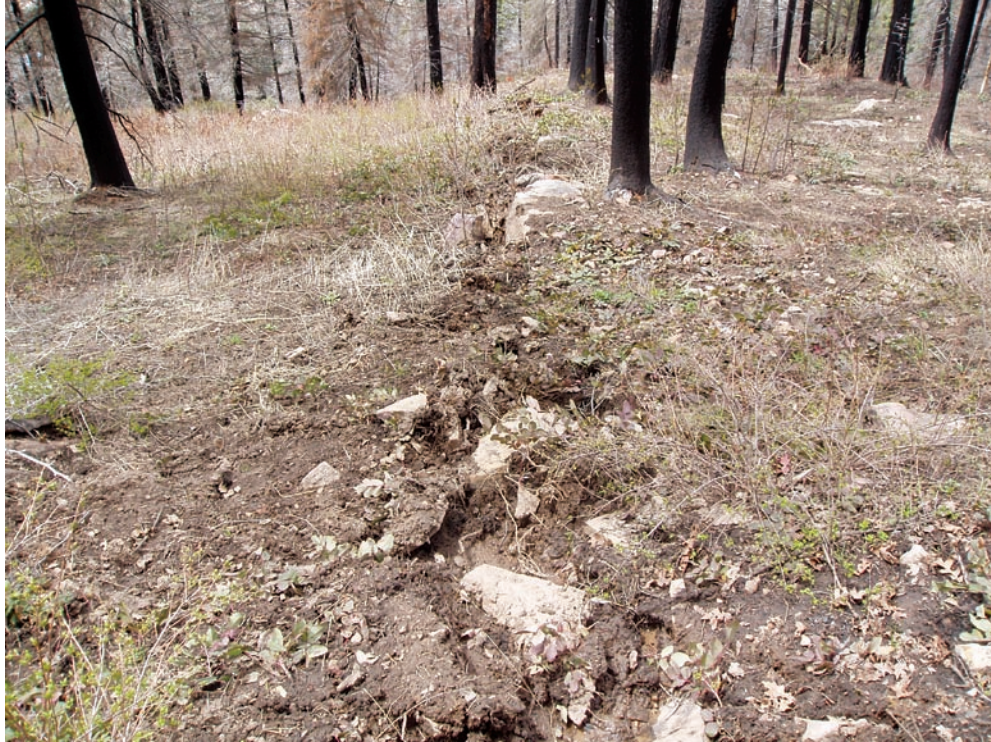
**Figure 9.** Lateral shear zone along the margin of a translational landslide that was active during spring 2005 within the Florida River landslide complex. Landslide is on the right side of the ground fracture. Trees along shear zone are about 0.3 m in diameter.

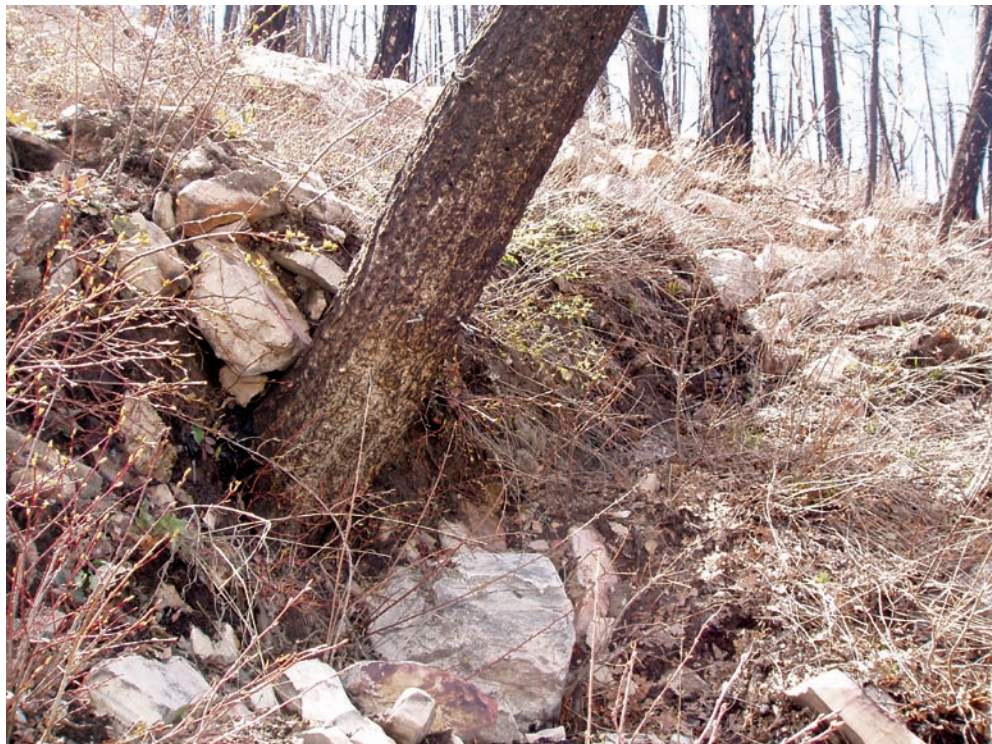
**Figure 10.** Toe of a translational landslide that was active during spring 2005 within the Florida River landslide complex. The toe is thrusting over the leaning tree that is about 0.4 m in diameter.

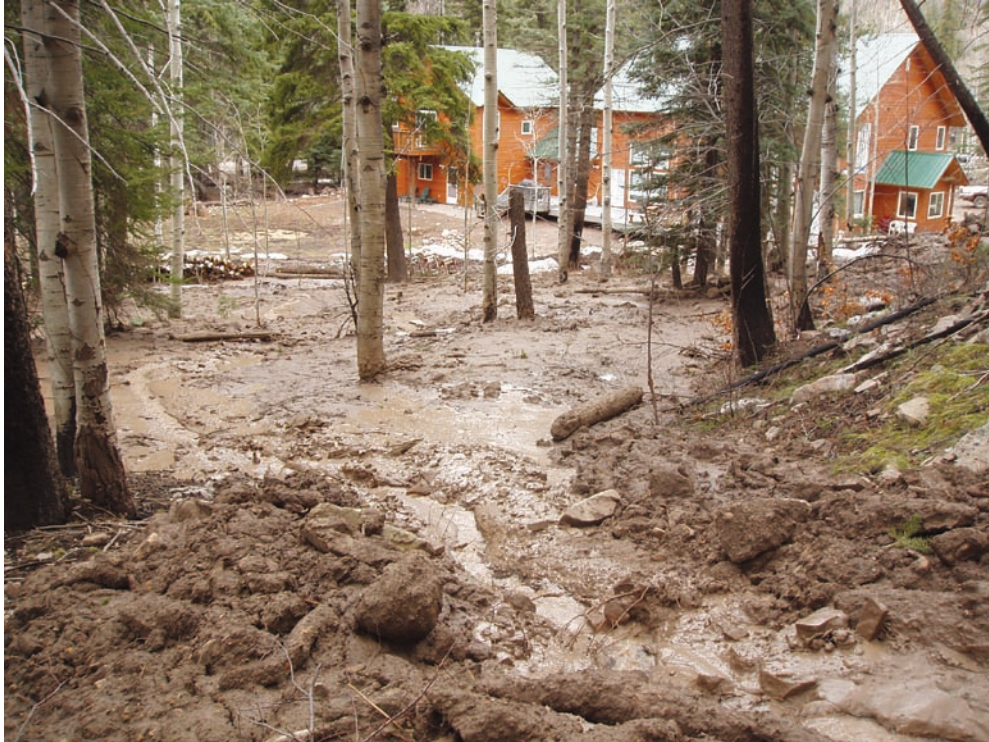
**Figure 11.** Deposit of a debris flow mobilized from a shallow landslide that was active during spring 2005 within the Florida River landslide complex.

Given that shallow translational landslides within the landslide complex typically are located far from residential structures, utilities, CR-243, and the Florida River, their movement poses little risk. However, these landslides commonly partly or wholly mobilize into debris flows. At this site debris flows can injure or kill humans, damage or destroy residential structures, CR-243, and utilities (mainly those located above ground), and could deposit debris in the Florida River. Position on the slope of the debris-flow source and debris-flow volume largely control the travel distance and velocity of debris flows, with larger debris flows on steeper slopes being more prone to travel farther at greater velocity. It appears likely that significant (above-average) snowmelt and rainfall events during the next two decades will trigger shallow landslides and debris flows within the landslide complex at a rate above that for unburned areas. These landslides and debris flows will probably be similar to those that occurred recently; however, only slightly larger debris flows than the recent flows could cause significant damage to residential structures and flow across CR-243 to the Florida River. The volumes of future individual debris flows will probably be less than about 5,000 m<sup>3</sup>.

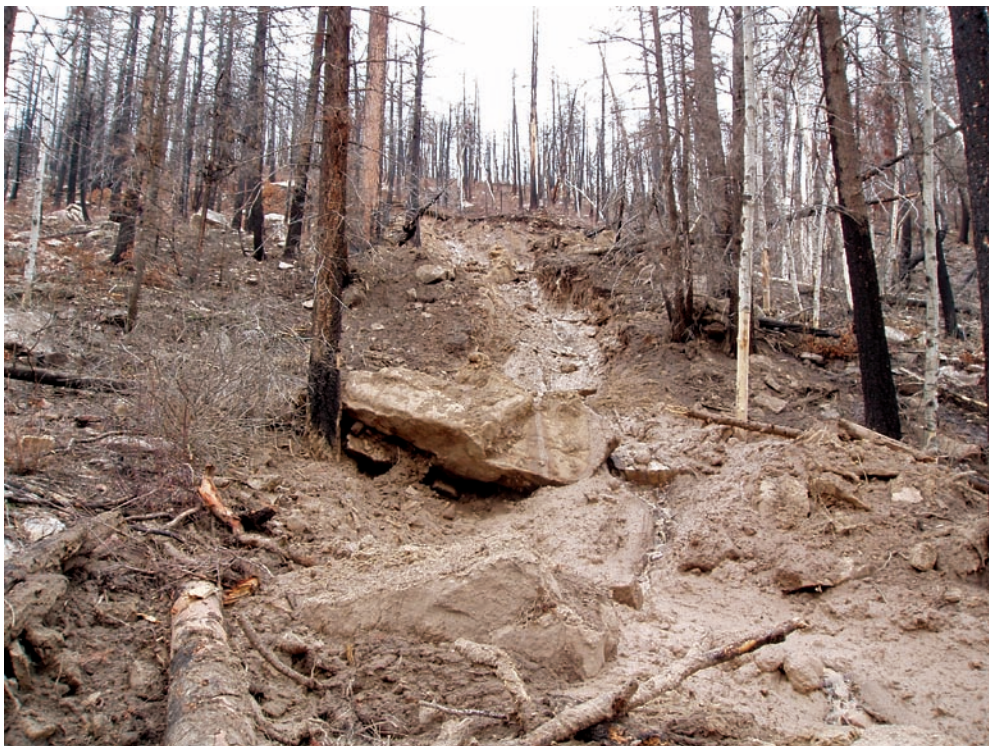
**Figure 12.** Source area, flow track, and part of a deposit of a debris flow mobilized from a shallow landslide that was active during spring 2005 within the Florida River landslide complex. Trees are 0.1-0.3 m in diameter.

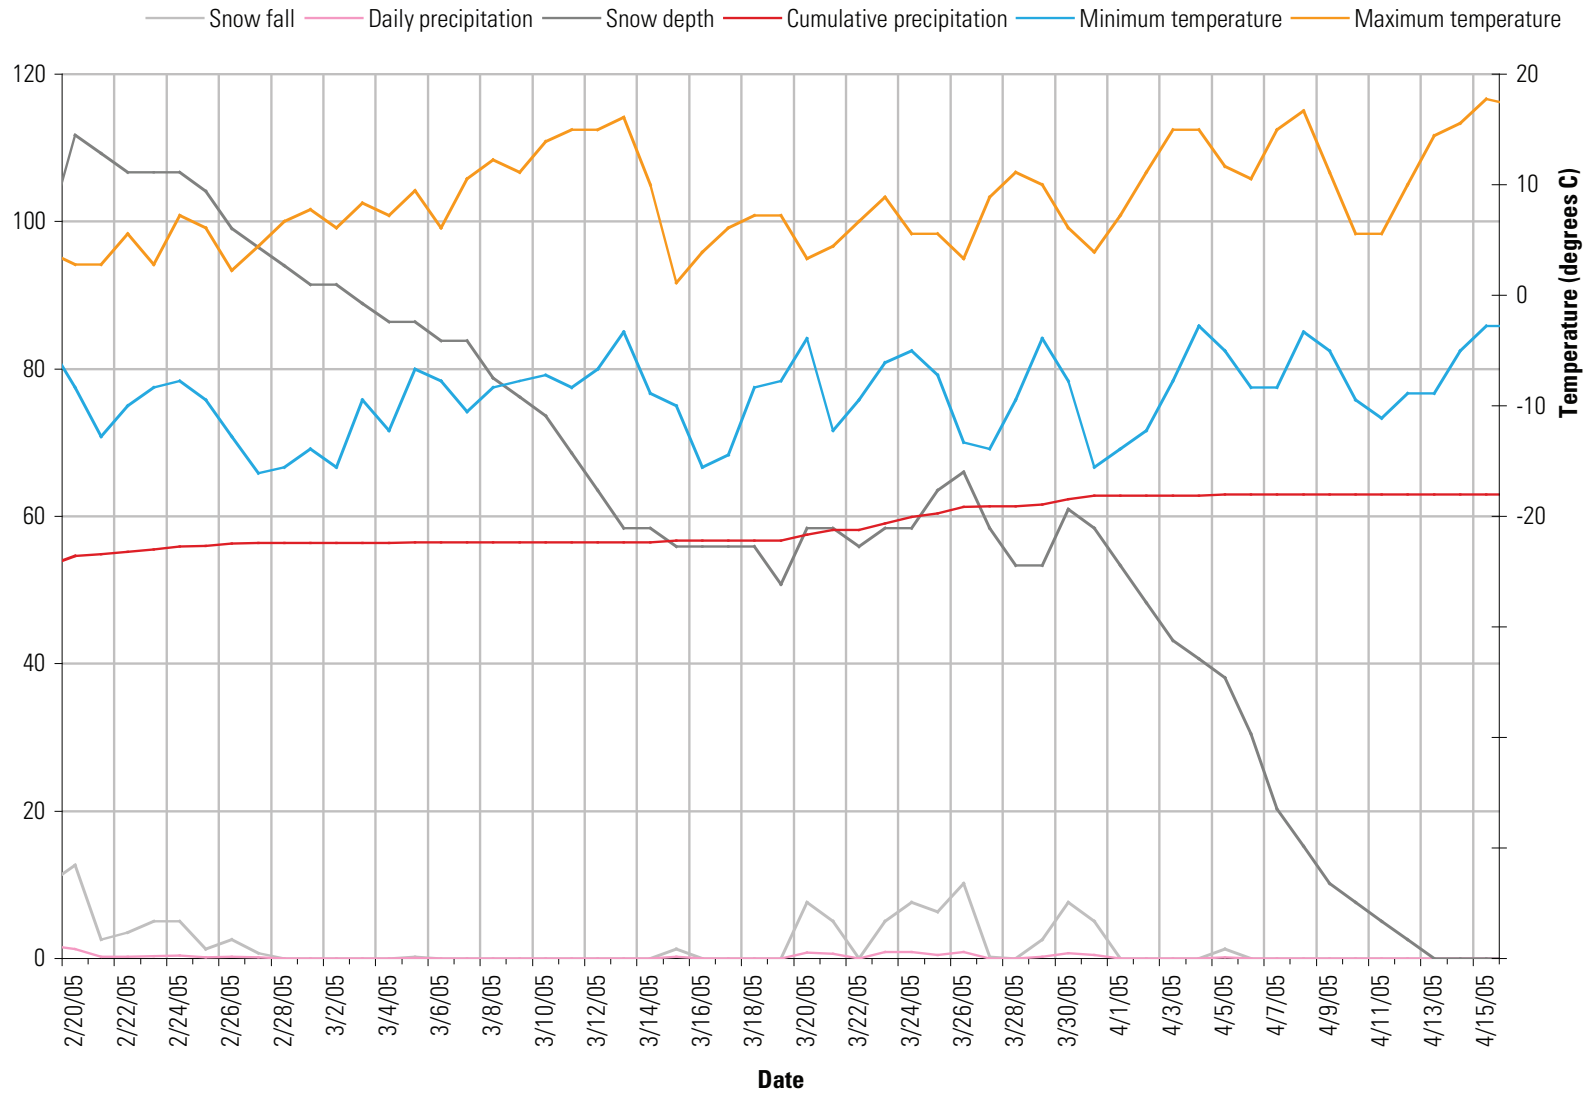
Figure 13. Climate data measured at Lemon Dam, February 20, 2005 – April 16, 2005.

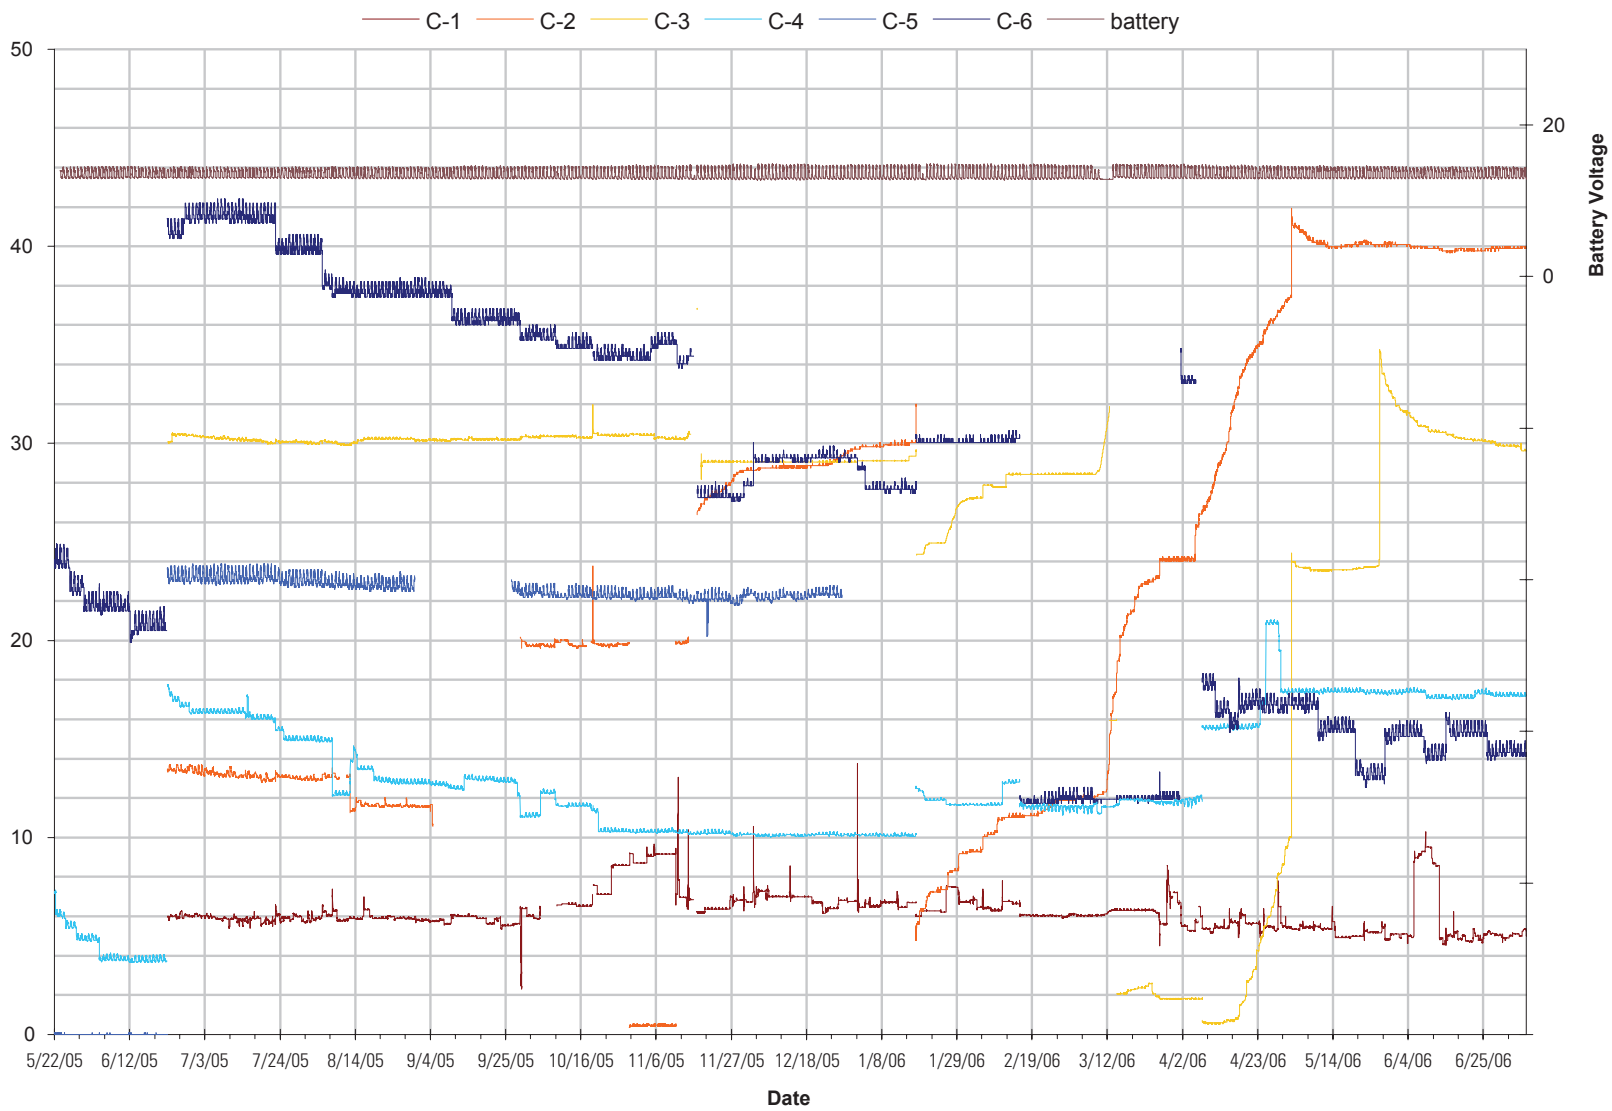
**Figure 14.** Extensometer (CET) data measured within the Florida River landslide complex, May 22, 2005 – July 7, 2006.

have stopped by the time our extensometers began obtaining reliable readings on June 22, 2005, and no landslide displacement has been detected by the extensometers as of July 14, 2006 (fig. 14). Apparent displacements suggested by extensometer reading changes shown on figure 14 are due to several factors. Extensometer reading fluctuations of a few centimeters or less are generally due to diurnal atmospheric fluctuation. Apparently instantaneous, large displacements suggested by the extensometers on figure 14 are either due to tree fall across extension cables and repair of such damage, or are false displacements due to long signal cable runs, rodent damage to signal cables, or atmospheric conditions. Gradual displacement measured by C-2 and C-3 during fall 2005 and winter 2005/06 was apparently due to formation of ice around extension cables that were encased within flexible metal conduit.

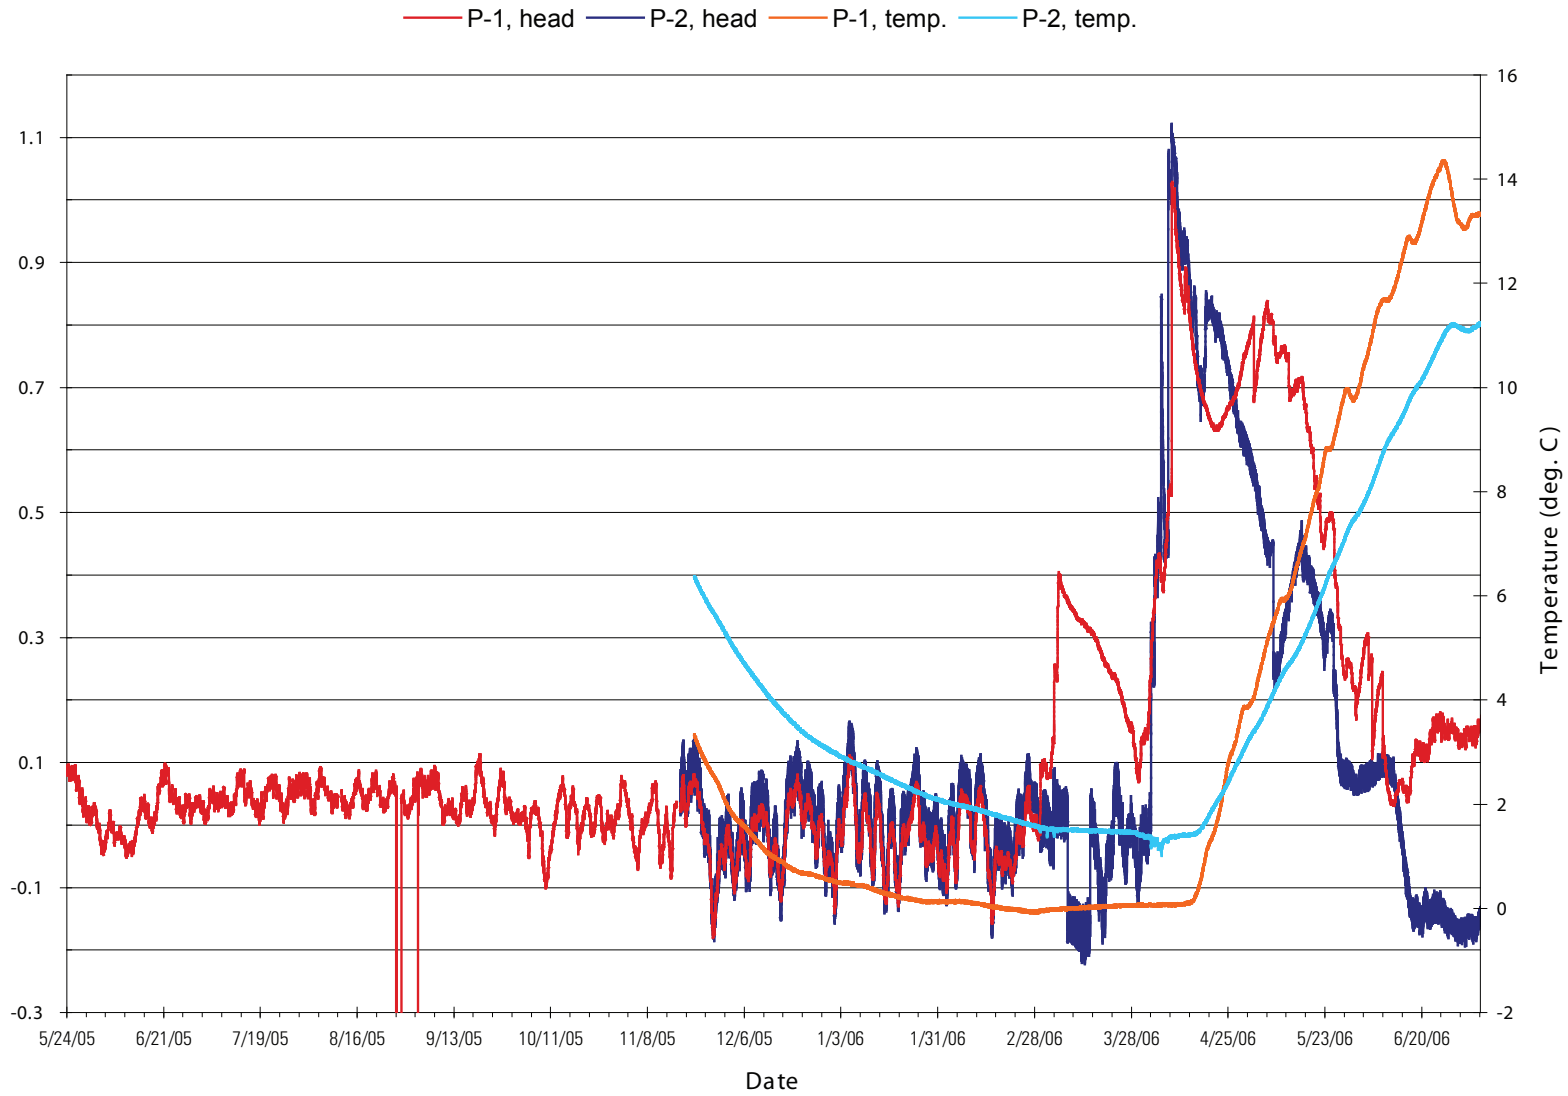
Figure 15. Piezometer data measured within the Florida River landslide complex, May 24, 2005 – July 7, 2006.

Ground-water conditions detected by our piezometers within the easternmost active landslide are shown on figure 15. The pressure head results shown on the figure have been modified from instrument output to account for instrument elevation and temperature. Expressed as pressure head and considering the installation method of the piezometers, the pressure head results (fig. 15) are approximately equivalent to the saturated thickness of the colluvium at the piezometer locations. The piezometers indicated an absence of ground water within colluvium until March 6, 2006. The head fluctuation, generally from -0.1 to 0.1 prior to March 2006, appears to correlate with atmospheric pressure fluctuations measured at

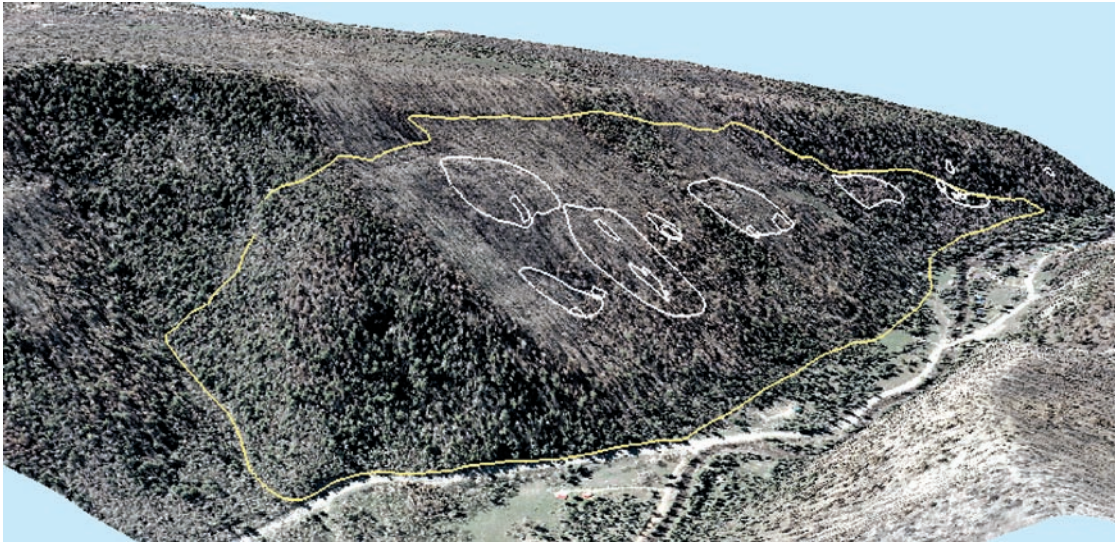
**Figure 16.** Virtual view to the southeast of the Florida River landslide complex. The older bedrock landslide is outlined in yellow and shallow landslides active during spring 2005 are outlined in white. View was created using a GIS by draping an orthophotograph and digital line graphs of mapped landslide boundaries onto the DEM.

section A-A' (pl. 1) and figures 16-17. The older landslide essentially has no left margin (when viewed in downslope direction) as the landslide head and toe meet at an acute angle. The right margin is difficult to identify beyond the landslide head, which is not uncommon in the absence of geologic exposures or recent ground displacement. The older landslide toe was generally mapped at the slope toe, except where a colluvial apron apparently formed following landslide movement. The approximate subsurface geometry of the older landslide was estimated from morphologic conditions and by constructing 18 geologic cross sections (for example, cross sections A-A' and B-B', pl. 1). The landslide covers an area of 490,000 m<sup>2</sup> and has an average thickness of 40 m. Much of the central part of the older landslide is on the order of 50-70 m thick. The volume of the older landslide is  $1.97 \times 10^7$  m<sup>3</sup>.
