# **Preliminary Assessment of Landslides Along the Florida River Downstream From Lemon Reservoir, La Plata County, Colorado**

Open-File Report 2006-1343

By William H. Schulz, Jeffrey A. Coe, William L. Ellis, and John D. Kibler

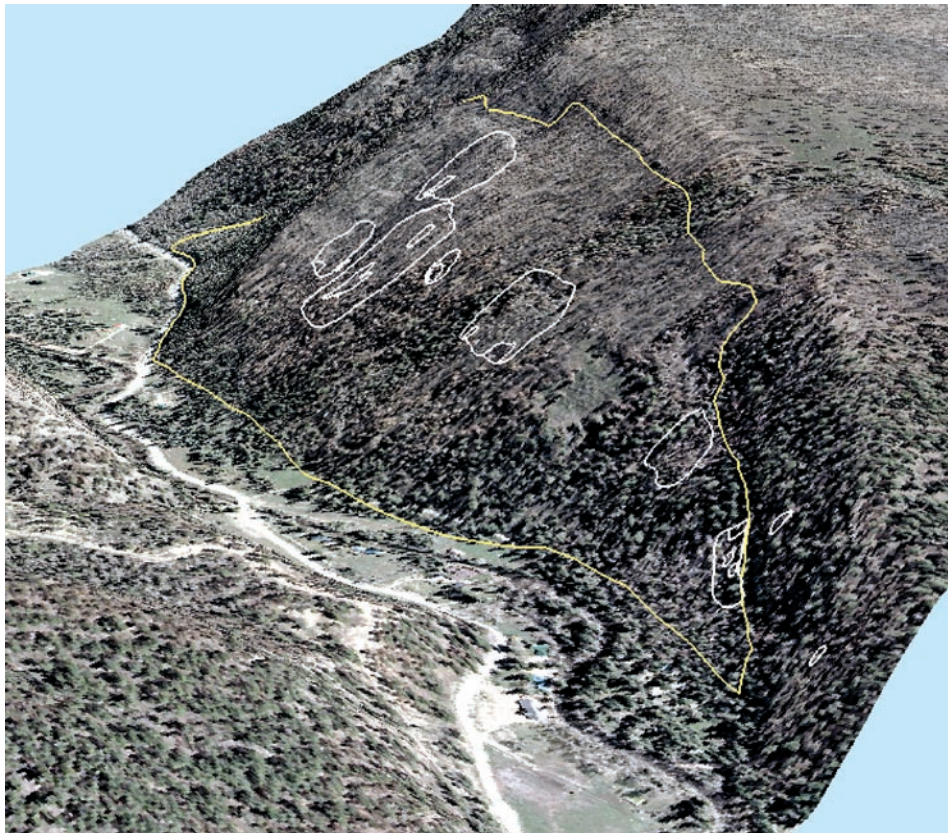
**Figure 17.** Virtual view to the northeast of the Florida River landslide complex. The older bedrock landslide is outlined in yellow and shallow landslides active during spring 2005 are outlined in white. View was created using a GIS by draping an orthophotograph and digital line graphs of mapped landslide boundaries onto the DEM.

section A-A' (pl. 1) and figures 16-17. The older landslide essentially has no left margin (when viewed in downslope direction) as the landslide head and toe meet at an acute angle. The right margin is difficult to identify beyond the landslide head, which is not uncommon in the absence of geologic exposures or recent ground displacement. The older landslide toe was generally mapped at the slope toe, except where a colluvial apron apparently formed following landslide movement. The approximate subsurface geometry of the older landslide was estimated from morphologic conditions and by constructing 18 geologic cross sections (for example, cross sections A-A' and B-B', pl. 1). The landslide covers an area of 490,000 m<sup>2</sup> and has an average thickness of 40 m. Much of the central part of the older landslide is on the order of 50-70 m thick. The volume of the older landslide is  $1.97 \times 10^7$  m<sup>3</sup>.
