The Problem...

The Solution...

Important Consumer In-Home Service Repair Information

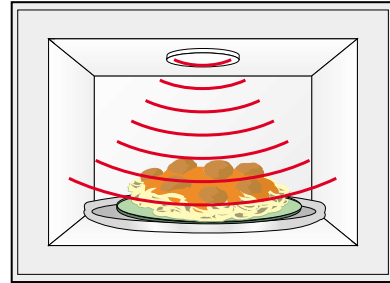
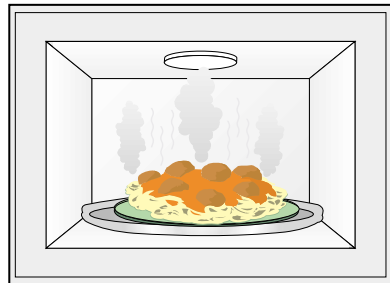
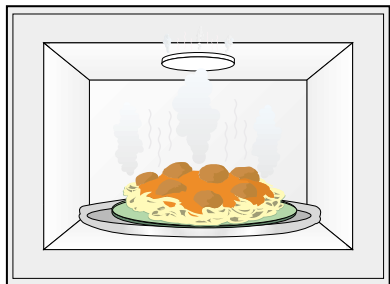
Microwave ovens use energy to warm and cook foods and beverages. The energy is delivered to the oven cavity through the wave-guide opening in the ceiling. The opening is covered by a disc, which allows the energy to pass through it to the food or beverage.

Many foods and beverages that are heated in microwave ovens release steam and oil vapor. In some cases, the steam and oil vapor pass through the disc mounted in the ceiling of the oven cavity and deposit on the edge of the wave-guide.

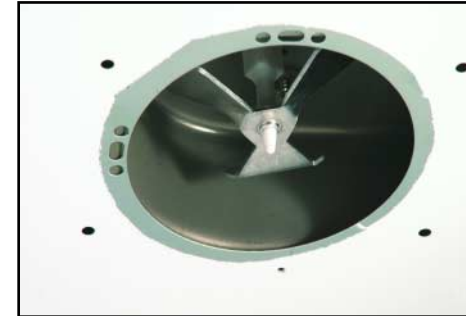
An accumulation of steam and oil vapors in and around the wave-guide opening can lead to overheating and fire, which could cause personal injury and property damage.

Whirlpool, working in close cooperation with the Consumer Product Safety Commission, has voluntarily recalled approximately 1.8 million microwave hood combinations (MHC) to repair this problem.
