DP-68 PERMANENT GROUND ANCHORS Volume 2 Field Demonstration Project Summaries

FHWA-DP-90-068-003
April 1990

REPORT NO. 1
REPORT OF FIELD PERFORMANCE
PERMANENT TIEBACK WALL

DEMONSTRATION SITE
I-75 - ATLANTA, GEORGIA

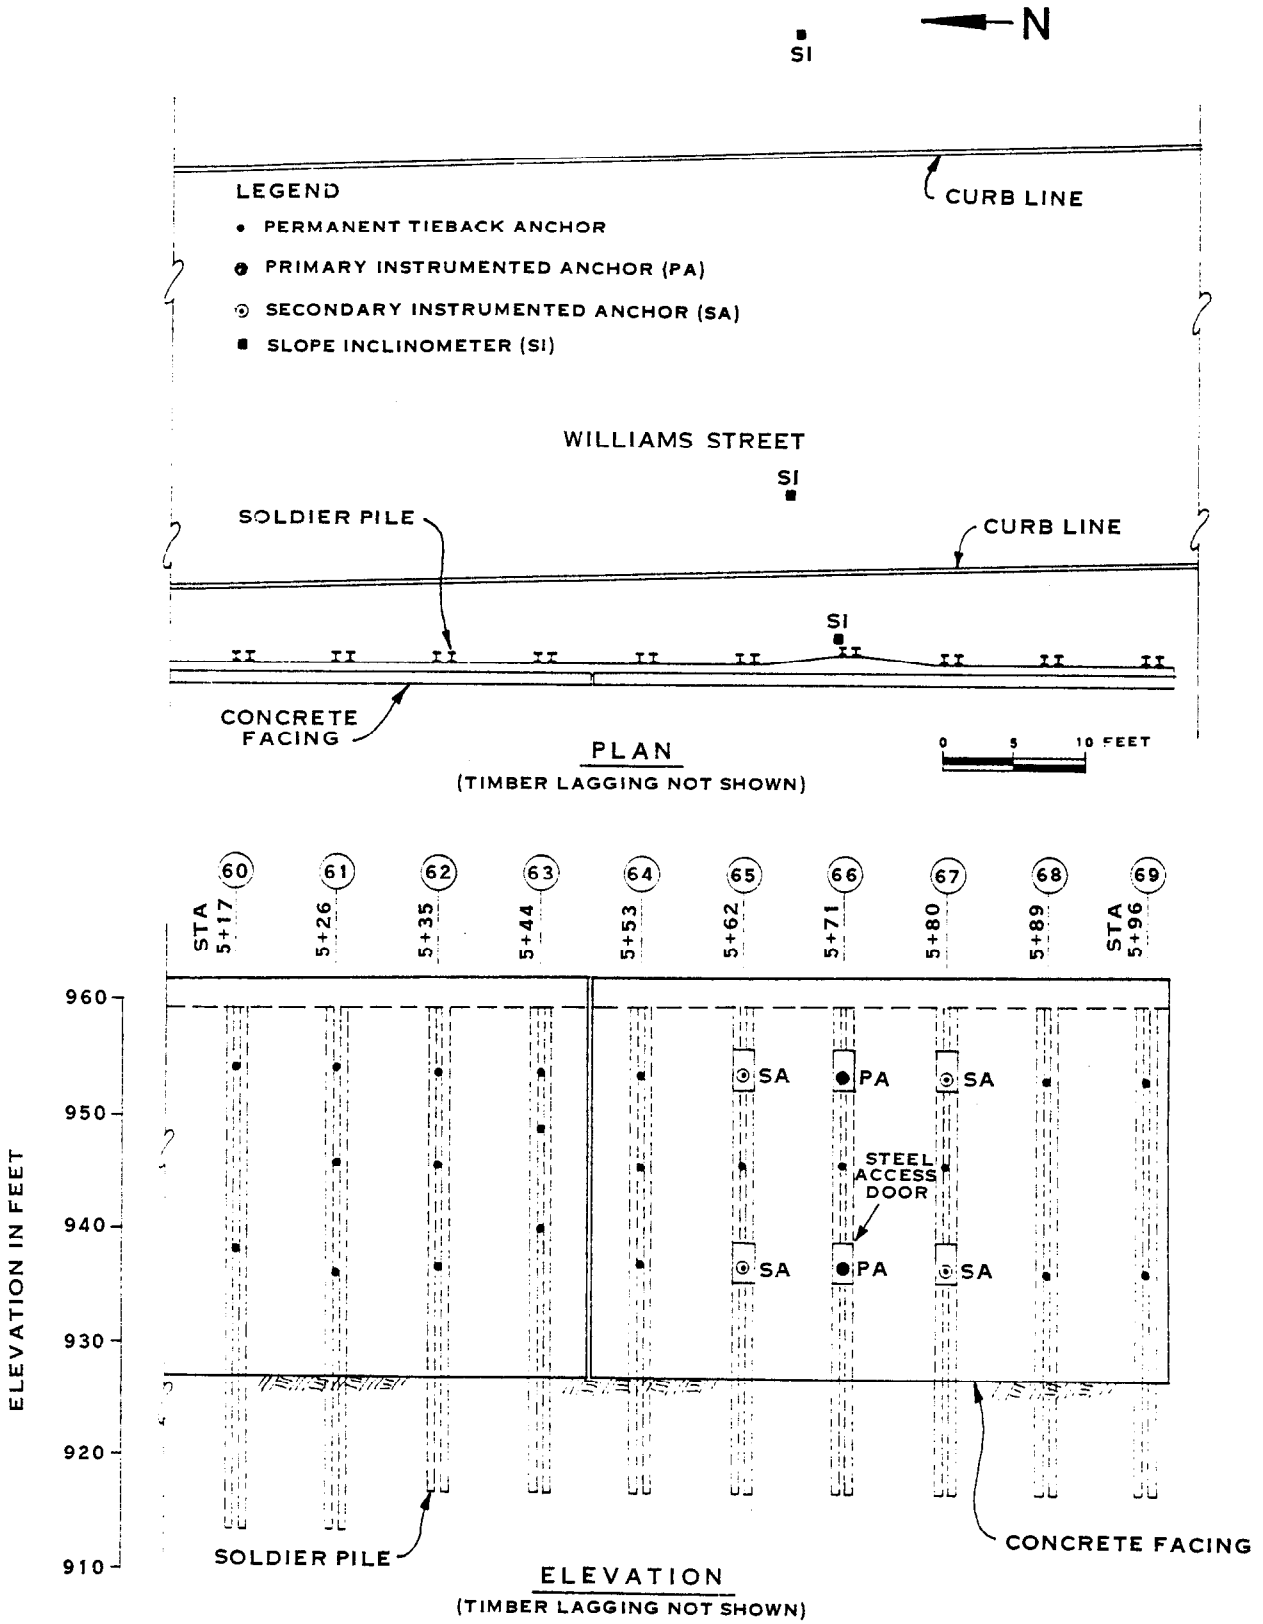
FIGURE 2 - PERMANENT TIEBACK WALL INSTRUMENTATION

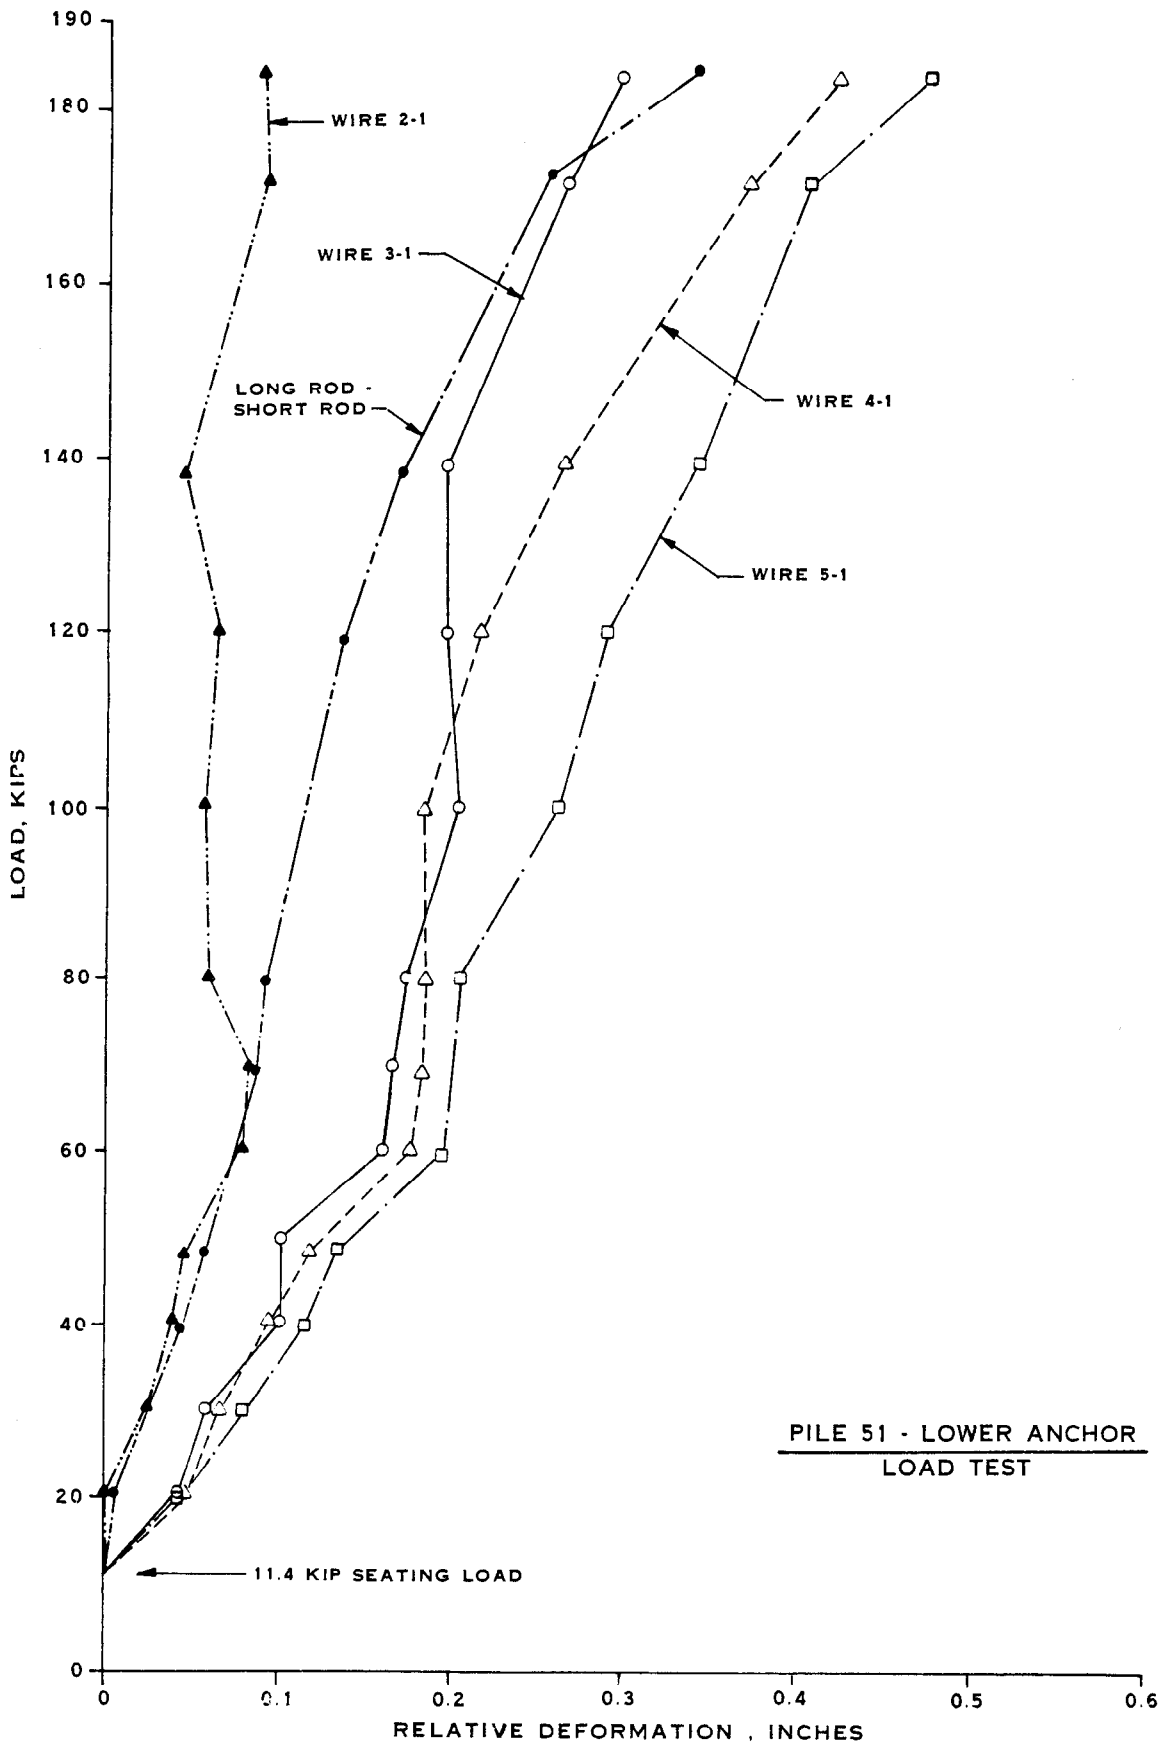
FIGURE 19 - RELATIVE DEFORMATION IN BOND ZONE - LOAD TEST

The amount of possible slippage of the wire #1 and short rod telltale anchors can be estimated by making the assumption that telltale anchor slippage is the only cause of difference between the apparently underestimated modulus values determined during the load test and the manufacturer's modulus. Thus, the difference between the elongation compatible with the manufacturer's modulus and the elongation measured by wire #1 (or the short rod) could approximately equal the amount of slippage. The amount of estimated slippage increases with increasing load and is approximately 0.3 inches at maximum loads. If the wire #1 and short rod readings are corrected for the estimated slippage, all the wire differences (2-1, 3-1, 4-1, 5-1, and the long rod-short rod) plotted on Figures 19 through 22 would be moved to the right with respect to the ordinate.

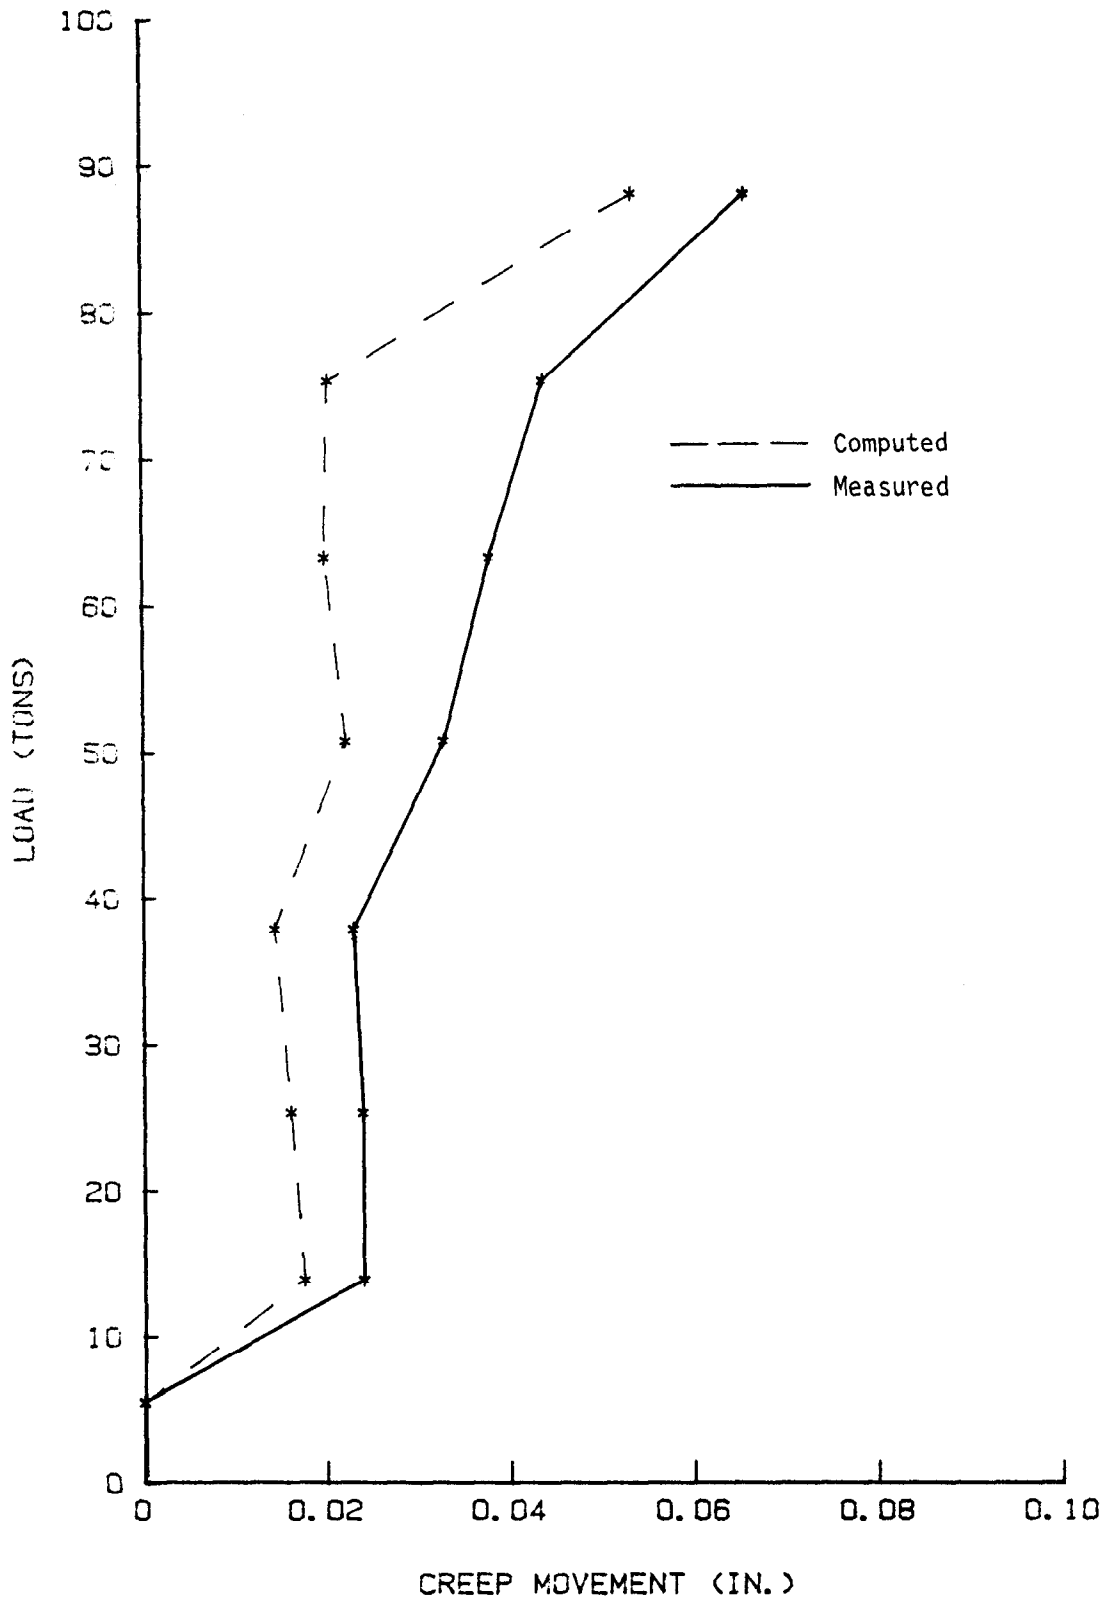
Figure 31. Measured Versus Computed Creep Movement of Tieback 18-2

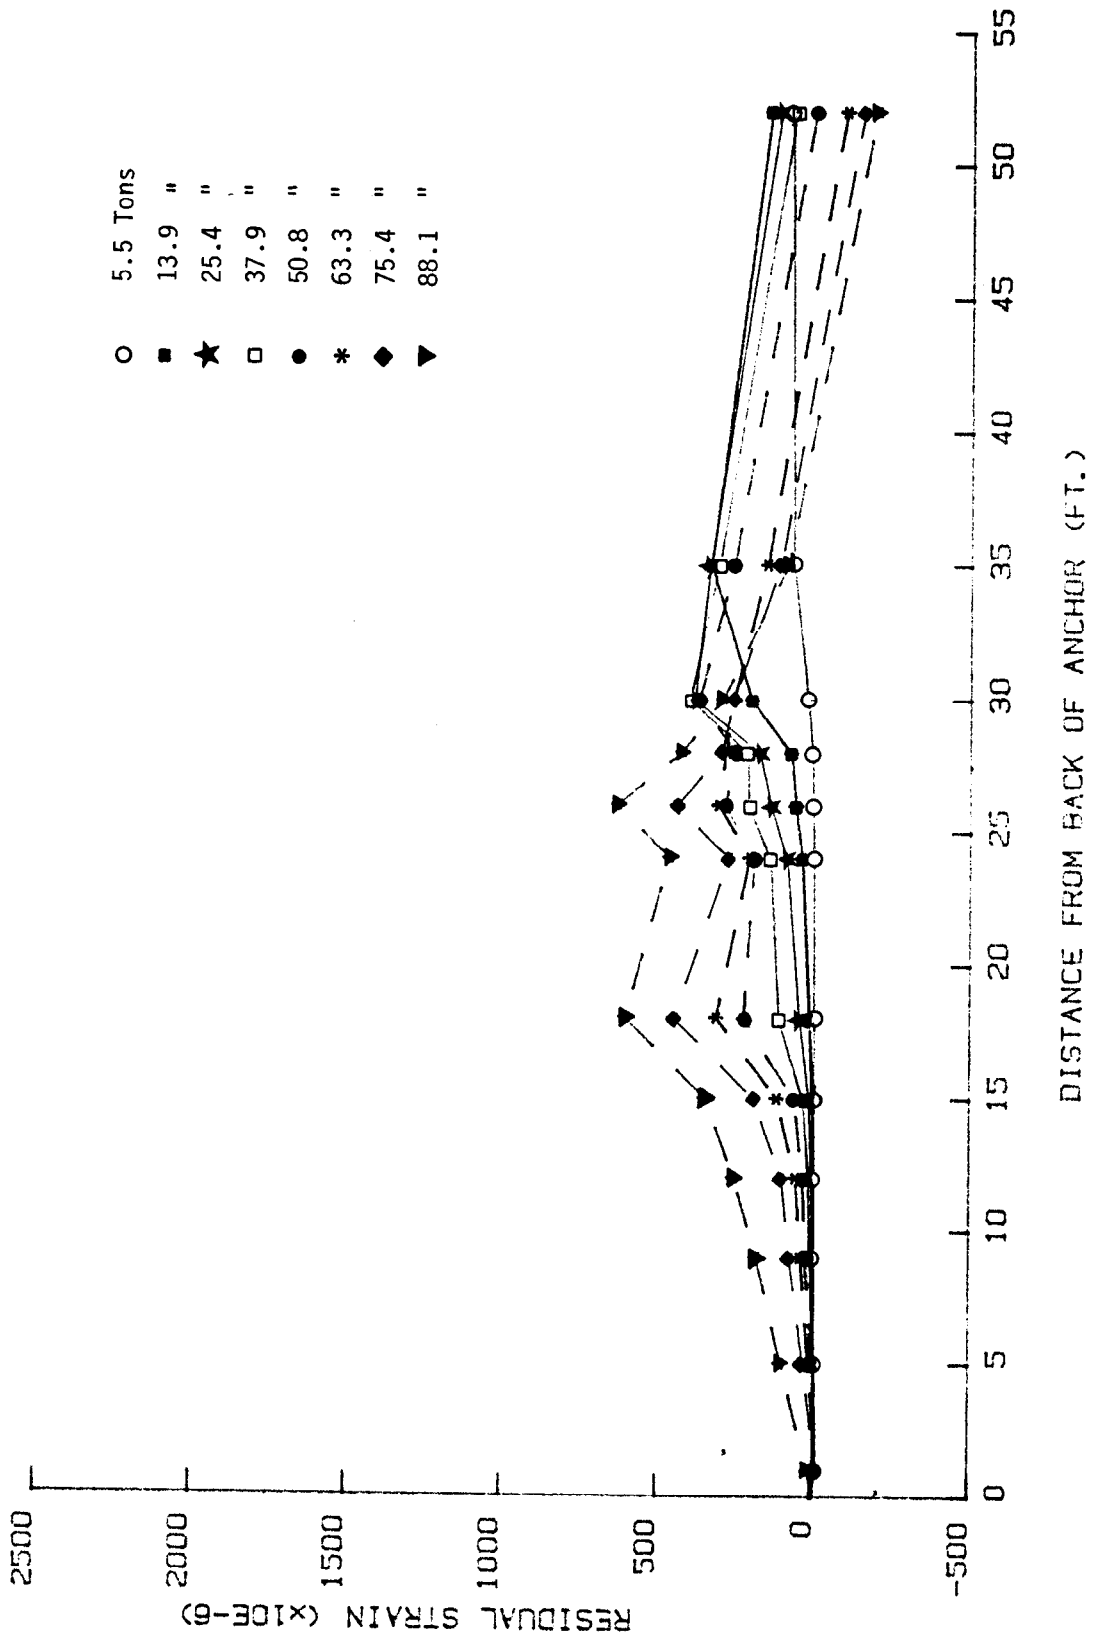
Figure 27. Distribution of Residual Strain in the Tendon of Tieback 18-2

Residual-strain distribution in the tendon is presented in Figure 27. In the unbonded length, residual strain decreased with increasing load, as was the case for tieback 15-8. The residual-strain distribution in the anchor length conformed to expected behavior. As the load increased, the residual strain in the tendon increased. The transition zone between the unbonded length and the anchor length was well-defined and occurred 28 to 30 feet from the back of the anchor. This indicates that the minimum unbonded length was provided.

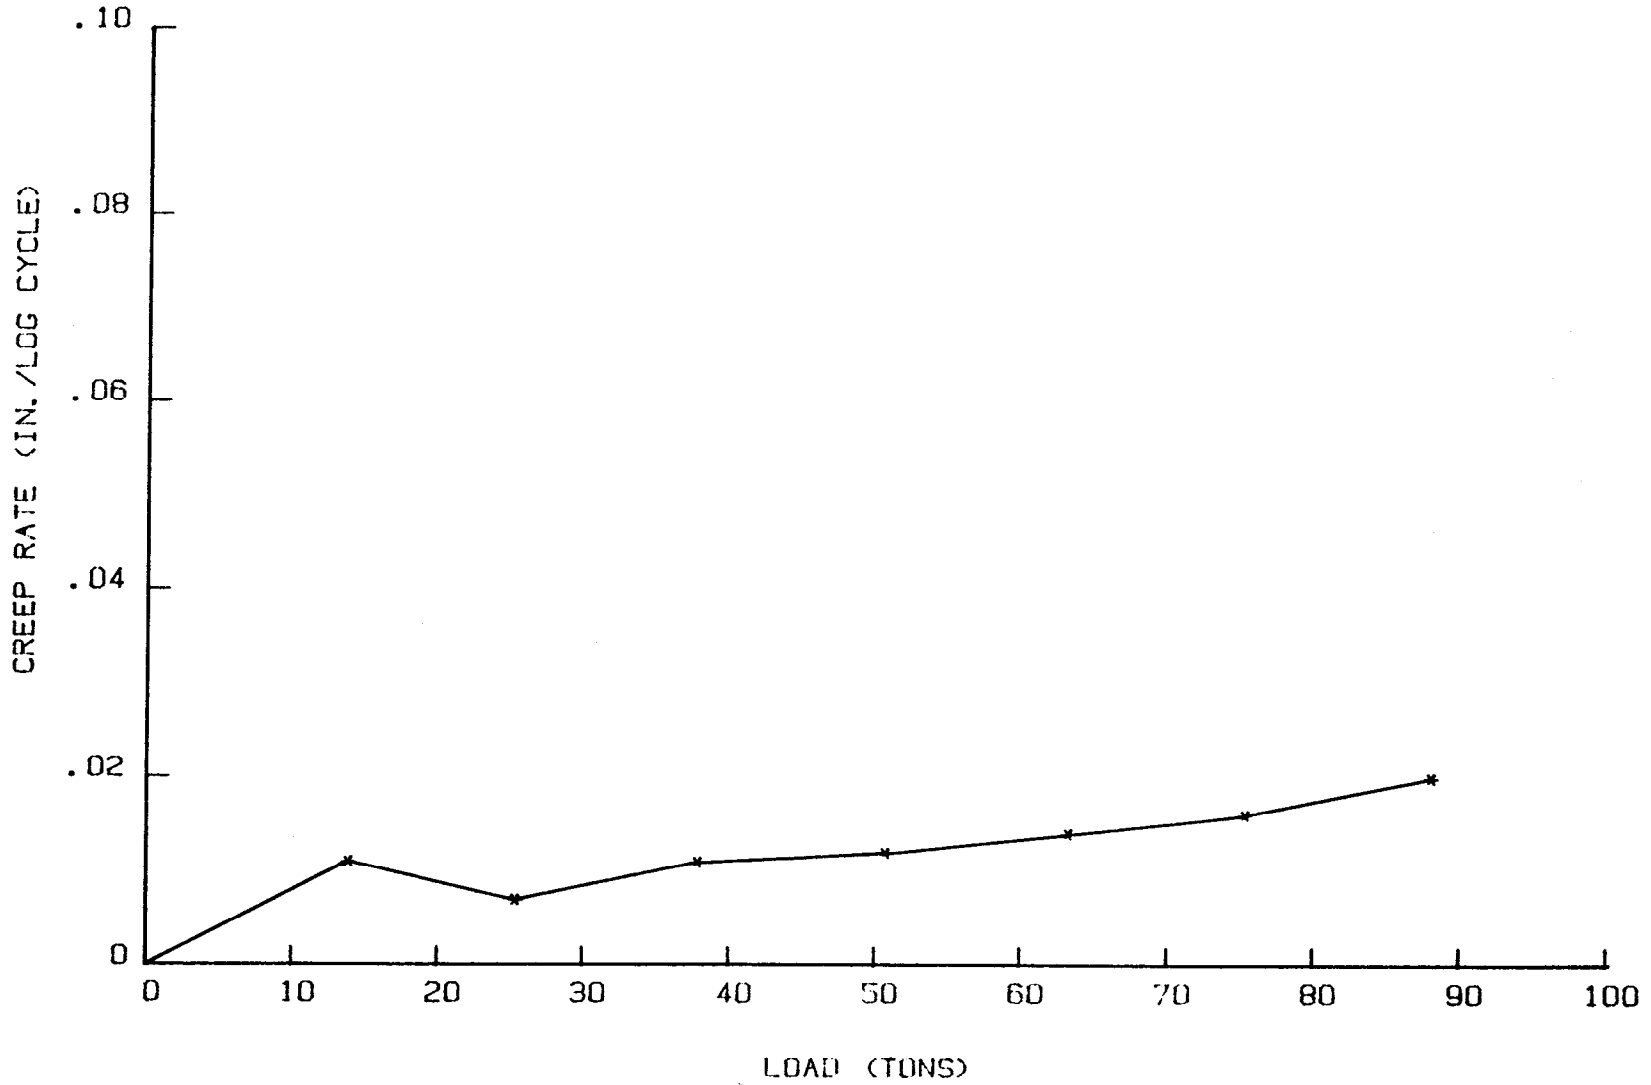
Figure 25. Creep Rate Versus Load for Tieback 18-2

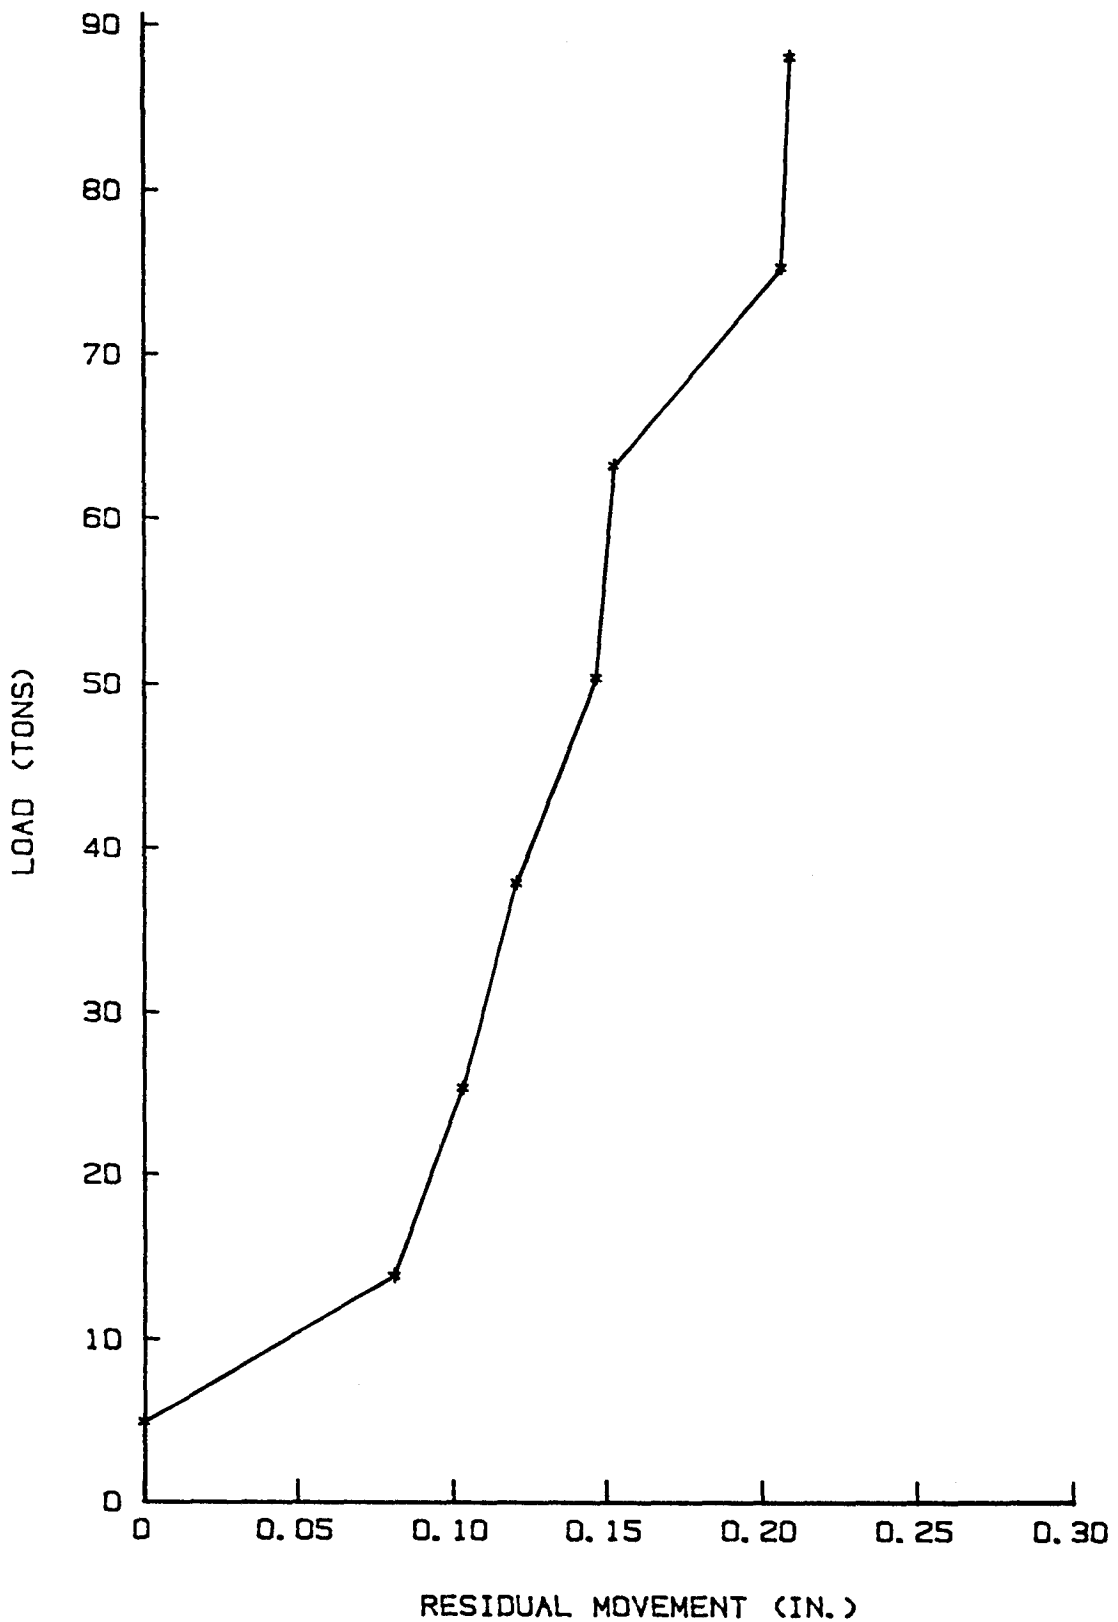
Figure 23. Residual Anchor Movement of Tieback 18-2

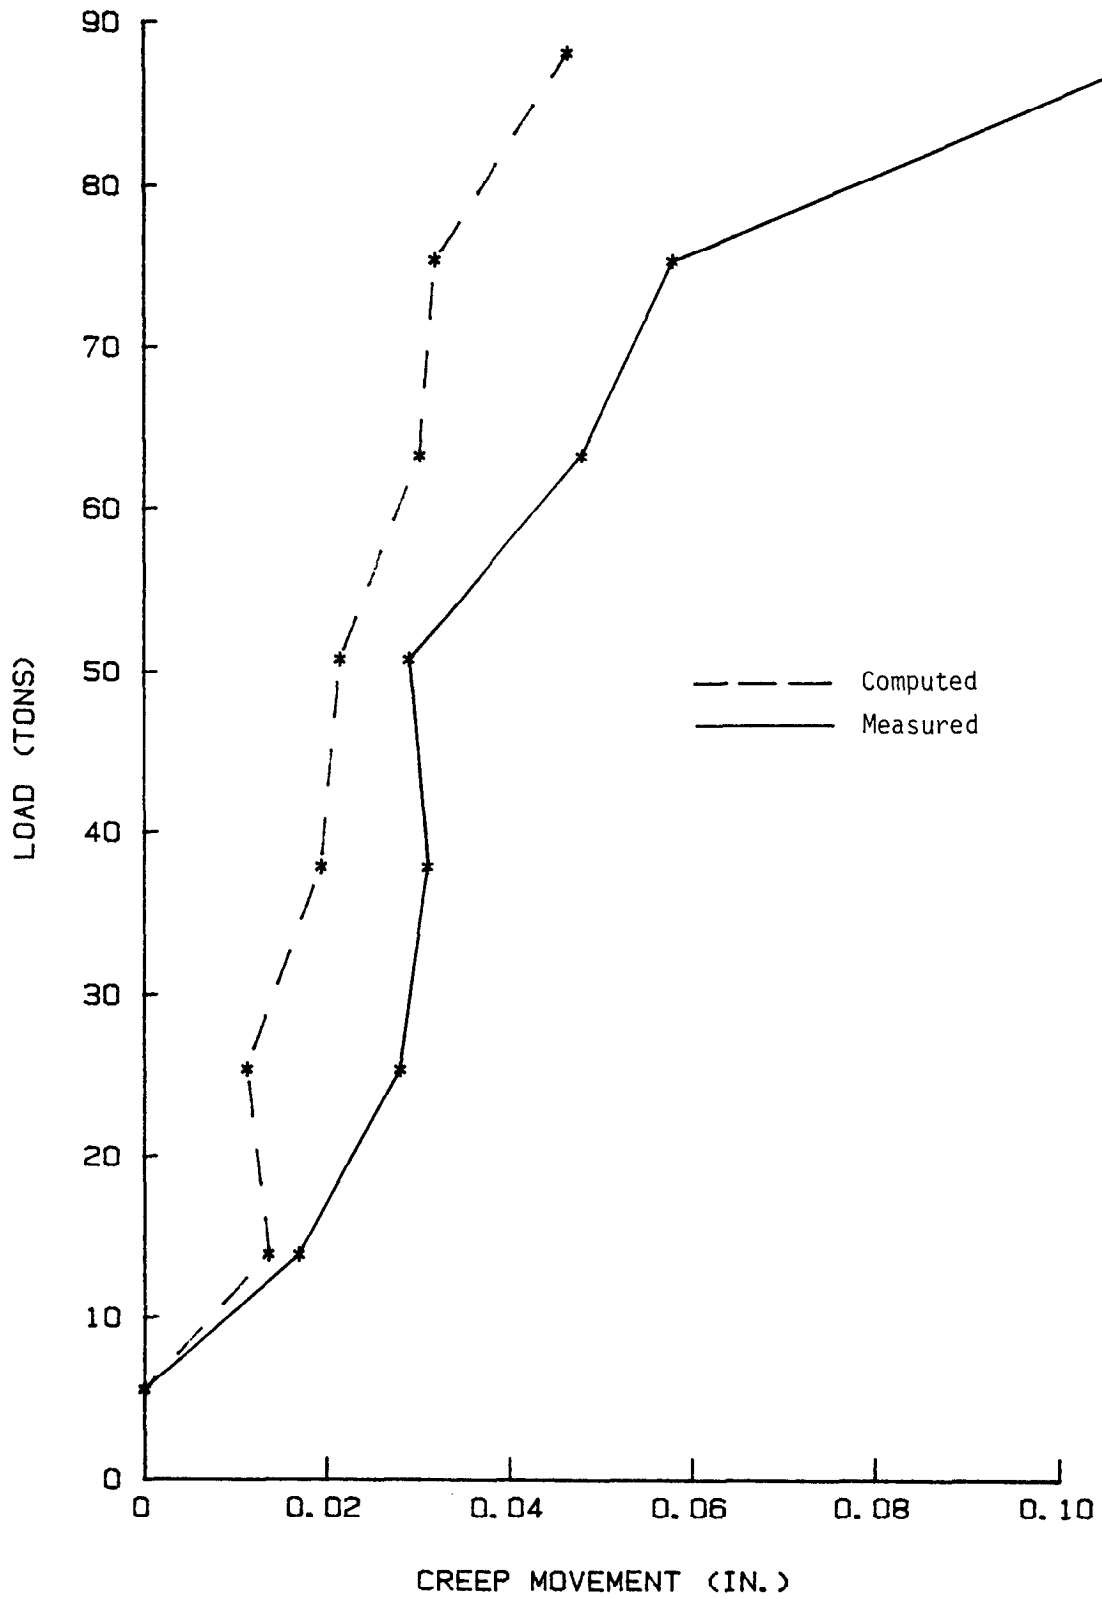
Figure 21. Measured Versus Computed Creep Movement of Tieback 15-8

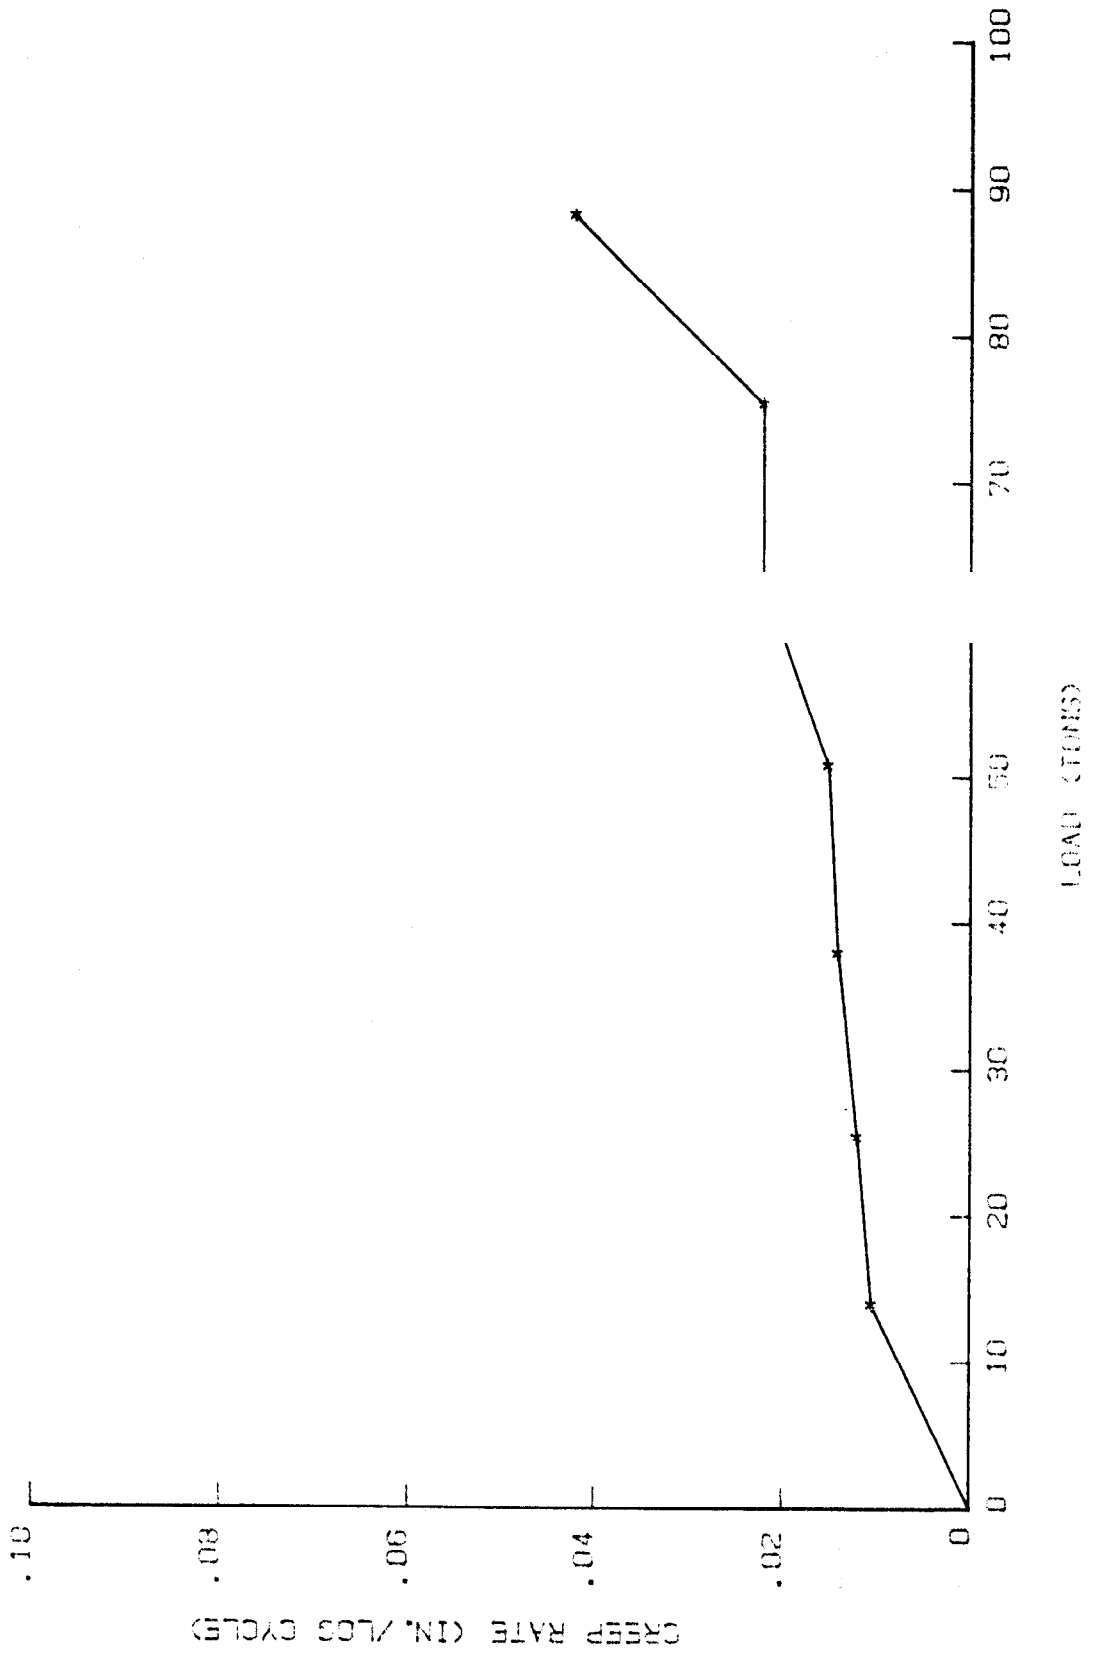
Figure 13. Creep Rate Versus Load for Tieback I5-8

The time-dependent response of tieback 15-8 is presented in Figures 12 and 13. At the maximum test load of 88.1 tons, the creep rate was essentially constant at .043 inches/logarithmic cycle in both the third logarithmic cycle (100 to 1,000 minutes) and the fourth logarithmic cycle (1,000 to 10,000 minutes). However, this creep rate was double the creep rate that occurred in the second logarithmic cycle (10 to 100 minutes). The change in creep rate from the second to the third logarithmic cycle has a plausible explanation. In jacking the load up to the final test load of 88.1 tons, the load was inadvertently maintained constant for a period of four minutes at a load of 86.4 tons. Once the error was discovered, the load was immediately jacked up to 88.1 tons and thereafter maintained constant. It is apparent that the creep movement of the tieback at 86.4 tons, and the effect of the previous loads, influenced the creep performance of the tieback at a load of 88.1 tons by reducing the amount of creep that occurred in the first two logarithmic cycles. The influence of load history on the time-dependent performance of tiebacks anchored in cohesive soils is been noted in other tests on instrumented and non-instrumented tiebacks.

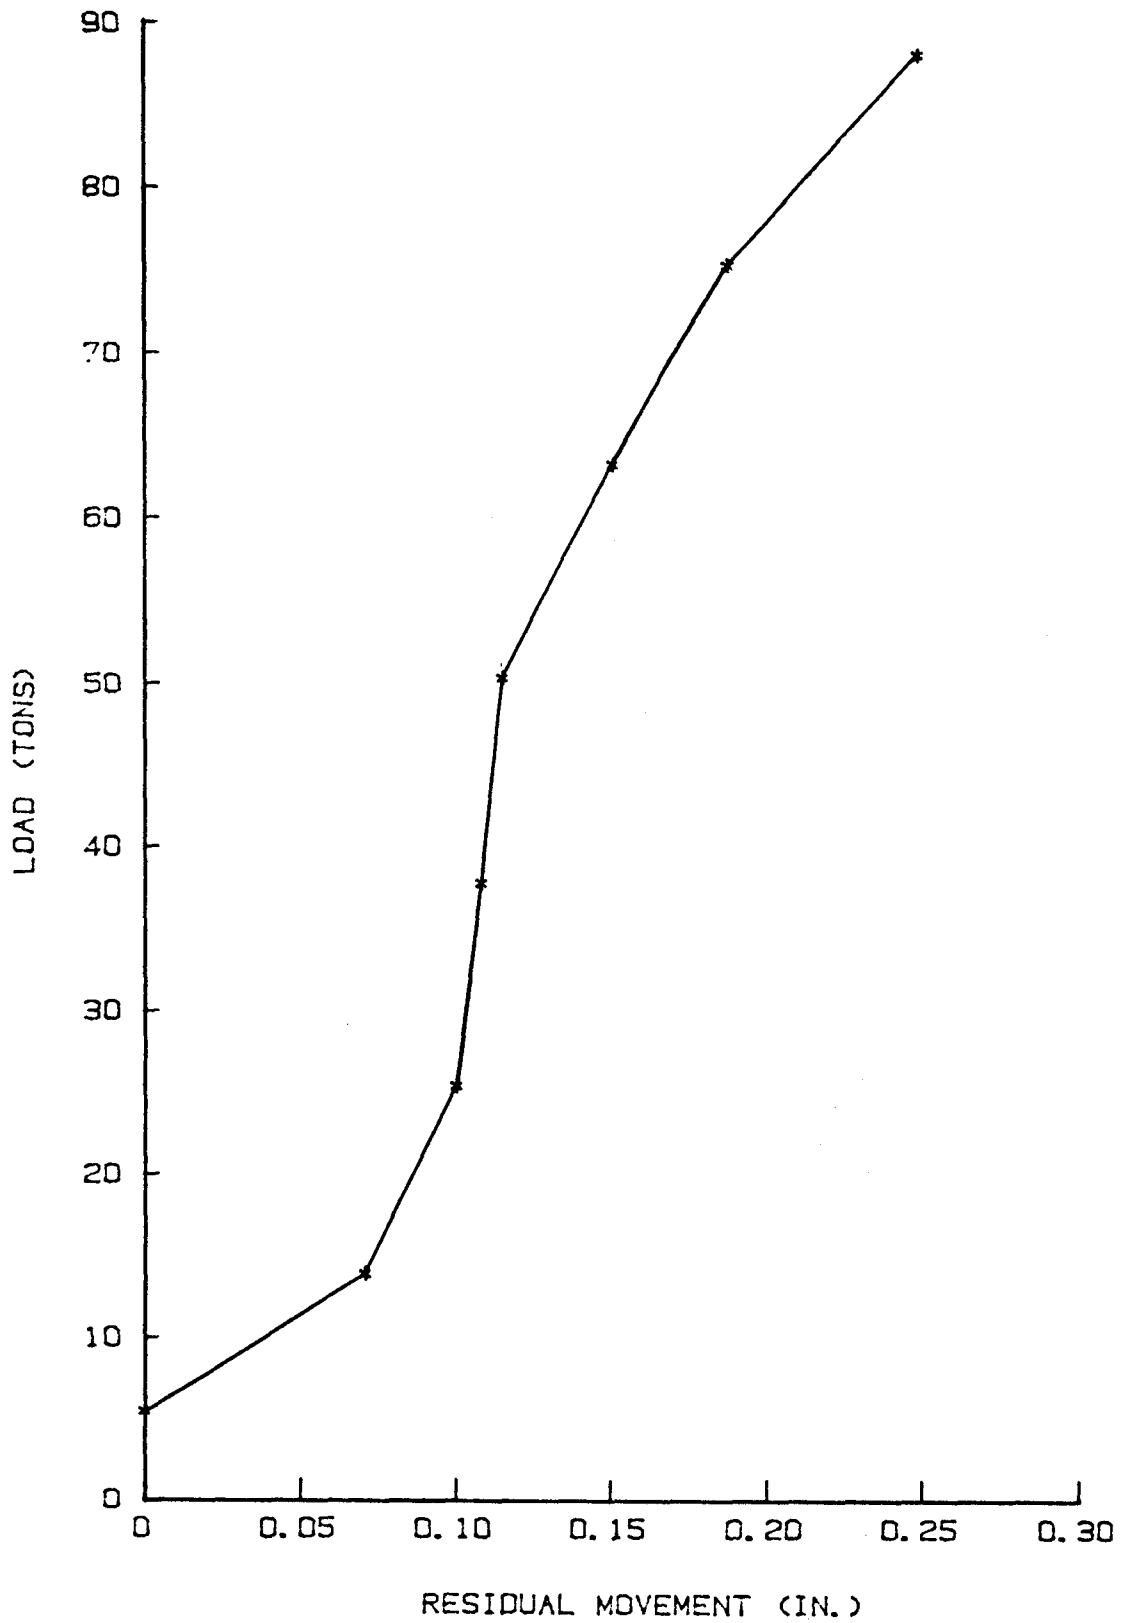
Figure 11. Residual Anchor Movement of Tieback 15-8

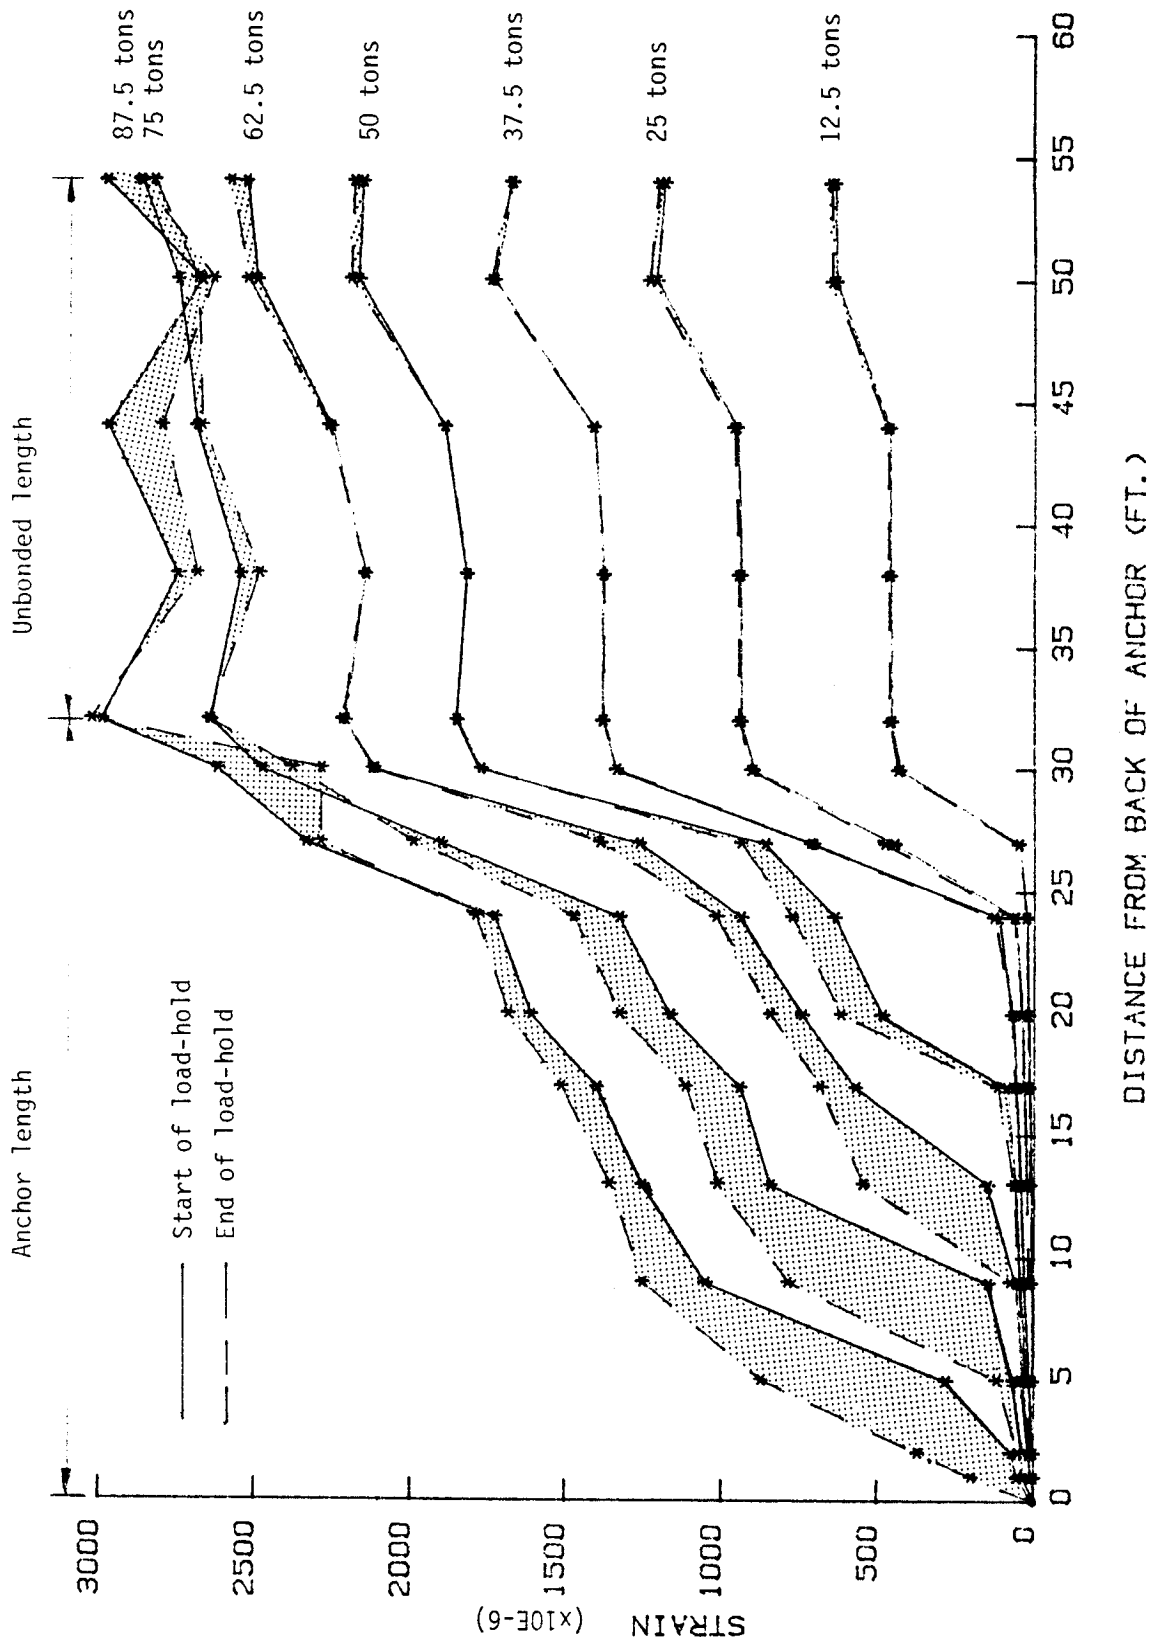
Figure 9. Distribution of Strain in the Tendon of a Straight-shafted Tieback Anchored in a Cohesive Soil

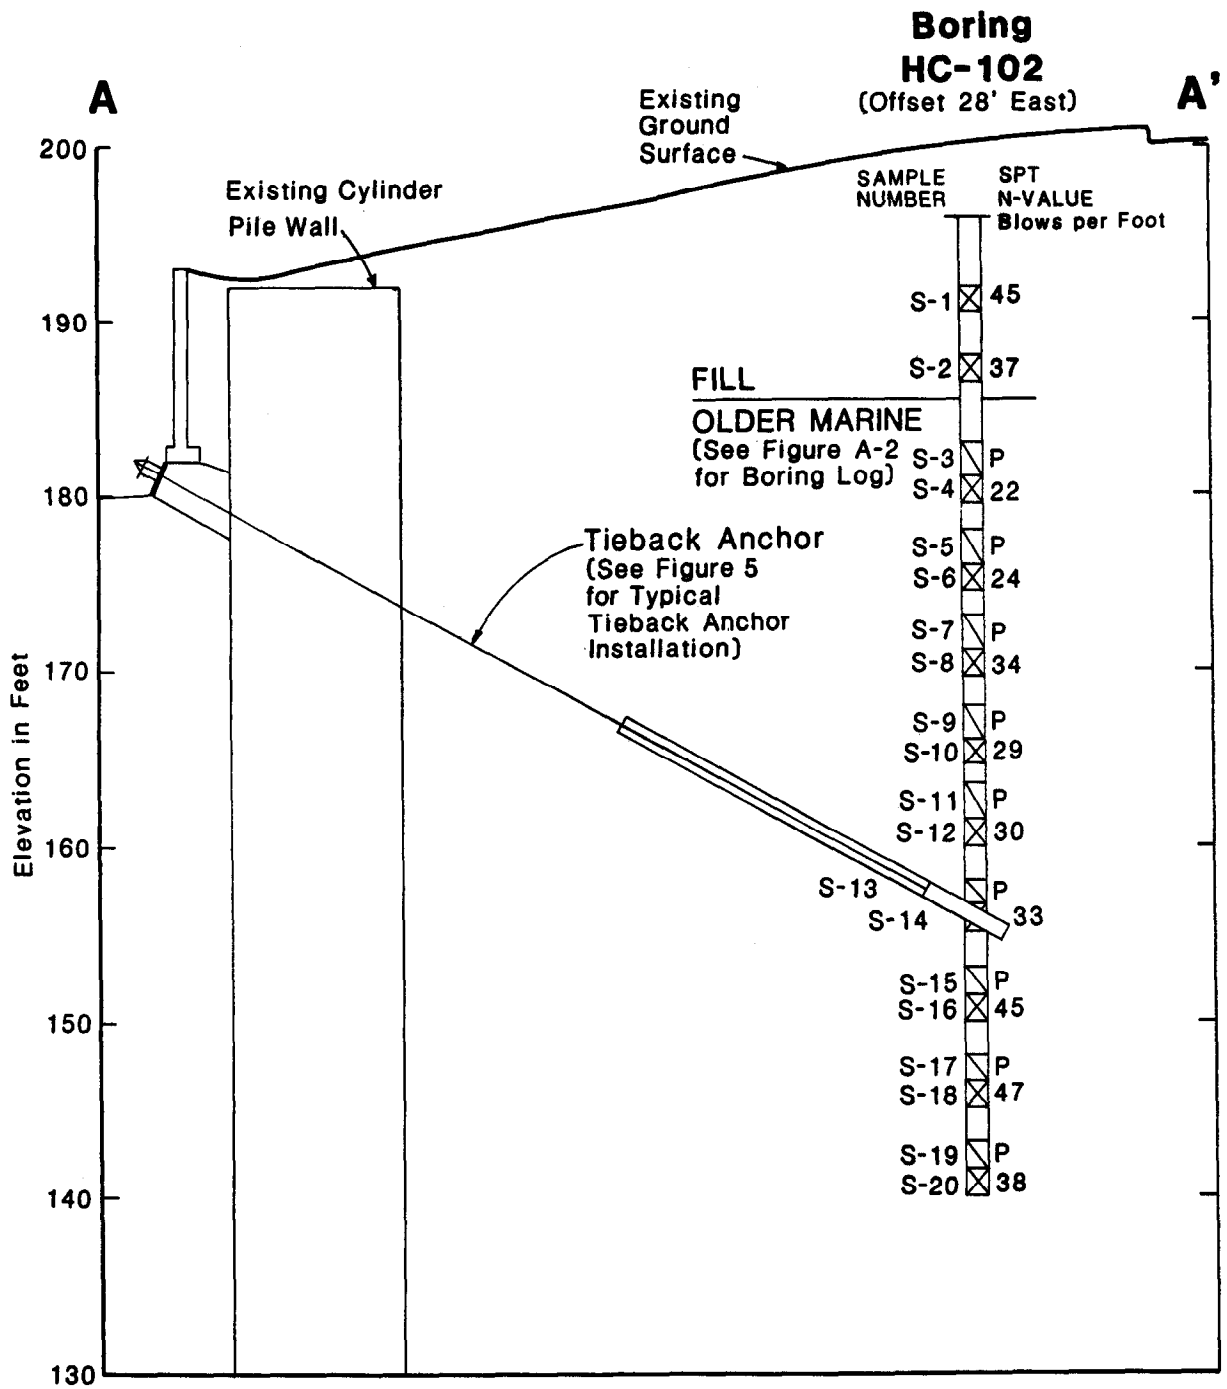
Generalized Subsurface Profile A-A'

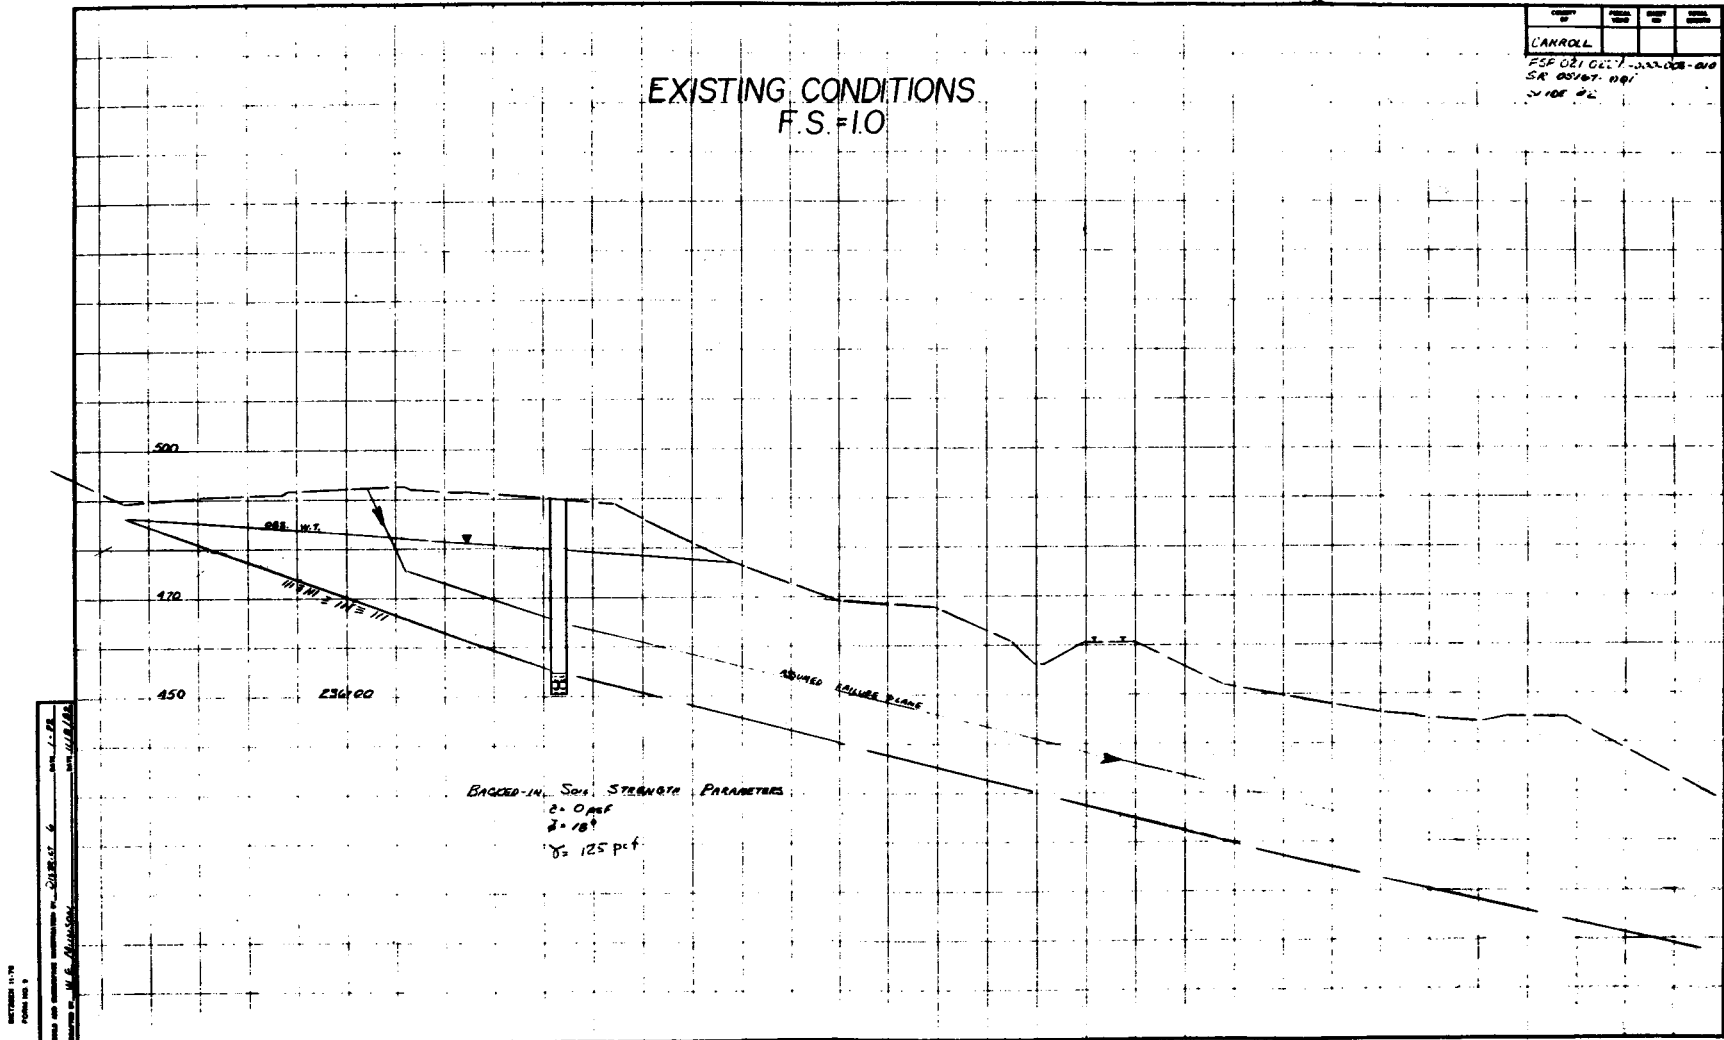
Figure 4. Cross Section Used for Stability Analysis Prior to Remedial Action.
