DP-68 PERMANENT GROUND ANCHORS Volume 2 Field Demonstration Project Summaries

FHWA-DP-90-068-003
April 1990

REPORT NO. 1
REPORT OF FIELD PERFORMANCE
PERMANENT TIEBACK WALL

DEMONSTRATION SITE
I-75 - ATLANTA, GEORGIA

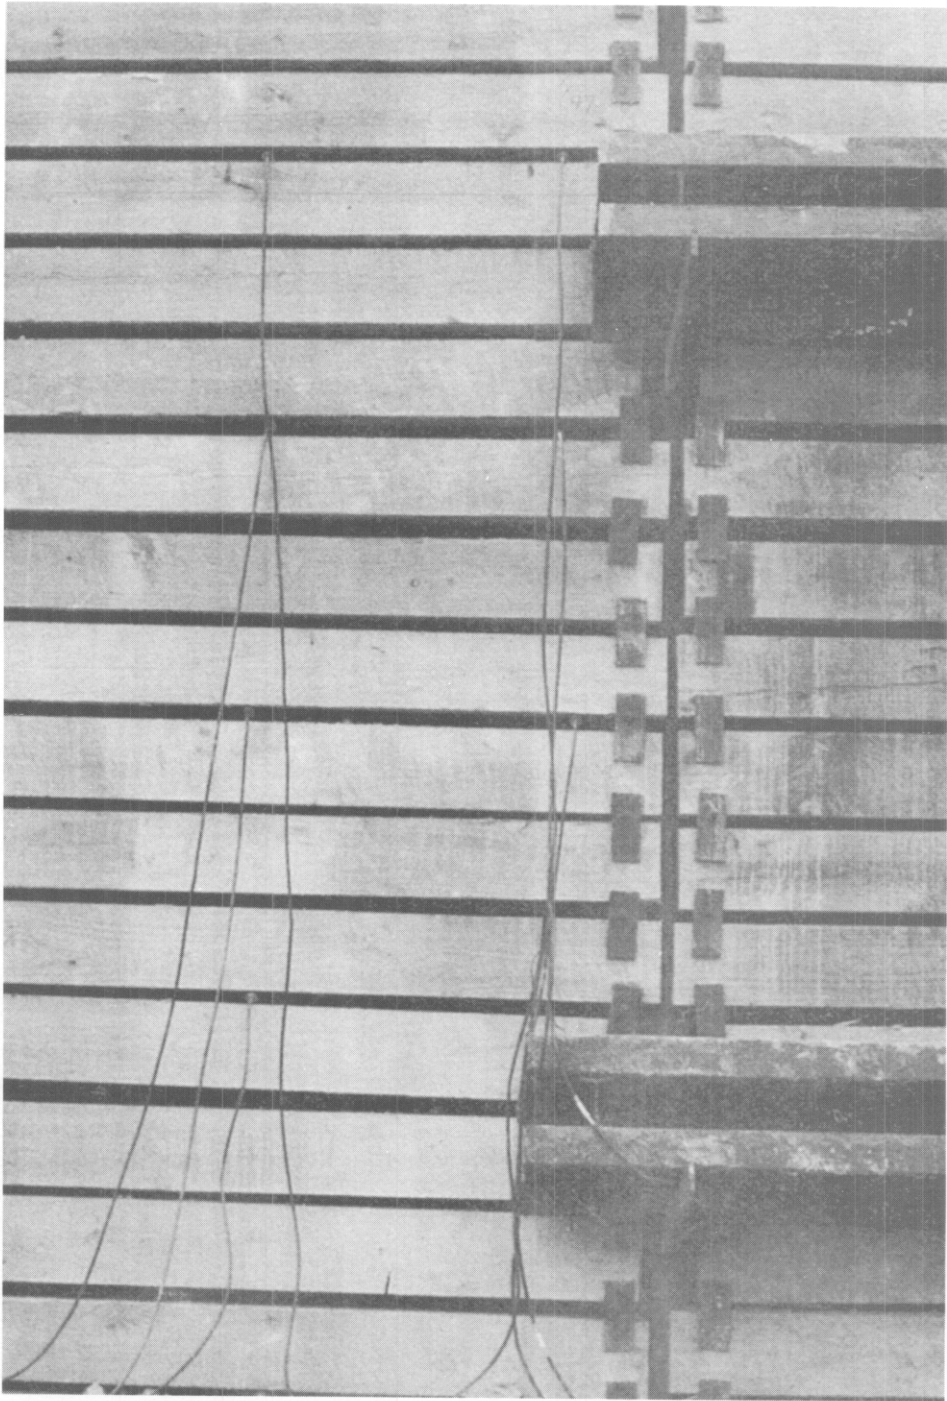
Figure 12. Typical Tieback Cross Section.

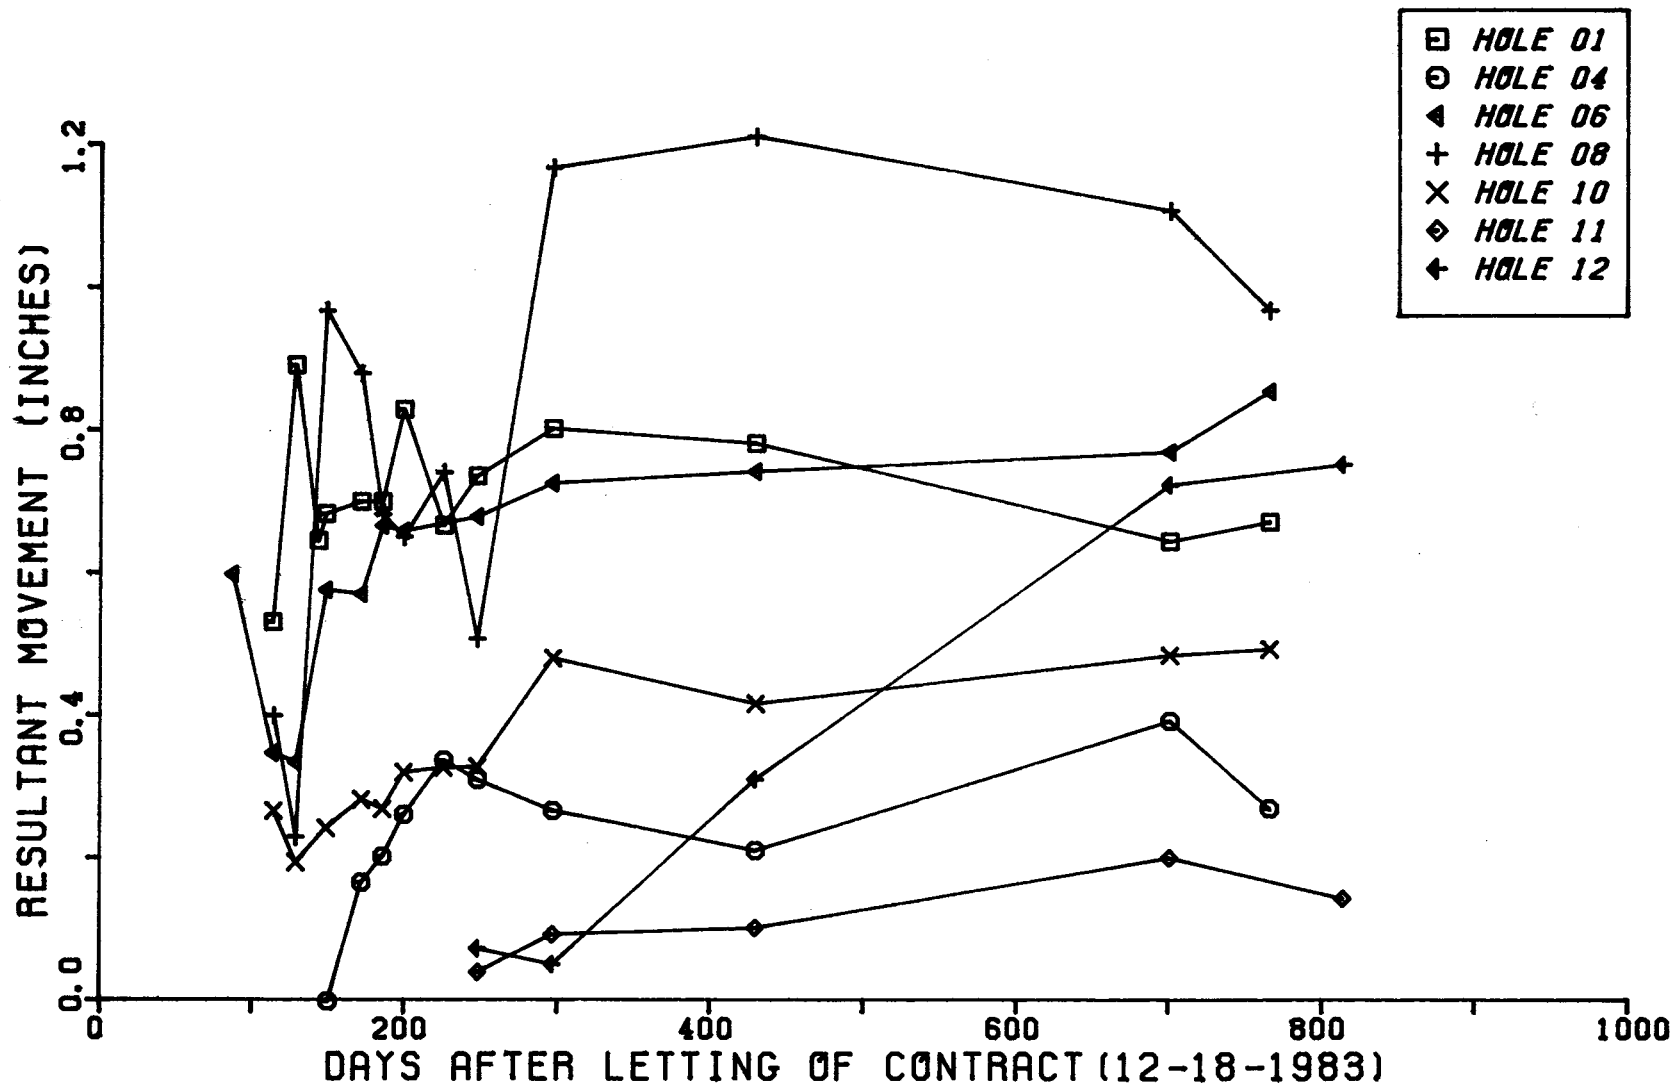
FIGURE 20. SLOPE INCLINOMETER 10 - LATERAL MOVEMENT AT STATION 240 + 00, 30 FEET RIGHT.

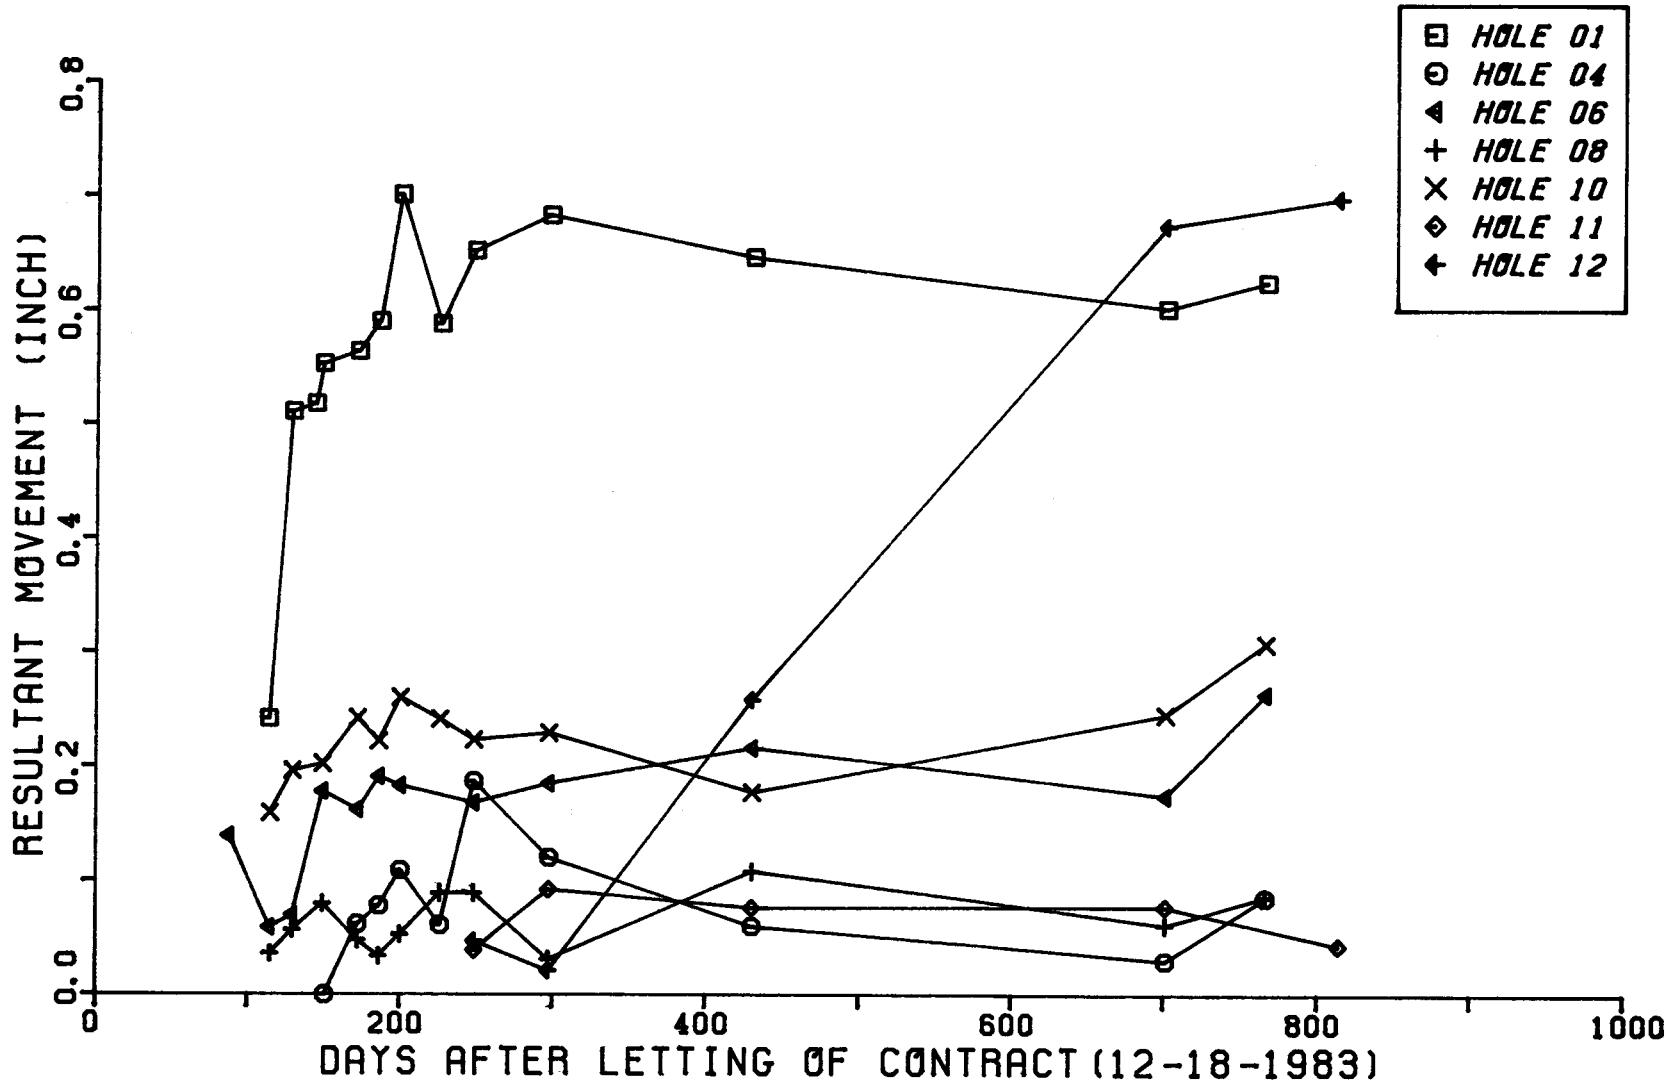
FIGURE 21. MOVEMENT OF TIEBACK WALL SLOPE INCLINOMETERS AT A DEPTH OF 1-2 FEET.

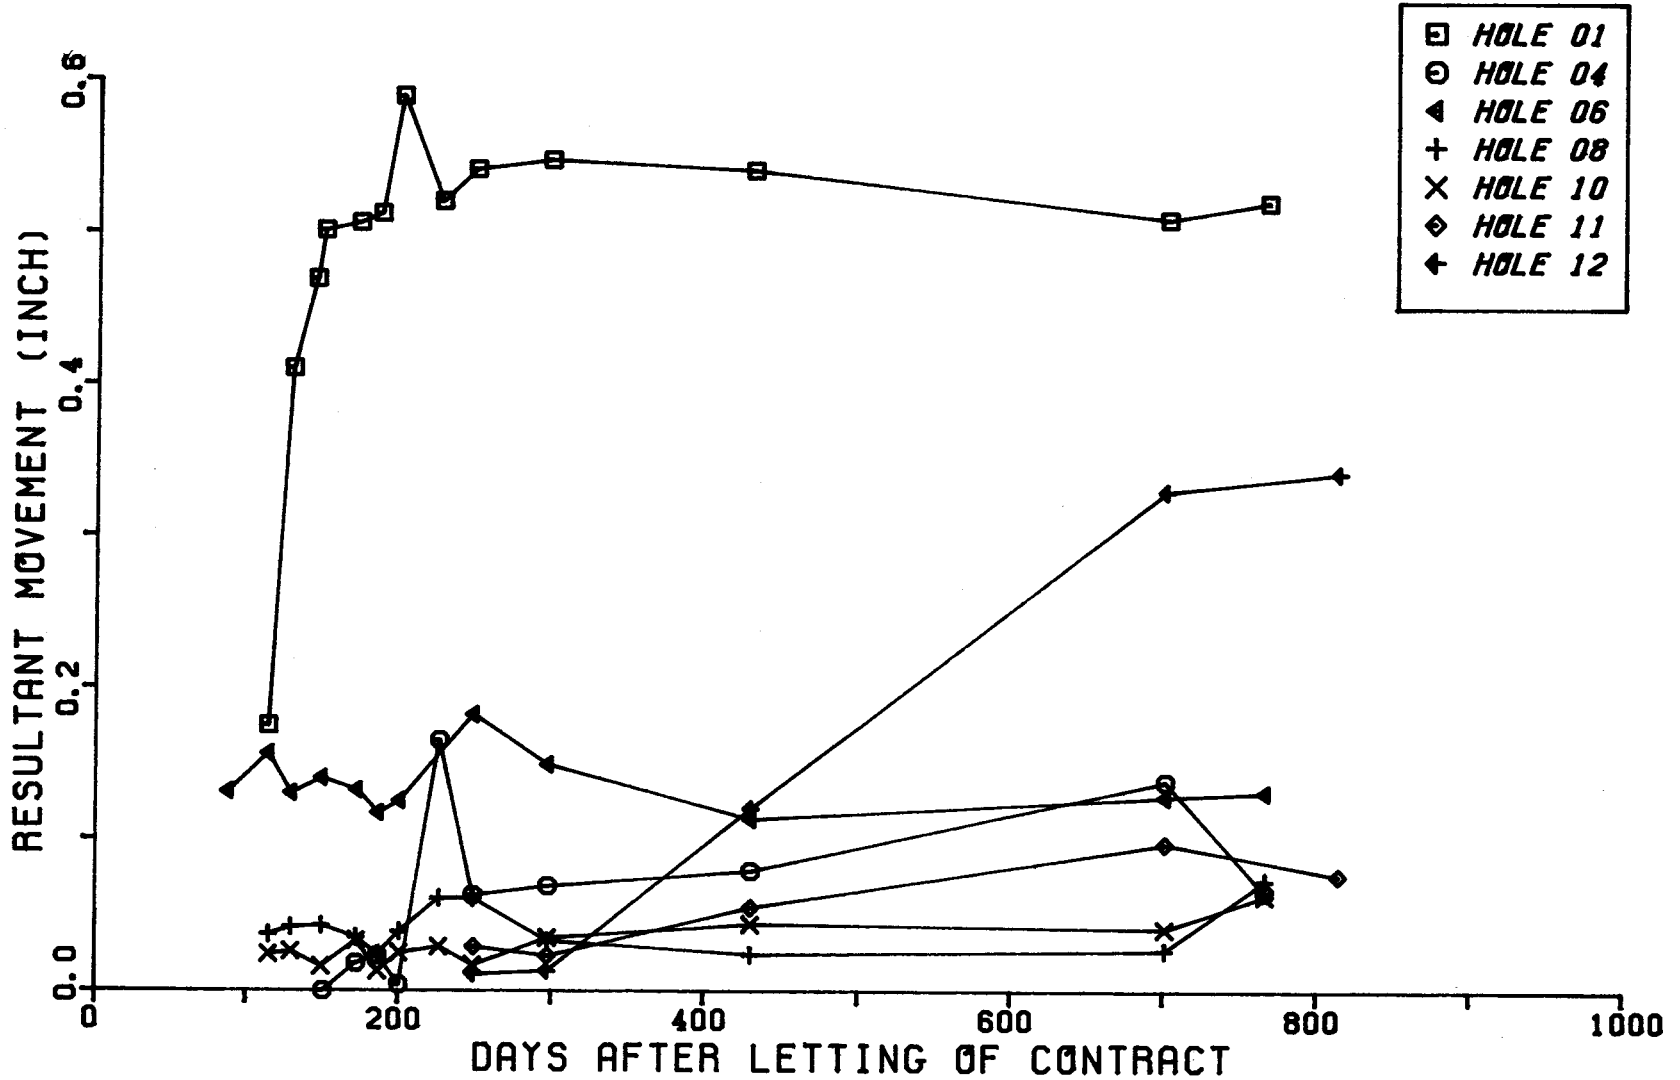
FIGURE 22. MOVEMENT OF TIEBACK WALL SLOPE INCLINOMETERS AT A DEPTH OF 7-8 FEET.

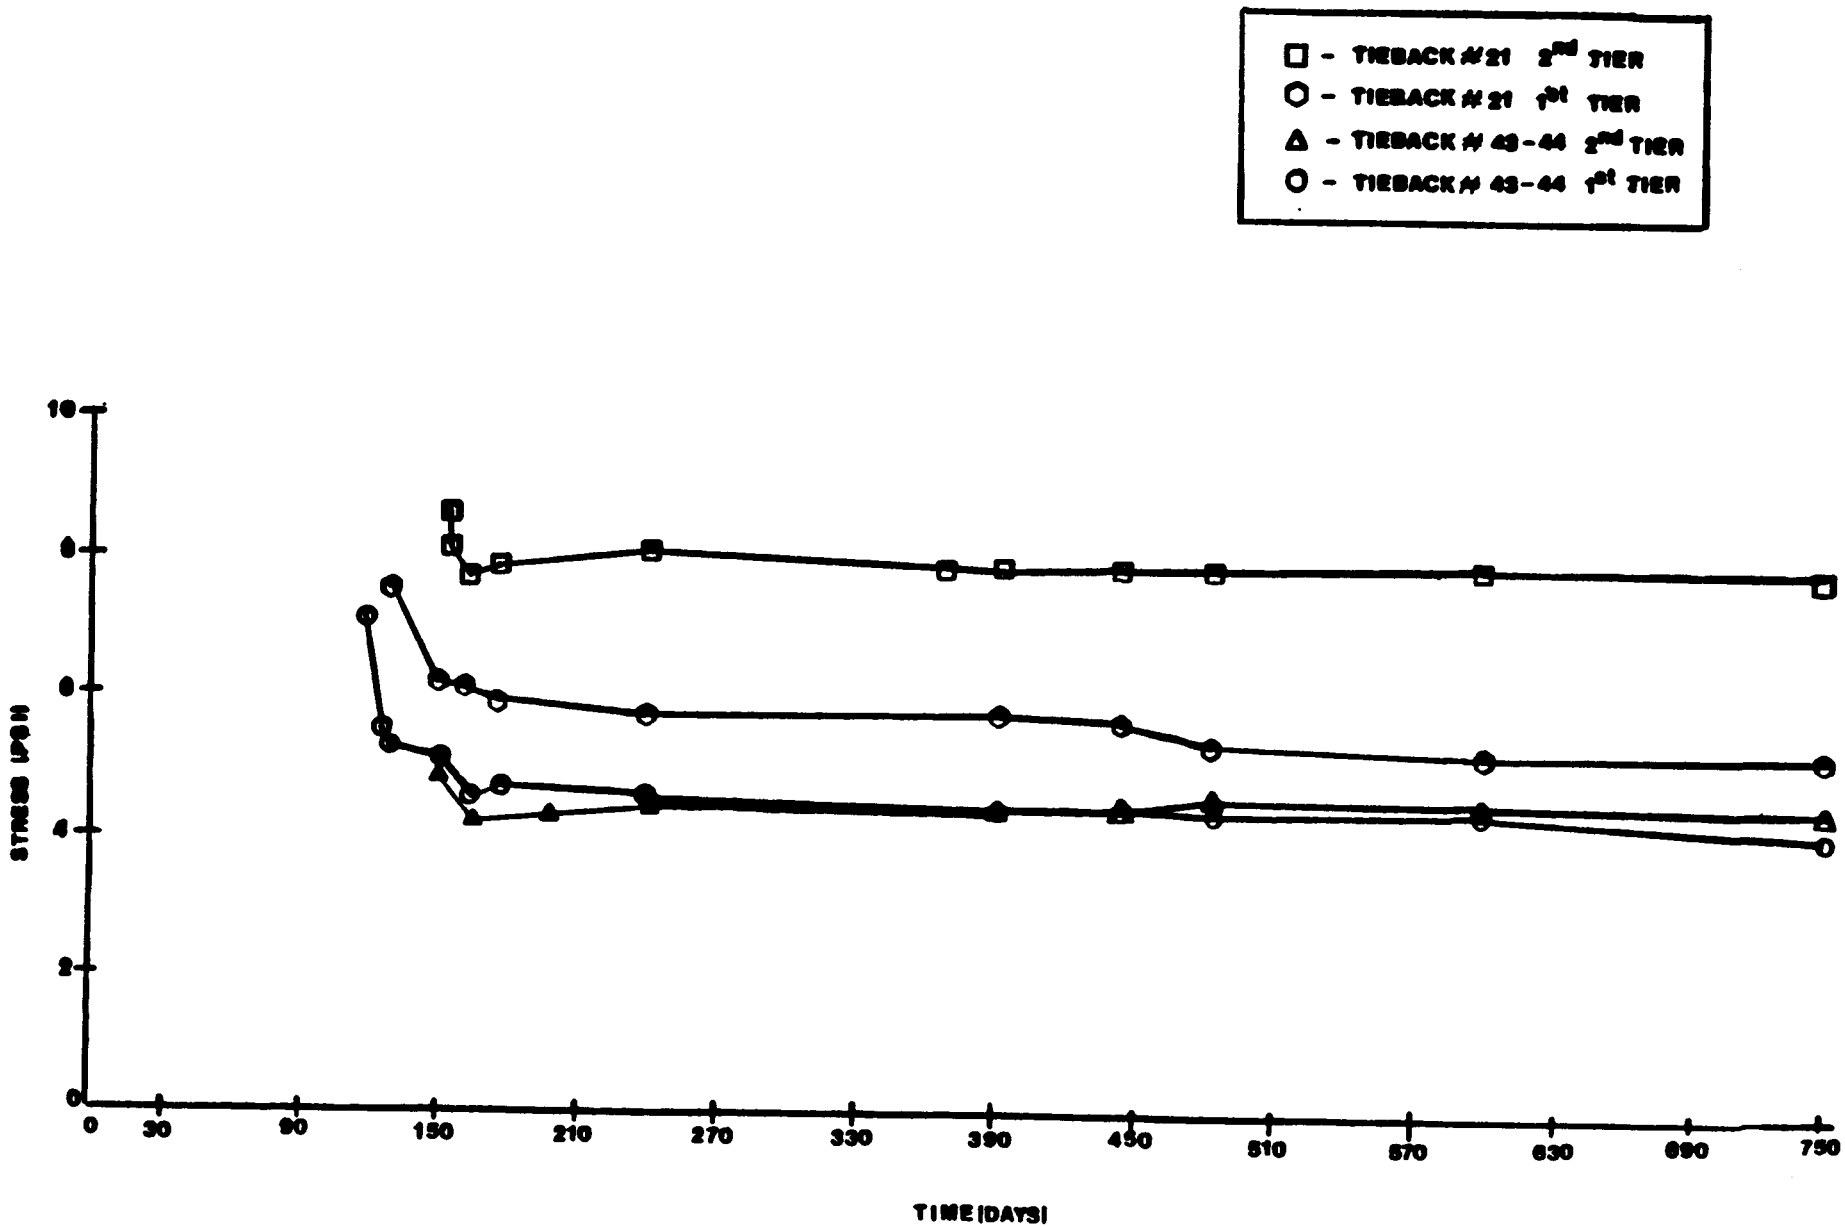
FIGURE 27. EARTH PRESSURE - NEAR PILE NUMBER 47.

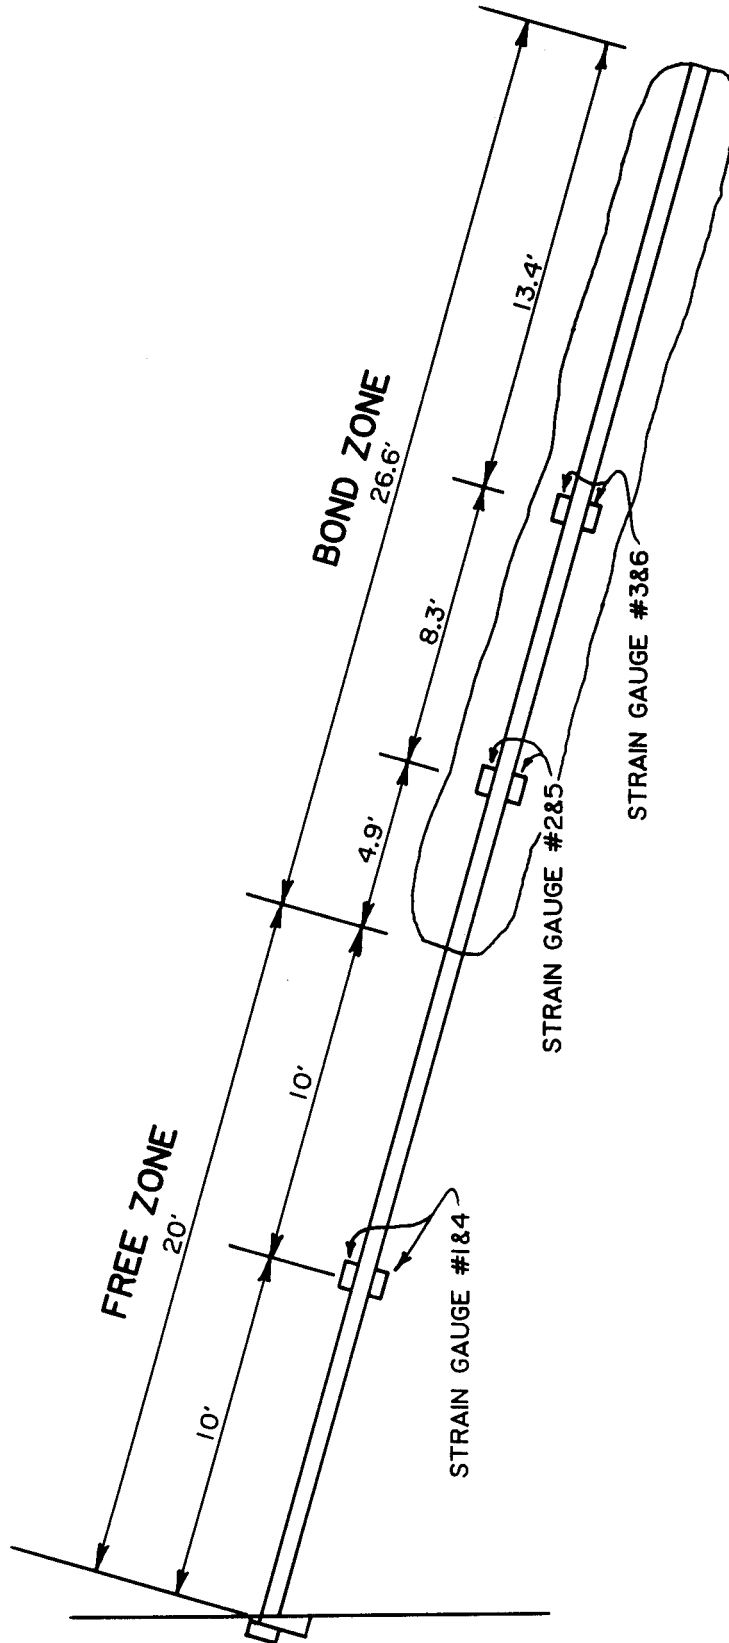
STATE OF ALASKA
DEPARTMENT OF TRANSPORTATION AND PUBLIC FACILITIES
PERMANENT GROUND ANCHOR DIMOND BLVD
Fig. 1
