DP-68

# PERMANENT GROUND ANCHORS

Volume 1, FINAL REPORT

FHWA-DP-90-068-003  
April 1990

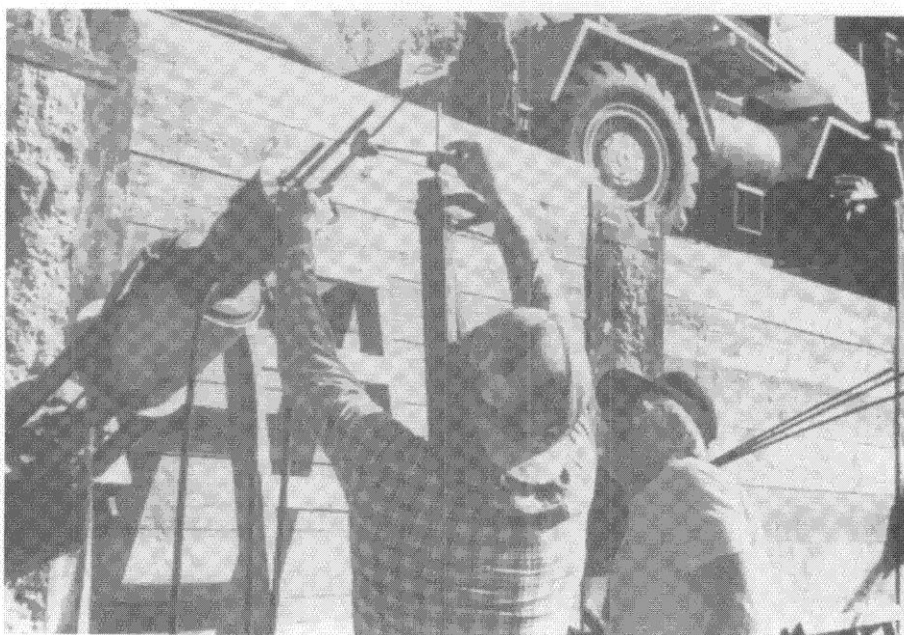
3A.--Testing of First Anchor Row

Figures 3A to 3E show three stages of construction of the anchored wall including the finished product in 1984 and 1988. All visual observations and instrument measurements confirm that the wall and anchors are performing as anticipated in design. Long-term measurements were taken on 60 vertical and horizontal survey points established on or behind the wall during construction. The measurements showed that the movements which occurred indicated active earth pressure conditions and ceased shortly after construction was completed. The survey points still available for reading indicate no definable wall or ground movement has occurred since 1983.

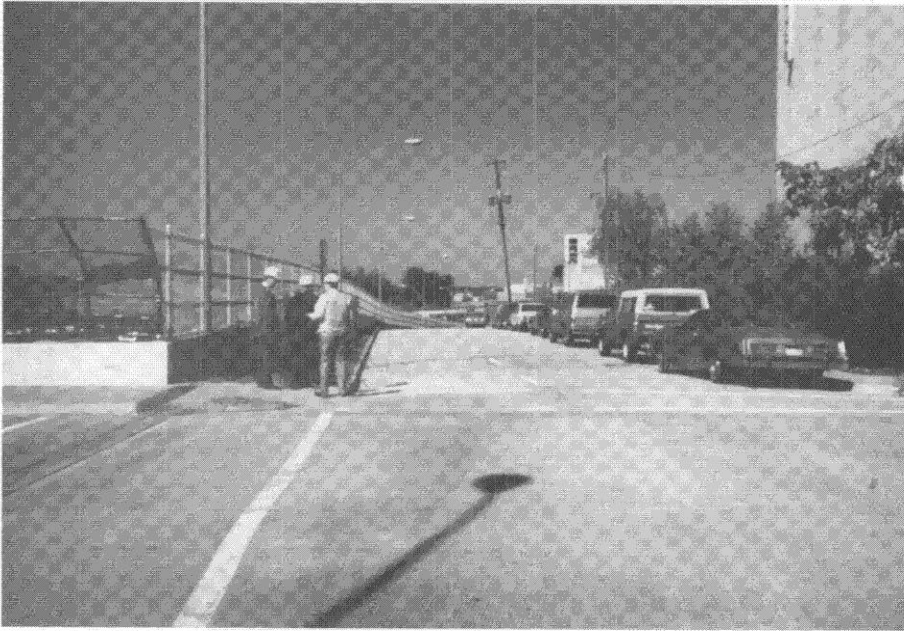
3E.--Stable Roadway, 1988  
Above Wall - No Pavement Cracks

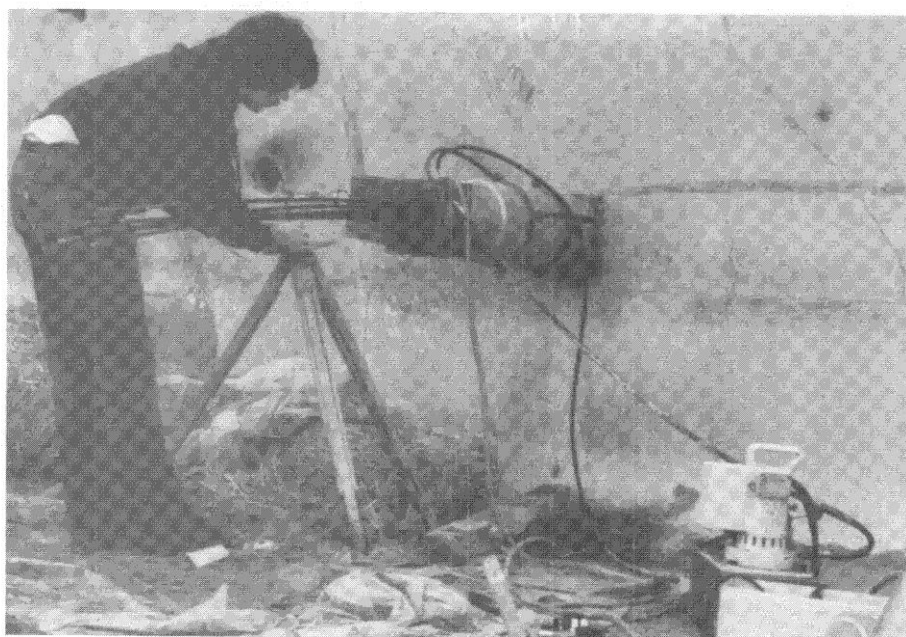
4D.--Anchor Testing

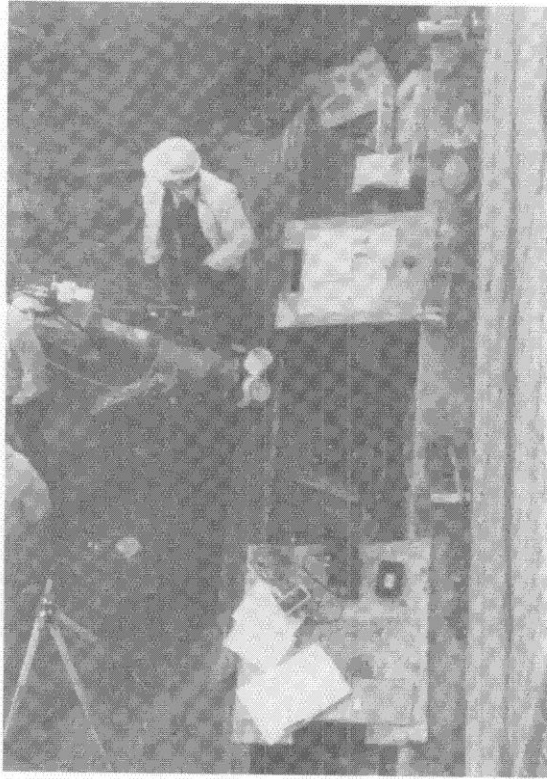
Figures 5C and 5D  
Instrumentation for Anchor Testing

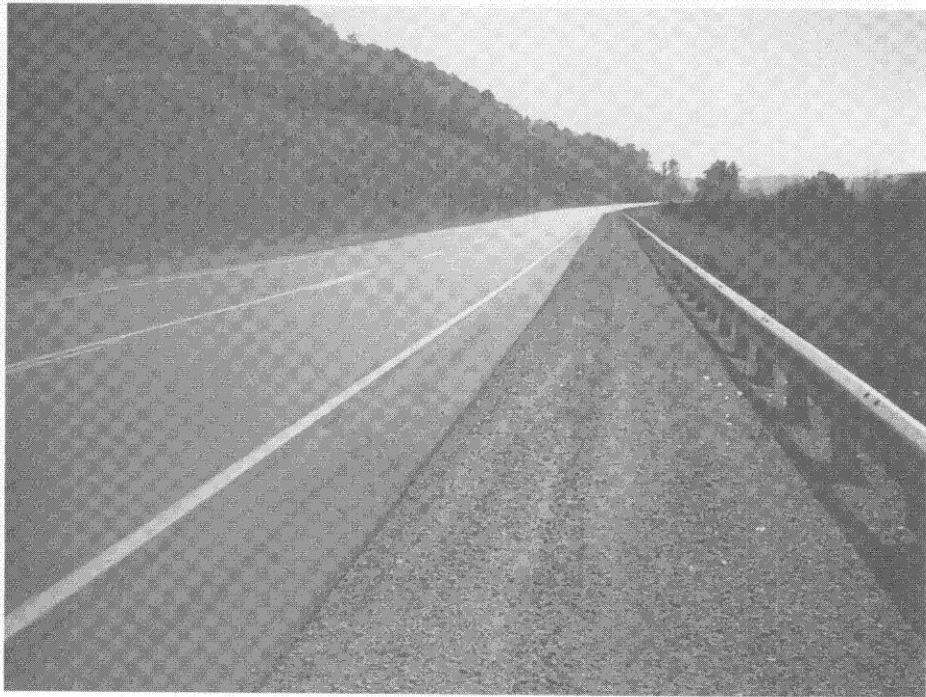
Figure 6A  
Embankment Stable With No Evidence of  
Movement 3 Years After Construction

An inspection of the completed permanent anchor wall by the FHWA project manager on October 15, 1987, indicated that the roadway behind the wall was stable. No evidence of any movement was observed in the roadway or guardrail (see Figures 6A-6C). However, two problems affecting durability of the wall face were observed. Termite infestation was observed in a few of the treated wood lagging sections, which comprise of the final wall face (see Figure 6D). Similar problems have been reported on other permanent walls faced with treated wood. It is postulated that the wood lags develop cracks during initial stressing of the anchors to the test load; i.e., commonly 1.33 to 1.50 of the design load. In fact, random lags may actually be subjected to higher stresses as distribution of load is not uniform across the wall face due to the unevenness of the soil cut face on which the lag bears. These cracks extend through the treated skin and into the untreated wood core which is eventually attacked by the termites. Highway agencies should carefully assess the use of wood lagging as the permanent, load-bearing face for permanent anchor walls, particularly in locations where routine inspection and maintenance are not feasible.

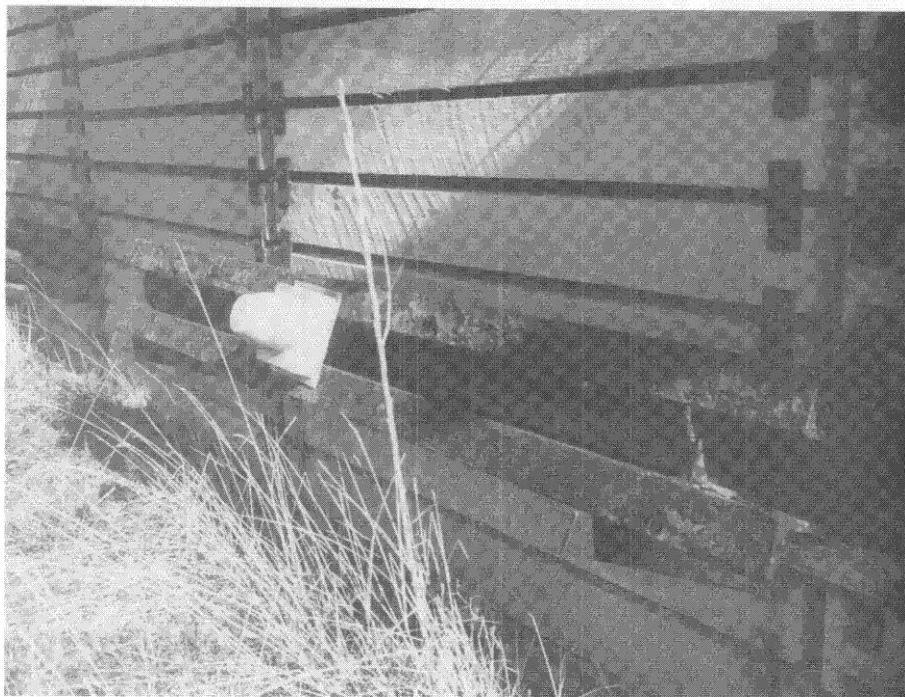
Figure 6E  
Blistering and Peeling of Protective Coating on Waler

The inspection also disclosed that the "Tapecoat TC Mastic," used as protective coatings on exposed steel surfaces, was blistering and peeling. Corrosion of the waler was observed beneath the peeled coating (see Figure 6E).

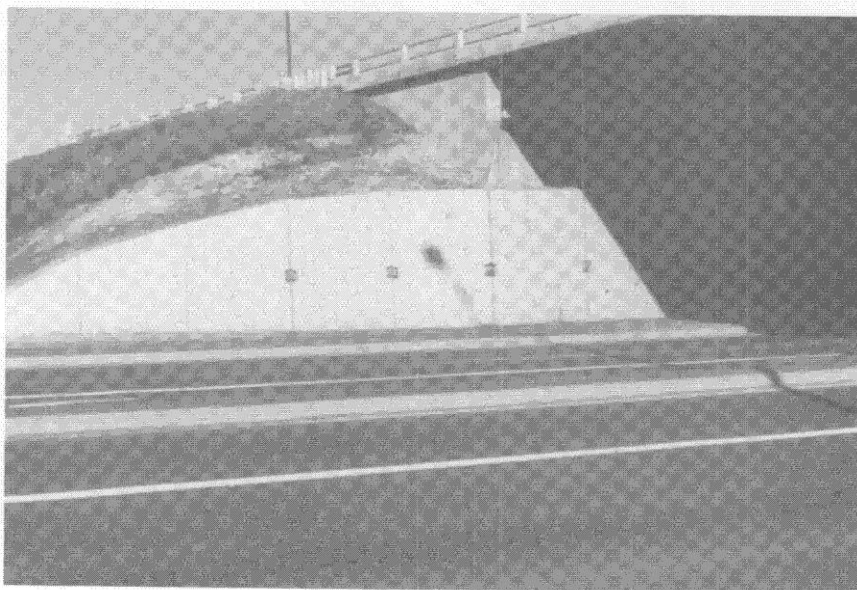
Completed Dimond Boulevard Wall

Although the final report for this project has not been submitted, observations made for a year after the construction indicate the anchored wall is functioning as designed (see Figure 7). It does appear that the wall moved into the backslope a small amount which caused a decrease in the **lockoff** load on the tendons. The reasons for this movement and decrease in load may be better known when the final report is received in 1990.

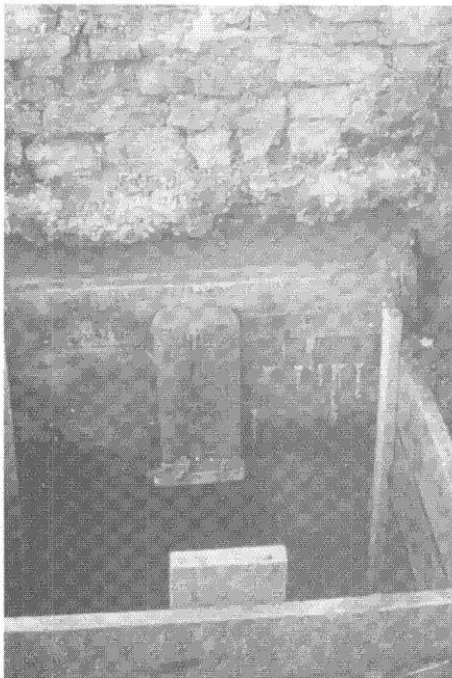
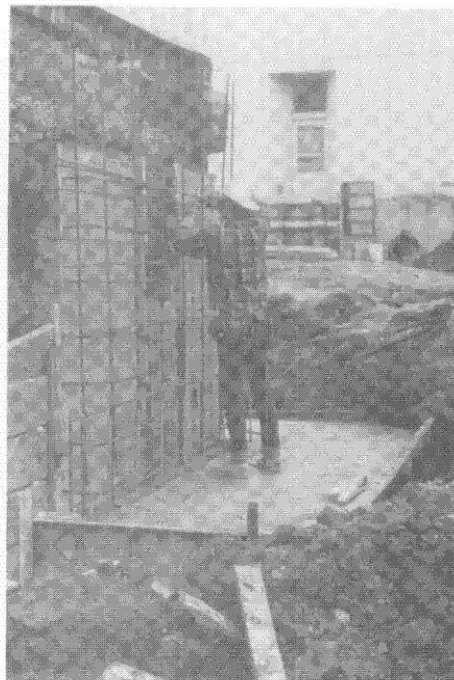
Figures 8A, 8B, and 8C.--Building Underpinning Operations

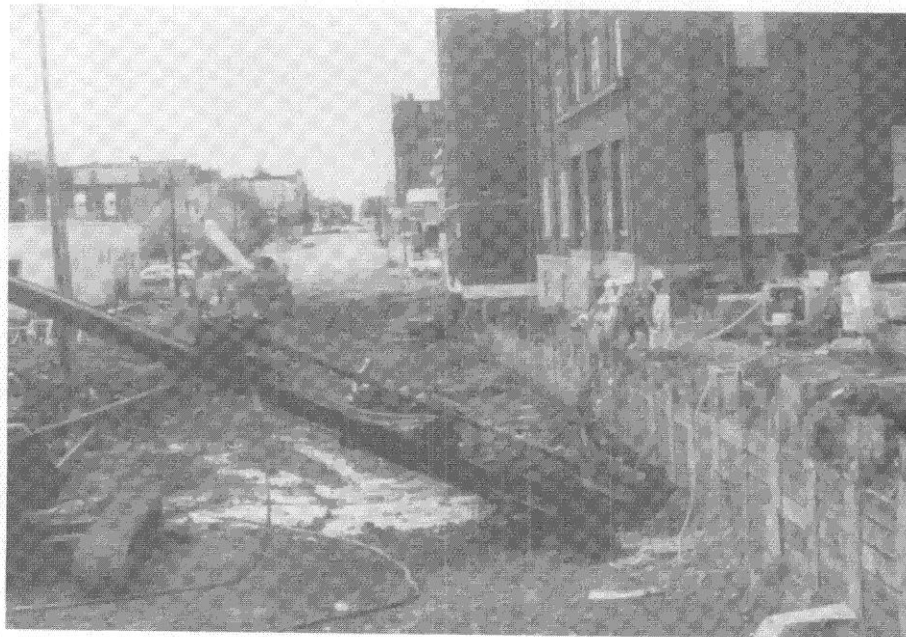
Figures 8D and 8E.--Anchor Drilling
