Landslides Induced by Hurricane Mitch in El Salvador— An Inventory and Descriptions of Selected Features

*By Anthony J. Crone, Rex L. Baum, David J. Lidke, Damon N.D. Sather,
Lee-Ann Bradley, and Arthur C. Tarr*

Open-File Report 01-444

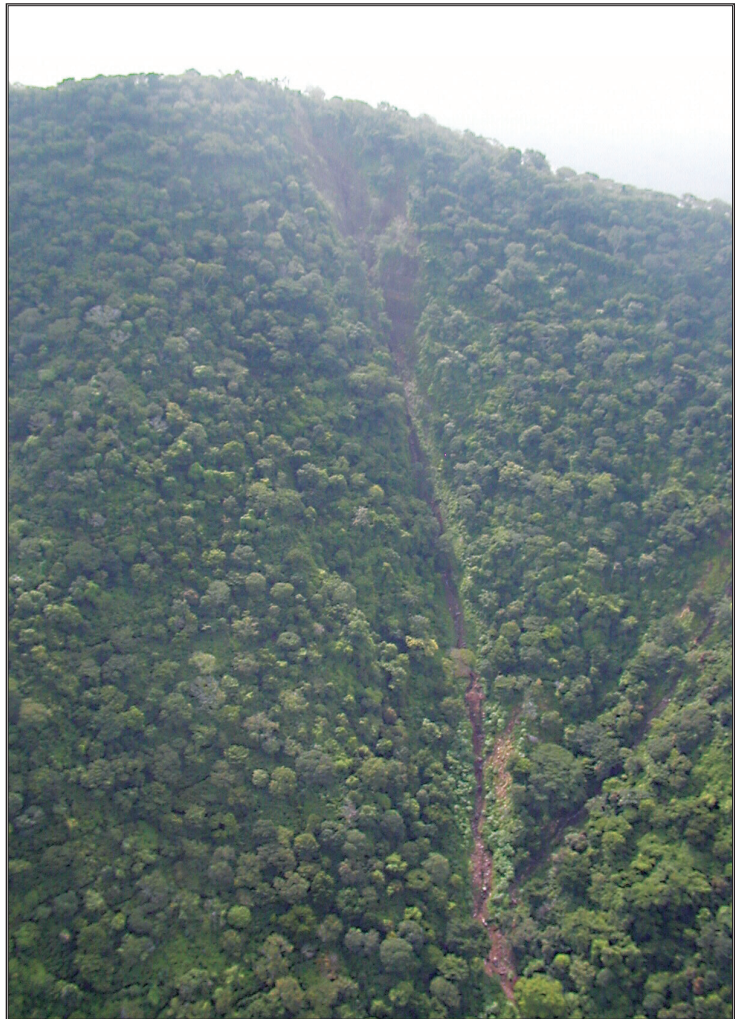
Figure 4. View of one of several recent landslides in the area south and west of Lago de Coatepeque. These recent landslides postdate January 1999 aerial photography and were probably triggered by the 13 January or 13 February earthquakes.

The largest concentration of landslides in this area is directly west and southwest of Lago de Coatepeque (Plate 2). Most of these slope failures are west of the lake along and near the eastern flank of Volcán Santa Ana O Ilamatepec. All of these landslides appear to be shallow failures, and only a few formed debris-flow channels with visible deposits at their bases. A few of the landslides damaged local roads, but none of the slides apparently damaged homes or infrastructure. The landslide closest to a population center is shown on the west flank of Cerro Pacho, directly east of the village of San Juan Las Minas El Chorizo (not shown on 1:50,00-scale map). Both aerial photographs and field reconnaissance of this landslide suggest that it is a very shallow slope failure that produces modest deposits at the base of the slope during most significant storm events; it does not appear to pose a significant threat to the nearby village. Aerial reconnaissance of the region south and west of Lago de Coatepeque revealed numerous post-Hurricane Mitch landslides that were probably caused by the 13 January or 13 February earthquakes (Figure 4).

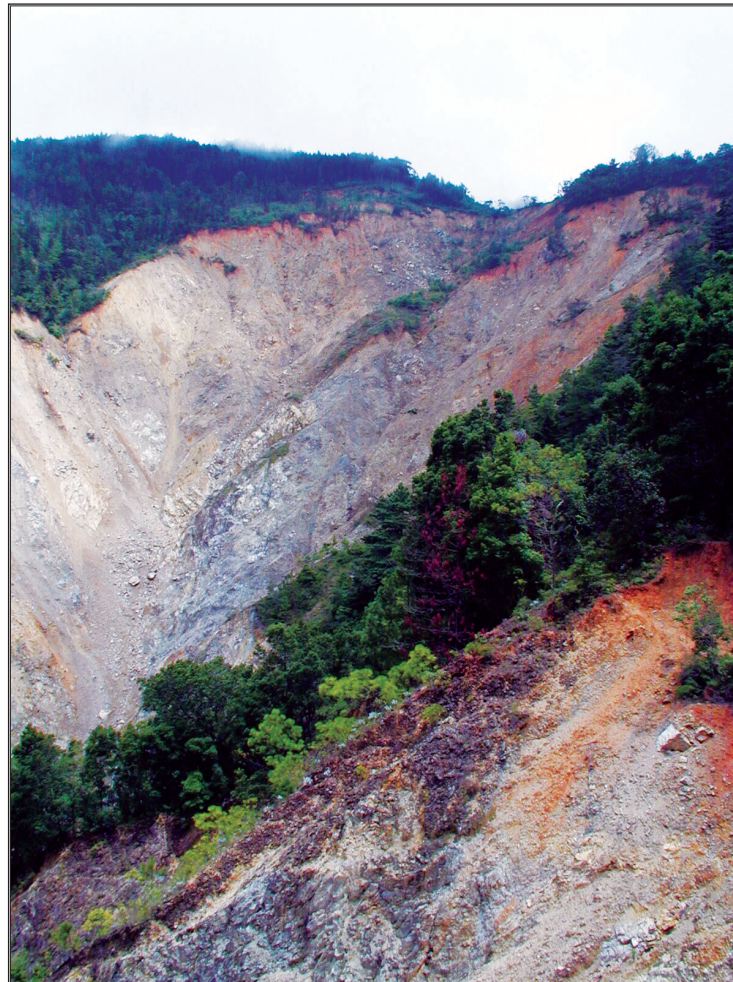
Figure 5. View to the northeast of the upper part of El Zompopera landslide. The collapse of unstable blocks in the upper part of the landslide destroyed a road at the crest of the ridge. Many unstable blocks remain in the upper part of the slide and a catastrophic collapse of those blocks could potentially dam the Río La Palma at the bottom of the valley.

El Zompopera landslide is the largest single landslide that we mapped in all of our study areas. The head of the landslide is about 300 m above the adjacent valley, and the denuded slopes drop steeply into the valley (Figure 5; Plate 4). Bedrock exposed by the land-

Although El Zompopera landslide was active prior to the hurricane, the storm caused unstable blocks in the upper part of the landslide to fail and add huge amounts of sediment to the adjacent valley of the Río La Palma o Los Pozos. This sediment initially moved into the valley as an earth slide and debris flow but, farther downstream, the landslide deposits were partially reworked into flu-

These continuing collapses are cause for concern. Many of the unstable blocks in the upper part of the landslide have volumes of several thousand cubic meters, and the simultaneous collapse of many of these blocks could potentially create a landslide dam in the Río La Palma o Los Pozos. If the dam were sufficiently large, a lake could form quickly behind the dam, and a catastrophic failure of the dam could release a major flood down the valley. A major flood could reach La Palma in a matter of minutes, and if large enough, could inundate

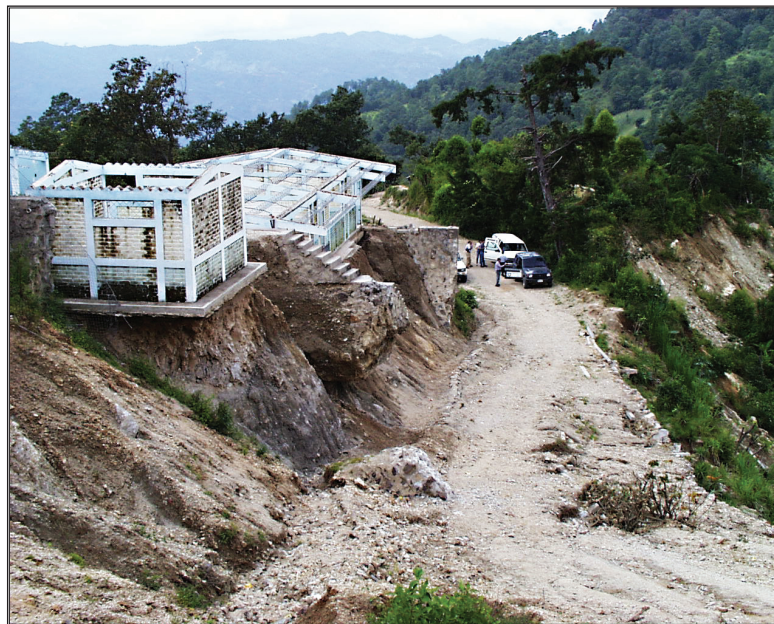
Figure 6. View of the El Pinar landslide and the abandoned school. A new road has been graded across the head of the landslide, which slid into the valley of the Río La Palma o Las Pozos on the right. Future movements on the landslide will likely disrupt the new road.

m of road and the only school in the area (Figure 6; Plate 4). El Pinar is located about 3 km east-northeast of La Palma, on the 15- to 25-m-wide crest of a steep-sided ridge. The landslide began at the crest of the ridge and traveled downslope about 150-200 m to the bottom of the Río La Palma o Los Pozos valley. The landslide undermined the foundation of the local school, which was not occupied when the failure occurred. A new road has been graded across the head of the landslide, but the slope of the landslide remains unstable and future movements will likely disrupt the road again and could threaten nearby homes.

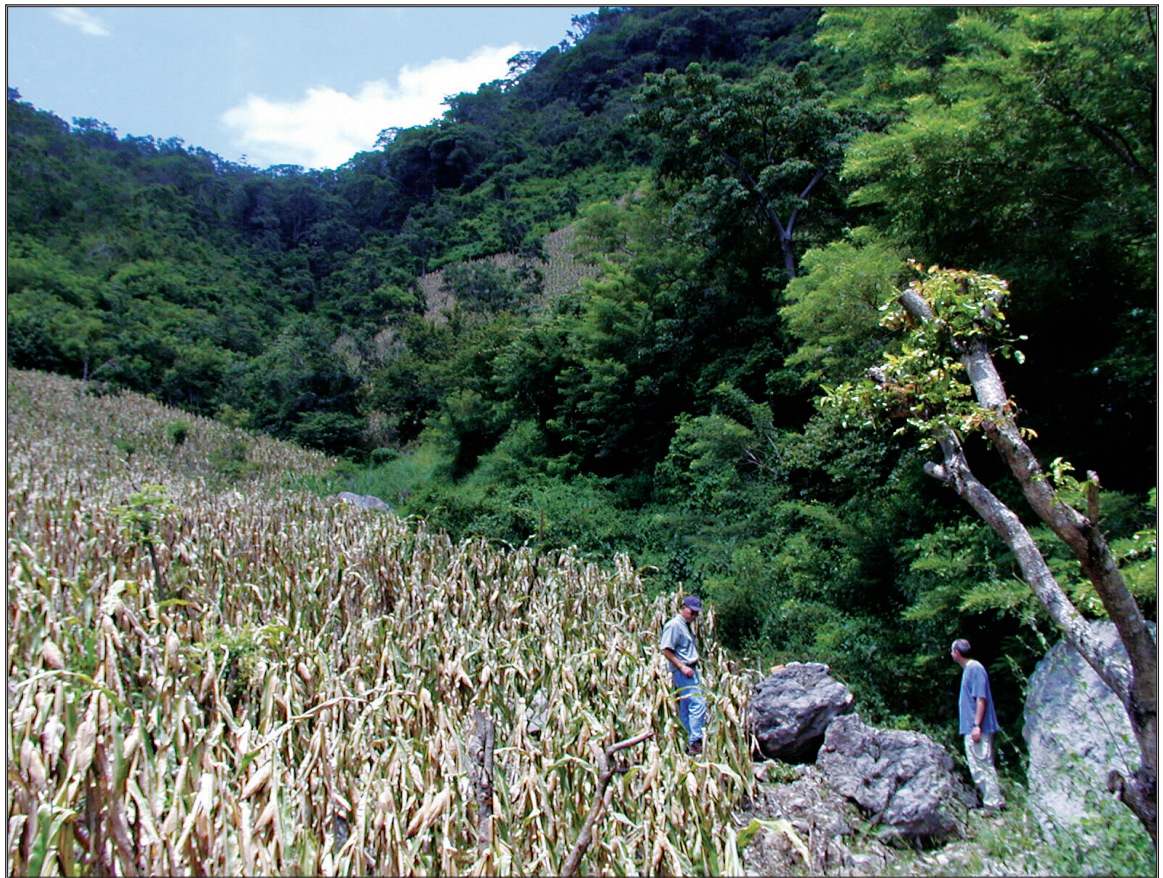
Figure 7. View of the western debris-flow channel and source area on Cerro El Coyote. The source area of the flow is at the ridge in the upper left of the photograph. Person on the left is standing on the debris-flow levee, which is about 3-4 m above the channel bottom. Note the 2-m-wide boulder (lower right) that was carried by this small but powerful debris flow.

Hurricane Mitch generated two debris flows on the south side of Cerro El Coyote, which is about 5.5 km north-northeast of El Paraiso and 3.5 km north-west of San Rafael (Plate 5). These debris flows had estimated volumes of a few thousand cubic meters, originated on steep, tree-covered slopes, and flowed 300-400 m down narrow channels. Levees along the western debris flow show that the flow filled the 5-m-wide channel to a depth of 3-4 m and transported 2-m-wide blocks more than half way down the channel (Figure 7). The source areas of the debris flows are now

completely overgrown, and even much of the coarse bouldery deposits is concealed by heavy vegetation. The catchment basins where the debris flows originated are very small relative to the volume of rock and water involved in the flow. During our field review, we observed several small flowing springs on the lower slopes of the Cerro El Coyote. We speculate that groundwater from springs scattered around Cerro El Coyote may have added to the surface runoff from the hurricane and may have been a factor in the development of these small, but highly fluid and powerful debris flows.

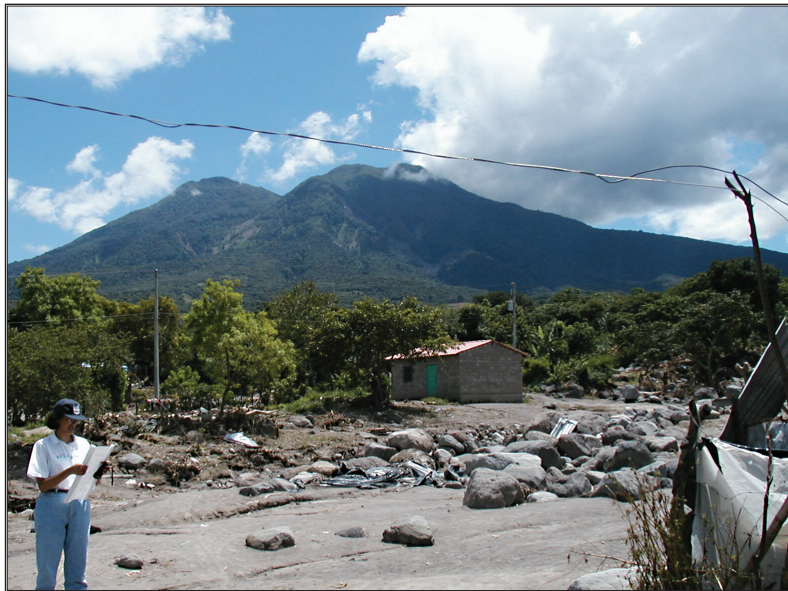
Figure 8. View of part of the town of Guadalupe that was struck by a debris flow on 15 September 2001. Temporary shelters in the right foreground were swept away by the debris flow, which originated on the western slopes of Volcán de San Vicente, shown in the background.

northeastern edge of the town of Guadalupe, destroyed several temporary shelters, and carried away a woman and a small child (Figures 8, 9, and 10). Other debris flows that swept across the highway between Guadalupe and Verapaz traveled several kilometers from their source areas on the east side of the volcano.

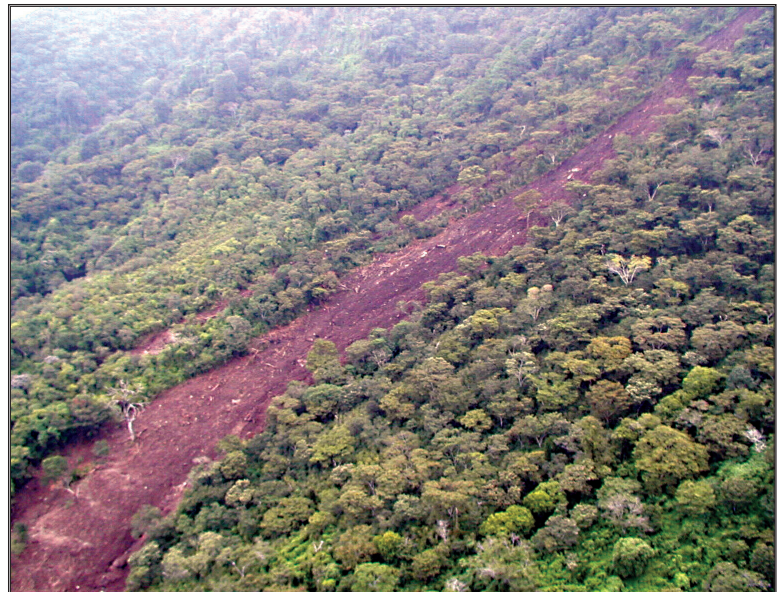
Figure 9. Oblique aerial view of the main source area for the debris flow that occurred on 15 September 2001 on Volcán de San Vicente. Smaller landslides along the banks of the channel, farther downslope also contributed sediment to the devastating debris flow that swept through Guadalupe.

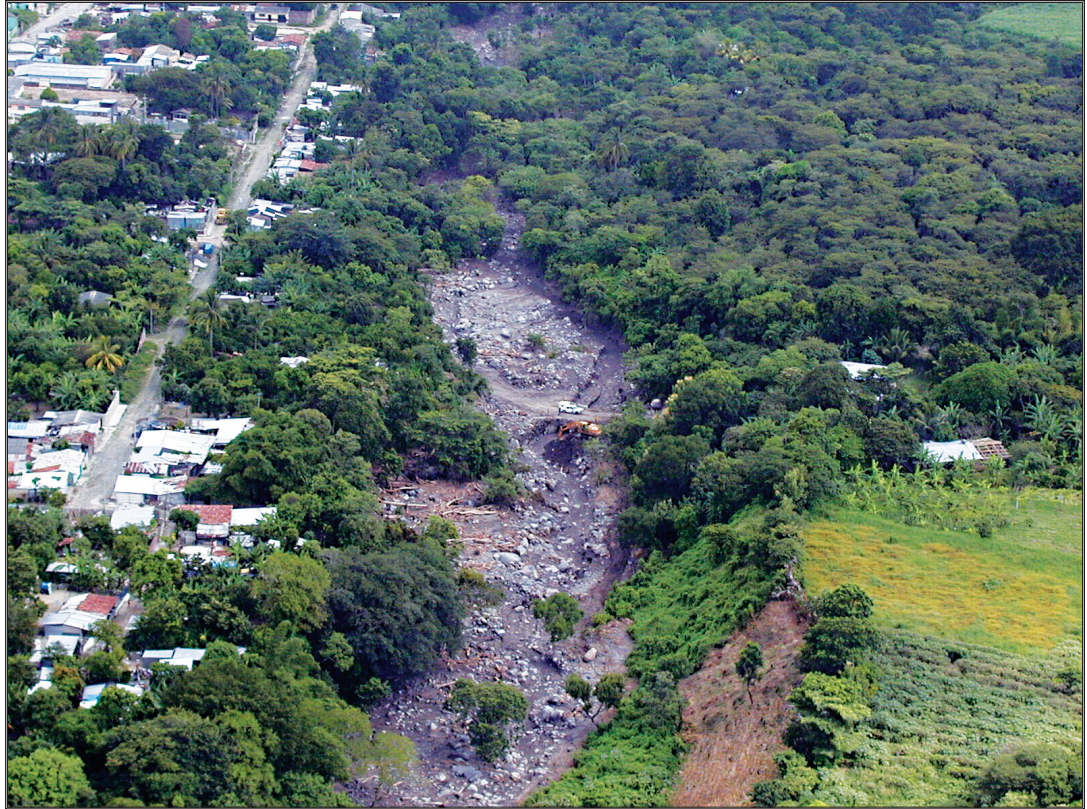
Figure 10. *Oblique aerial view of the debris flow on the northeast side of the town of Guadalupe that occurred on 15 September 2001. Many of the large boulders in the channel were transported by the debris flow.*

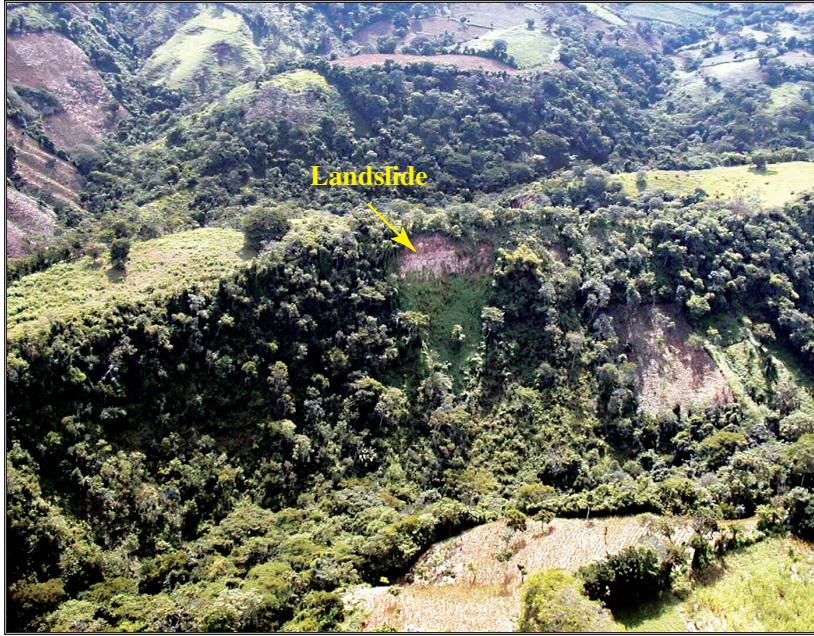
Figure 11. Partially overgrown scar of a shallow landslide in the area west of San Lorenzo. Dozens of small shallow landslides similar to this one occurred in this area as a result of Hurricane Mitch, but few caused significant damage.

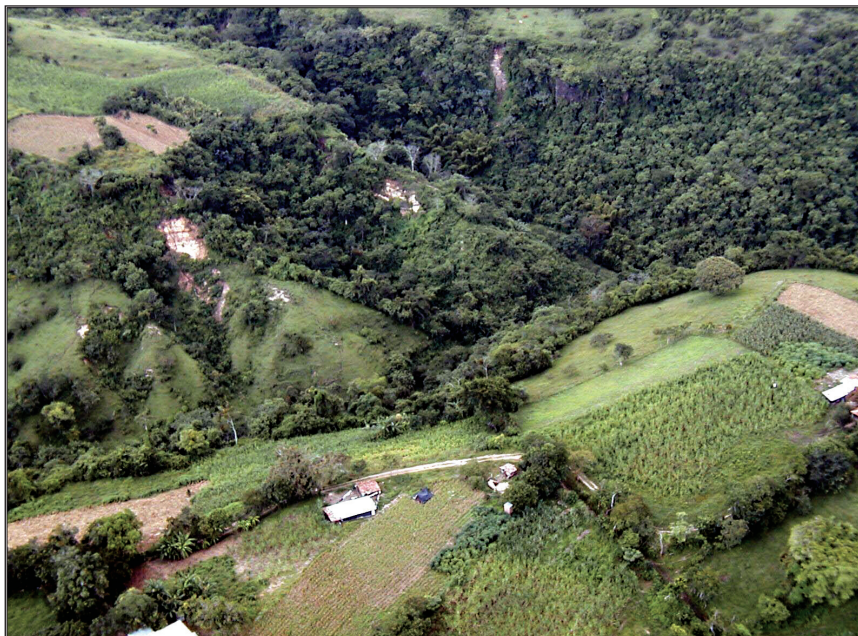
Figure 12. Scars of landslides caused by the 13 February 2001 earthquake west of San Lorenzo. Like the Hurricane Mitch landslides, these shallow landslides caused little serious damage, but repeated sliding here shows that these slopes are highly susceptible to landslides.

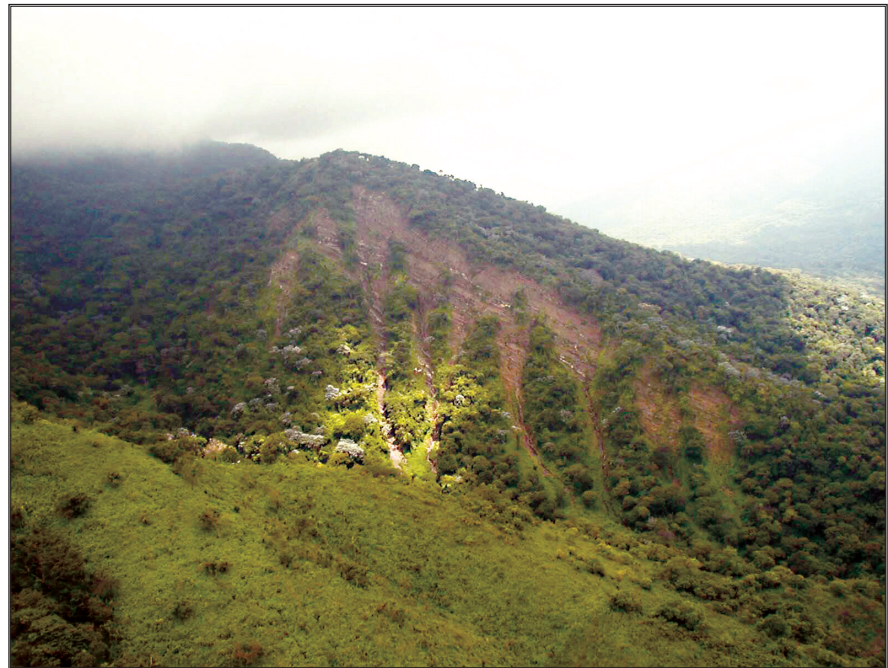
Figure 14. Scars of landslides on Volcán de Usulután triggered by the 13 February 2001 earthquake. Numerous landslides like these occurred on the volcano as a result of strong shaking, and produced large amounts of sediment that will be eroded from the volcano and deposited in surrounding areas during future years.

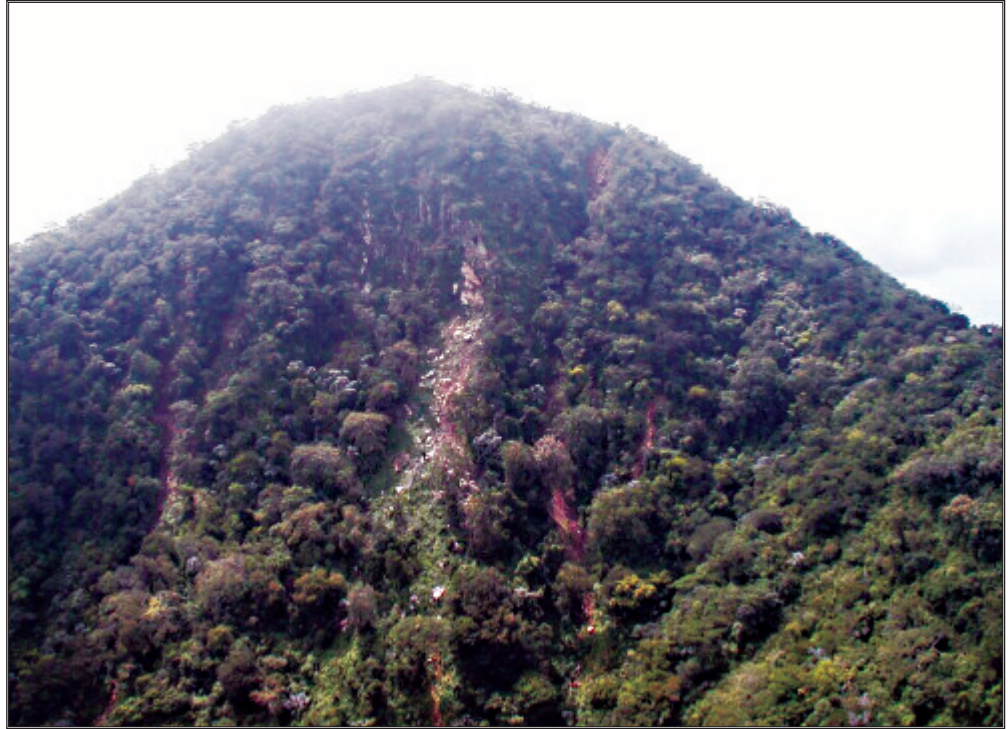
Figure 15. Landslides inside the crater of Cerro El Taburete that were probably caused by the 13 February 2001 earthquake. Many similar landslides occurred on this and nearby volcanoes as a result of the earthquake. Shallow landslides in this area that were caused by Hurricane Mitch were probably very similar.

Two landslides that occurred inside the crater rim of Cerro El Taburete appear to be shallow landslides in colluvium and weathered residuum derived from the volcanic rock (Plate 10). The larger of these slides is about 200 m long and started at the crater rim; the second is about 80 m long and initiated about mid-way up the crater wall. In the field, we observed new landslides inside the crater rim and on the outside of the volcano that were triggered by the 13 February 2001 earthquake (Figure 15).

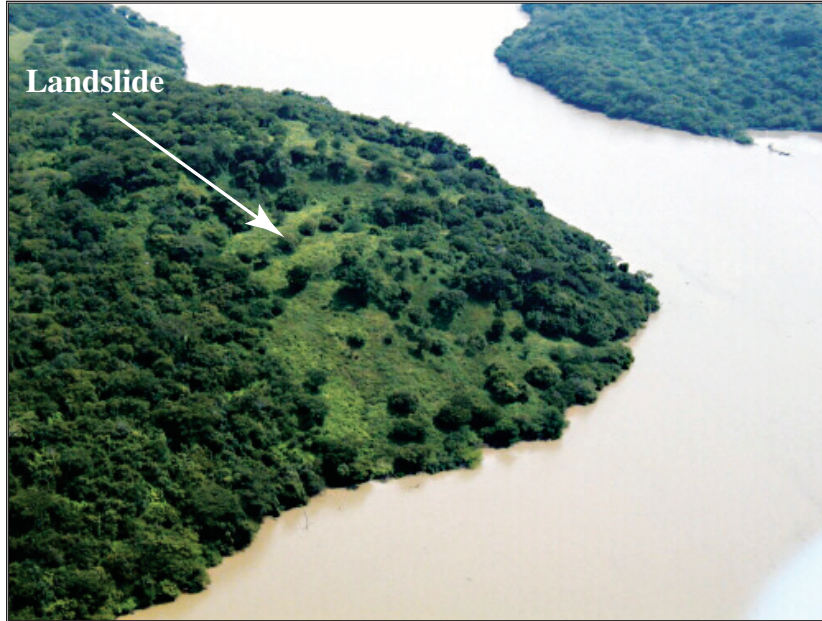
Figure 16. Large dormant pre-hurricane landslide on the shore of Embalse 15 de Septiembre. If reactivated, a large landslide such as this one might partially block the reservoir, however, it is far enough upstream from the dam that it probably would not interfere with operation of the dam or the hydroelectric facilities.

The few landslides observed along the shores of the Embalse 15 de Septiembre are unlikely to pose any serious threat to the dam or reservoir. These slides include a debris flow on the southwest shore (about 400 m upstream from the dam), a large pre-hurricane rotational slide on the northwest shore (Figure 16, 5 km upstream from the dam), and a shallow landslide on the west wall of the flooded Río Malancolo valley (Figure 17, 7 km upstream from the dam). Of these, only the pre-hurricane slide has a large enough volume to have a significant impact on the

reservoir. We observed no signs of recent activity of the slide during an overflight in September 2001 (Figure 16). Reactivation of the slide might partially block the reservoir, but such a blockage is unlikely to be large enough to interfere with operation of the dam.

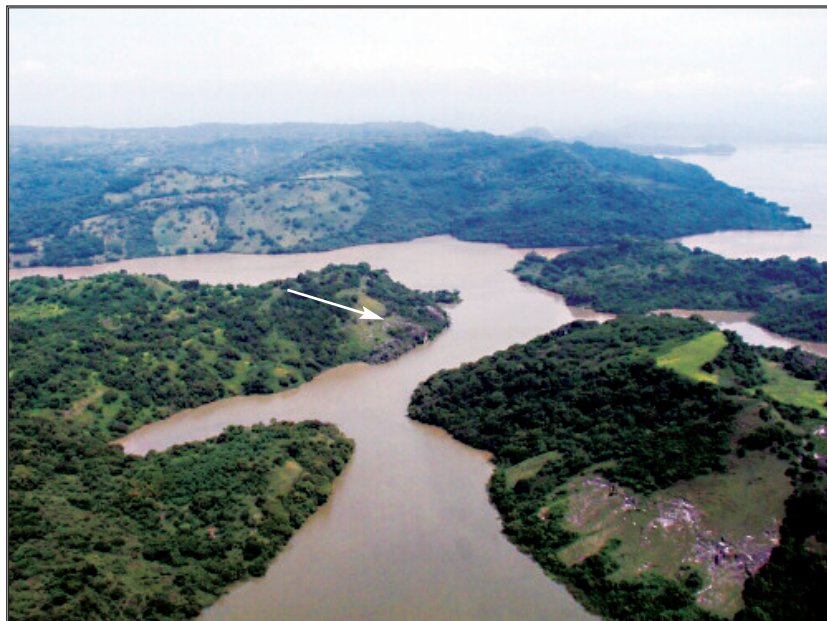
Figure 17. Shallow landslide on the shore of Embalse 15 de Septiembre. The scar was largely vegetated when this photograph was taken in September 2001.

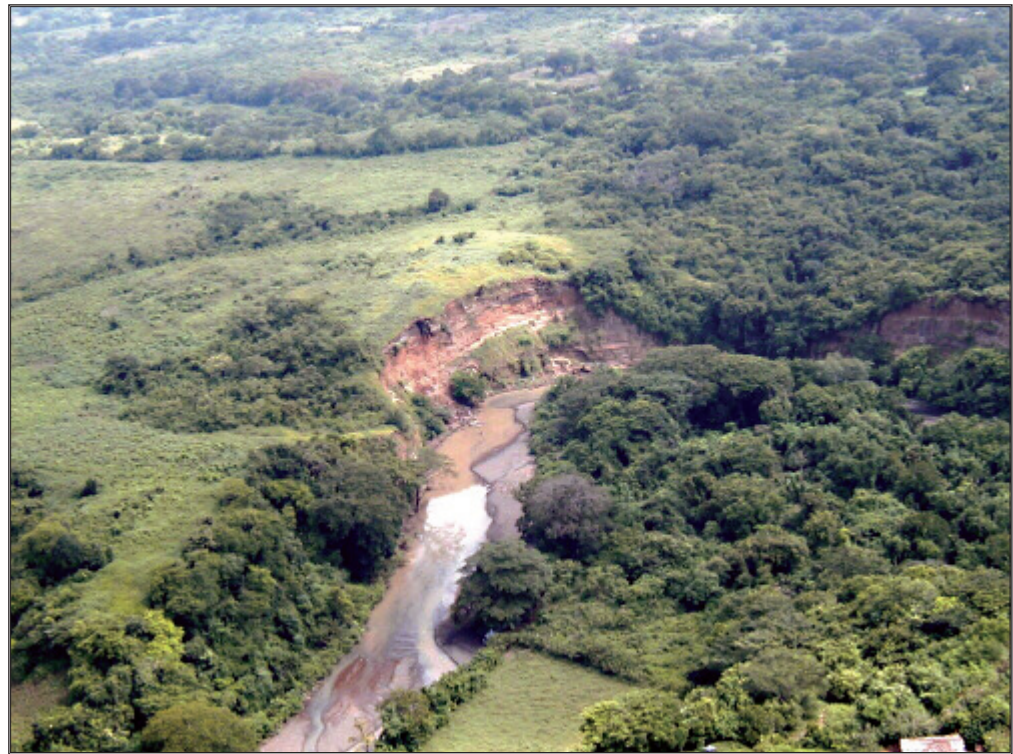
Figure 18. Bank failure on the Río Gualcho about 4 km upstream of Embalse 15 de Septiembre. This and similar failures along the Río Gualcho may have resulted from accelerated bank erosion caused by the high stream flows that occurred during Hurricane Mitch.

Banks of the deeply incised Río Gualcho are actively failing at several places downstream from Comunidad Nuevo Gualcho, about 4 km upstream from where the river enters the reservoir (Plate 9). Most of the bank failures are on the outside of meanders where undercutting has caused failure either by toppling or slumping (Figure 18). Bank failure at these locations likely was ongoing before Hurricane Mitch, but many scars or deposits are fairly recent. High flow in the Río Gualcho from Hurricane Mitch may have accelerated these bank failures.
