HISTORICAL DEBRIS FLOWS ALONG THE INTERSTATE-70 CORRIDOR IN CLEAR CREEK COUNTY, CENTRAL COLORADO

Jeffrey A. Coe and Jonathan W. Godt

U.S. Geological Survey, MS 966, Denver Federal Center, Denver, CO 80225

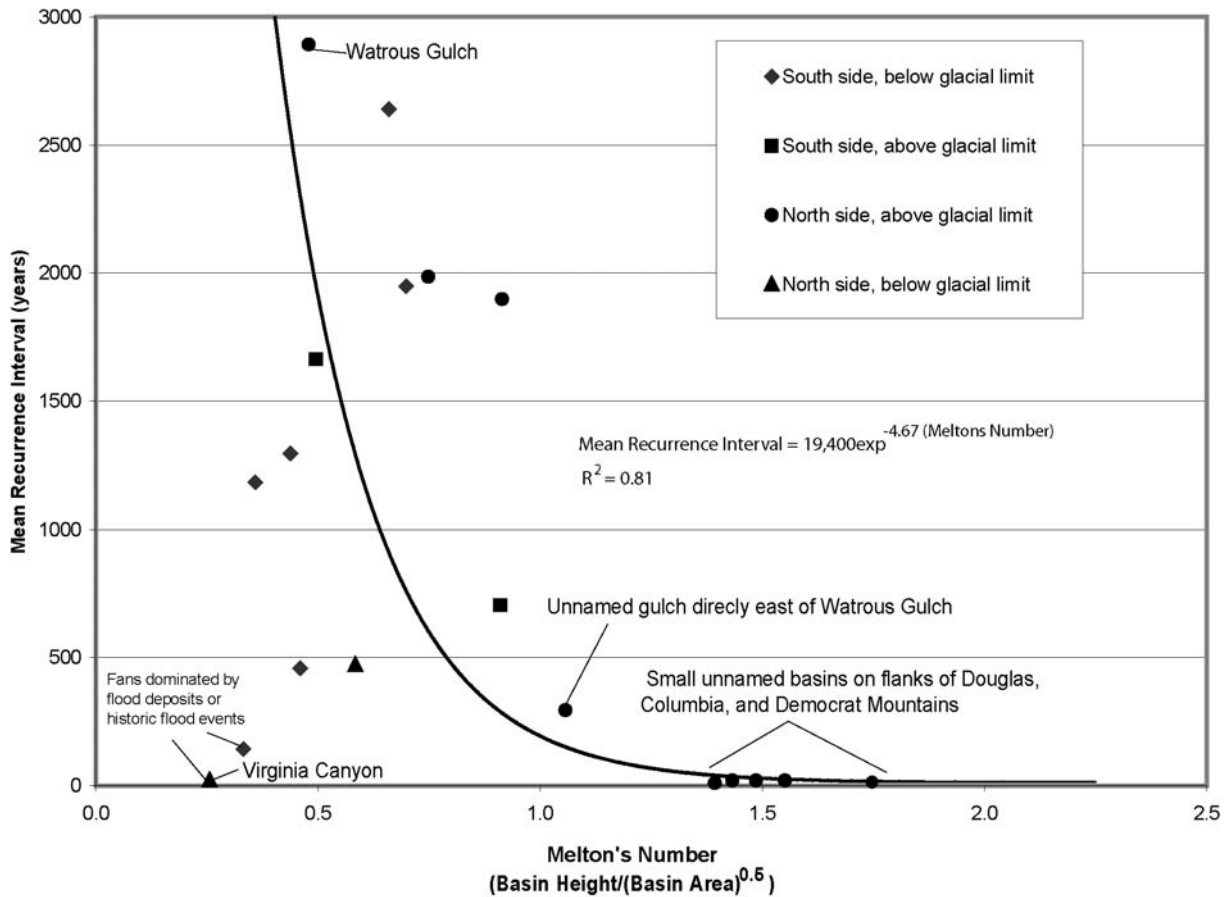
Figure 2. Scatter plot showing mean recurrence interval data from fans, and Melton’s Number data from corresponding basins along I-70 in Clear Creek County (from Coe et al., in press). Mean recurrence interval data were derived from stratigraphic and/or historical data at each fan. A regression analysis yielded the best-fit line and equation. Fans dominated by flood deposits or historical flood events were not used in the regression analysis. Fans/basins with historical debris-flow events discussed in the text are labeled. Location of fans on the north or south side of I-70, and above or below the glacial limit, is also shown.

Observations of debris flows along I-70 that we have made since the summer of 1996 (described in Coe et al., 2002; Godt & Coe, 2003; and Coe et al., in press) suggest that one of the reasons that debris flows occur frequently on fans at the mouths of basins with relatively large Melton's Numbers is that they have a greater likelihood of flowing to the fan than do debris flows in basins with relatively small Melton's Numbers. We suspect that if debris flows were to occur with equal frequency on hillslopes in all basins, many of the debris flows in the large basins with low to moderate relief (small Melton's Numbers) would deposit material at the base of hillslopes within the basins, not on fans at the mouths of basins. This would also explain why fans at basins with very small Melton's Numbers are dominated by flood events (Coe et al., in press), rather than debris-flow events. In basins with high Melton's Numbers, the base of the hillslope and the mouth of the basin are essentially the same. Debris flows in these basins simply flow down the hillslopes and are deposited on fans.

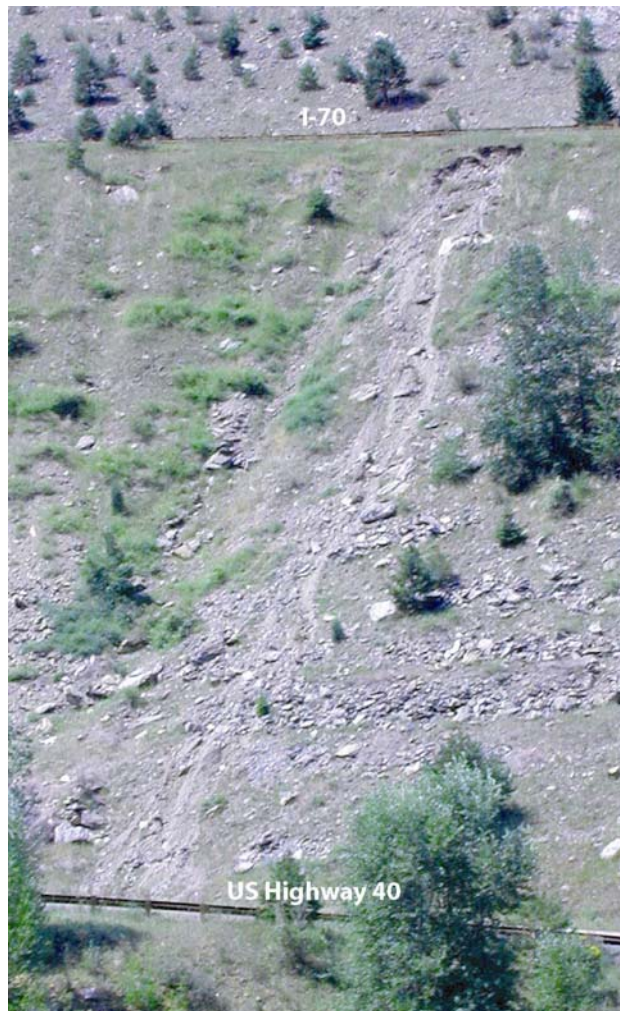
Figure 3. Debris flow along the north flank of I-70 at Floyd Hill. View is to the south. Photo taken August 4, 2000. See guard rails along I-70 and US Highway 40 for scale.

The historical debris-flow event located farthest east in Clear Creek County is on the north flank of Floyd Hill near mile marker 245 (Figures 1 and 3, Event 1 in Table 1). To our knowledge, this was the only debris flow triggered by a rainstorm in late July 2000. This debris flow initiated as a shallow landslide (also referred to as a soil slip, Campbell, 1975; also see Reid et al., 1988 and Iverson et al., 1997) in fill material beneath I-70 (Figure 3). Another debris flow occurred at Floyd Hill on July 8, 2001 (Event 2, Table 1). This debris flow deposited debris on the eastbound lane(s) of the highway.

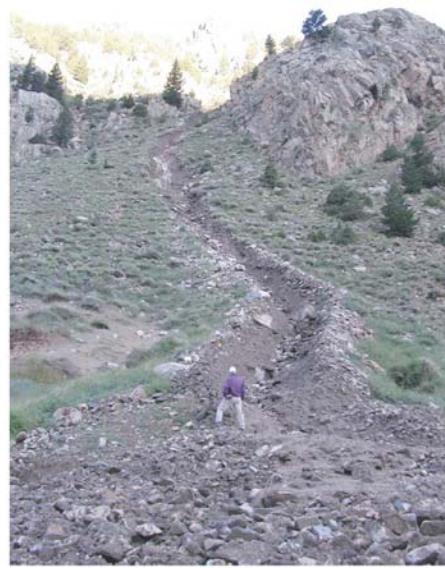
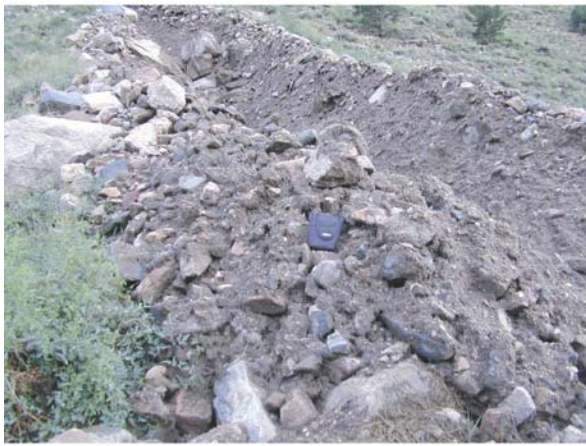
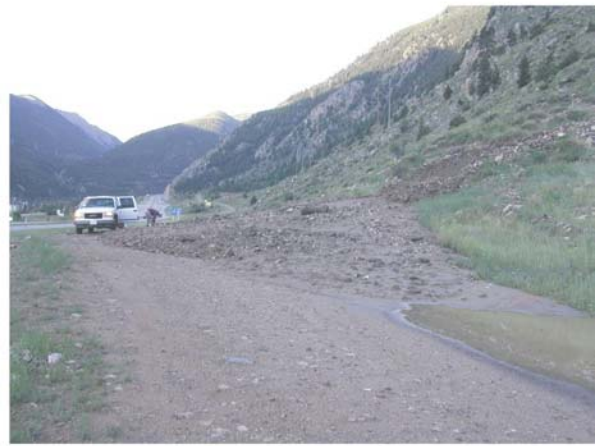
Figure 6. Drainage basin and July 13, 2001, debris-flow deposits near Georgetown (see Figure 4 for location). A) Drainage basin. Photograph taken August 30, 1996. B) Debris-flow channel. C) Matrix-supported debris-flow levee. Note camera case for scale. D) Fan formed by deposit. Photos B, C, and D were taken July 14, 2001.

One of the best locations to observe July 2001 debris-flow features in the area is on the north side of I-70 near Georgetown (Figure 6). The fan at this location is matrix-supported, poorly sorted, and contains randomly oriented clasts. Grain-size analysis (U.S. Geological Survey, 1999, unpublished data) of a similar deposit at the same location that resulted from a July 27 or 28, 1999, rainstorm (Event 11, Table 1) indicated that sand-sized material makes up most of the matrix (74 percent), followed by silt- (21 percent), and clay-sized material (5 percent). Unlike some of the other debris-flow channels in the area, this channel has matrix-supported levees that seemingly receive fresh material with each debris-flow event (e.g., see Figure 6c).

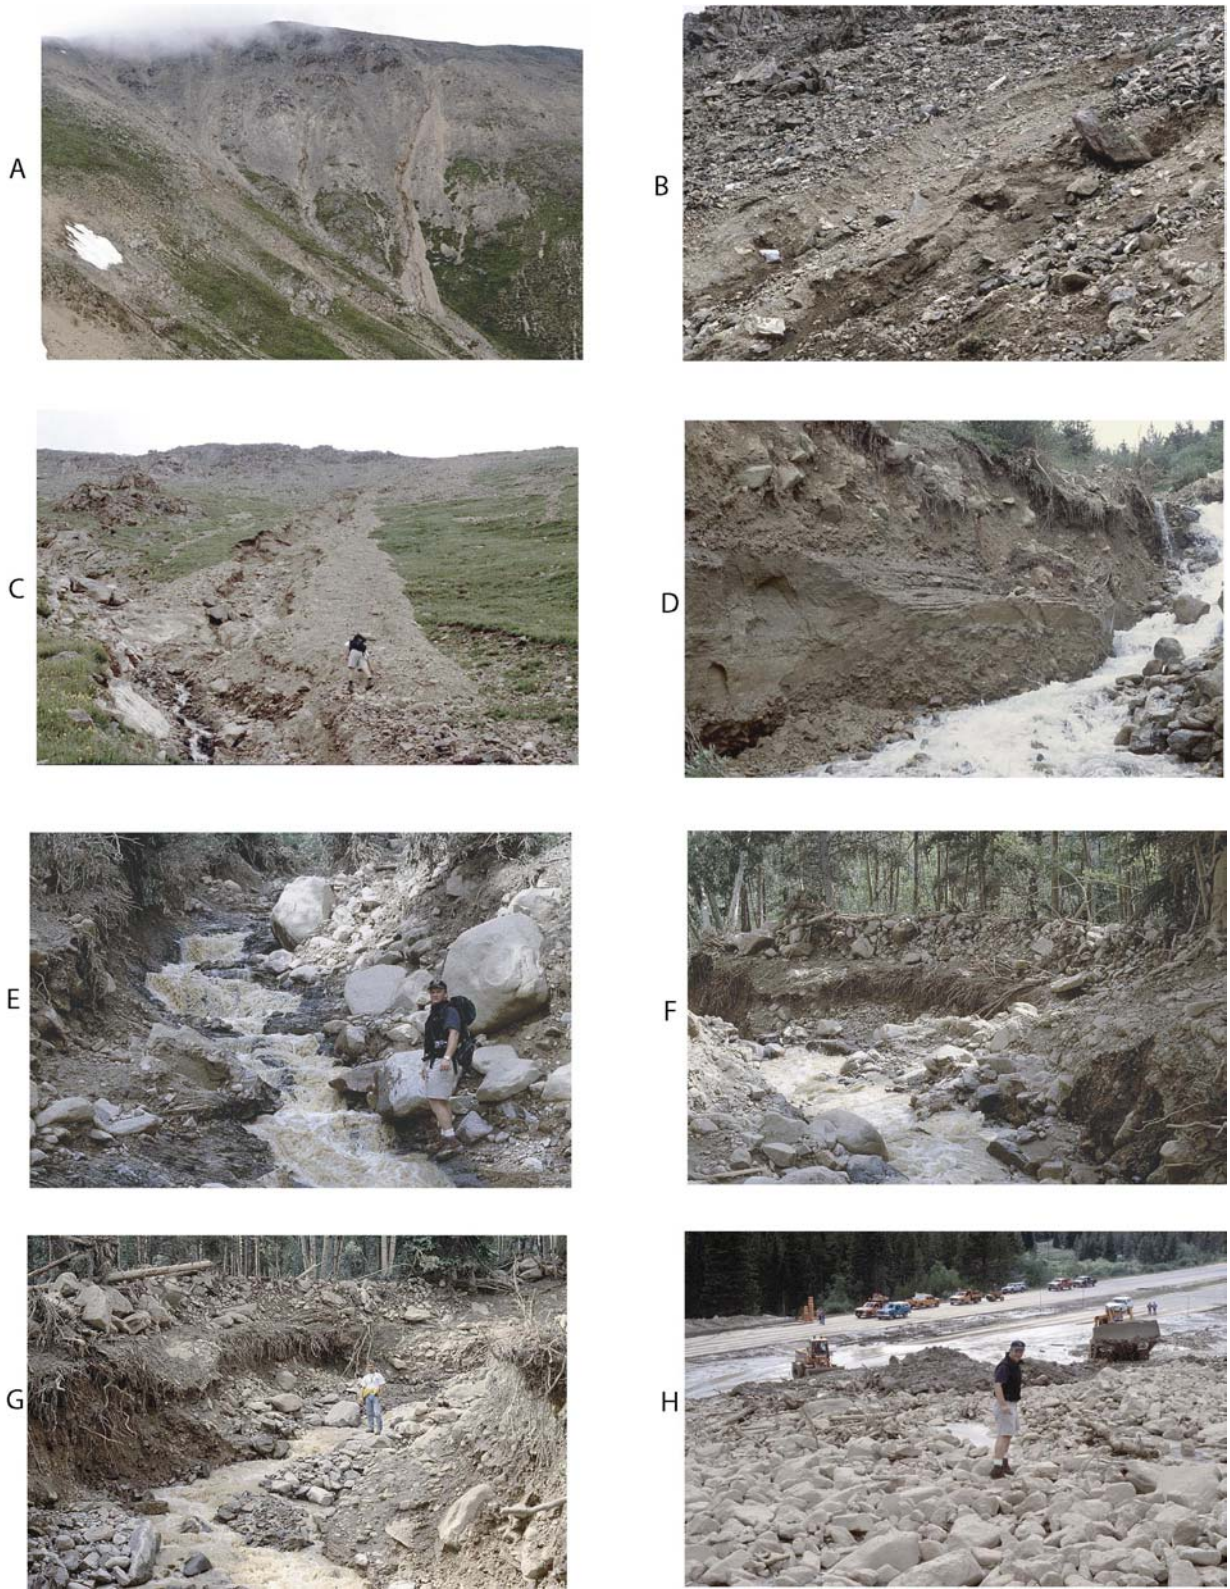
Figure 10. Photographs of Watrous Gulch taken after the July 28, 1999, debris-flow event. A) Rills in the source area. View to the east. Relief visible is about 610 m (2,000 ft).

Figure 10 – continued. B) Head of the largest rill in the source area (see quart-sized sample bag at lower left for scale). View to the north. C) View upstream along the largest rill. Note geologist for scale. D) Deposits exposed by the July 1999 debris-flow event located about half way between the head of the largest rill and the fan. Channel is about 3 m deep. Matrix-supported boulder-rich deposit on top, sorted, stratified, silt-rich deposit at base. View to the northwest. E) Bedrock-lined channel exposed by the July 1999 debris flow. F) Matrix-supported levee deposits along a bend in the channel above the fan. View downstream to south. Channel depth (thalweg to top of levee) is about 4 m. G) Matrix-supported levee deposits along a bend in the channel above the fan. View upstream to north. H) Fan on I-70. Photos A through D taken on August 4, 1999. Photos E through H taken July 29, 1999.

colluvium at the head of the largest rill included 84 percent sand-sized material, 8 percent silt-sized material, and 8 percent clay-sized material (U.S. Geological Survey, 1999, unpublished data). Clasts made up about 50 percent of the colluvium. As the Watrous Gulch debris flow(s) progressed downslope, it eroded material from the channel. Parts of the channel were incised several meters by the flow (Figures 10d, e, f, g). Material eroded from the channel included deposits of layered sandy-silt (Figure 10d), as well as matrix-supported deposits containing sub-angular to sub-rounded boulders (Figure 10d). The matrix of the flow became finer-grained as it progressed downslope. The matrix of the deposit on I-70 (Figure 10h) included 69 percent sand-sized material, 24 percent silt-sized material, and 7 percent clay-sized material. Clasts made up about 70 percent of the deposit on I-70 and were larger and more rounded than those in the colluvium at the source area (compare Figure 10b with Figure 10h).

An analysis of super-elevation of debris-flow levees (see Costa (1984) for description of the method) at a bend in the channel of Watrous Gulch directly above I-70 (Figures 10f and 10g) indicated a velocity for the Watrous Gulch debris flow of 32 ft/s (10 m/s). This compares favorably with video footage shot of the debris-flow from I-70 (Denver television station “News 4” footage). This footage shows what appears to be a hyperconcentrated flow coming from the mouth of the basin and mobilizing debris flows on the fan. It is unclear at what time during the debris-flow event the footage was shot.

The debris flow in Watrous Gulch, as well as a debris flow in the gulch directly east of Watrous Gulch, exposed fan stratigraphy that displayed a record of past debris flows (see Figure 13 in Coe et al. (2002)). This stratigraphy indicates that the mean recurrence intervals for debris flows in Watrous Gulch, and the gulch to the east, are about 3,000 yrs and 300 yrs, respectively. The Melton’s Numbers for the basins are 0.48 and 1.1, respectively. The negative correspondence between Melton’s Number and mean recurrence interval at these two basins fits the overall pattern for the corridor as a whole; that is, fans at the mouths of basins with larger Melton’s Numbers have shorter debris-flow recurrence intervals than fans at the mouths of basins with smaller Melton’s Numbers (Figure 2). Additionally, the fan stratigraphy at the mouths of the two gulches also suggests that there was at least one previous debris-flow event (between 720 and 930 cal yrs BP) that affected both fans.
