U.S. Department of the Interior
U.S. Geological Survey

Floods of June 28-29, 1998 in Ohio

Water-Resources Investigations Report 99-4192

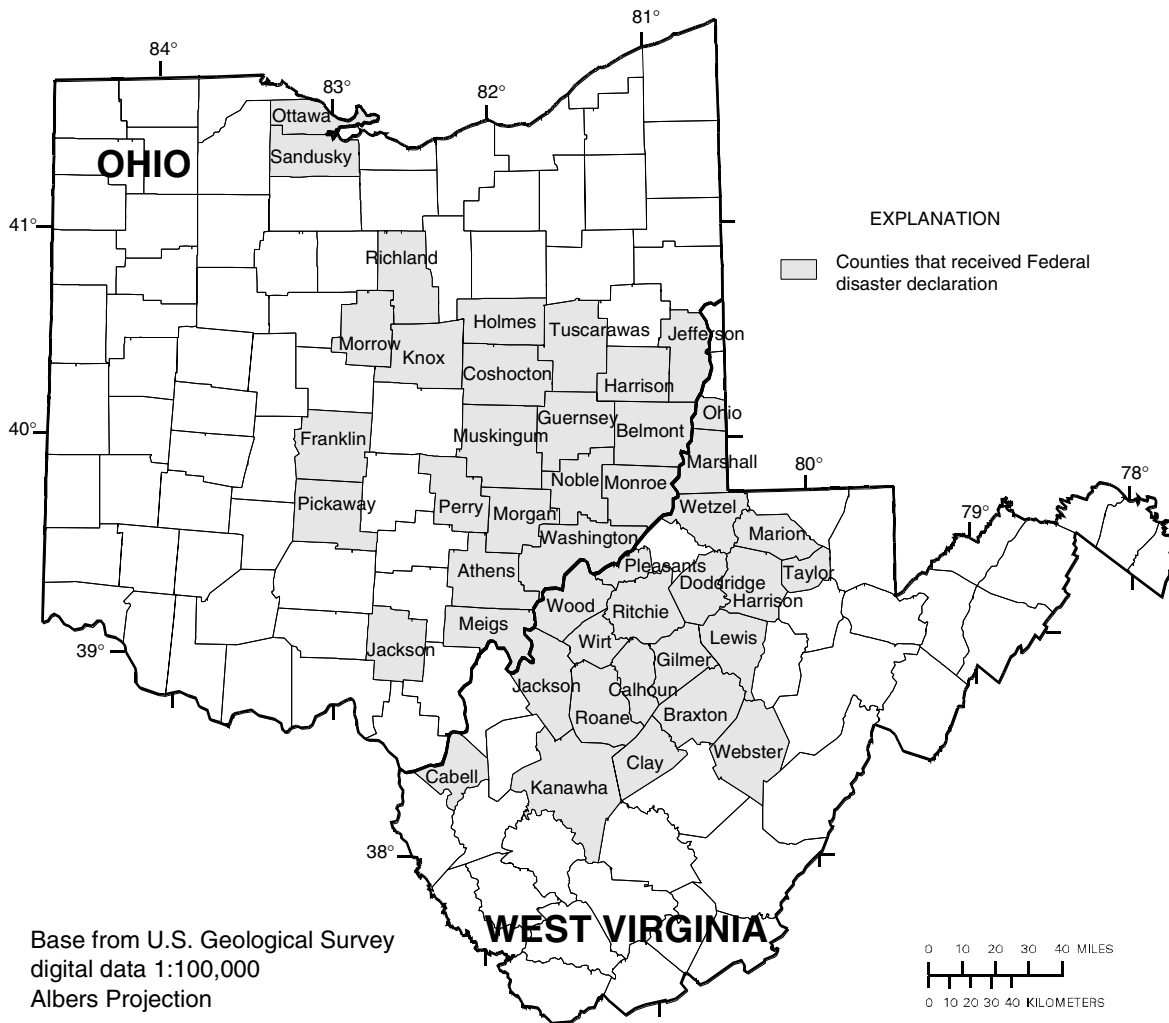
Figure 3. Ohio and West Virginia counties that received Federal disaster declarations as a result of storms and flooding in late June 1998.

The June 1998 storms caused flooding and other damage in much of central, east-central, and southeastern Ohio and in parts of northwestern, north-central, and central West Virginia. Flood and storm damage was sufficient to make 23 counties in Ohio (Athens, Belmont, Coshocton, Franklin, Guernsey, Harrison, Holmes, Jackson, Jefferson, Knox, Meigs, Monroe, Morgan, Morrow, Muskingum, Noble, Ottawa⁵, Perry, Pickaway, Richland, Sandusky⁵, Tuscarawas, and Washington) and 21 counties in West Virginia (Braxton, Cabell, Calhoun, Clay, Doddridge, Gilmer, Harrison, Jackson, Kanawha, Lewis, Marion, Marshall, Ohio, Pleasants, Ritchie, Roane, Tyler, Webster, Wetzel, Wirt and Wood) eligible for Federal disaster assistance (fig. 3). Flooding was most severe in the Ohio counties of Guernsey, Noble, and Washington and the West Virginia counties of Jackson, Kanawha, and Wood. All six counties lie roughly along a single north-south line coincident with the band of heaviest rainfall.

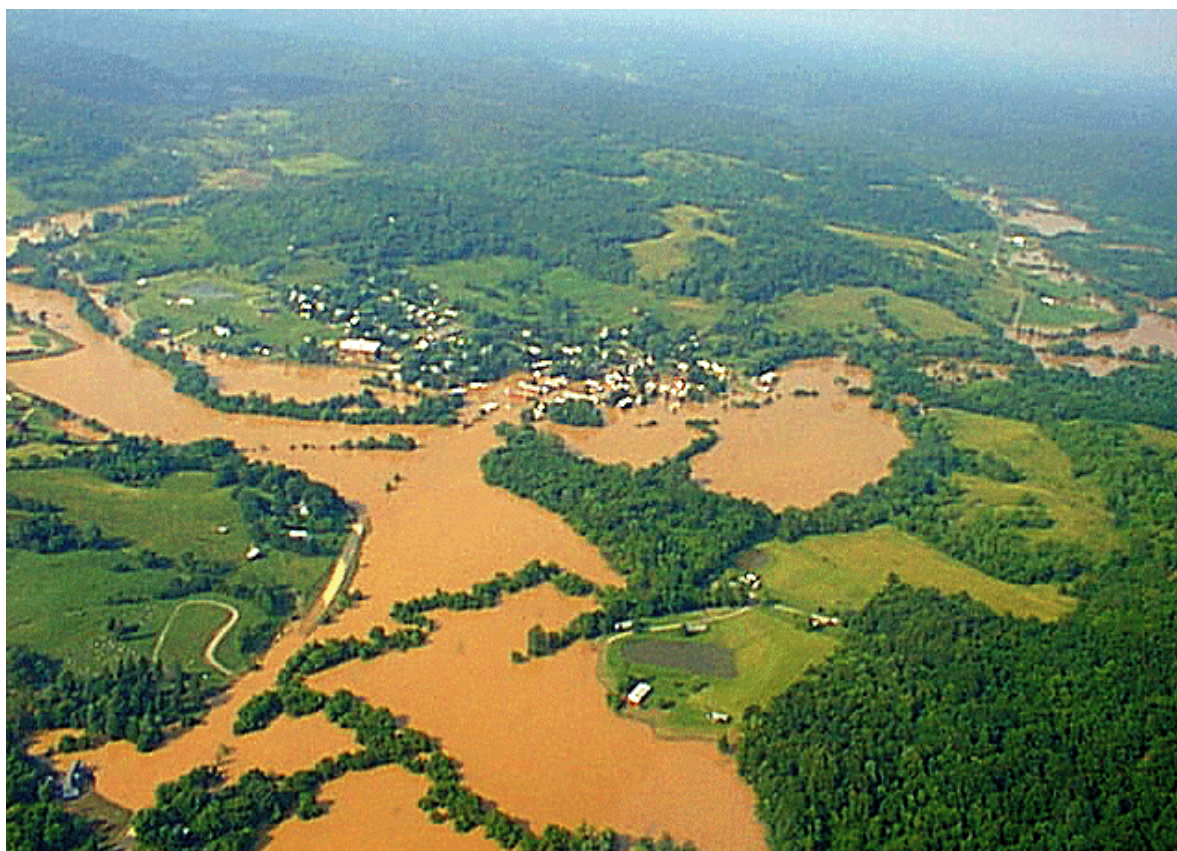
Figure 5. Aerial view of flood waters at the confluence of McDougal Branch and Federal Creek in the Village of Amesville, Ohio (view looking northeast).

Federal Creek (Athens County) — The Village of Amesville (figs. 4 and 5) has experienced several large floods this century including three large floods since 1963. Mayo and Webber (1969) stated that in March 1963, water was 7 ft deep on the main street (presumably the present State Route 550) and that a flood of similar magnitude occurred in the early 1920's. Severe flooding occurred again in March 1997. Flood levels in 1997 were reported to be about 6 ft lower than those in 1998 (Federal Emergency Management Agency, 1998), indicating that the flood of 1997 reached levels somewhat higher than the 1963 flood. The flood of 1998 is the flood of record, with peak flood levels in the Village of Amesville exceeding 1963 levels by about 7-8 ft.

The USGS indirectly determined the peak discharge for Federal Creek by means of the slope-area method. The

slope-area calculations were based on data collected for a stream segment beginning about 1,500 ft downstream from the confluence of Federal Creek and McDougal Branch and extending downstream approximately 9,800 ft. The peak streamflow calculated for the Federal Creek stream segment described above is 31,800 ft³/s (table 1). No streamflow data have been collected on Federal Creek from which to make a direct estimate of the flood recurrence interval; however, an estimate derived from the most current regional regression equations for estimating flood magnitude and frequency (Koltun and Roberts, 1990) indicates that 1998 flood was considerably in excess of a 100-year flood.

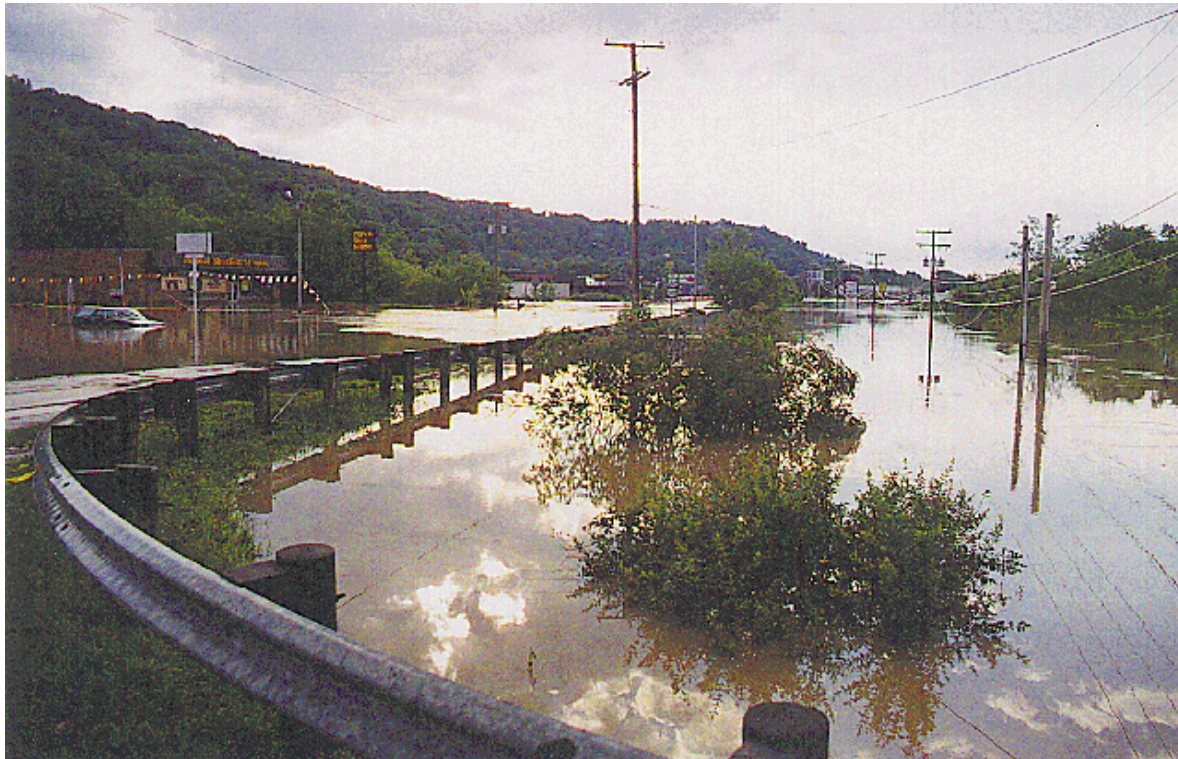
Figure 7. Flooding from Wills Creek along State Route 209 in Cambridge, Ohio (view looking northwest).

Wills Creek (Guernsey County) — The City of Cambridge and the Village of Byesville were severely impacted by flooding from Wills Creek (figs. 4 and 7). The USGS has operated a streamflow-gaging station on Wills Creek at Cambridge, Ohio (station number 03142000) (fig. 4), since May 1937. A gage was also operated during the period June 1926 to September 1928. Senecaville Lake, located on Seneca Fork, a tributary of Wills Creek, has regulated streamflow in Wills Creek at both Cambridge and Byesville since about 1937. The U.S. Army Corps of Engineers operates the dam on Senecaville Lake principally for flood control and was not releasing water from the dam during the peak of the flood. However, on June 29, 1998, water levels in Senecaville Lake came within less than 1 ft of the spillway crest and eventually reached a record peak level of 842.39 ft above sea level (0.17 ft lower than the spillway crest) on July 3, 1998 (Gary Mankin, U.S. Army Corps of Engineers, written commun., 1999).

On June 29, 1998, the streamflow-gaging station on Wills Creek at Cambridge recorded a record peak stage of 26.91 ft with a corresponding streamflow of 11,400 ft³/s. The peak stage of 26.91 ft, which corresponds to an elevation of 799.25 ft above sea level, is larger than any historically documented peak stage at that site (including pre-regulation
