RIGID PAVEMENT

CONCRETE PAVEMENT JOINTS

T 5040.30

November 30, 1990

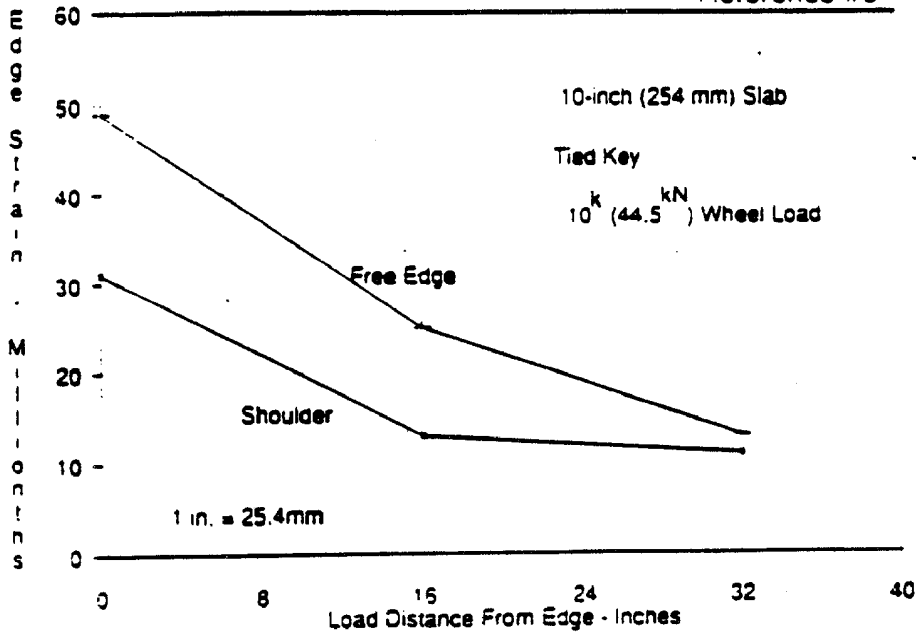
Figure 10

Edge Strain in Laboratory Test Slab
