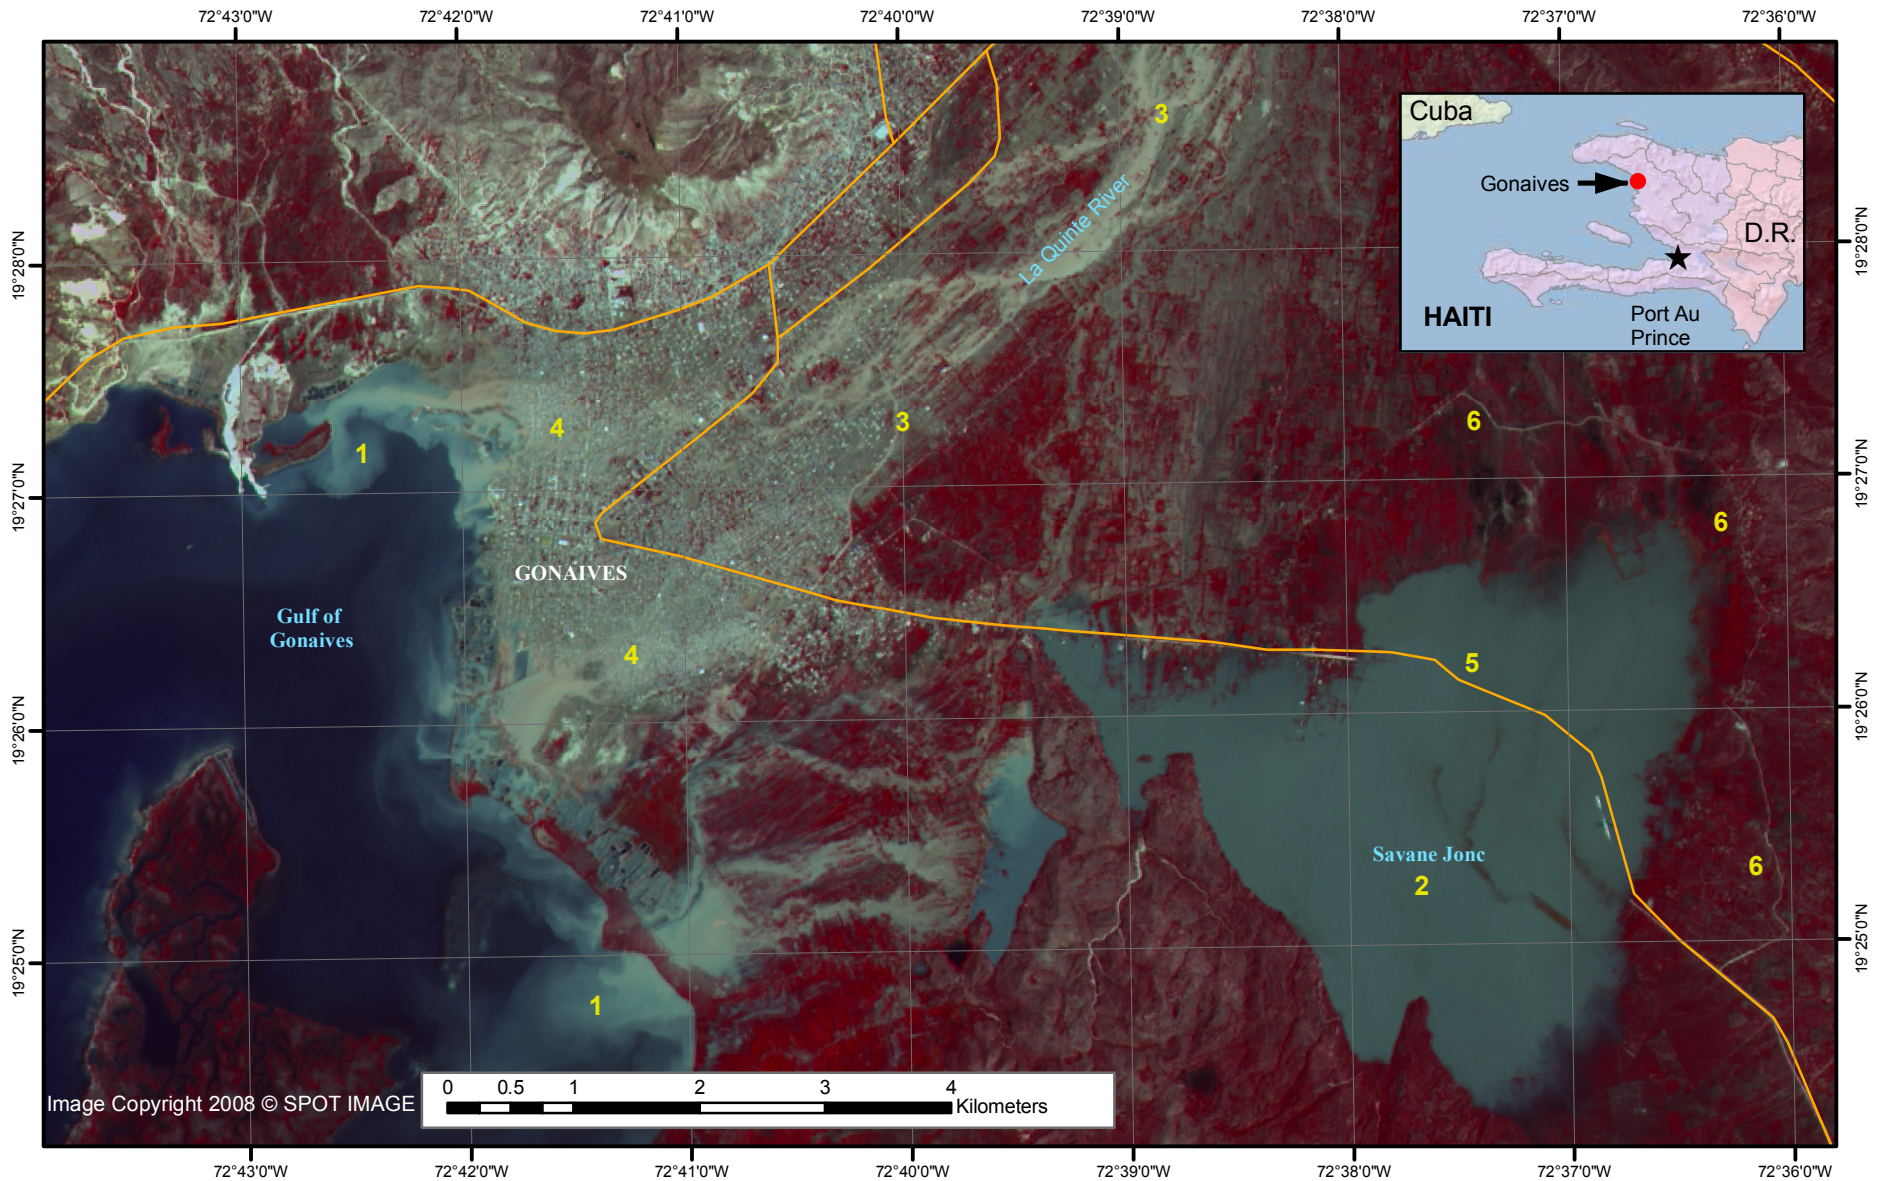
The effects of extreme rainfall related to Hurricanes Hanna and Ike cause flooding, destruction and loss of life in Gonaives and other regions of Haiti. This image clearly shows the sediment loaded runoff still coloring the water bodies, including the Gulf of Gonaives (1) and the Savane Jonc (2). The La Quinte River has deposited significant quantities of sediment outside of its channel (3) and changed its route to the sea, cutting directly through the city of Gonaives (4). The Savane Jonc has swollen and submerged the causeway linking to points south (5). Engineers are working to increase the capacity of a detour to handle the increased traffic loads (6).
