2008 HURRICANES IN THE CARIBBEAN

Gonaives, Haiti
September 9, 2008

Post Hurricane Hanna/Ike Damage Overview

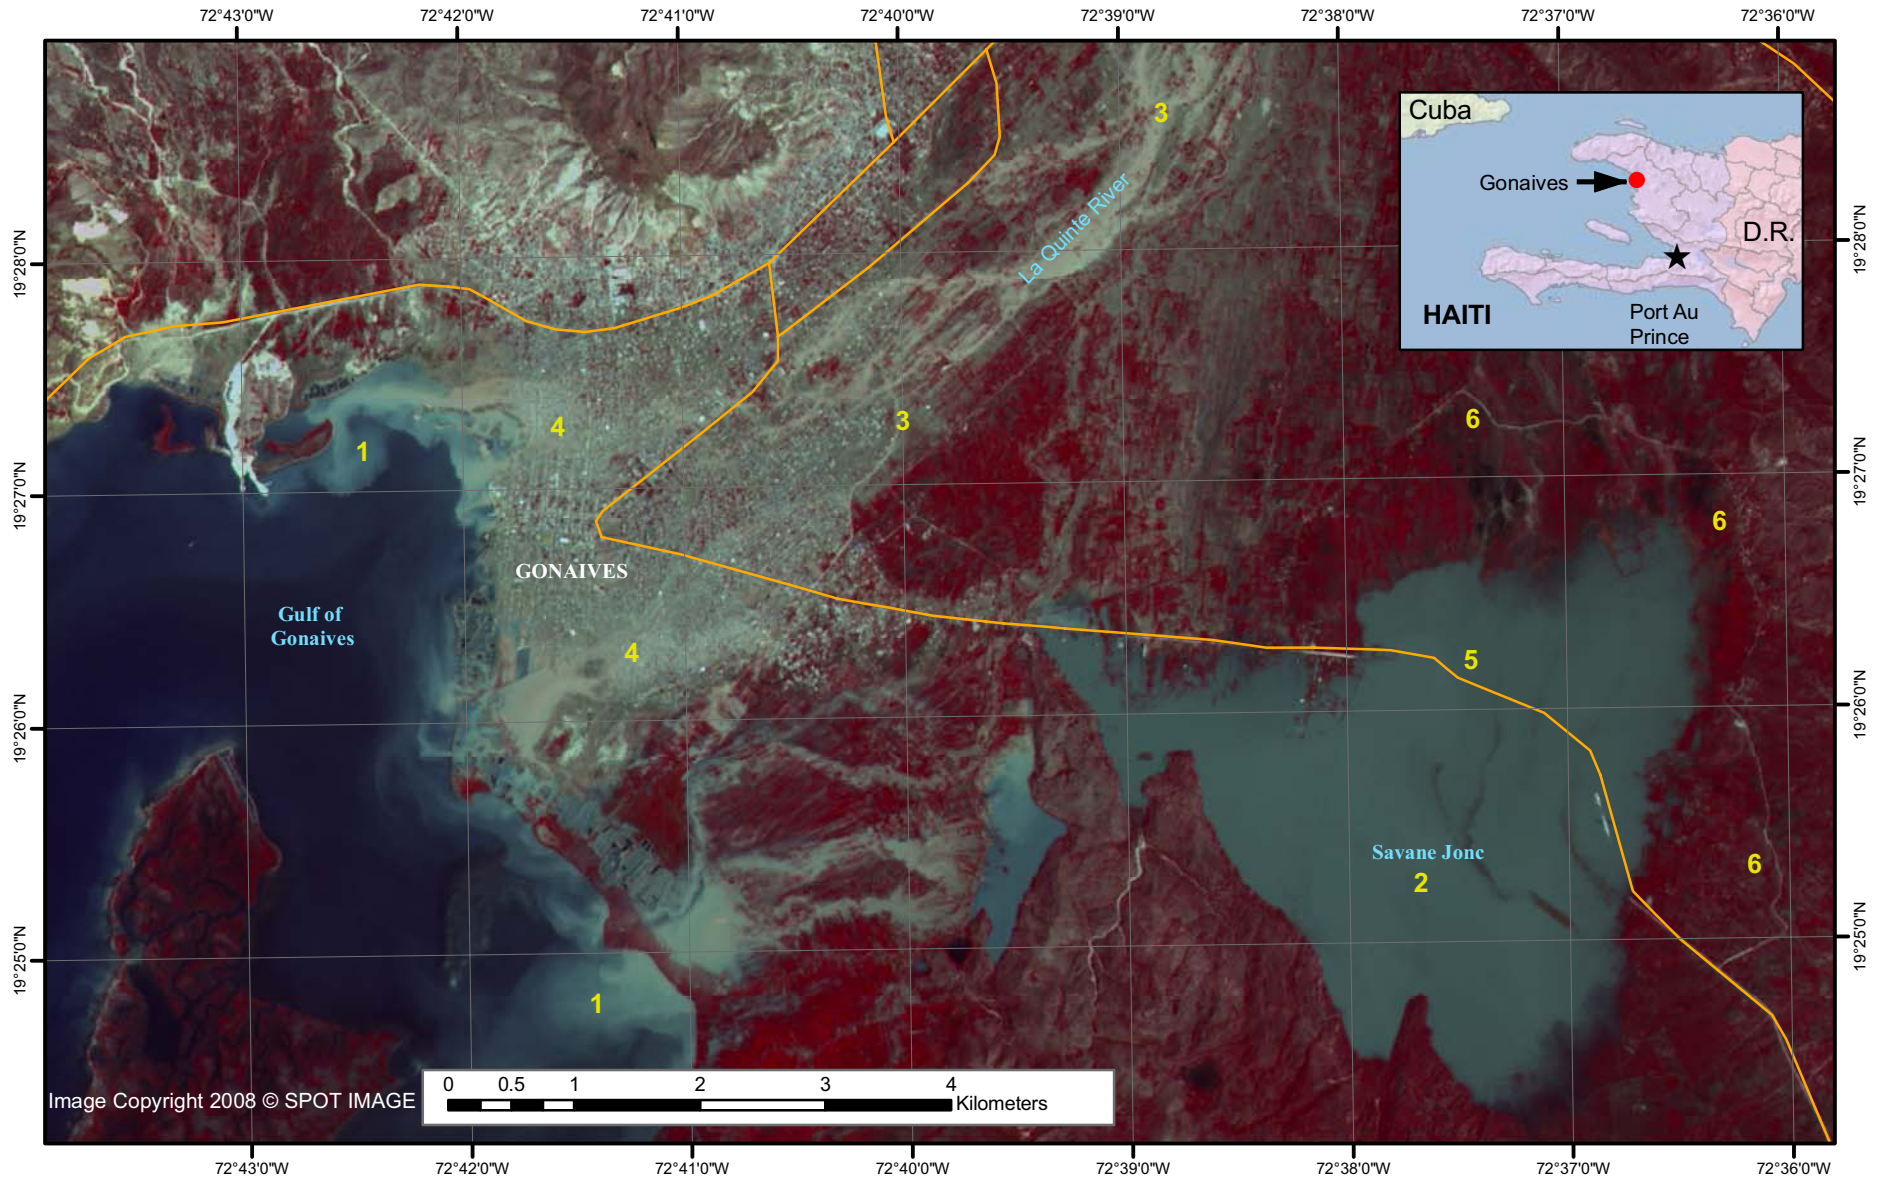
The effects of extreme rainfall related to Hurricanes Hanna and Ike cause flooding, destruction and loss of life in Gonaives and other regions of Haiti. This image clearly shows the sediment loaded runoff still coloring the water bodies, including the Gulf of Gonaives (1) and the Savane Jonc (2). The La Quinte River has deposited significant quantities of sediment outside of its channel (3) and changed its route to the sea, cutting directly through the city of Gonaives (4). The Savane Jonc has swollen and submerged the causeway linking to points south (5). Engineers are working to increase the capacity of a detour to handle the increased traffic loads (6).
