NIOSH HEALTH HAZARD EVALUATION REPORT:

HETA #2002-0239-2922
United States Postal Service
Norman, Oklahoma

January 2004

Evaluation of a Human Transporter to Deliver Mail

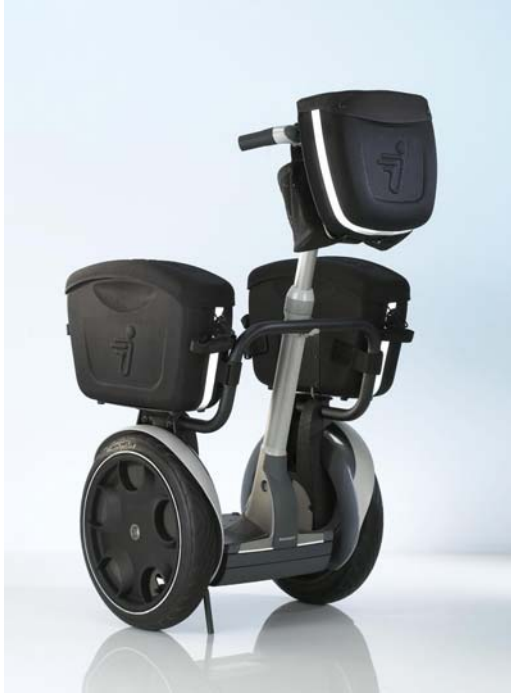
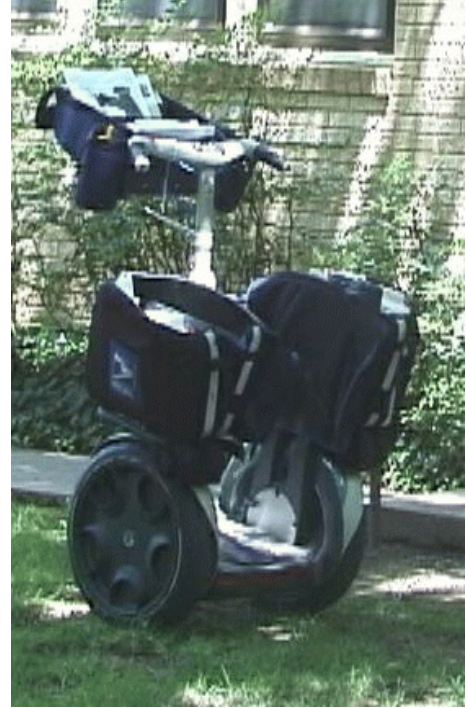
Figure 1: A view of the basic e-series cargo carrying human transporter (left) and the modified human transporter (right) used in Norman, Oklahoma.

Figure 1 shows a comparison between the HT with cargo carrying accessories and the modified HT the USPS used in Norman, Oklahoma. The dimensions of the modified HT are shown in Table 3.

The main dimensions of the HT used in Norman that could influence the comfort and usability for letter carriers of various sizes are the height adjustment of the handle bar, the height and size of the mail carrier bins, and the length and diameter of the handle grips.

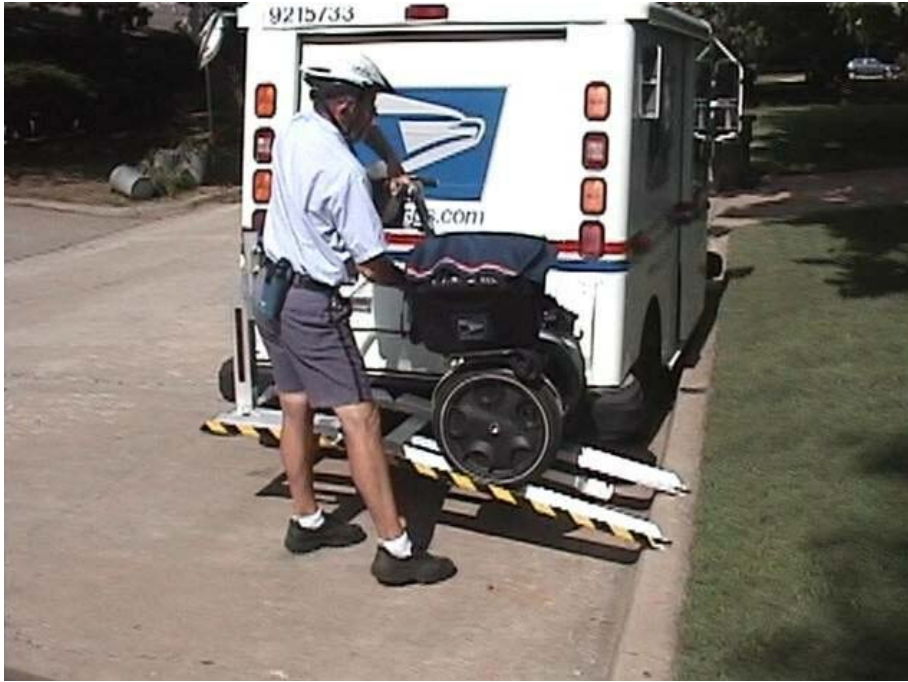
Figure 2: Mail carrier guiding the HT down the transport ramp.

The HT is carried by the LLV by means of a platform attached to the rear frame, 17 inches above ground level. The HT is placed on the platform by means of a retractable dual ramp. The HT can be dragged up the ramp or “walked” up with the HT in “follow mode,” one of the many selections provided by the unit’s control switch. The HT can go up and down the loading ramps with the left side carrier on, but the right side bin must be removed for clearance. It is easier to lock the ramps in the vertical position if the left carrier is also not on the HT.

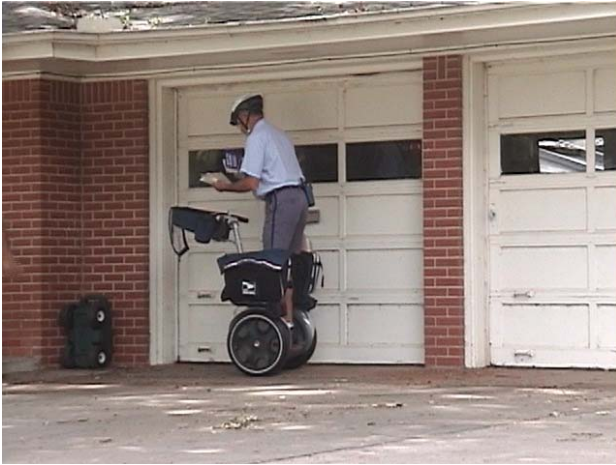
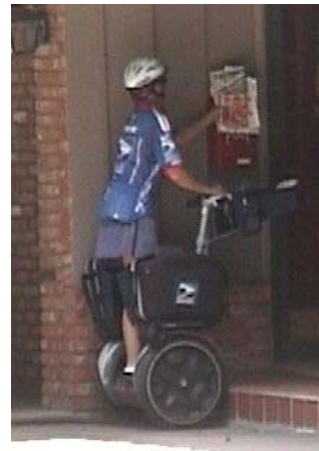
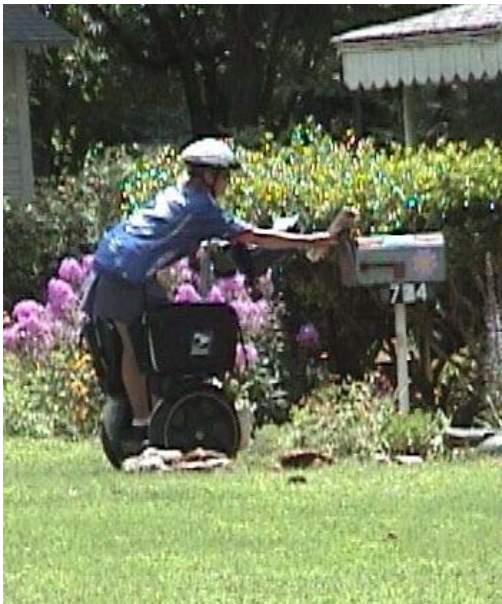
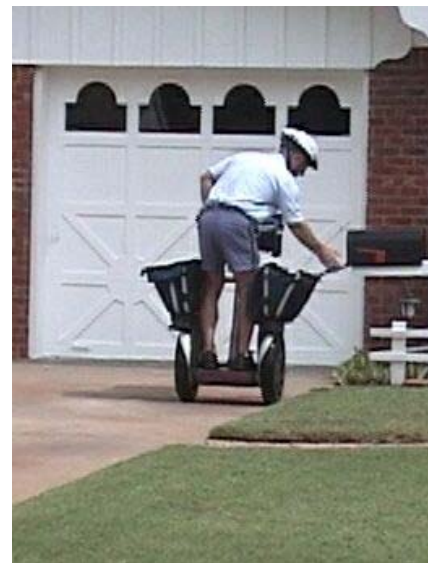
Figure 3: Neutral body postures while delivering mail on the HT (a, b); Reaching and bending to deliver mail while standing on the HT (c, d).

The ergonomics evaluation consisted of a comparison of the physical dimensions and adjustability features of the HT to what is described in the ergonomics literature as acceptable to the various percentiles of the adult population. Analysis of video tapes taken during the evaluation served as a means of determining if use of the HT to deliver mail was associated with any postural demands (excessive reaching, awkward body positions or wrist postures) that would not occur during traditional mail delivery (see Figure 3).

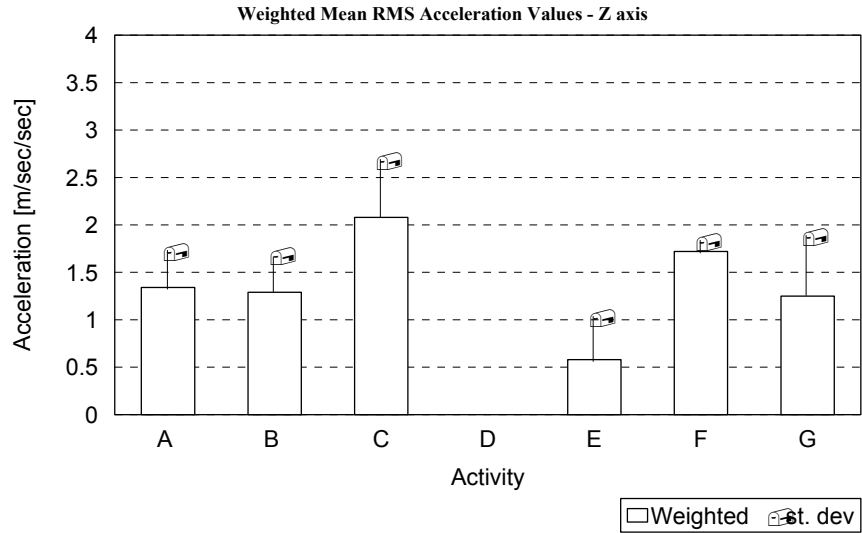
Figure 4
 Segway Unit #34
 U. S. Postal Service
 Norman, OK
 HETA 2002-0239
 July 16-17, 2002

A - drive & street; B - street; C - lawn; D - sidewalk; E - idle; F - bump; G - other

driveway and street activity both occurring in the same period. The mean acceleration values and standard deviations for each activity were calculated for both the weighted and flat measurement conditions in the z-axis and are presented in Figures 4-7, which represent the four Segway units. Each activity was not observed for each measurement period and for instances where only one observation of an activity was seen, there is no standard deviation given on the figure. The greatest mean acceleration values were measured at approximately 2 m/sec² (which is equivalent to the m/sec/sec metric on the figures). Travel on lawns and over observable bumps generally were found to have the greatest amount of vibration in the z-axis.

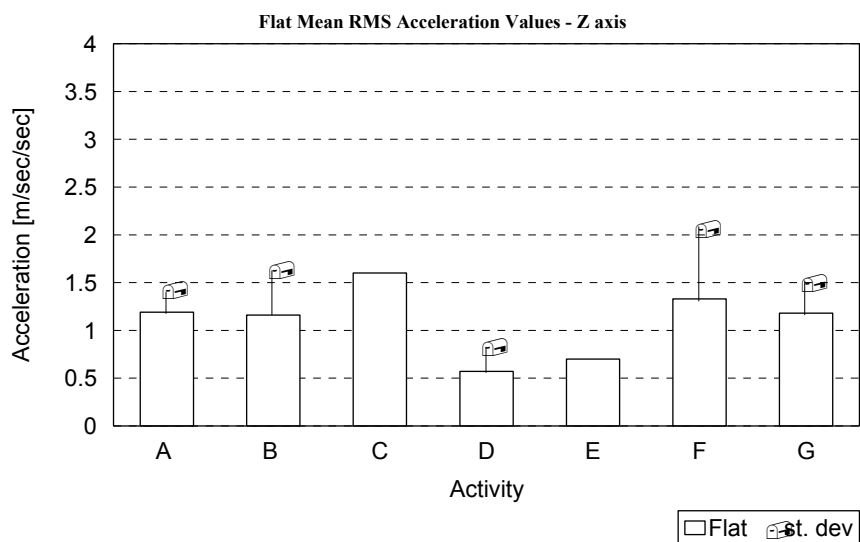
Figure 6
 Segway Unit #20
 U. S. Postal Service
 Norman, OK
 HETA 2002-0239
 July 16-17, 2002

A - drive & street; B - street; C - lawn; D - sidewalk; E - idle; F - bump; G - other
