**Federal Highway
Administration**

Publication No. FHWA-RD-88-001
December 1988

More Effective Cold, Wet-Weather Patching Materials for Asphalt Pavements

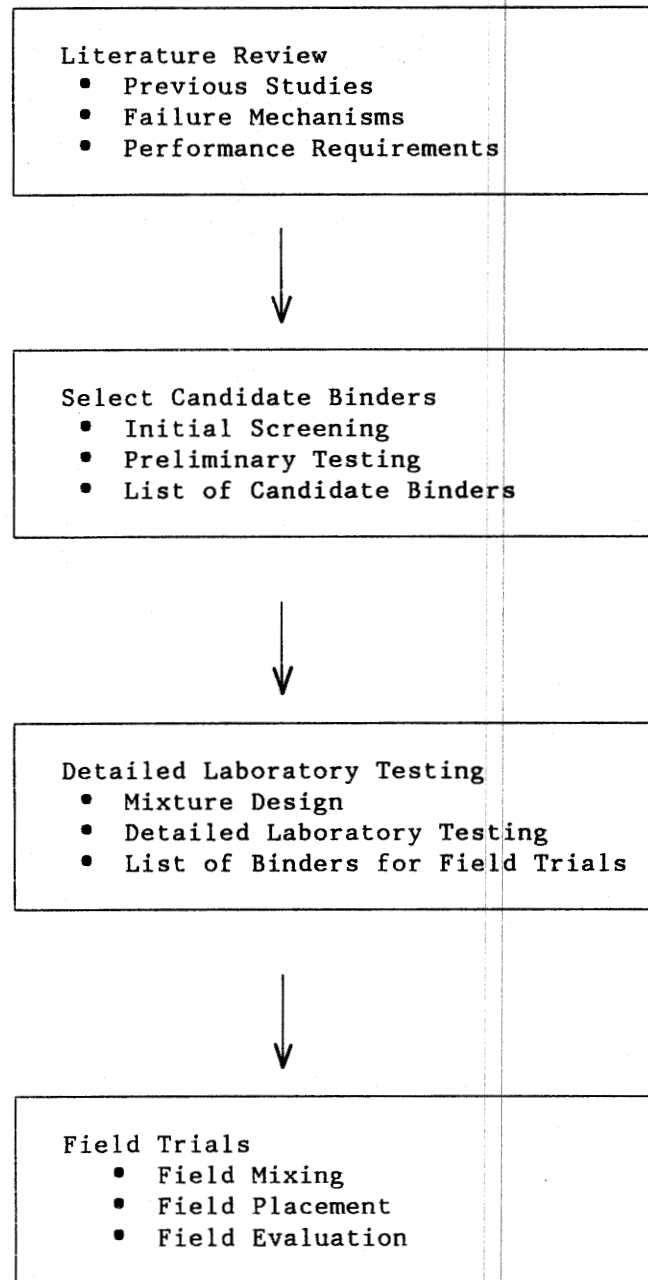
Figure 1. Flowchart for selection and testing of patching mixtures.

The flowchart shown in figure 1 depicts the sequence for the selection and testing of the patching mixtures developed in the study.

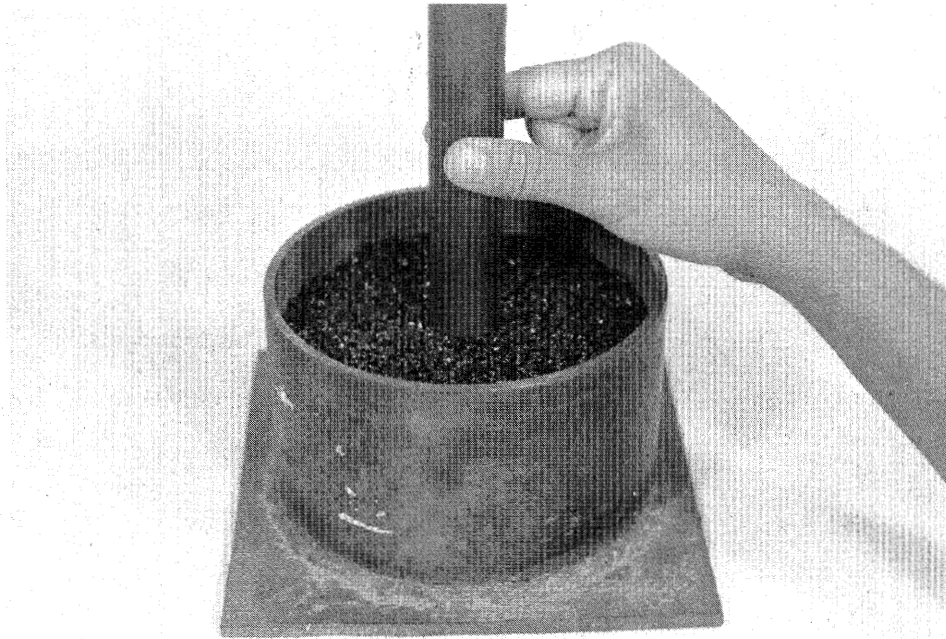
Figure 4. Stability test mold and loading foot.

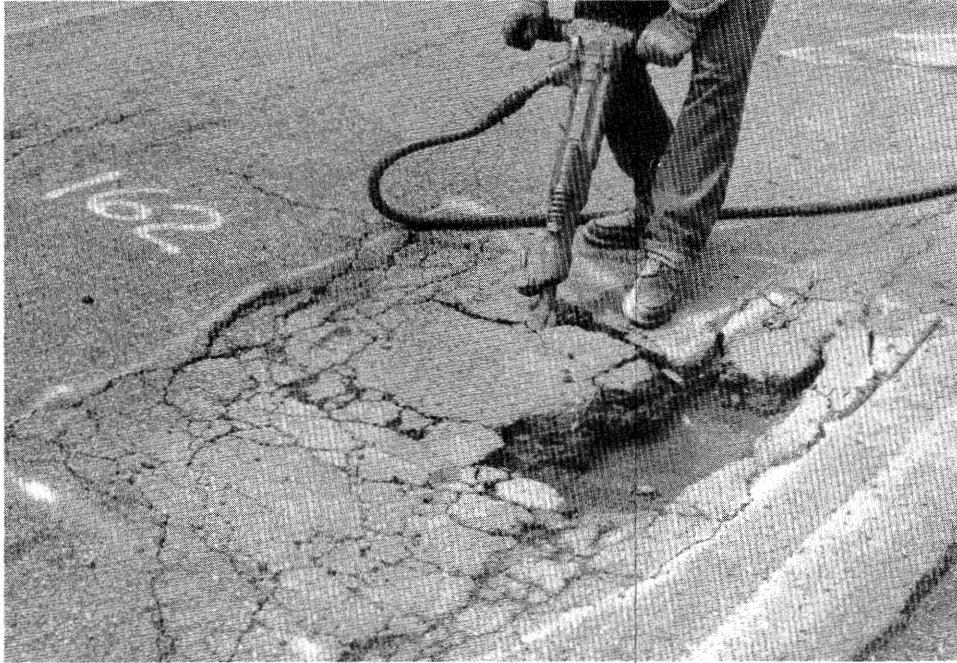
Figure 7. Cutting operation for standard procedure.

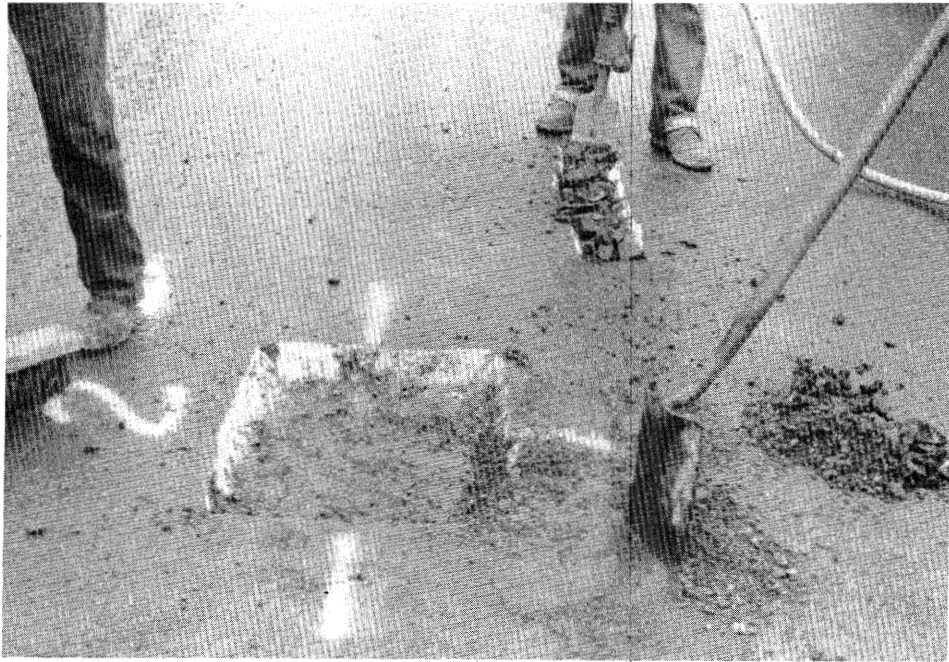
Figure 8. Cleaning operation for standard procedure.

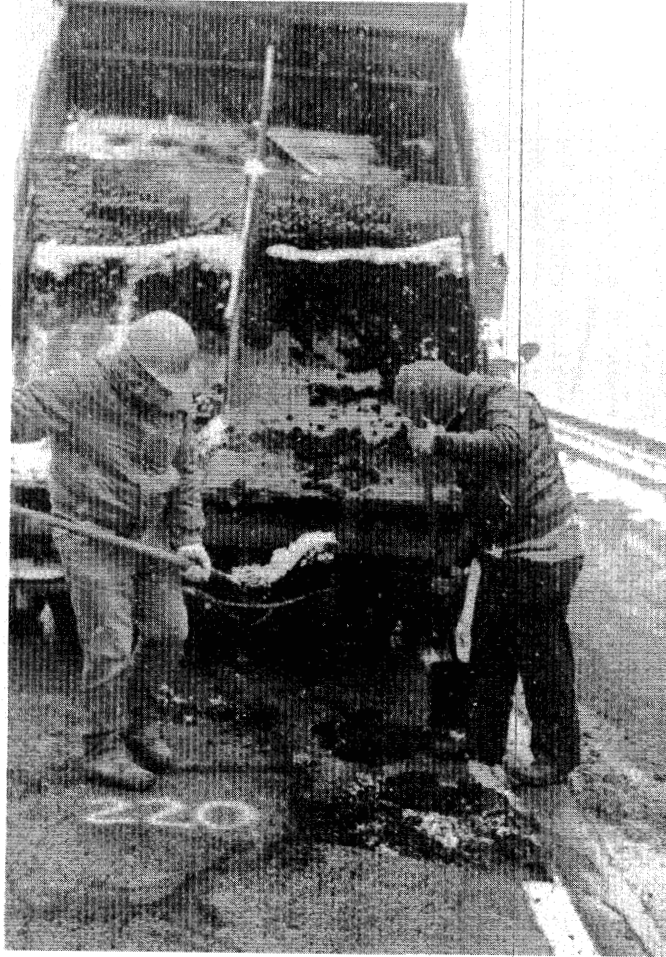
Figure 10. Nonstandard repair procedure.

The nonstandard strategy, illustrated in figure 10, does not involve cutting out the affected area. Loose material is removed with a shovel or broom, and patching material is shoveled into the hole. Compaction is usually accomplished by a few passes with the repair truck or a few blows with the back of a shovel. In this study, for the nonstandard method, compaction was performed with the truck.

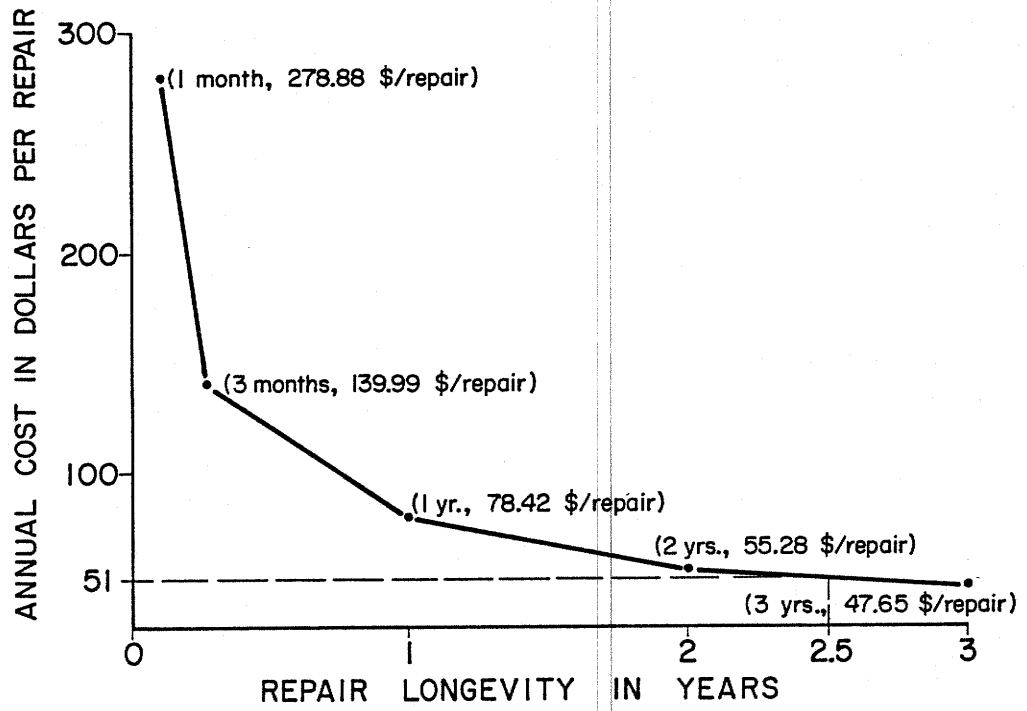
Figure 19. Variation in equivalent uniform annual cost with repair longevity.

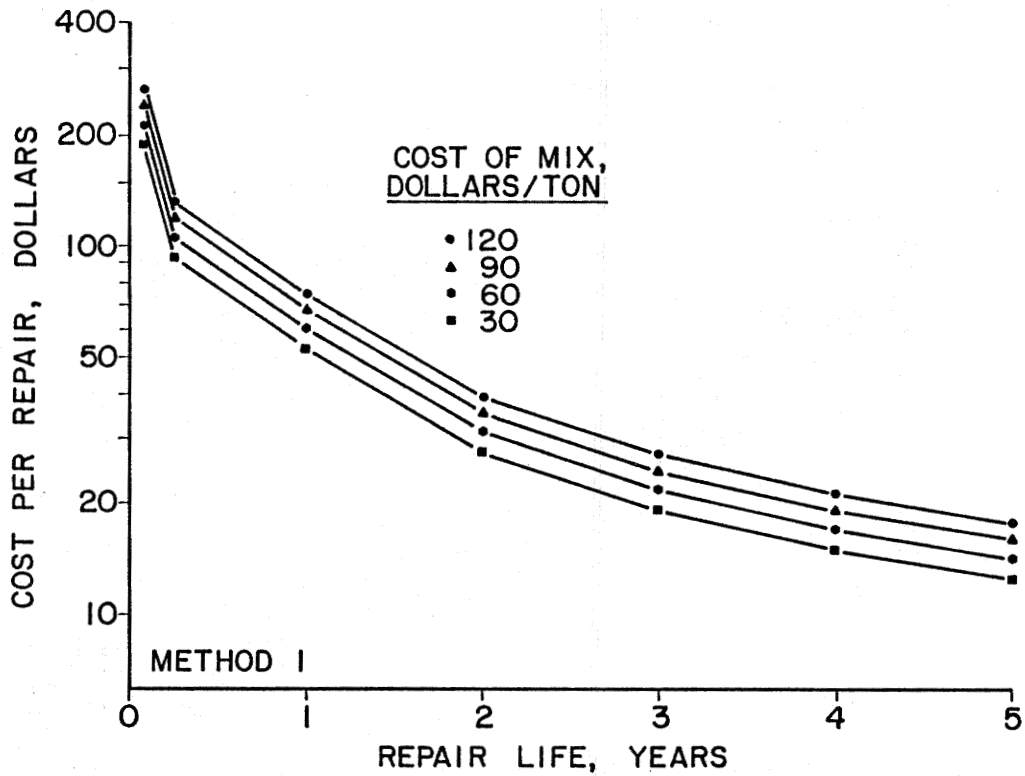
Figure 20. Equivalent uniform annual cost (dollars per repair) for the standard method when repairs can be productionized.

A review of figures 20 through 22 provides some insight into the influence of material cost on annualized costs. As can be seen, the annualized cost differential for various materials ranging in cost from \$30 per ton to \$120 per ton is relatively small. This is especially true for the range of costs shown in table 18, \$30 to \$46 per ton. The dominant influence on annualized cost is the longevity of the repair.

Figures 20 through 22 can be used to compare costs for different materials. Suppose an agency is presently using a material that cost \$30 per ton, and the average repair life using the standard procedure is 1.0 year. The cost of each repair is \$52.58 (figure 20). Figure 20 clearly shows that if the average service life can be extended to 2 years, then the use of material costing as much as \$120 per ton would result in a significant cost saving. Even the HFMS-2BF at \$46.66 per ton, which was the most expensive mix studied, is comparable to the \$30 per ton mix if the average service life can be extended from 1.0 to 1.1 years or more. A similar pattern prevails with longer service lives. A \$30 per ton mix lasting 2.0 years is comparable to a

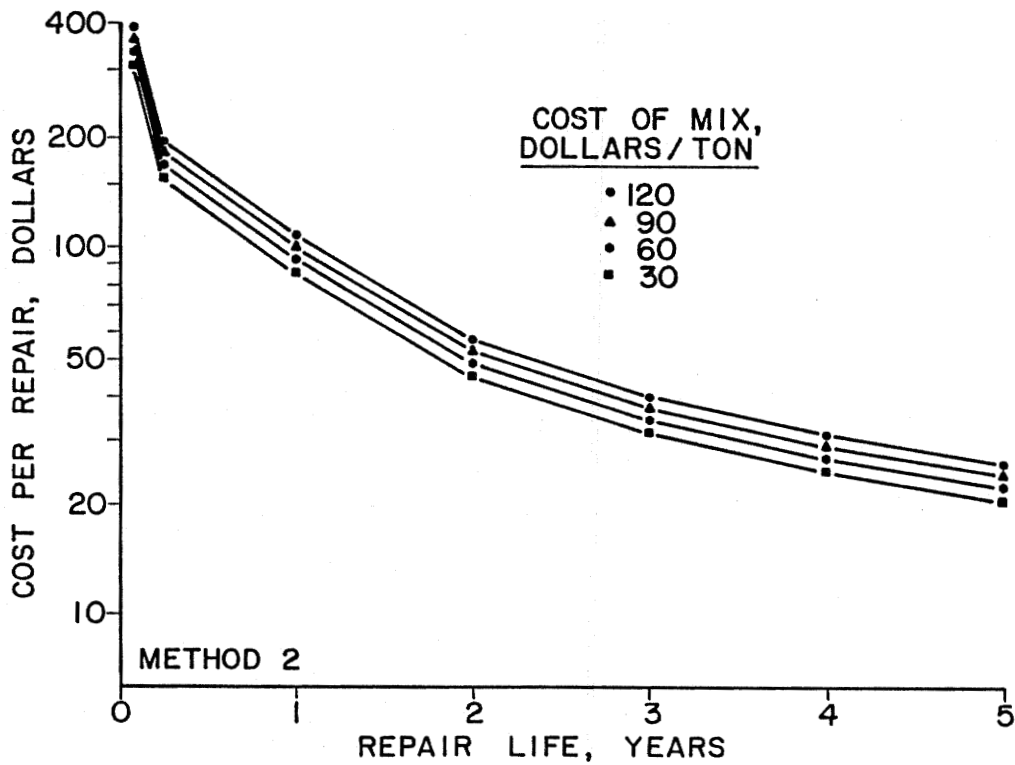
Figure 21. Equivalent uniform annual cost (dollars per repair) for the standard method when repairs cannot be productionized.

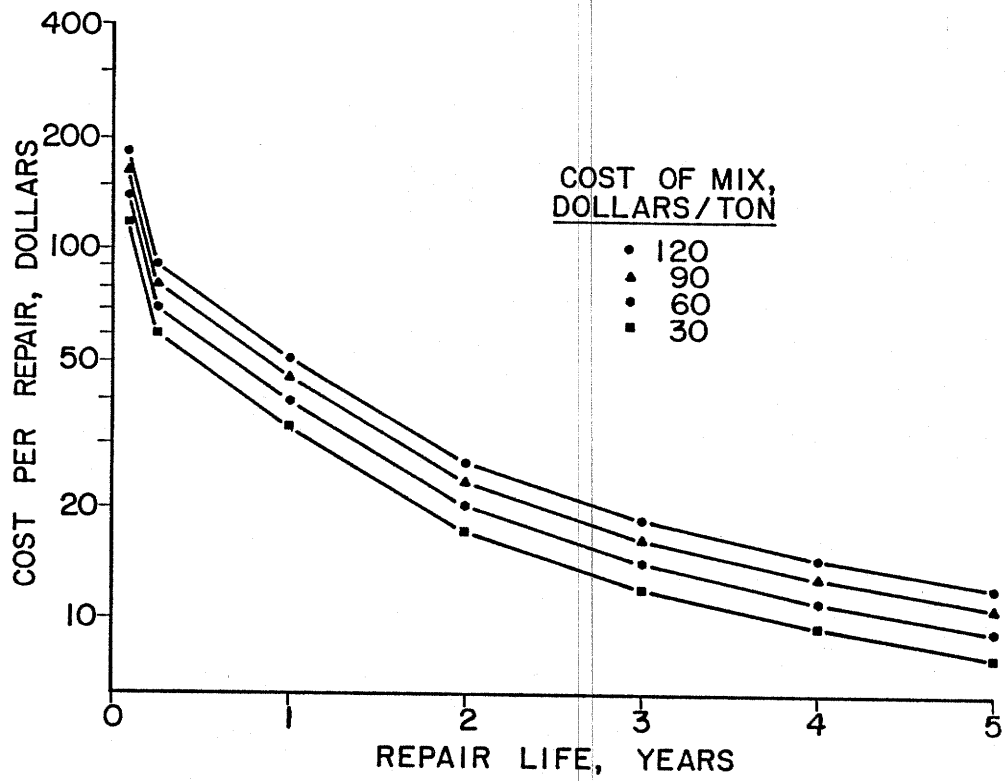
Figure 22. Equivalent uniform annual cost (dollars per repair) for the nonstandard method.
