SUMMARY REPORT

US 23, Future I-26 New Interstate Concrete Paving

**Madison County, North Carolina
Summer 2002**

FHWA MCL Project # 0205

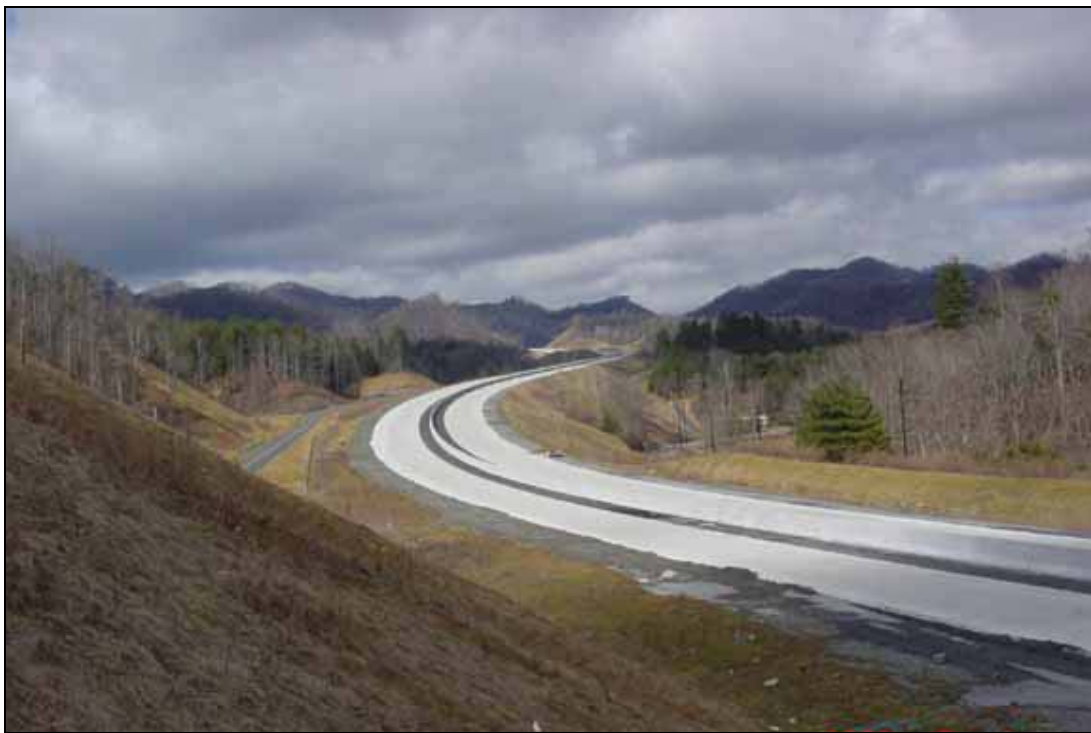
Figure 1. Completed concrete pavement on Future I-26, Madison Co., NC.

This report summarizes the findings from a concrete materials test program conducted by FHWA's Mobile Concrete Laboratory on new concrete interstate paving on US Route 23 between Mars Hill, North Carolina and Sam's Gap at the Tennessee State line (North Carolina State Project No. 8T842401, MCL Project # 0205). The project traverses extremely rugged mountain terrain in the Smokey Mountains north of Asheville. The project required the excavation of 37 million cubic yards of material with cuts as high 600 feet and embankments as high as 220 feet. The majority of the project is on 5 and 6% vertical grade. During the summer of 2002, approximately 9 miles of new concrete interstate pavement was placed. The pavement consists of six lanes of jointed plain concrete pavement (JPCP) 10" in depth over a 3" asphalt base layer. The joints were doweled and spaced at 18, 19, 21 and 22 feet. Figure 1 shows a section of the project after the completion of concrete paving.

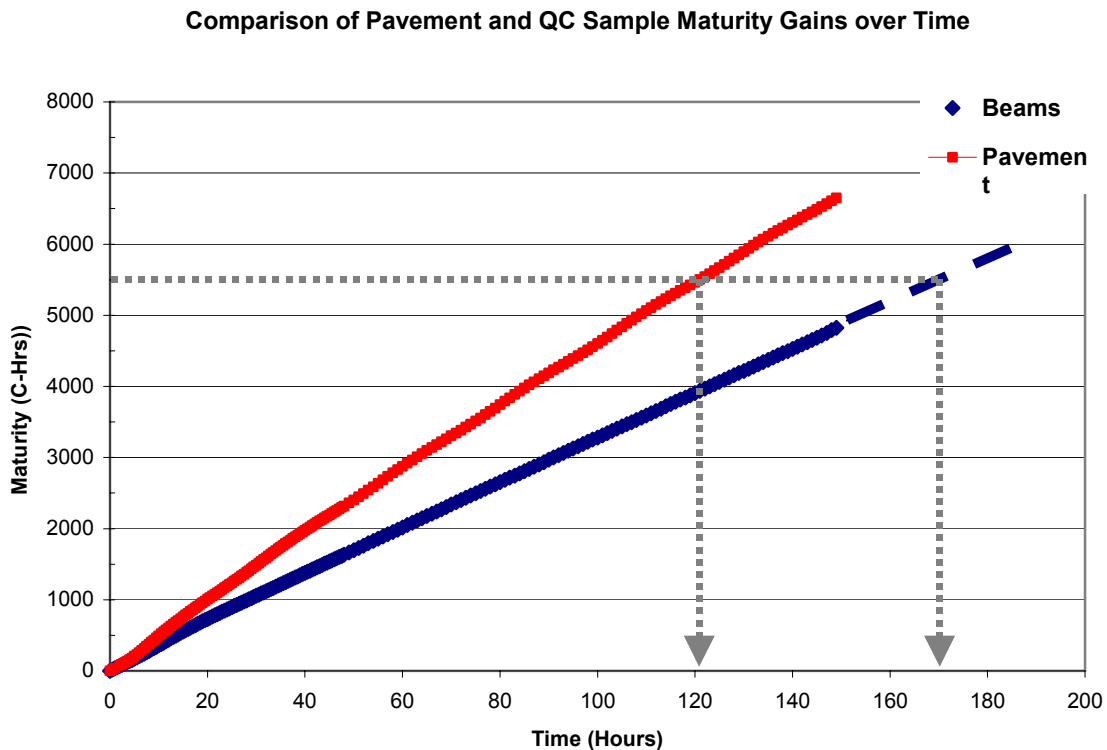
Figure 2. Maturity gain of pavement and QC specimens over time.

1. Use of maturity to assess in-place pavement strengths would have allowed construction traffic on the pavement 2-days earlier. For the specific site conditions encountered during our test program, the pavement reached the 550psi NCDOT opening to strength criteria in 5 days, while the companion beams took over 7 days. Typical time savings may be less or greater, depending on the environmental conditions during and subsequent to concrete placement. Figure 2 illustrates how the maturity of the pavement (in-place concrete) is increasing at a greater rate than that of the quality control beams.

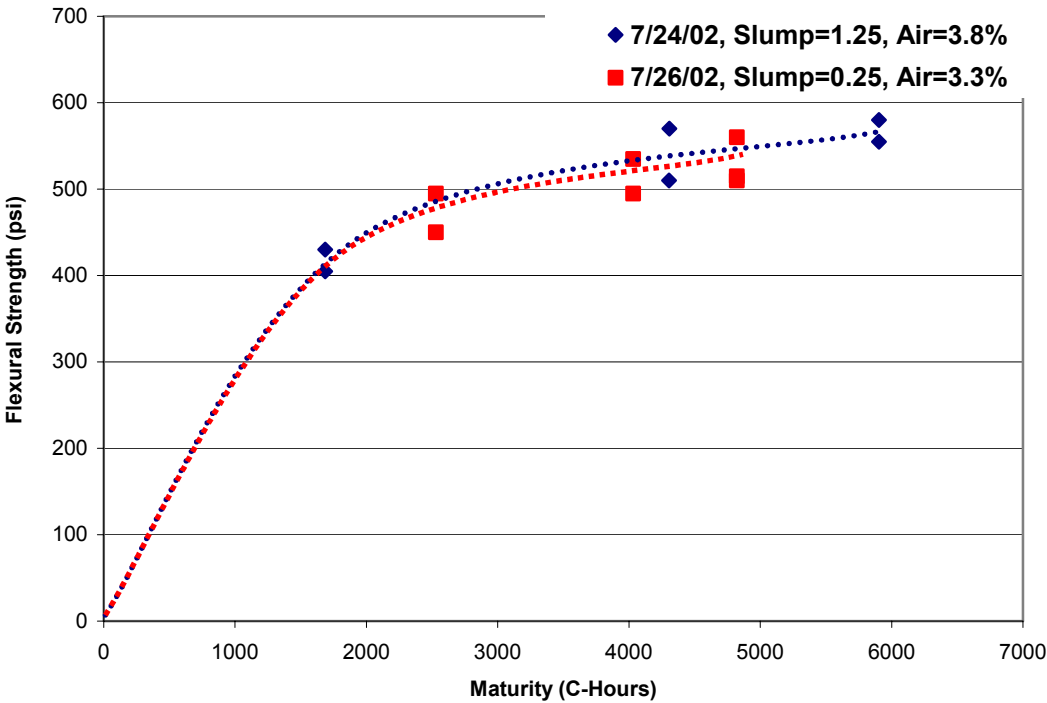
Figure 3. Maturity/strength relationships for two separate placements.

Test results also show how the maturity relationships are reproducible during the course of a project. Maturity-strength relationships were generated for concrete placements taking place on July 24, 2002 and July 26, 2002. Figure 3 shows how the relationships are very similar, even with significant slump differences and changes in air content.

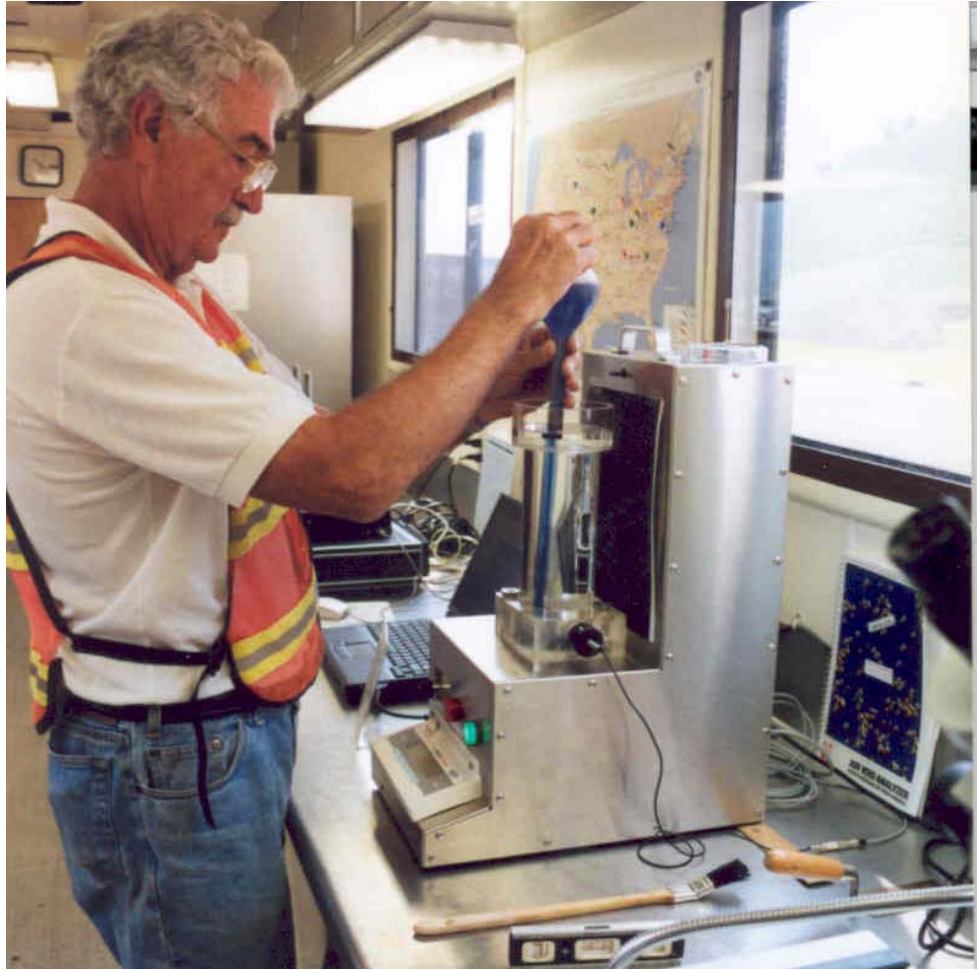
Figure 5. Air Void Analyzer being prepared for testing

- Air void analysis of the plastic concrete sampled at the batch plant indicates that the air void system is marginal to inadequate when the slump is less than 1 ½ inches. Of the six samples tested, three exhibited spacing factors (SF) greater than 0.010 inches (the generally accepted maximum limit). Without exception, the spacing factor was greater than 0.010 inches when the slump was less than 1 ½ inch. In addition, the specific surface (SS) was less than 600 (the generally accepted minimum limit) in those same instances. In summery, the air voids are too coarse and spaced too far apart when the slump is less than 1 ½ inch. This may be related to less efficient mobilization of the air-entraining admixture in the lower-slump mixtures (due to lower amounts of water). Figure 4 shows the Air Void Analyzer used for this analysis. Table 1 summarizes the AVA data.

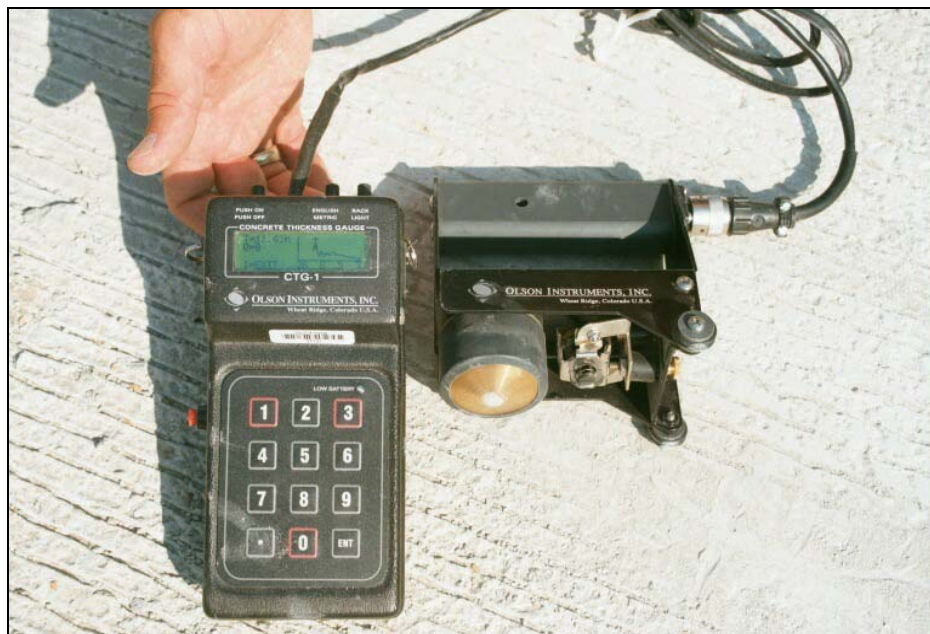
Figure 6. The CTG-1 impact-echo unit.

3. The Concrete Thickness Gauge (CTG-1) does not determine concrete pavement thickness accurately (within $\frac{1}{4}$ inch) when the concrete pavement is bonded intimately to an asphalt base. The concrete pavement at this site bonded very well to the underlying asphalt base, possibly as a result of the young age of the asphalt base (a few weeks to months) and the high temperatures during construction (80-90F). The lack of a clear boundary at the bottom of the concrete slab reduces the amount of energy that is reflected back to the surface of the pavement as a result of a surface impact. Accurate CTG results are dependent on this reflected portion of the signal. CTG measurements in six locations differed with core thicknesses by as much as $\frac{1}{2}$ inch. All tests showed a poor signal integrity, indicating the lack of a clear boundary at the bottom of the concrete pavement. Figure 6 shows the CTG-1 used for this testing.

In an attempt to verify the CTG's capability on concrete pavements that are not bonded to an asphalt base, tests were performed on an 11 inch thick 4 foot by 4 foot concrete slab that had previously been removed from the pavement for unrelated reasons. The slab was positioned on a dense aggregate surface along the roadway shoulder. All CTG tests conducted on this slab were within $\frac{1}{4}$ inch of the actual slab thickness, as determined with a measuring tape. The signal integrity for all these test was high, confirming the presence of a clearly defined boundary at the bottom of the slab.

3. The CTG-1 impact-echo unit is suitable for use as a non-destructive pavement thickness measurement device only when the concrete pavement has a clearly defined boundary at the bottom of the pavement. When the concrete is intimately bonded to the material below, accuracy suffers significantly.
