**Re: GE-Pittsfield/Housatonic River Site  
Lyman Street Area (GEC430)  
Summary of July 2008 Inspection of Natural Resource Restoration/Enhancement Measures**

GENERAL ELECTRIC COMPANY  
 PITTSFIELD, MASSACHUSETTS  
 JULY 2008 INSPECTION

**AREAS SUBJECT TO NATURAL RESOURCE RESTORATION/ENHANCEMENT ACTIVITIES**

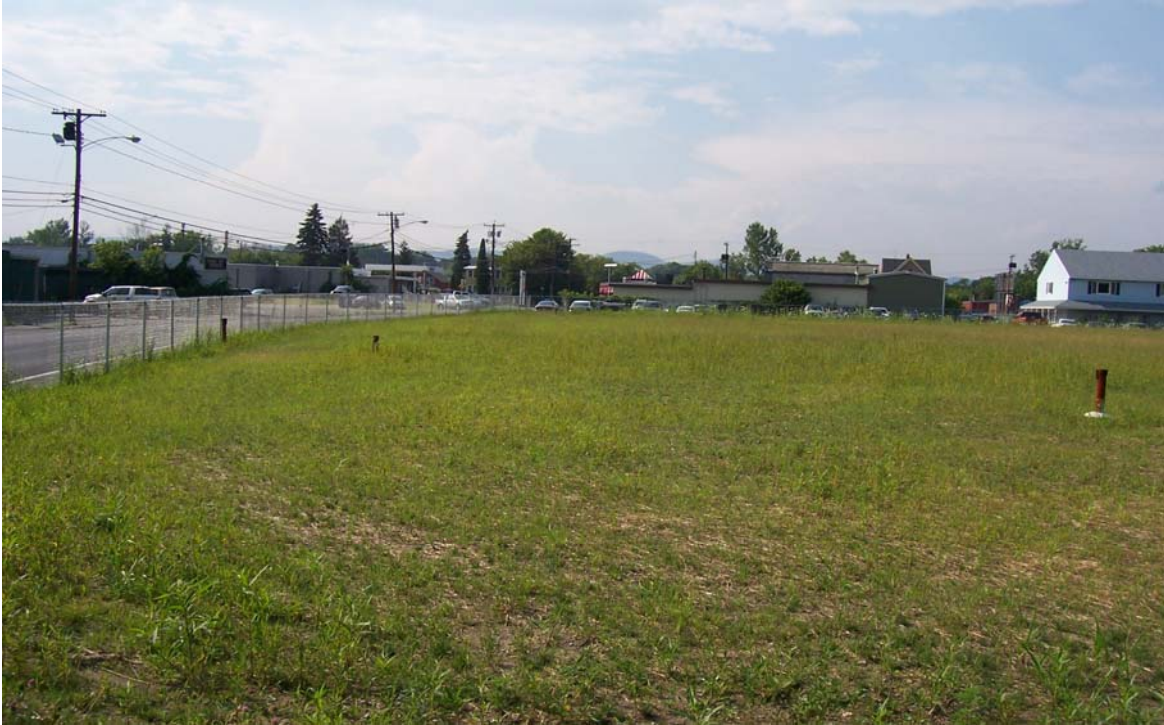
Photo #1:                      Herbaceous Cover on Parcel I9-8-1 within NRRE Areas  
Photo taken from access road in a northern direction.

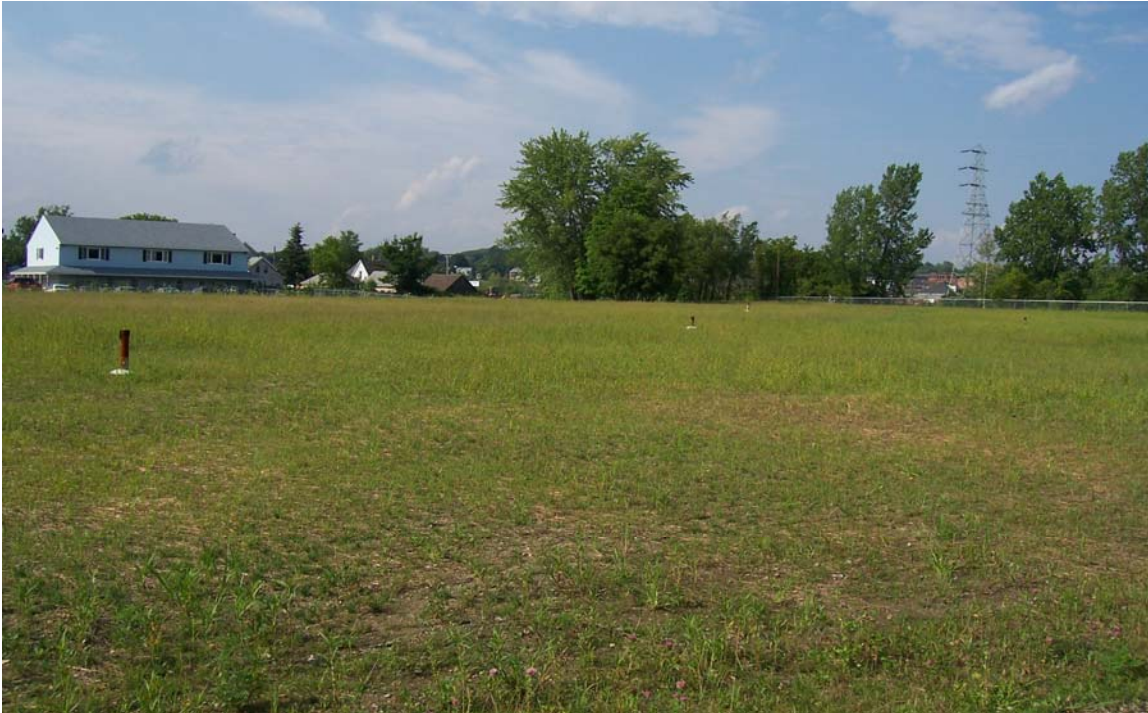
Photo #2:                      Herbaceous Cover on Parcel I9-8-1 within NRRE Areas  
Photo taken from access road in a northern direction.

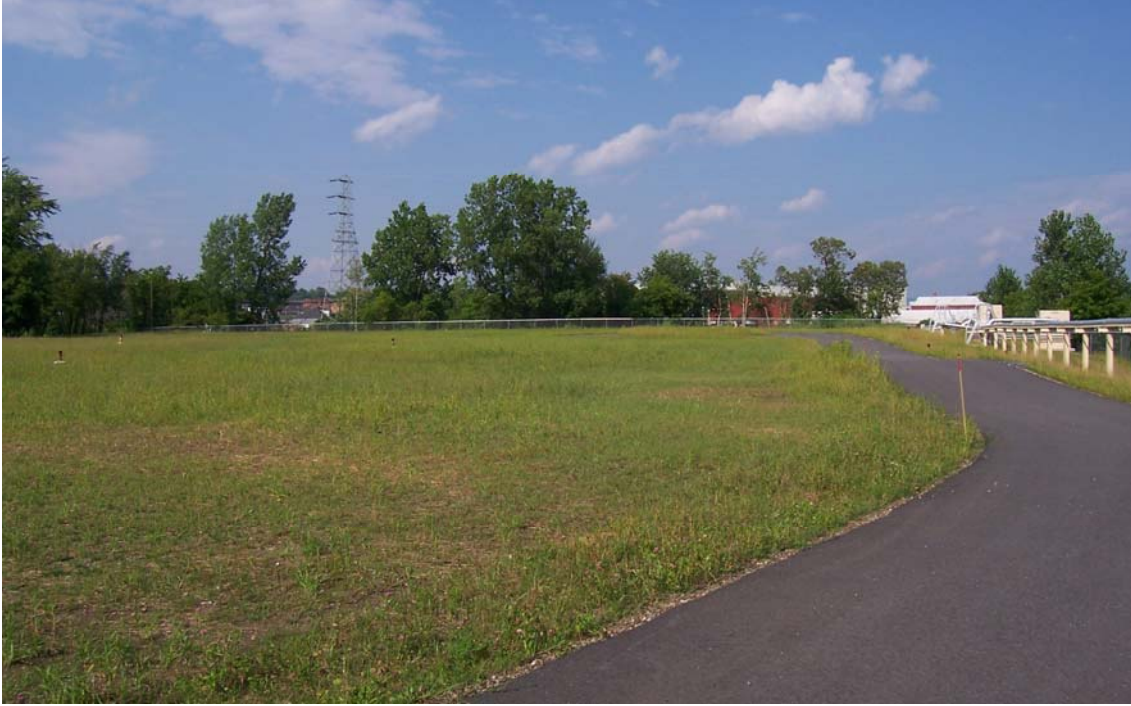
Photo #3: Herbaceous Cover on Parcel I9-8-1 within NRRE Areas  
 Photo taken from Lyman Street in an eastern direction.

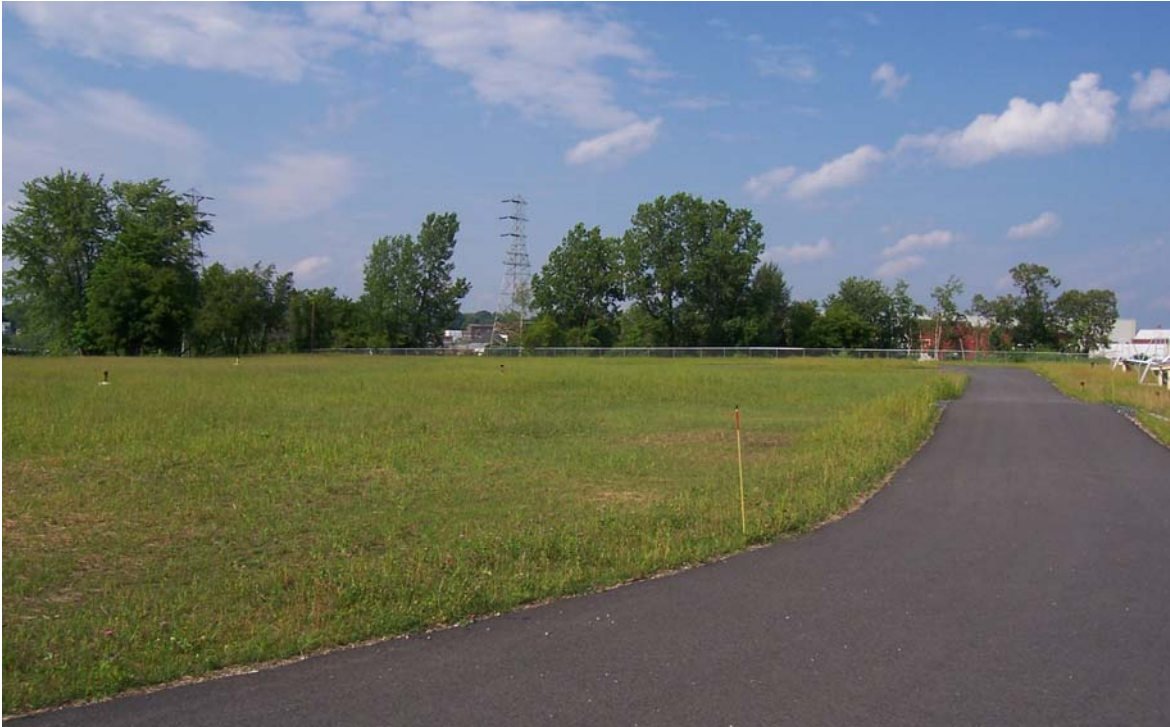
Photo #4: Herbaceous Cover on Parcel I9-8-1 within NRRE Areas  
 Photo taken from Lyman Street in an eastern direction.

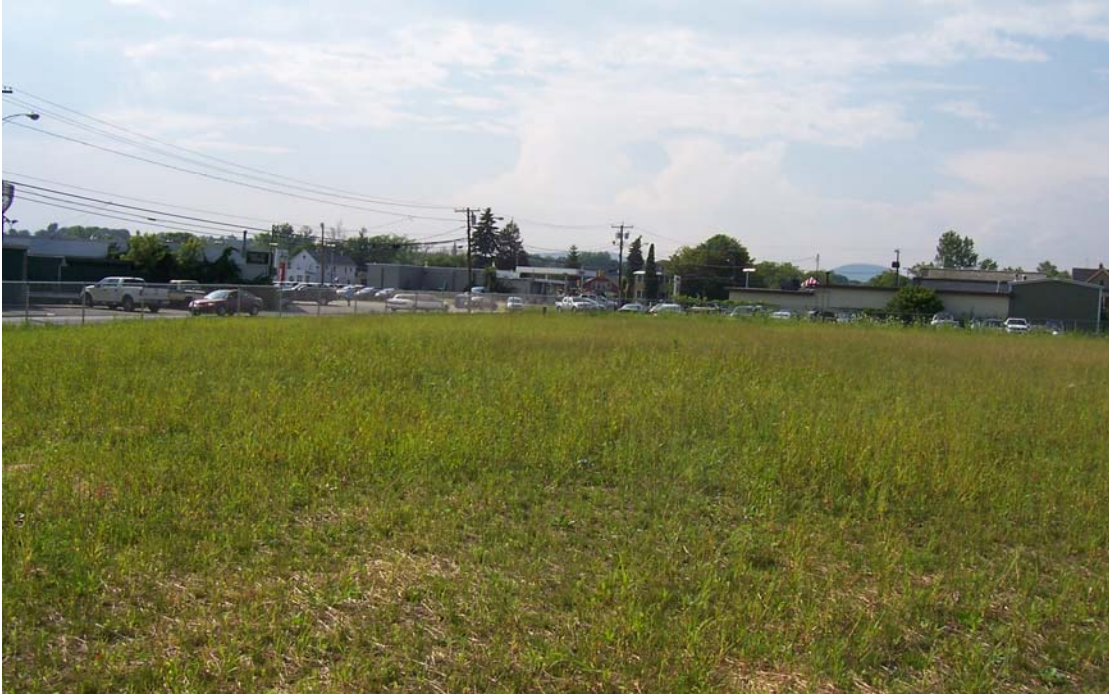
Photo #5: Herbaceous Cover on Parcel I9-8-1 within NRRE Areas  
 Photo taken from southwestern area in a northern direction.

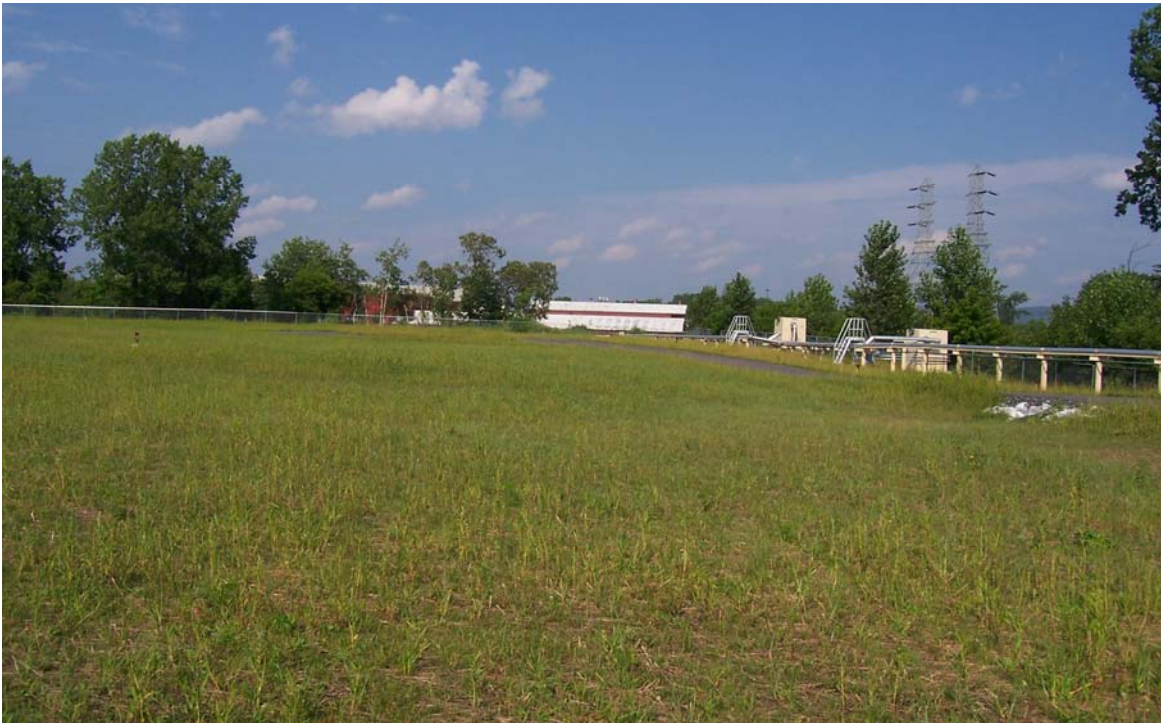
Photo #6: Herbaceous Cover on Parcel I9-8-1 within NRRE Areas  
 Photo taken from Lyman Street in an eastern direction.

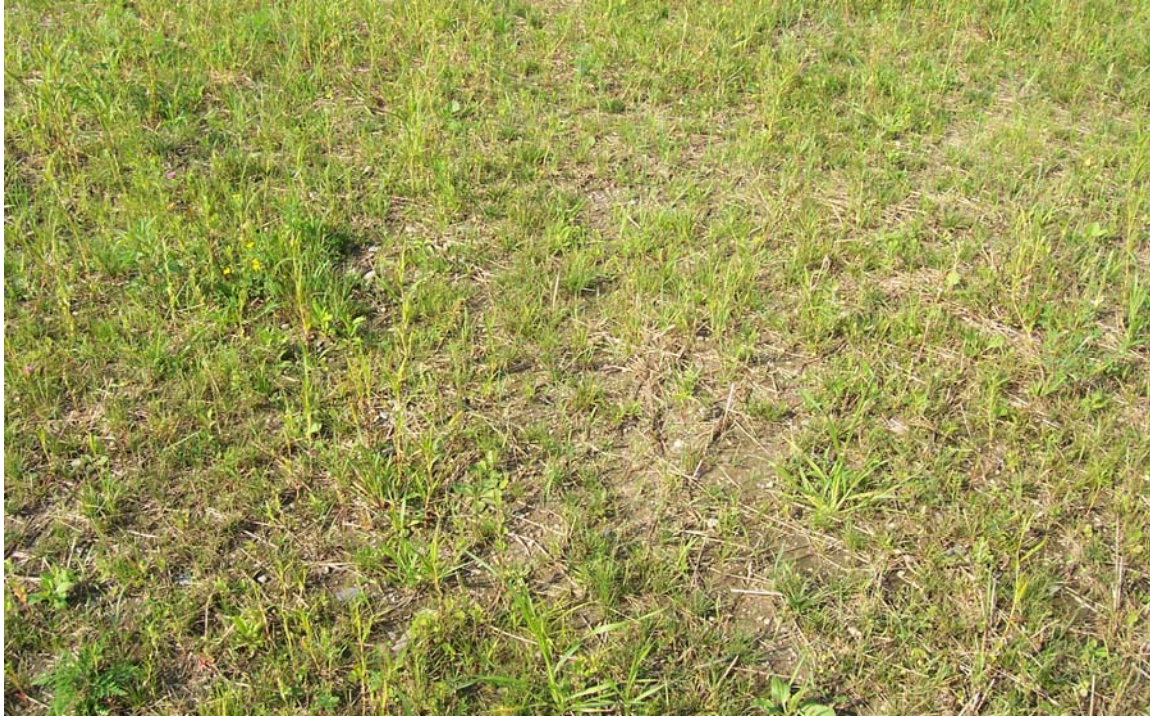
Photo #7: Herbaceous Cover on Parcel I9-8-1 within NRRE Areas  
Photo taken in southwestern area of Parcel I9-8-1.

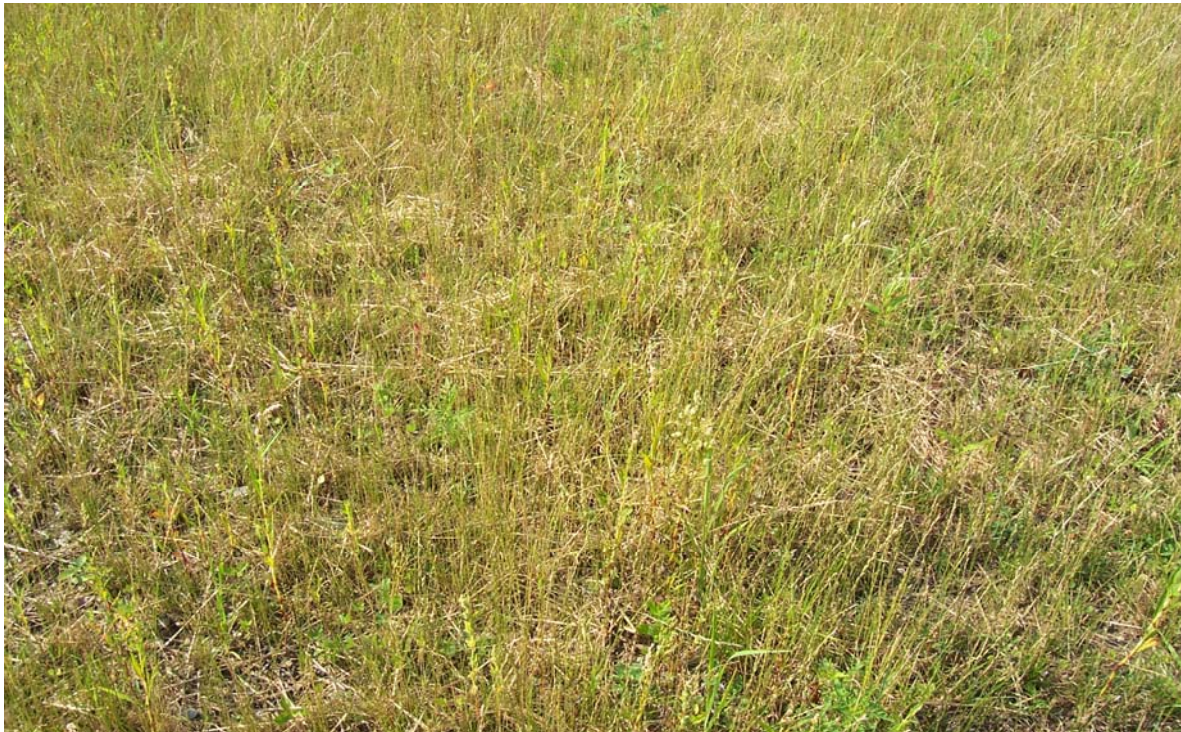
Photo #8: Herbaceous Cover on Parcel I9-8-1 within NRRE Areas  
Photo taken in central/western area of Parcel I9-8-1.

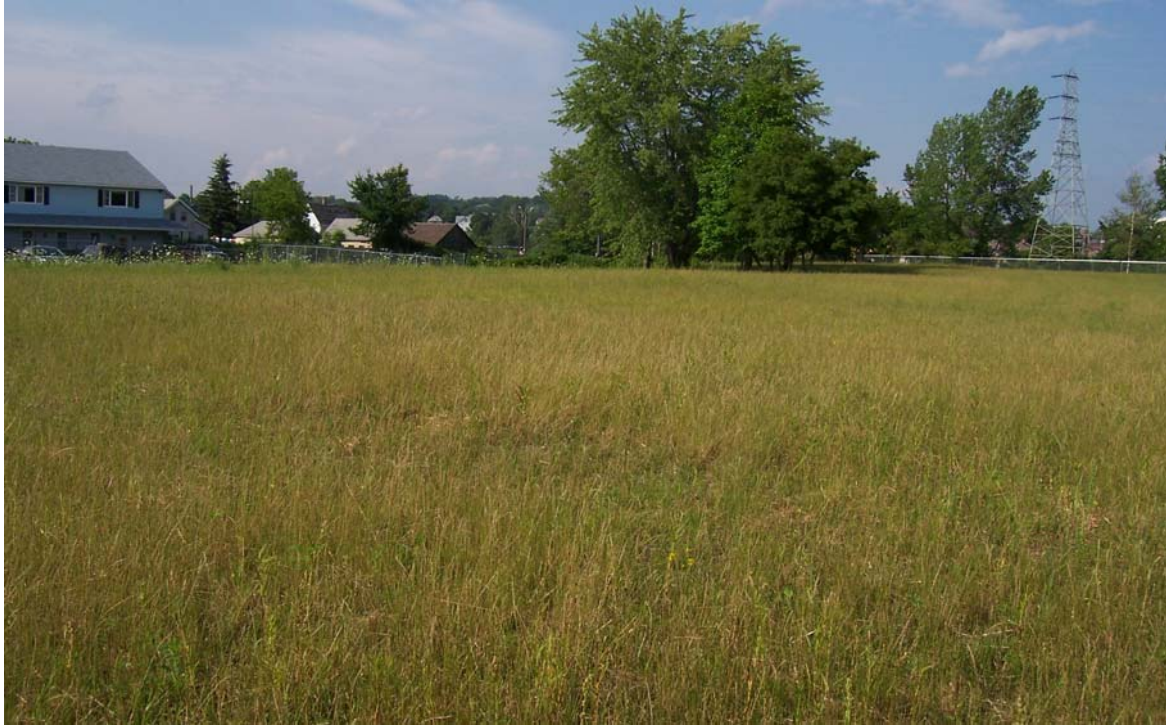
Photo #9:                    Herbaceous Cover on Parcel I9-8-1 within NRRE Areas  
 Photo taken from central/western area in a northern direction.

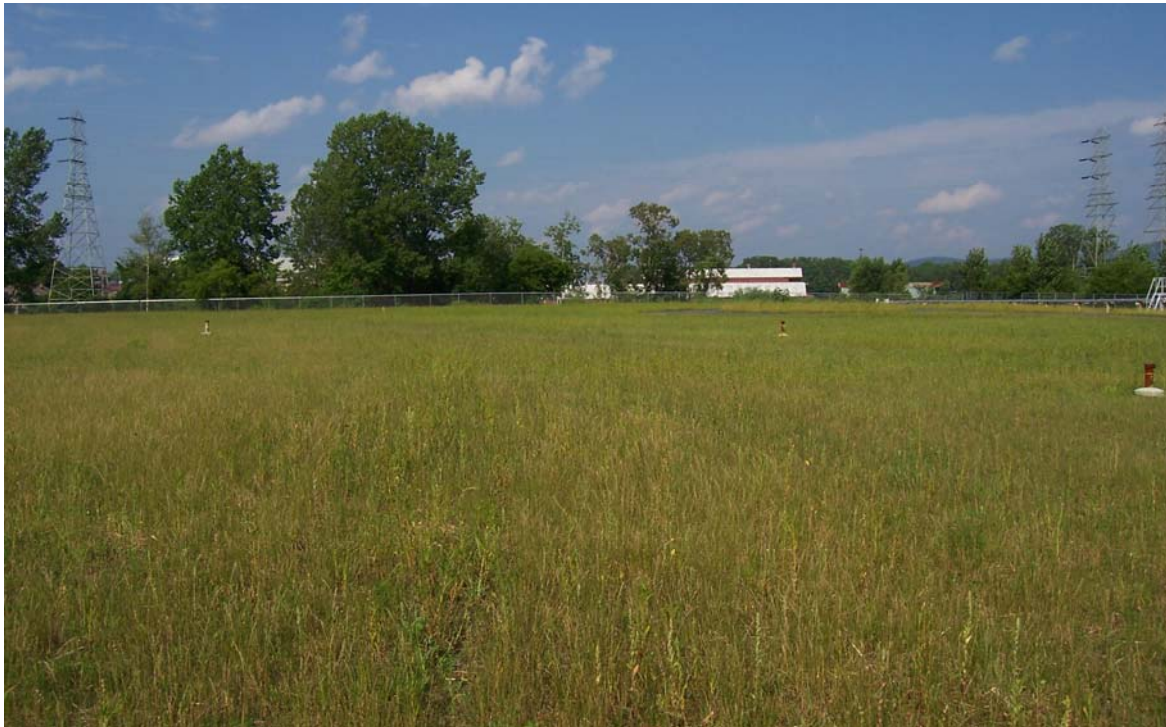
Photo #10:                    Herbaceous Cover on Parcel I9-8-1 within NRRE Areas  
 Photo taken from central/western area in an eastern direction.

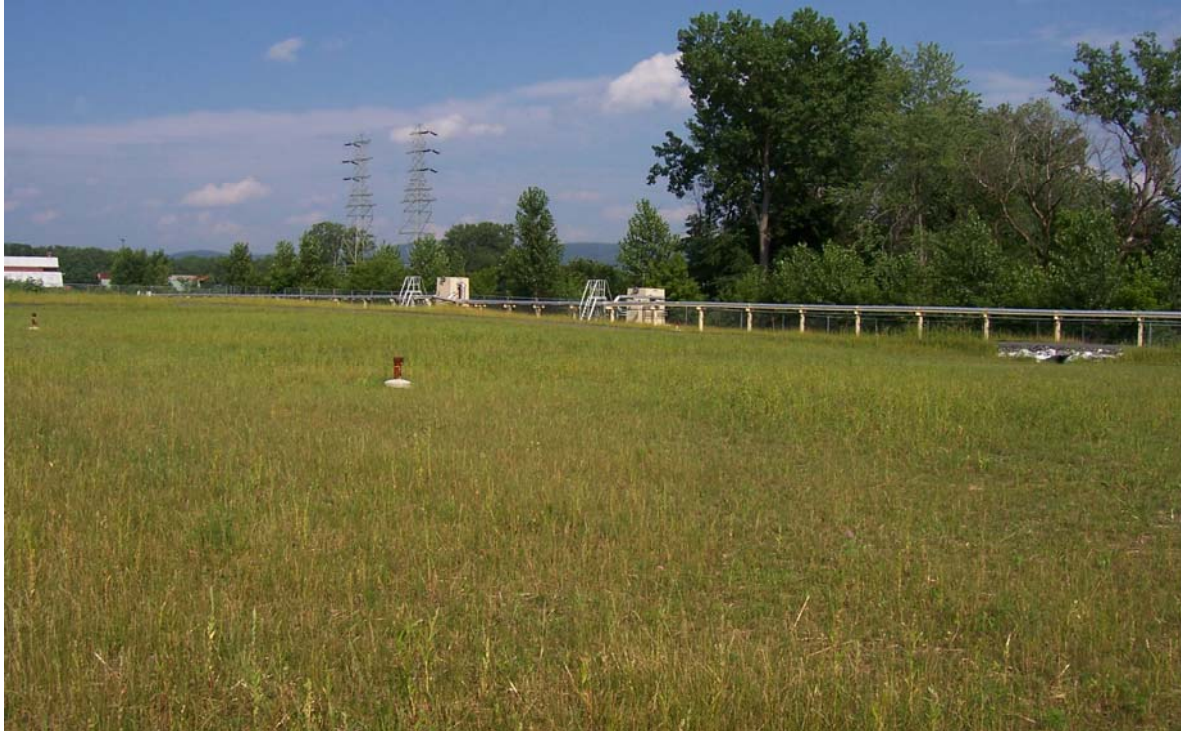
Photo #11: Herbaceous Cover on Parcel I9-8-1 within NRRE Areas  
Photo taken from central/western area in a southeastern direction.

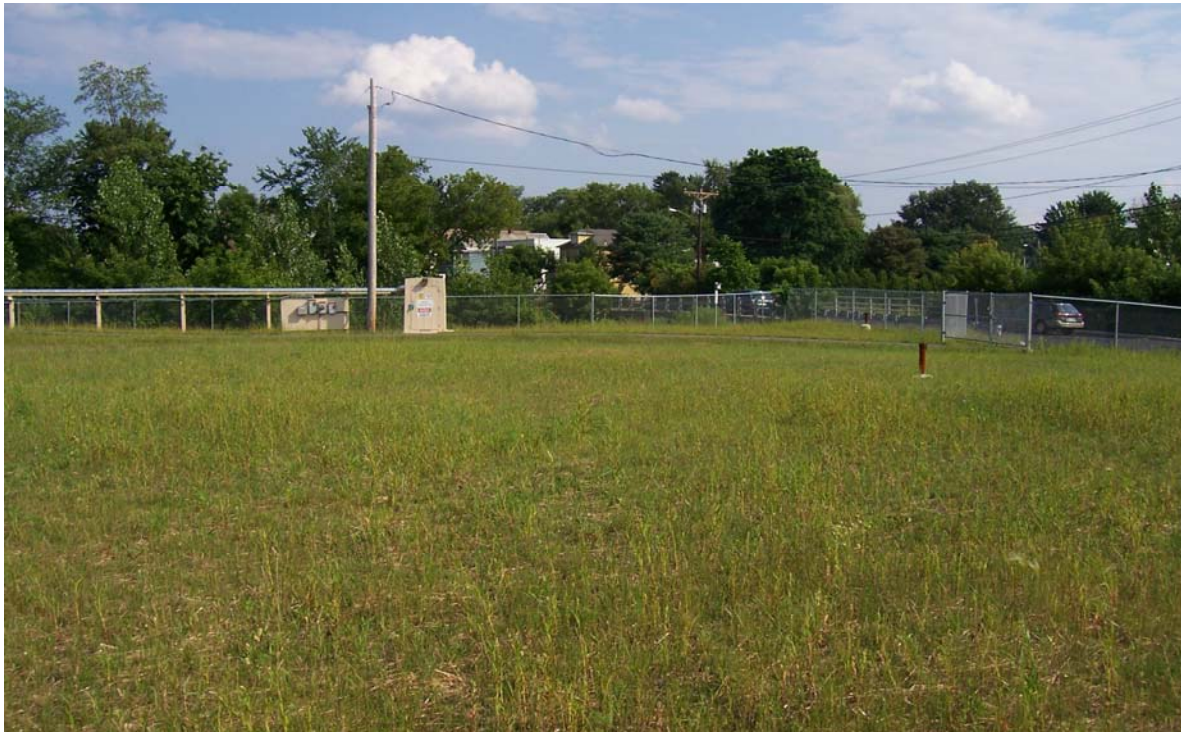
Photo #12: Herbaceous Cover on Parcel I9-8-1 within NRRE Areas  
Photo taken from central/western area in a southern direction.
