**Re: GE-Pittsfield/Housatonic River Site  
Newell Street Area II (GEC450)  
Summary of July 2008 Inspection of Natural Resource Restoration/Enhancement Measures**

GENERAL ELECTRIC COMPANY  
 PITTSFIELD, MASSACHUSETTS  
 JULY 2008 INSPECTION

**AREAS SUBJECT TO ANTURAL RESOURCE RESTORATION/ENHANCEMENT ACTIVITIES**

Photo Log

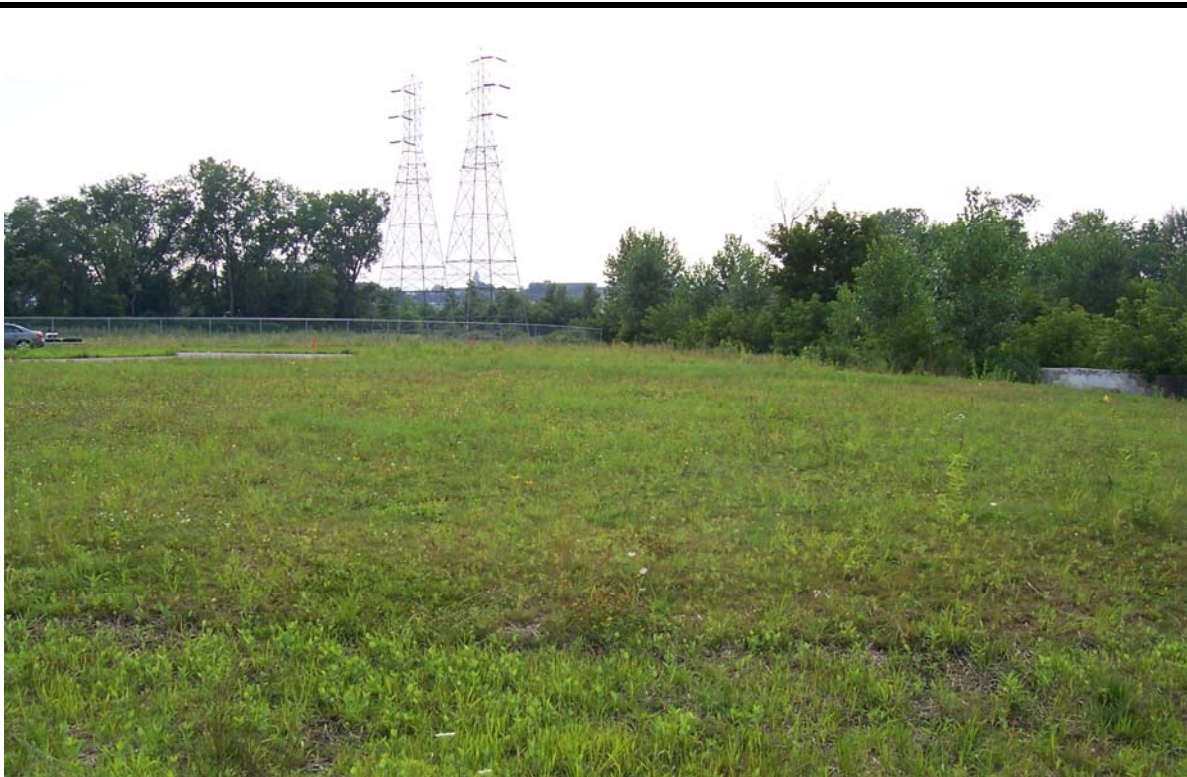
Photo #1: Herbaceous Cover on Western Portion of NRRE Areas on Parcel J9-23-12  
Photo taken from "former wooded area" in a western direction.

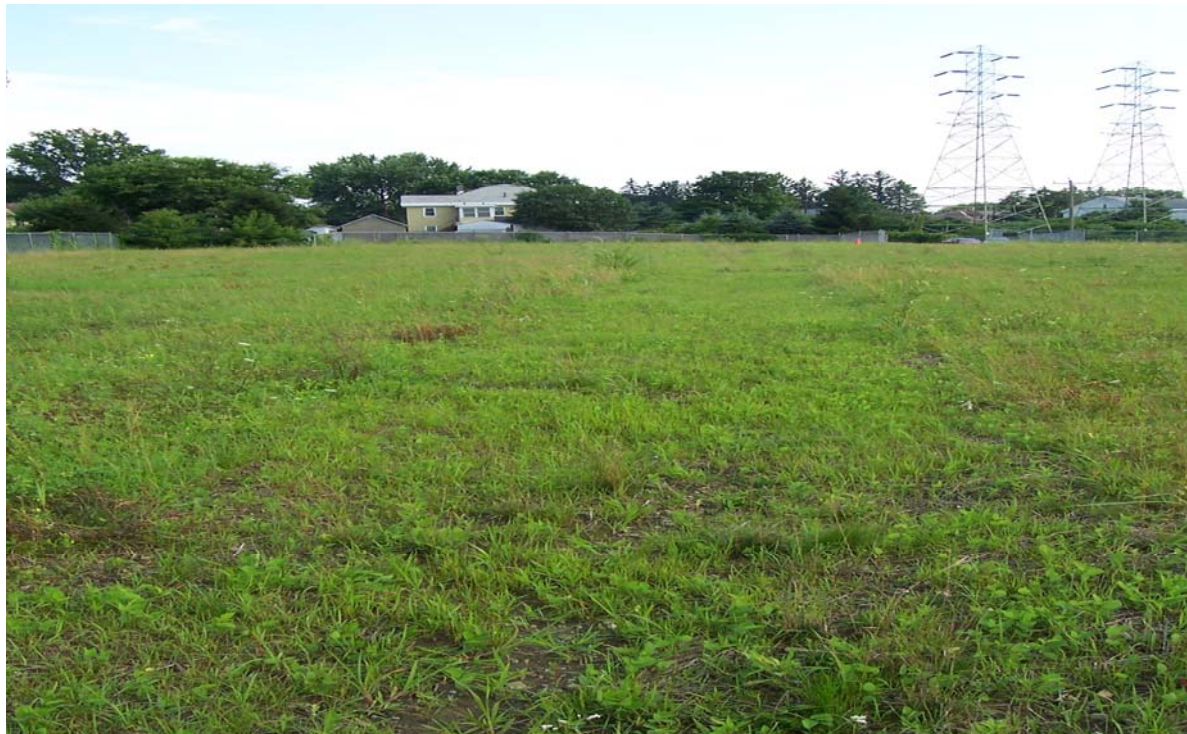
As also indicated in the NRRE Inspection Checklist, the inspection identified an area of minimal erosion within the northern-most portion of the swale (adjacent to the Housatonic River) located in the western portion of the Newell Street parking lot area. In response, GE installed topsoil, the Trustee-proposed seed mix, and no more than 2 inches of straw mulch to the eroded area.

- All other NRRE areas not addressed with topsoil, were over-seeded with Trustee-proposed seed mix in spring 2008.
- Minimal erosion observed in northern-most portion of the swale (adjacent to Housatonic River) located in the western portion of the Newell Street parking lot area.

Photo #2: Herbaceous Cover within Swale on Parcel J9-23-12  
Photo taken from riverbank in a southern direction.

- Install additional topsoil and Trustee-proposed seed mix in the six areas identified above as having 70% to 75% groundcover.
- Install additional topsoil and Trustee-proposed seed mix in eroded swale area noted above.
- Install no more than 2 inches of straw mulch cover over areas addressed with topsoil and Trustee-proposed seed mix.

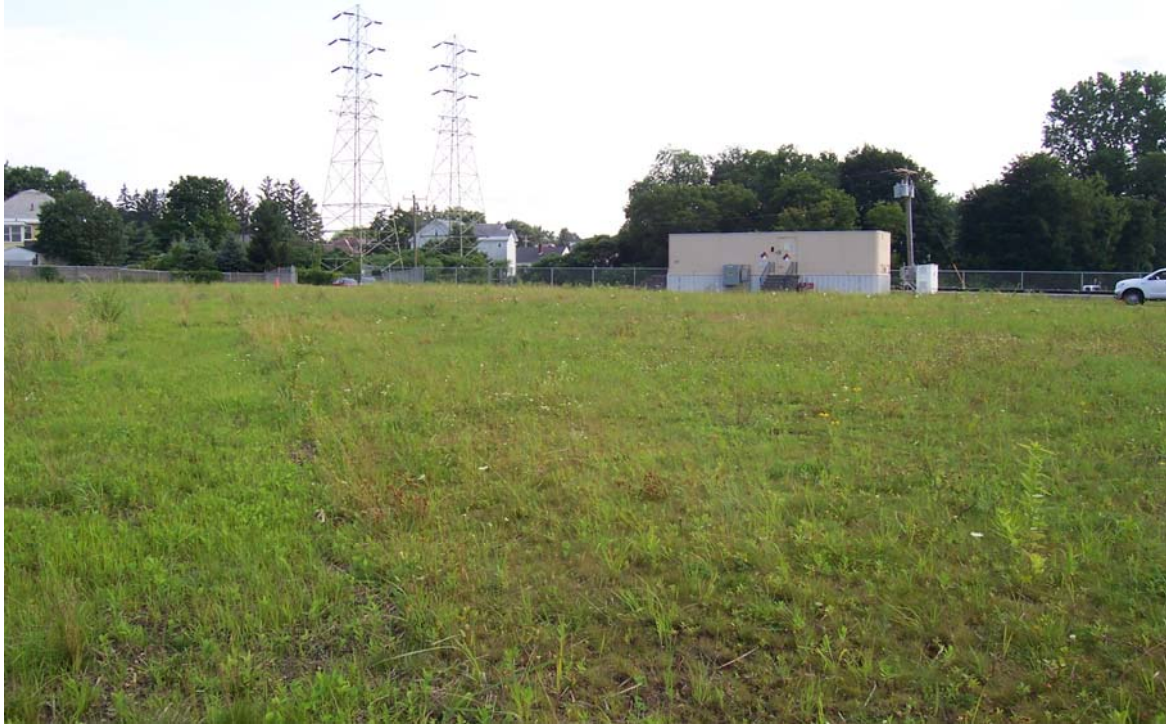
Photo #3: Herbaceous Cover on Western Portion of NRRE Areas on Parcel J9-23-12  
Photo taken from riverbank in a southwestern direction.

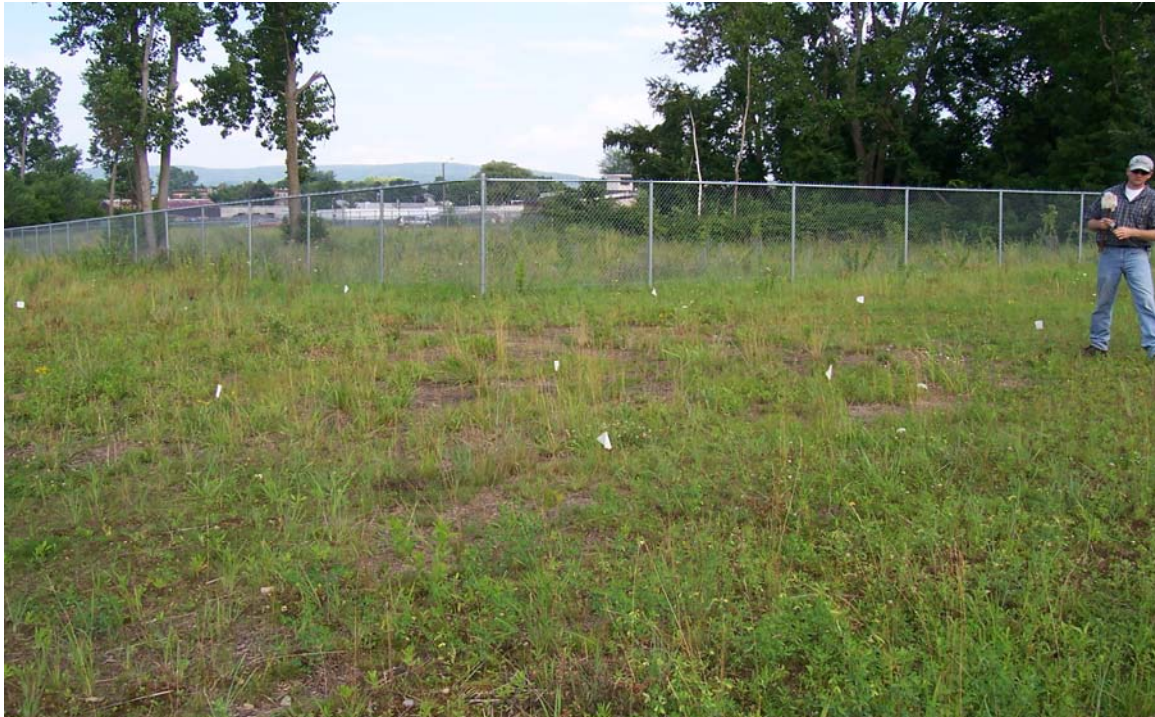
- Eastern portion of Newell Street parking lot area and portion of the "wooded area" - 95% to 100% total groundcover; 80% of the species observed from seed mix.
- Western portion of Newell Street parking lot area (area west of wooded area) - 95% to 100% total groundcover; 80% of the species observed from seed mix. Six areas within the western portion of the Newell Street parking lot area were identified as having 70% to 75% total groundcover; 75% of the species observed from seed mix.

Photo #4: Portion of Herbaceous Cover Requiring Follow-up Maintenance Activities  
Photo taken from riverbank in a southeastern direction.

In response to these observations, GE and the Trustees agreed that areas with 95% to 100% cover are anticipated to achieve the 100% coverage Performance Standard without the performance of additional planting or seeding activities. Additionally, GE proposed, and the Trustees approved, a plan to install topsoil, the Trustee-proposed seed mix, and no more than 2 inches of straw mulch over the six areas described above with approximately 70% to 75% groundcover. These planting activities were completed in August 2008. The Trustees indicated that, following completion of these planting activities, they anticipate that the six areas with 70% to 75% groundcover will achieve the required 100% groundcover during the 2008 growing season.

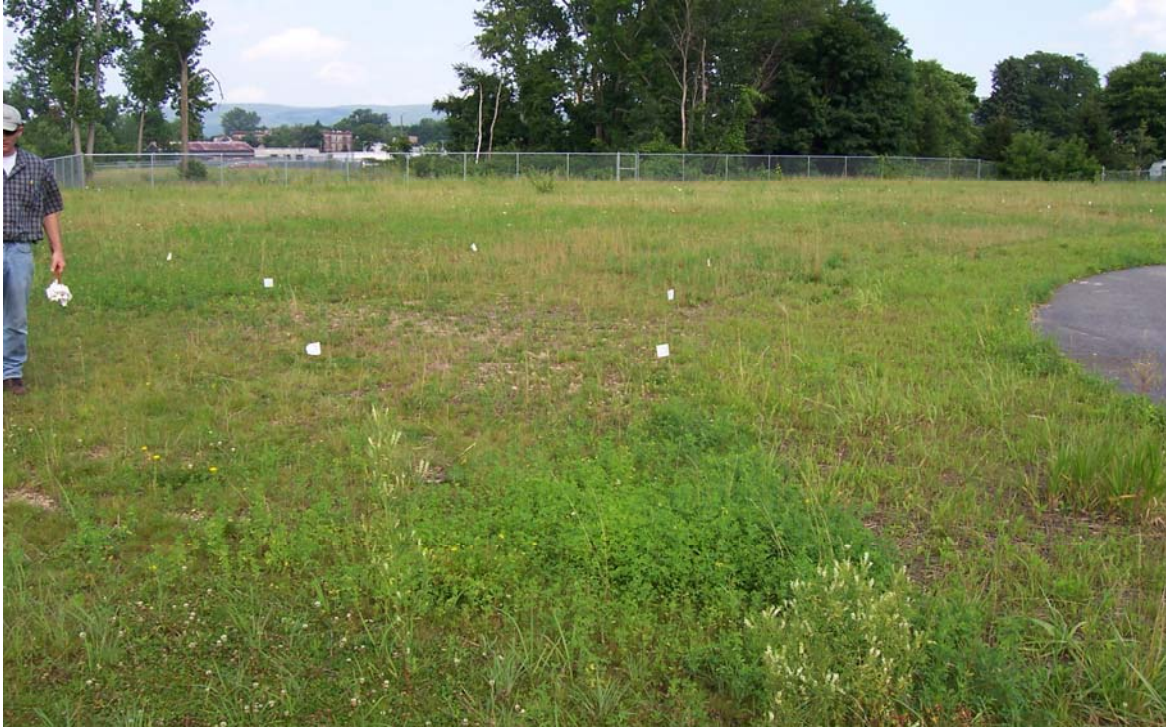
Photo #5: Portion of Herbaceous Cover Requiring Follow-up Maintenance Activities  
Photo taken from riverbank in a southeastern direction.

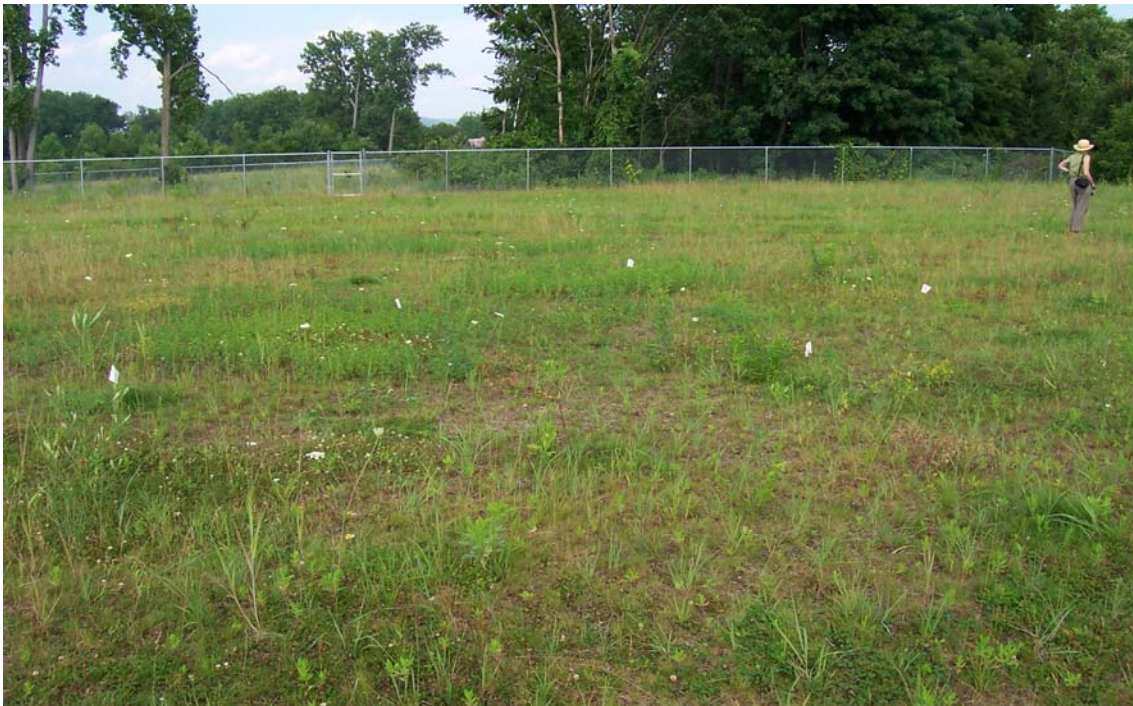
Photo #6: Portion of Herbaceous Cover Requiring Follow-up Maintenance Activities  
Photo taken from access road in an eastern direction.

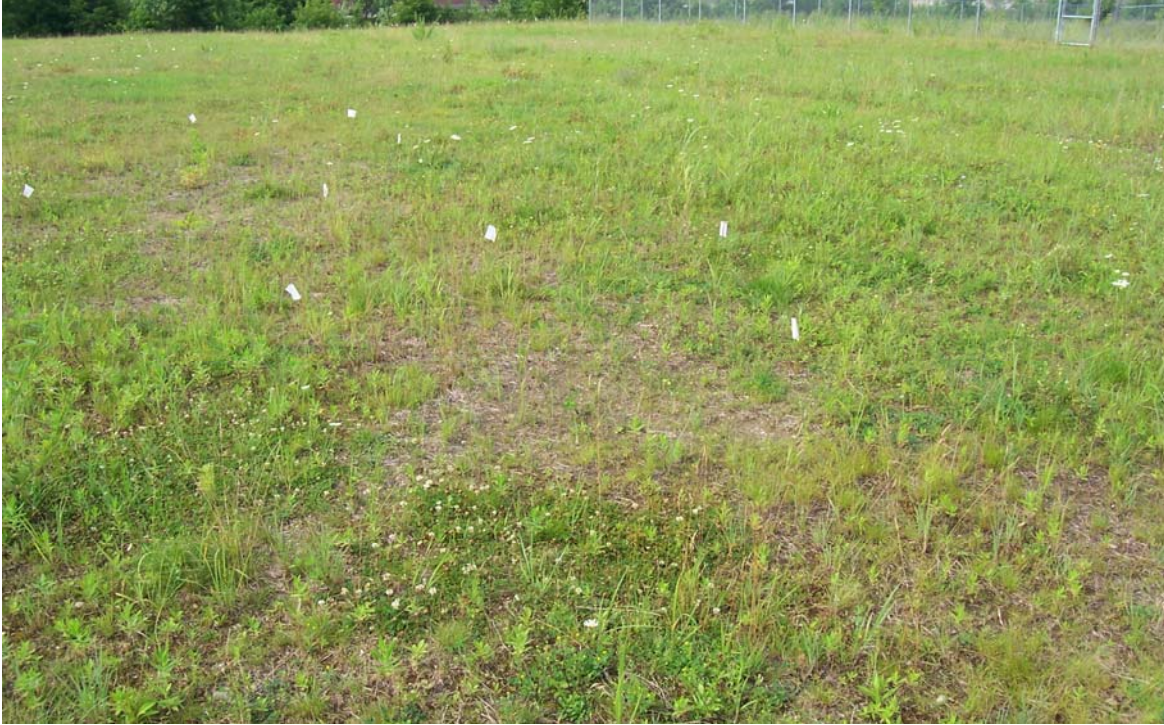
Photo #7: Portion of Herbaceous Cover Requiring Follow-up Maintenance Activities  
Photo taken from southern portion of site in a northern direction.

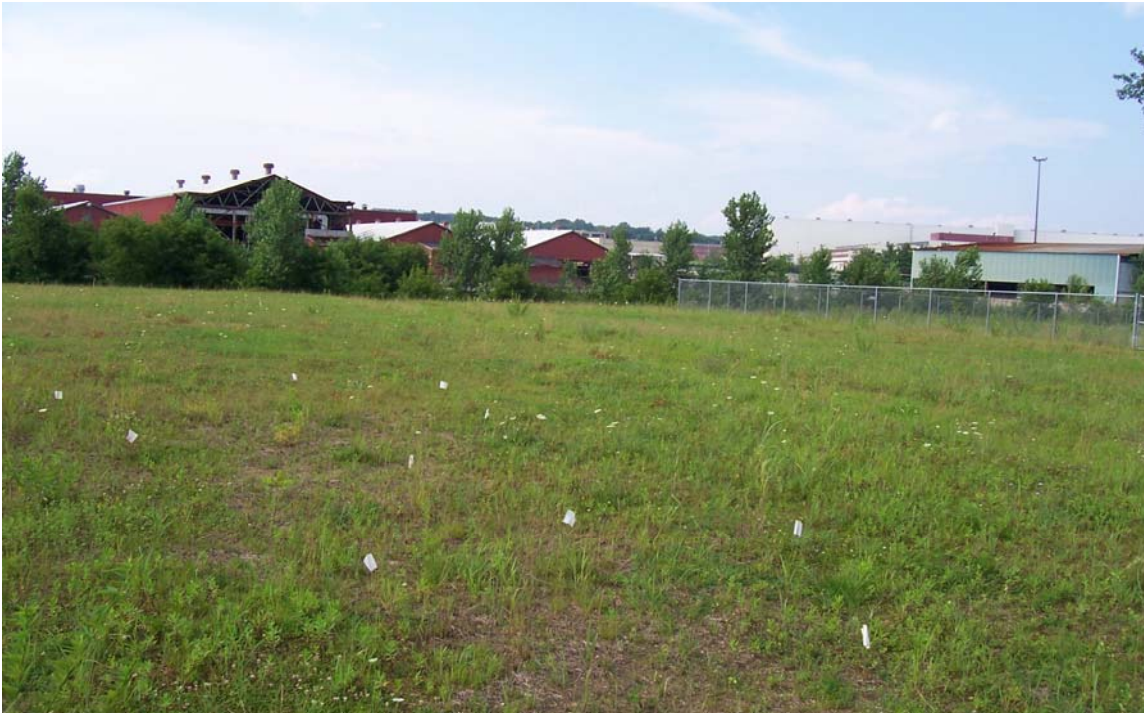
Photo #8: Portion of Herbaceous Cover Requiring Follow-up Maintenance Activities  
Photo taken from southern portion of site in a northern direction.

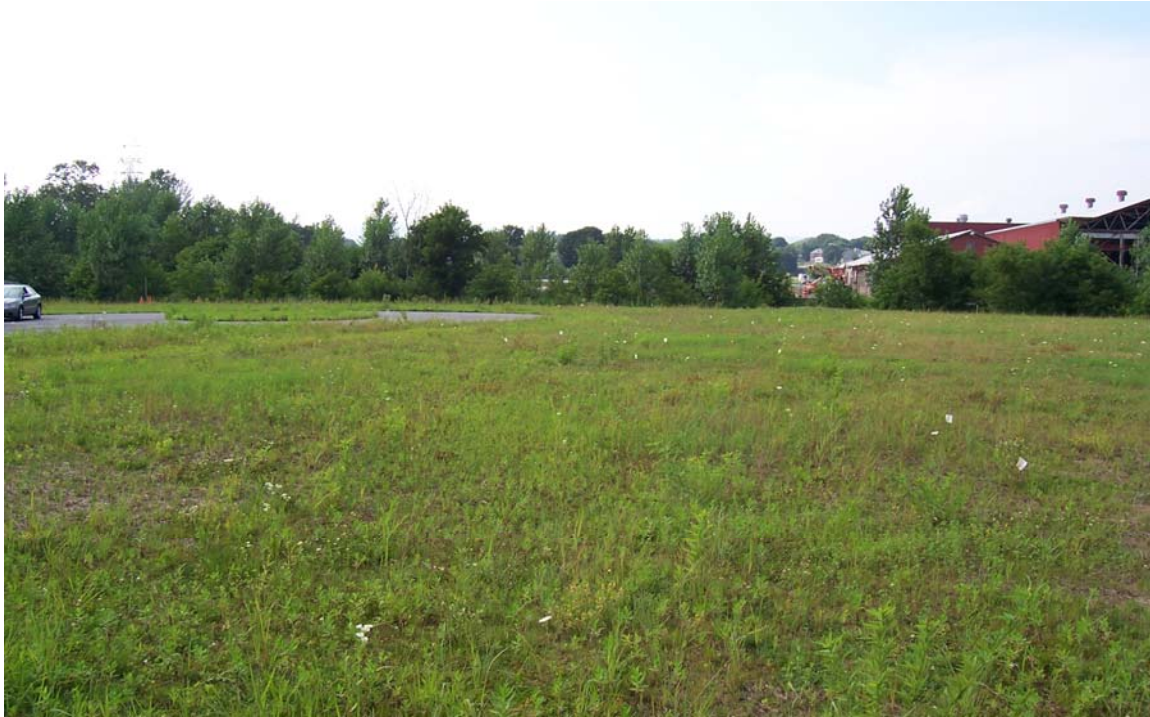
Photo #9: Portion of Herbaceous Cover Requiring Follow-up Maintenance Activities  
Photo taken from southern portion of Parcel J9-23-12 in a northern direction.

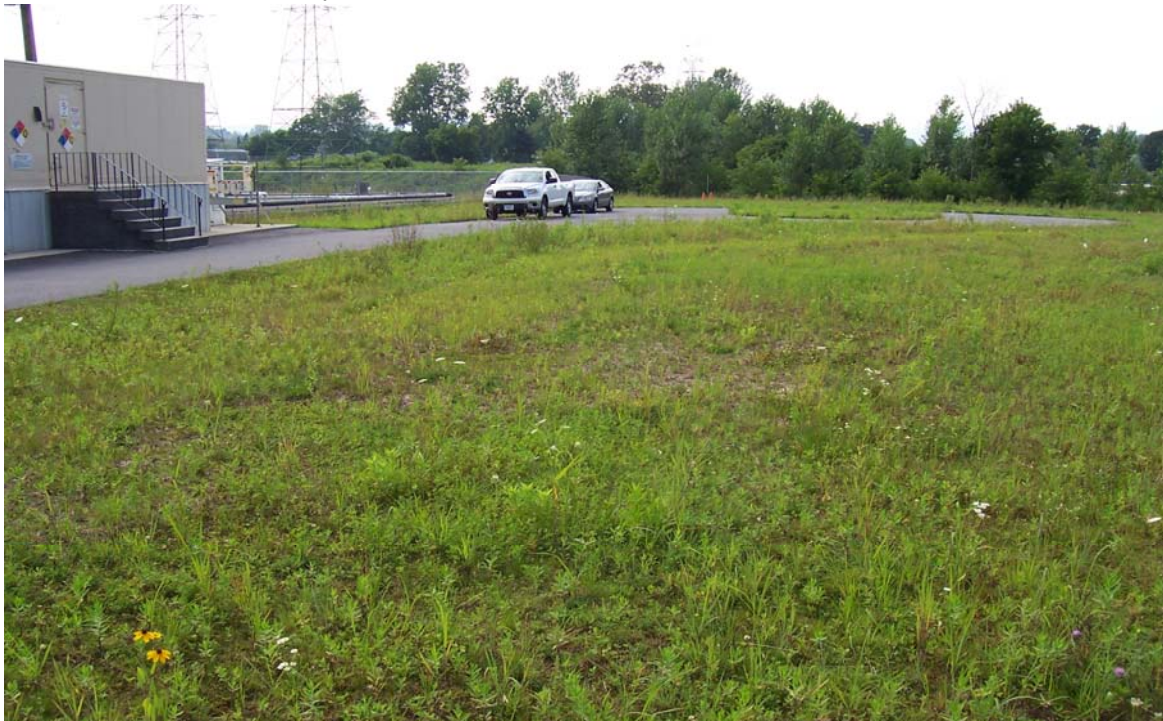
Photo #10: Newly Established Herbaceous Cover Along Access Road  
Photo taken from southern portion of Parcel J9-23-12 in a northern direction.

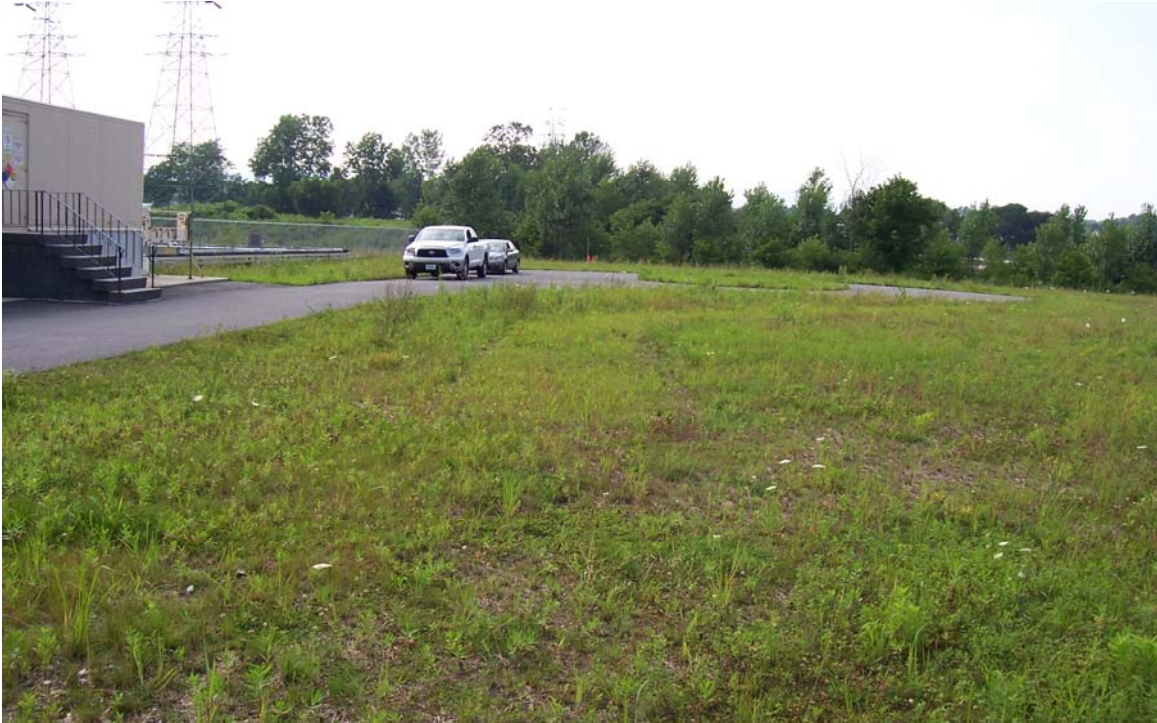
Photo #11: Newly Established Herbaceous Cover Along Access Road  
Photo taken from southern portion of Parcel J9-23-12 in a northern direction.

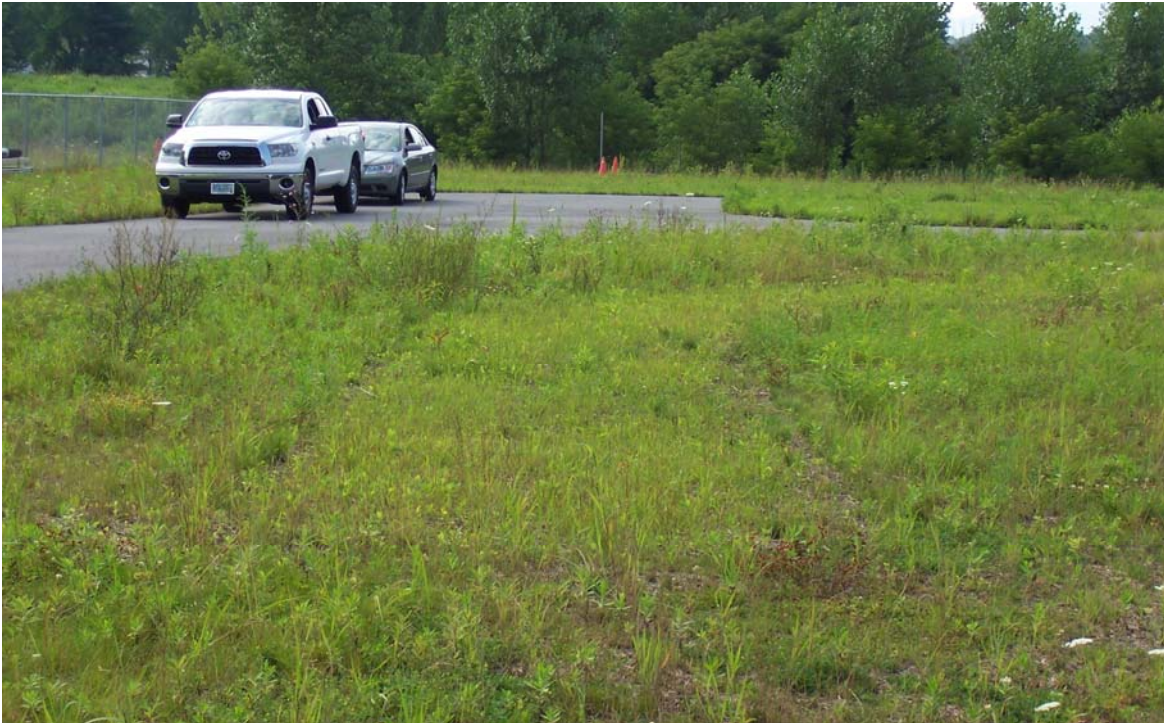
Photo #12: Newly Established Herbaceous Cover Along Access Road  
Photo taken from southern portion of Parcel J9-23-12 in a northern direction.
