**Re: GE-Pittsfield/Housatonic River Site
Unkamet Brook Area (GEC170)
Second Supplement to the Pre-Design Investigation Report for Unkamet Brook Area
Removal Action**

GENERAL ELECTRIC COMPANY
 PITTSFIELD, MASSACHUSETTS
**SECOND SUPPLEMENT TO THE PRE-DESIGN
 INVESTIGATION REPORT FOR UNKAMET BROOK AREA
 REMOVAL ACTION**

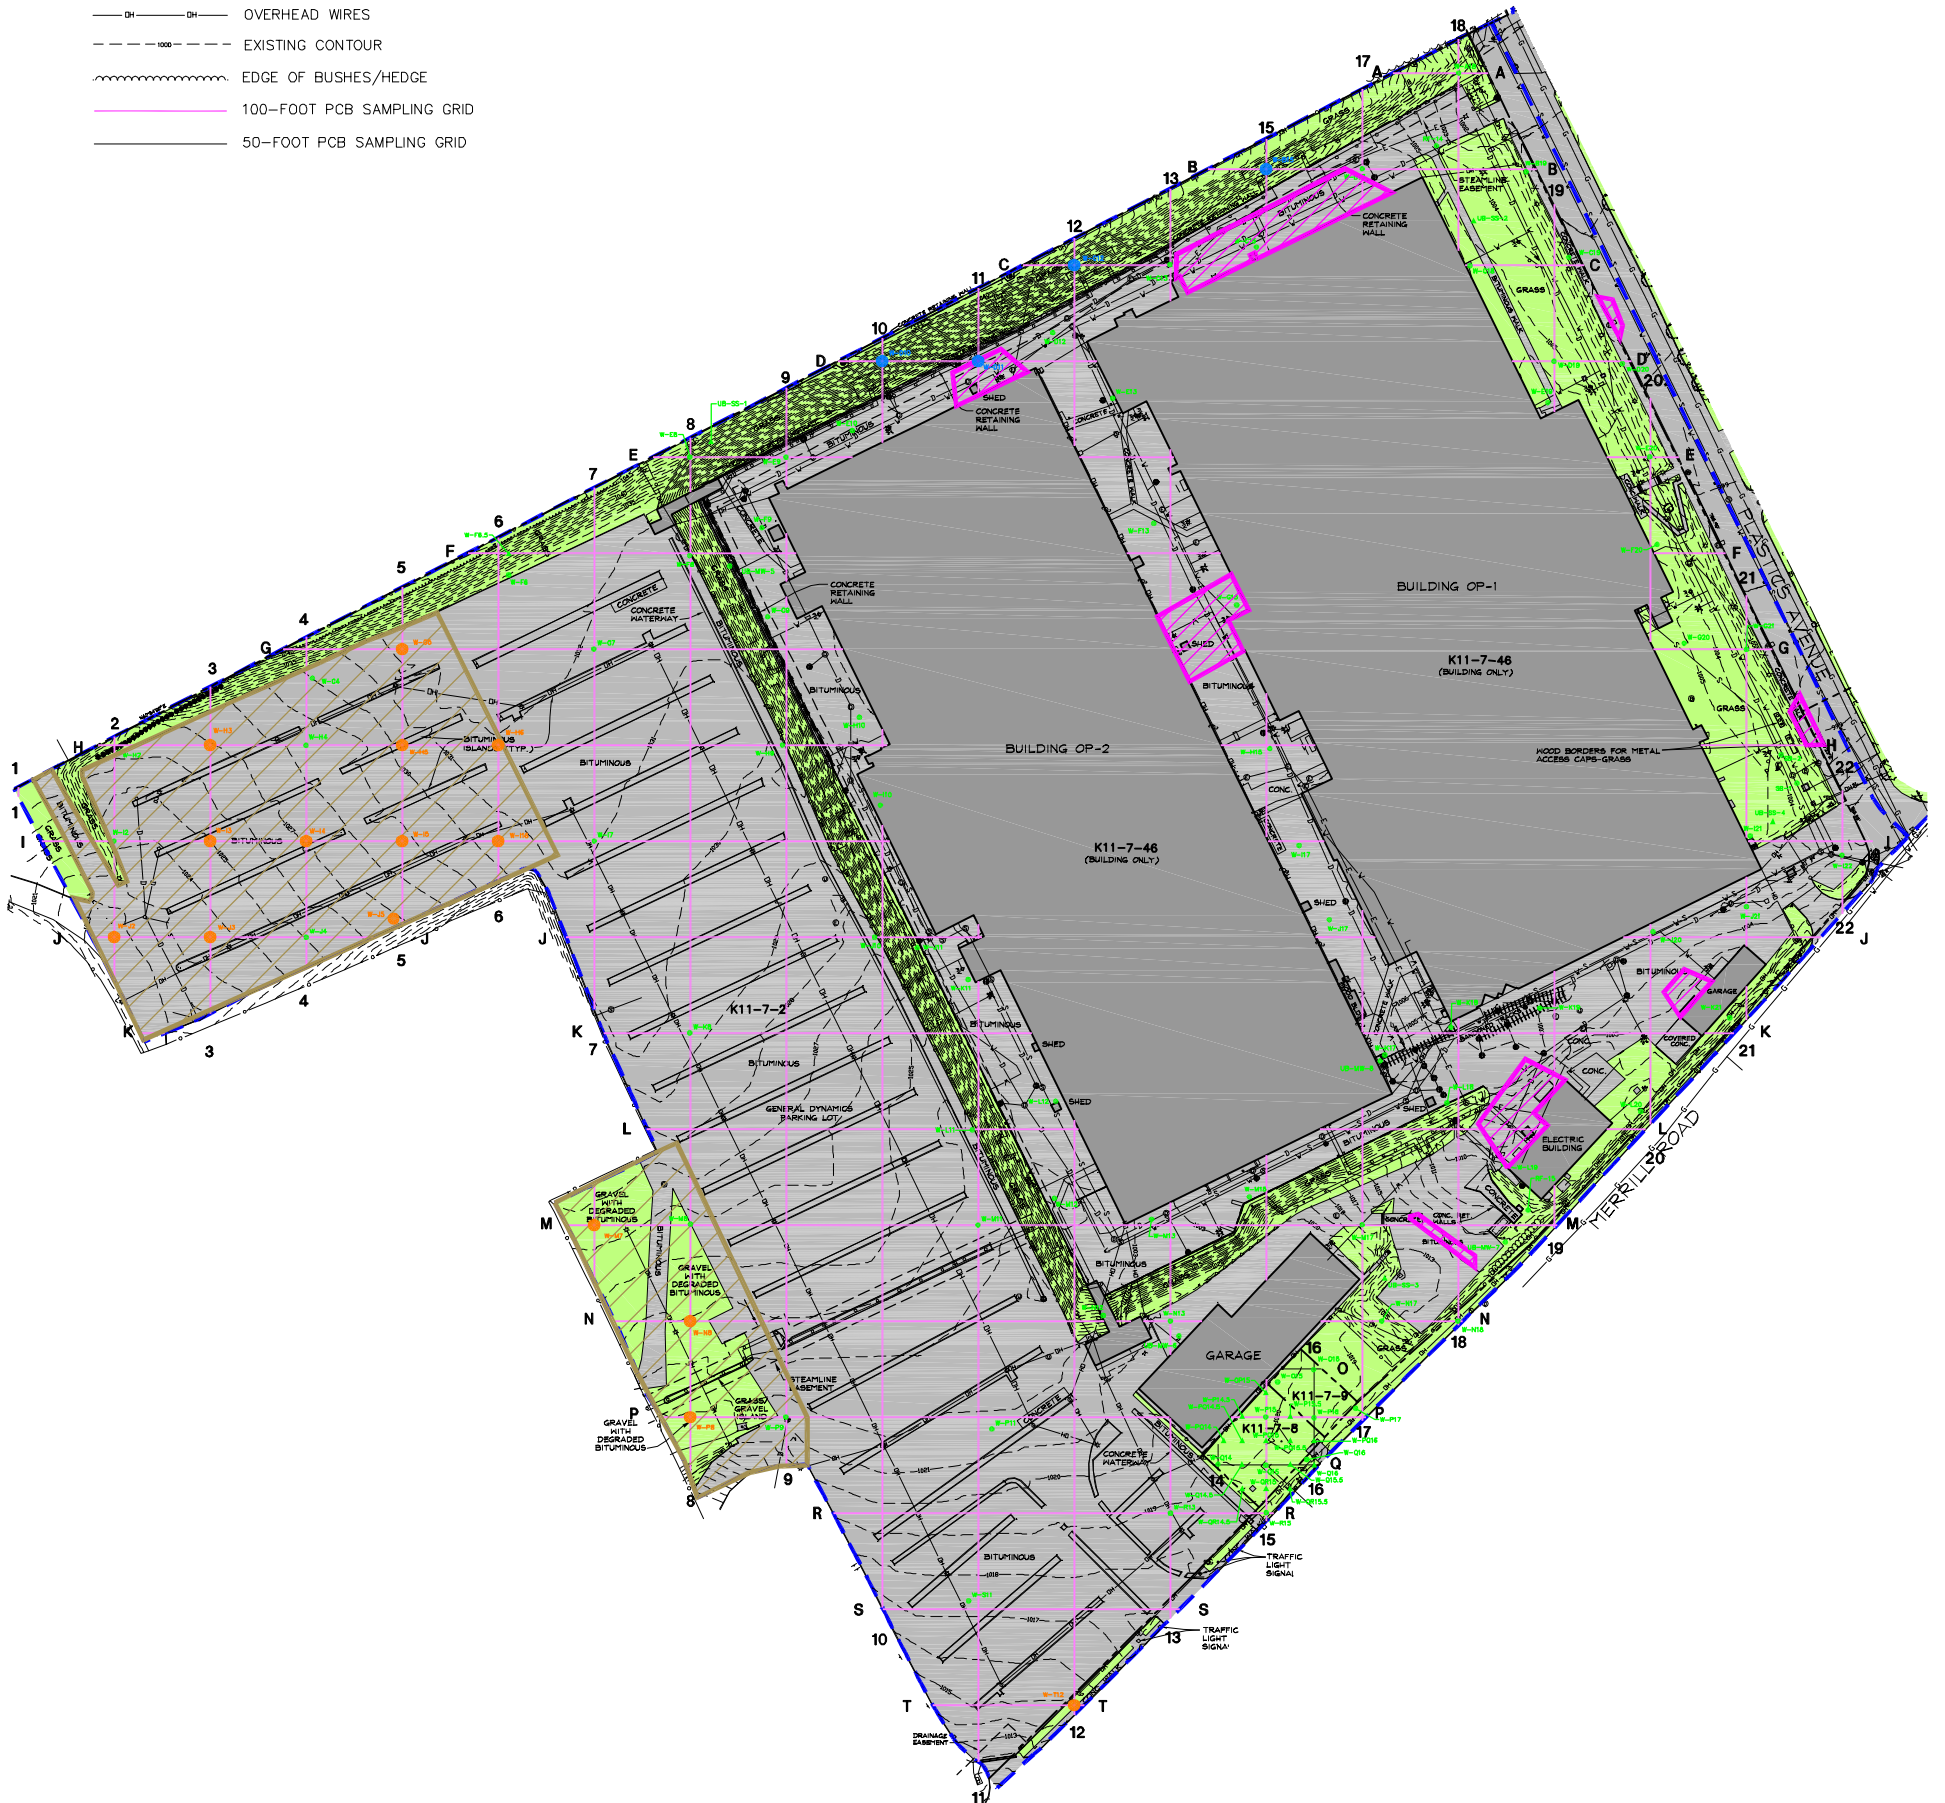
**FORMER WEST AREA - PCB
 CHARACTERIZATION LOCATIONS**

- During pre-design activities, the westernmost portion of Parcel K11-7-2 was considered to be paved (see areas hatched in brown on Figure A attached to this report). During the recent pavement inspection site walk, these areas were observed to consist at the present time primarily of vegetation (i.e., unpaved) and degraded pavement. As a result, GE has elected to characterize these areas as unpaved. Therefore, GE proposes to conduct additional PCB and non-PCB Appendix IX+3 sampling in these areas on the same basis as the samples collected as part of the pre-design investigation. The additional sample locations are shown on attached Figure A and details regarding the proposed sampling activities are provided on Table 2.
