# East Branch Housatonic River

- Habitat Restoration Goals and Objectives
- Ecological Characterization Data
- Existing Conditions Plans
- Proposed Conditions Plans & Specifications
- Restoration Construction
- Long-Term Monitoring

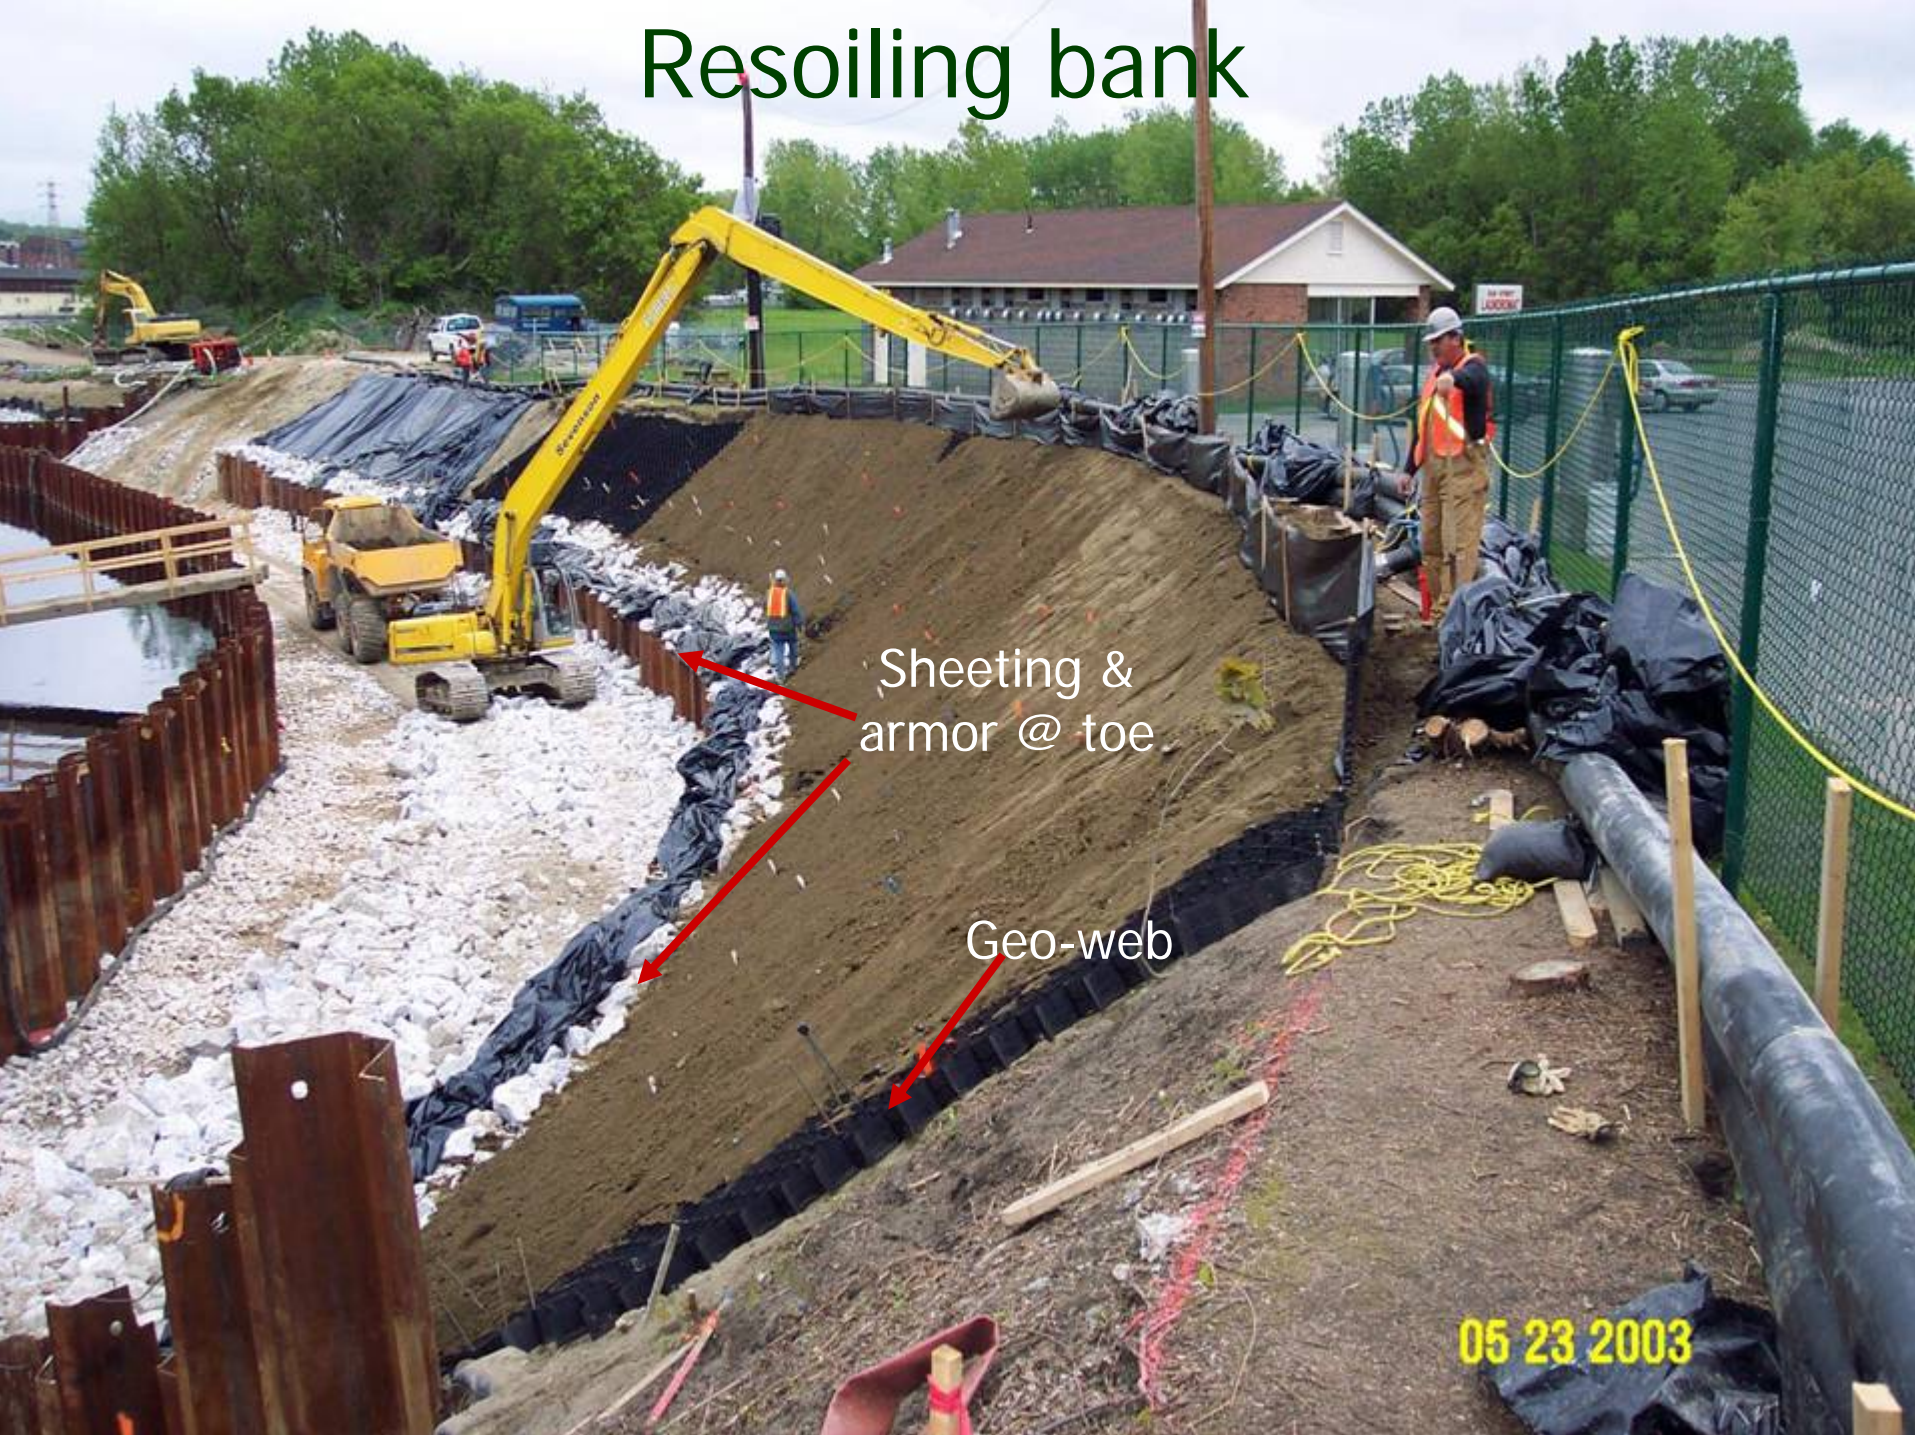
# Resoiling bank

Sheeting &  
armor @ toe

Geo-web

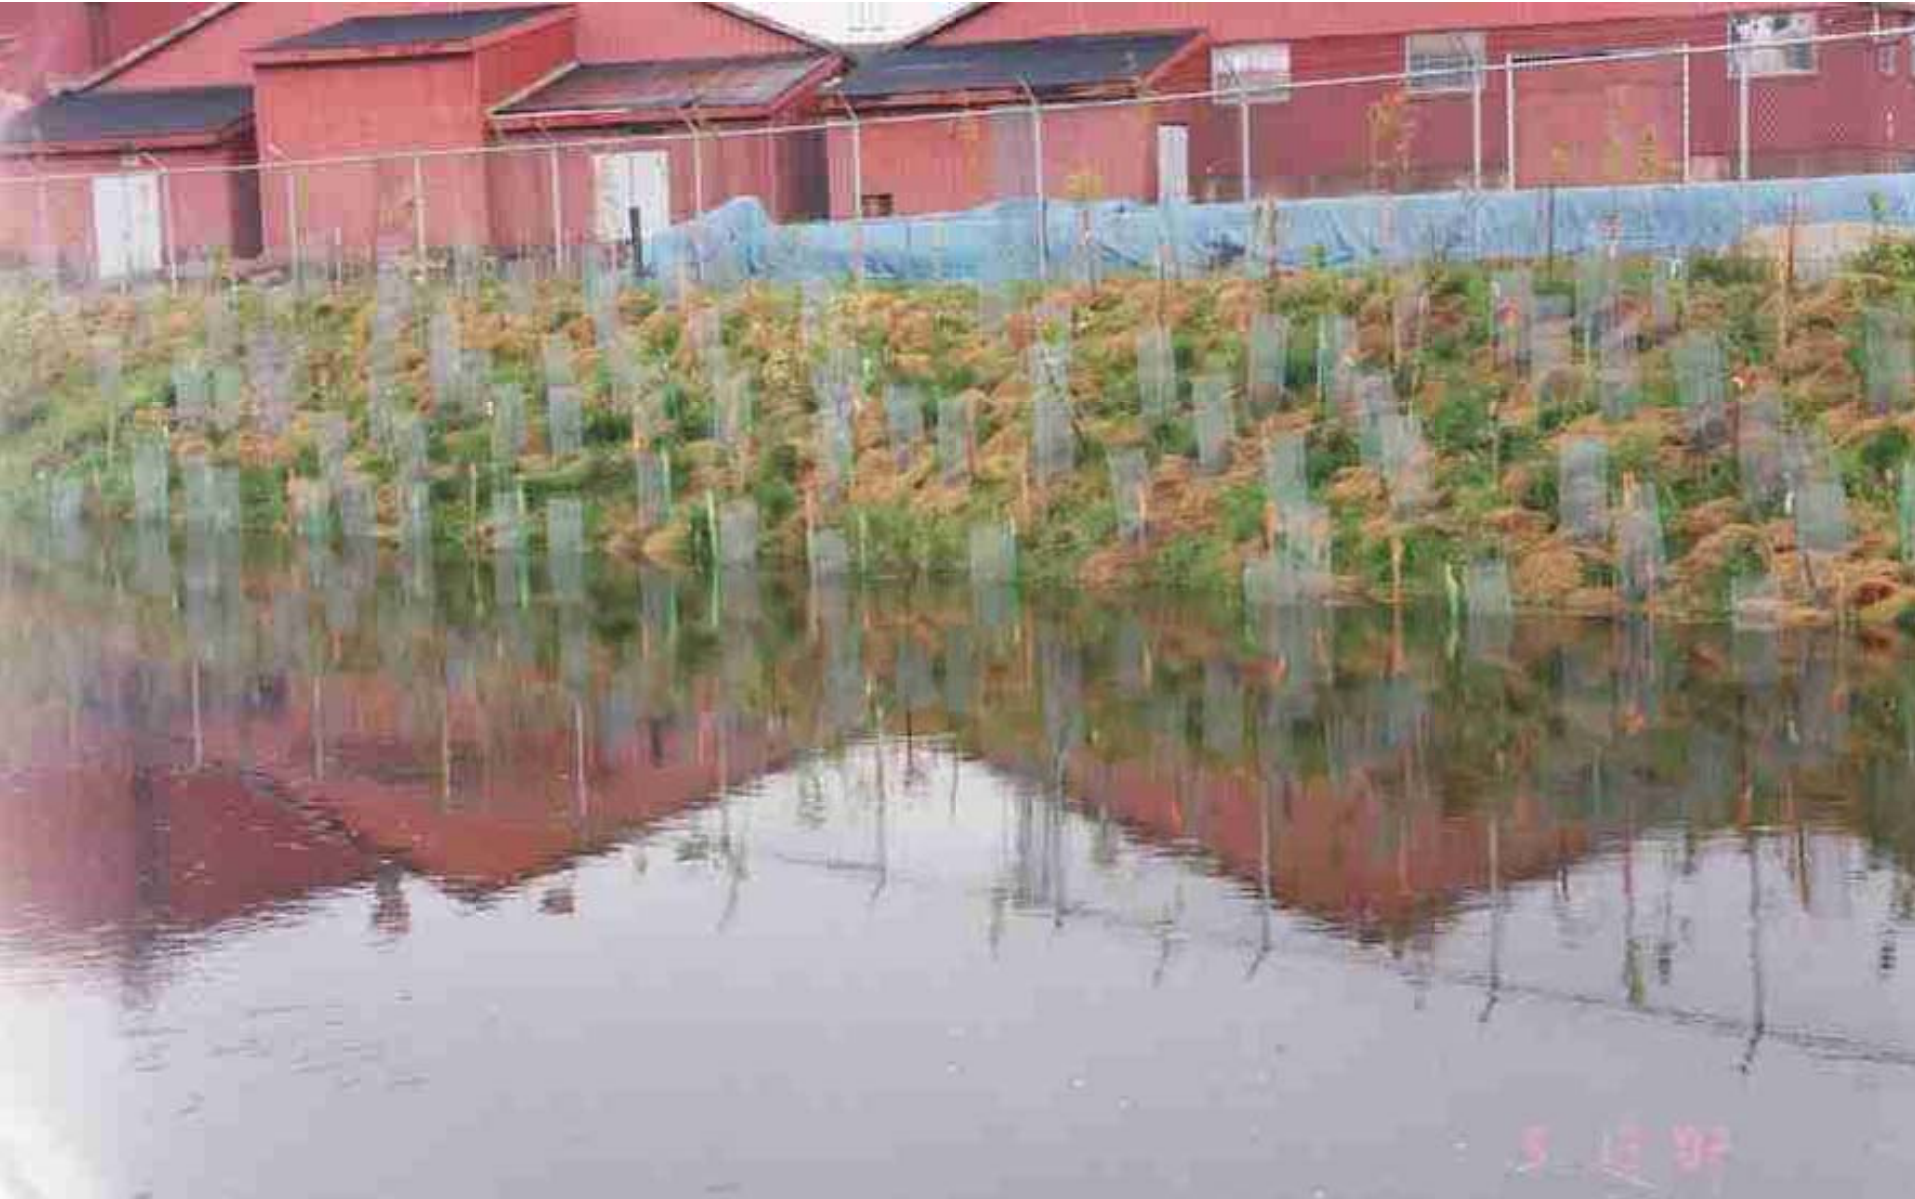
# Dense plantings to reestablish riparian vegetation and control erosion

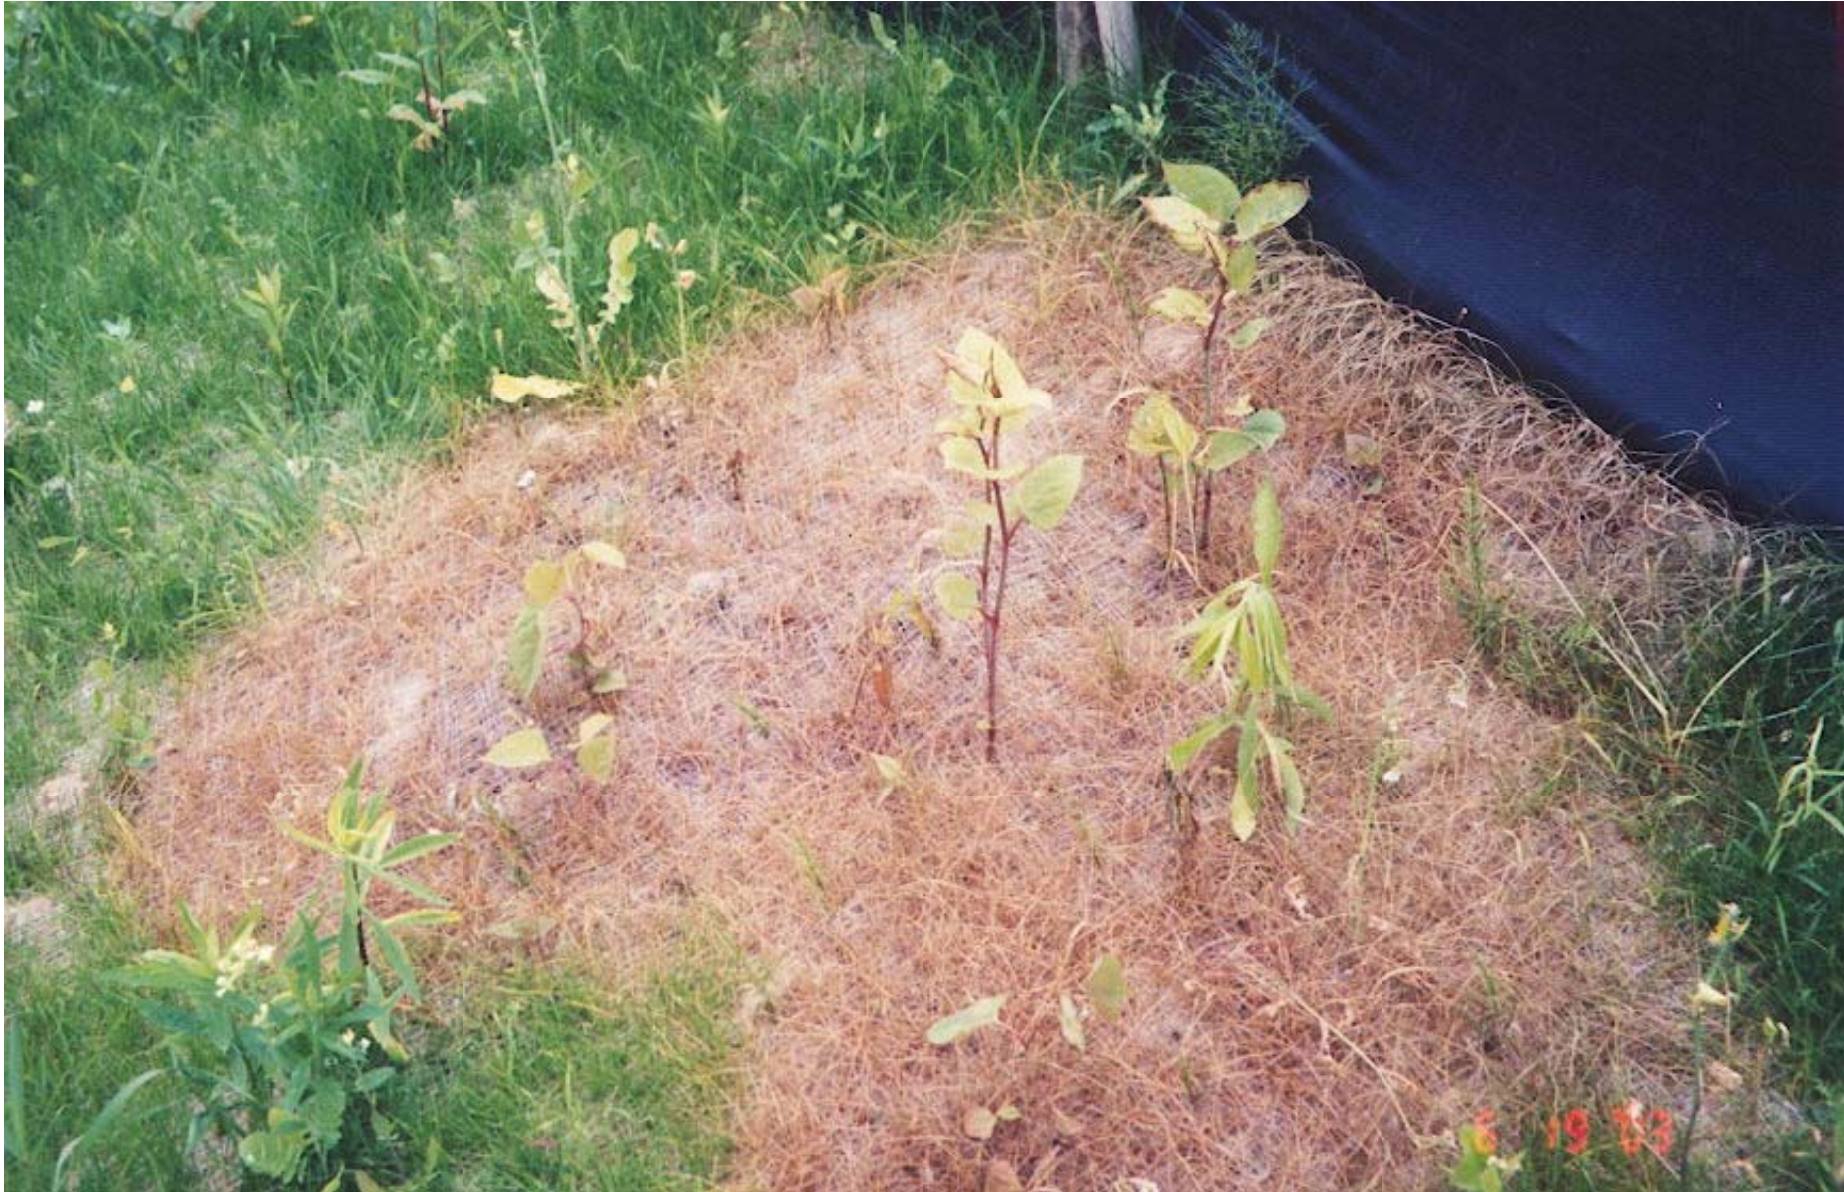
# Invasive Species – Japanese knotweed controlled with herbicide

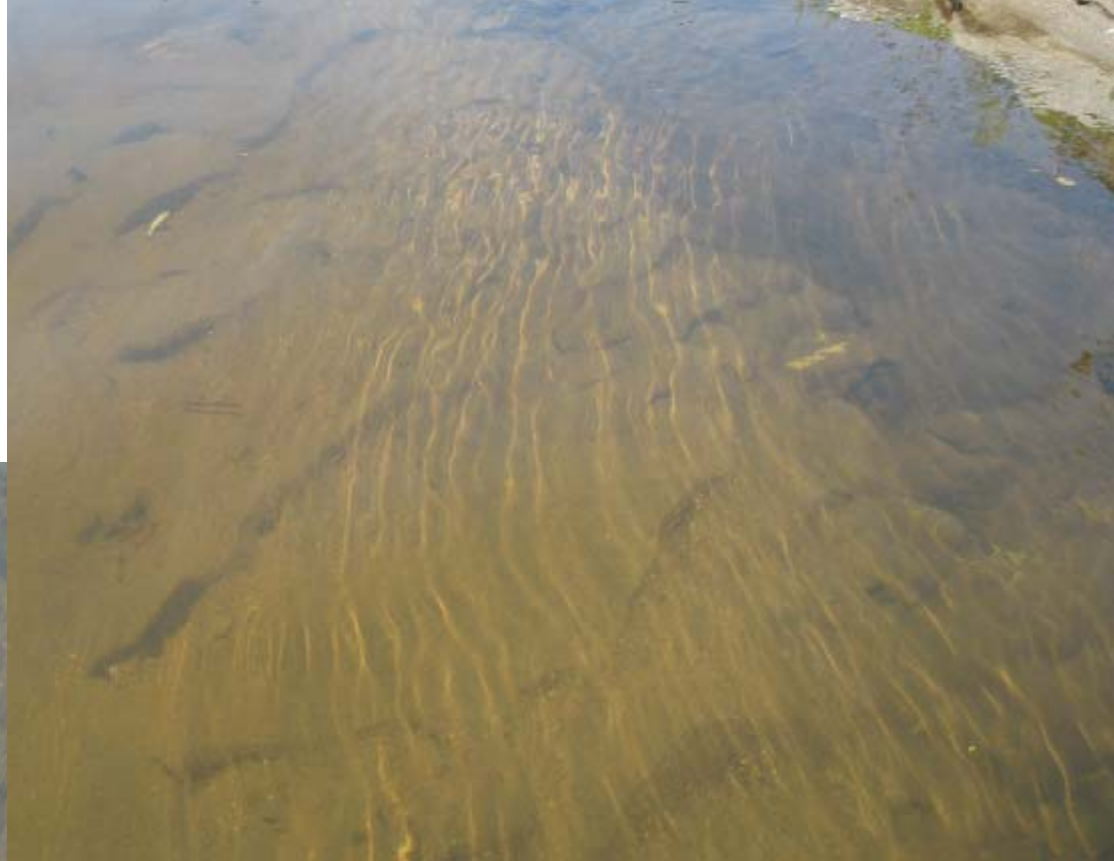
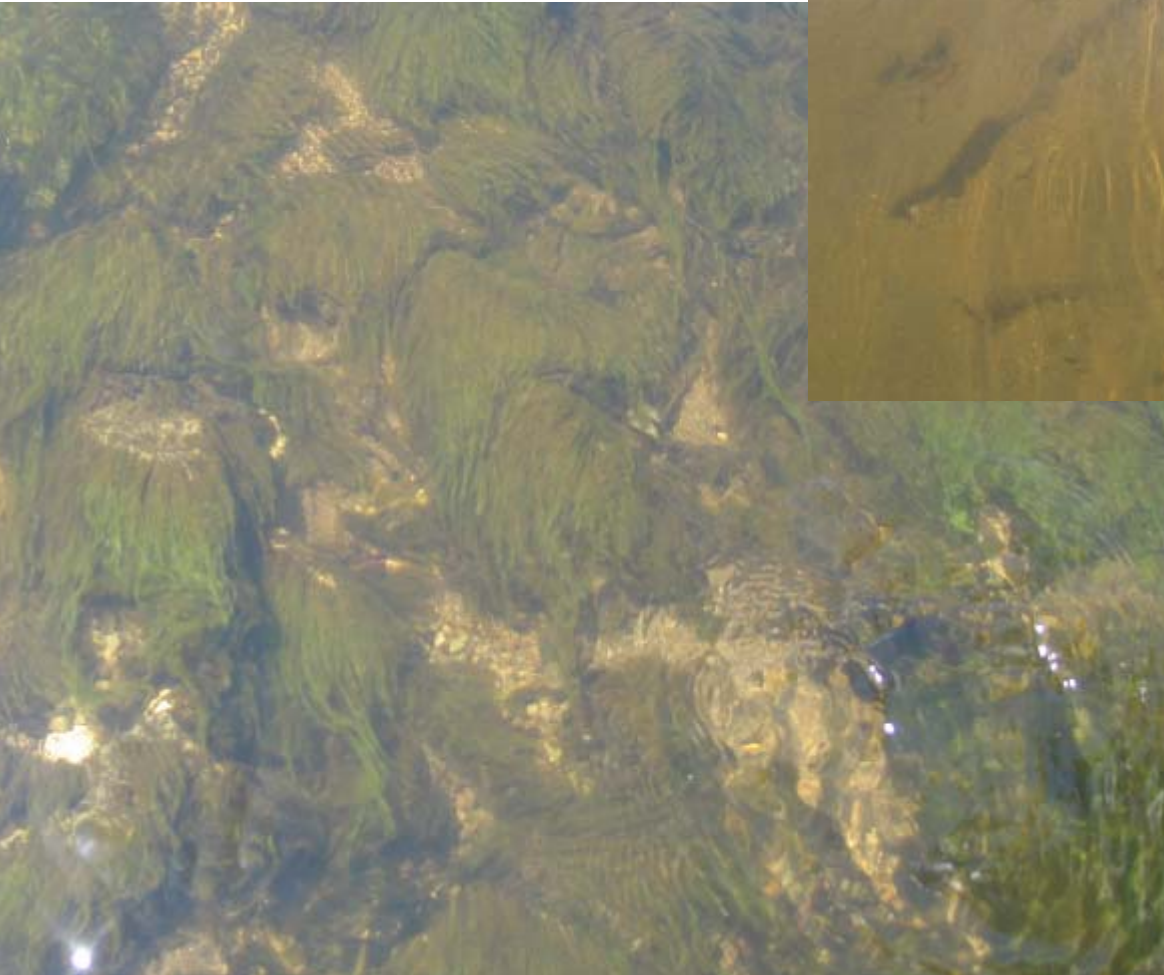
Riprap placed Fall 2005,  
quiescent area

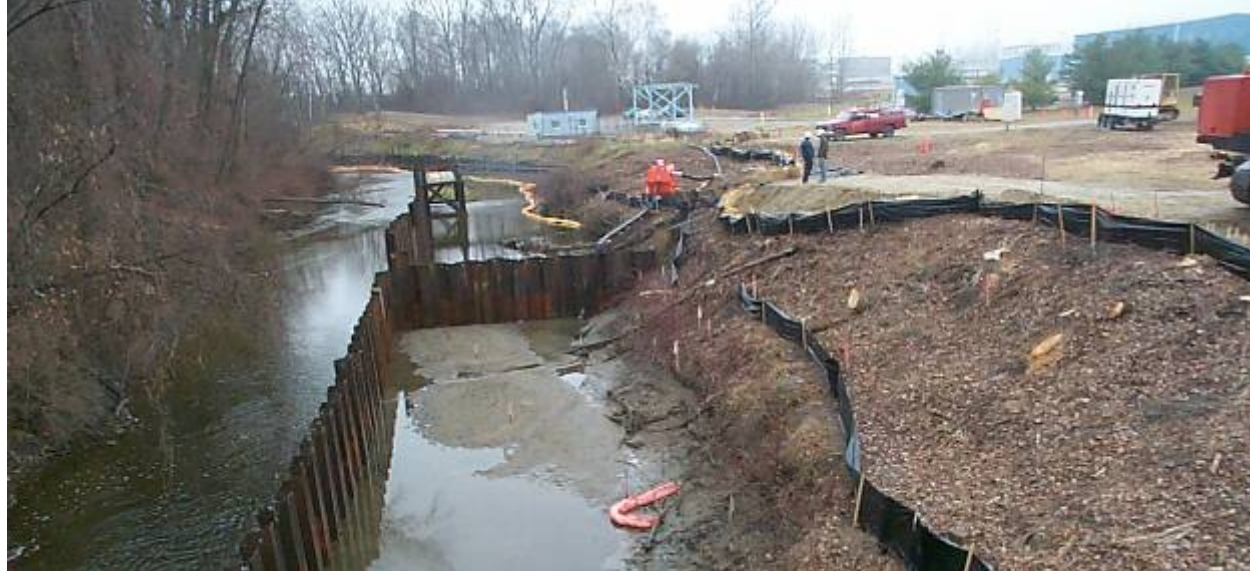
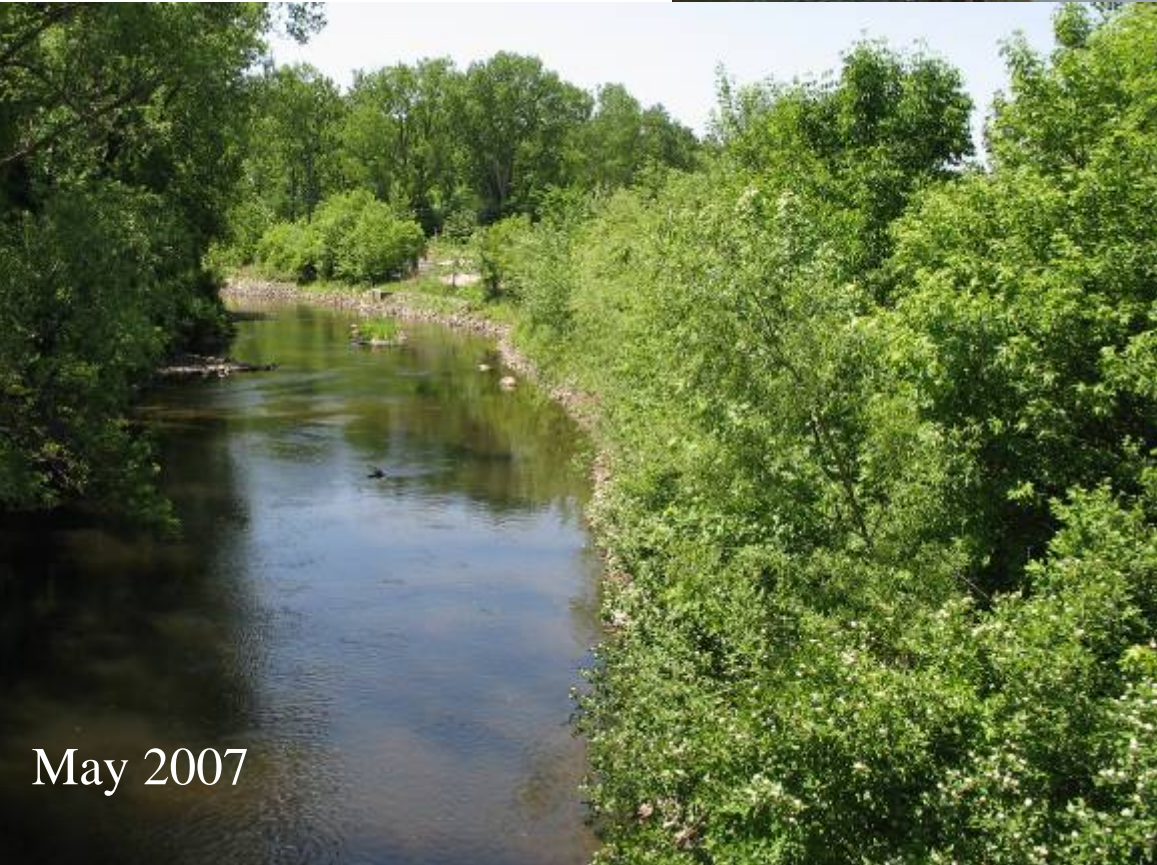
Riprap placed Summer 2005,  
higher velocities
