**Re: GE Pittsfield/Housatonic River Site
Upper ½-Mile Reach Removal Action (GECD800)
2001 Annual Vegetative Monitoring Report**

**2001 ANNUAL MONITORING REPORT
ECOLOGICAL RESTORATION ACTIVITIES
UPPER ½ MILE REACH OF THE HOUSATONIC RIVER**

Ecological Streambank Restoration August 2001 Monitoring Event
Draft Monitoring Report

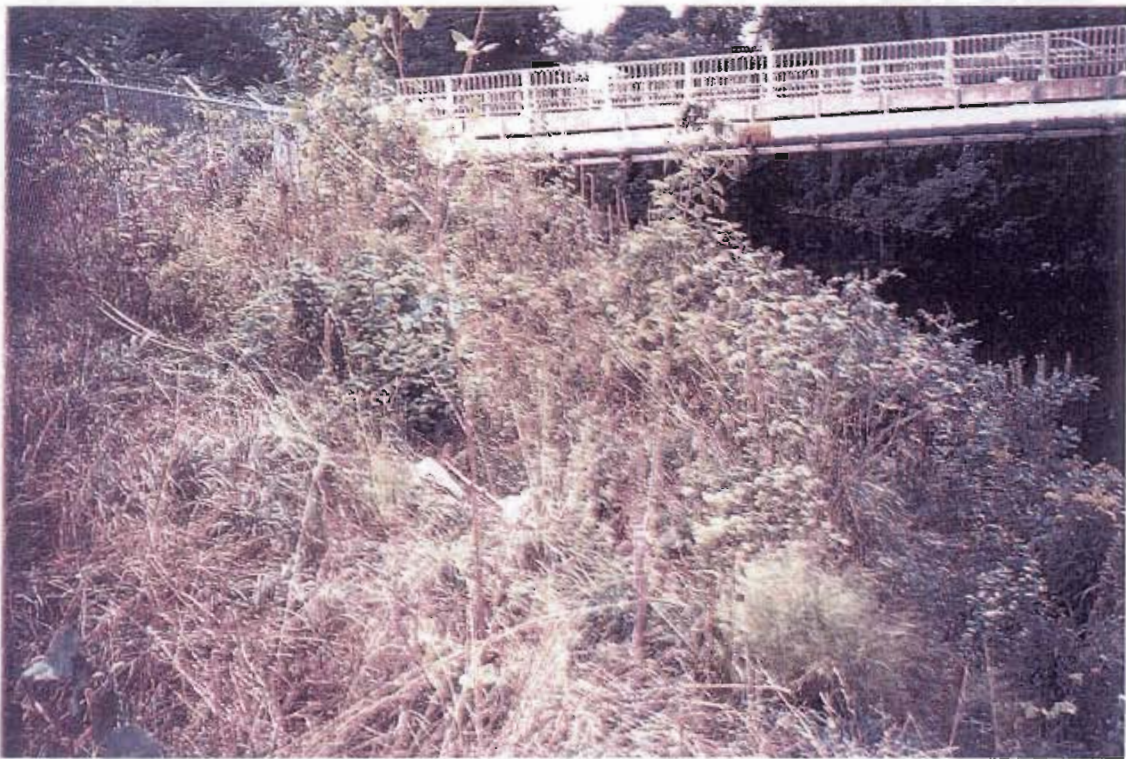
Photograph 1 Planting Area 1 Near Newell Street Bridge

In general, Area 1 showed the lowest success rate of canopy species, understory species and herbaceous cover. Area 1, located adjacent to the Newell Street Bridge, was the first area that was remediated and restored. The canopy species were 45 below the target performance standard. Of those canopy species that were standing, 42% were considered to be stressed. Cottonwood and boxelder were the two species that showed the greatest success rate. Black willow showed the poorest success rate, though that appeared to be primarily due to herbivory. There are two understory cells in Area 1, with the one closest to the Newell Street Bridge showing less planting success than the understory cell located further downstream. As with all five of the monitoring areas, serviceberry showed the poorest survival of the understory specimens and if present, was generally stressed. Herbaceous coverage was poor in Area 1, ranging from 50% cover to 85% cover in the various sections that were monitored.

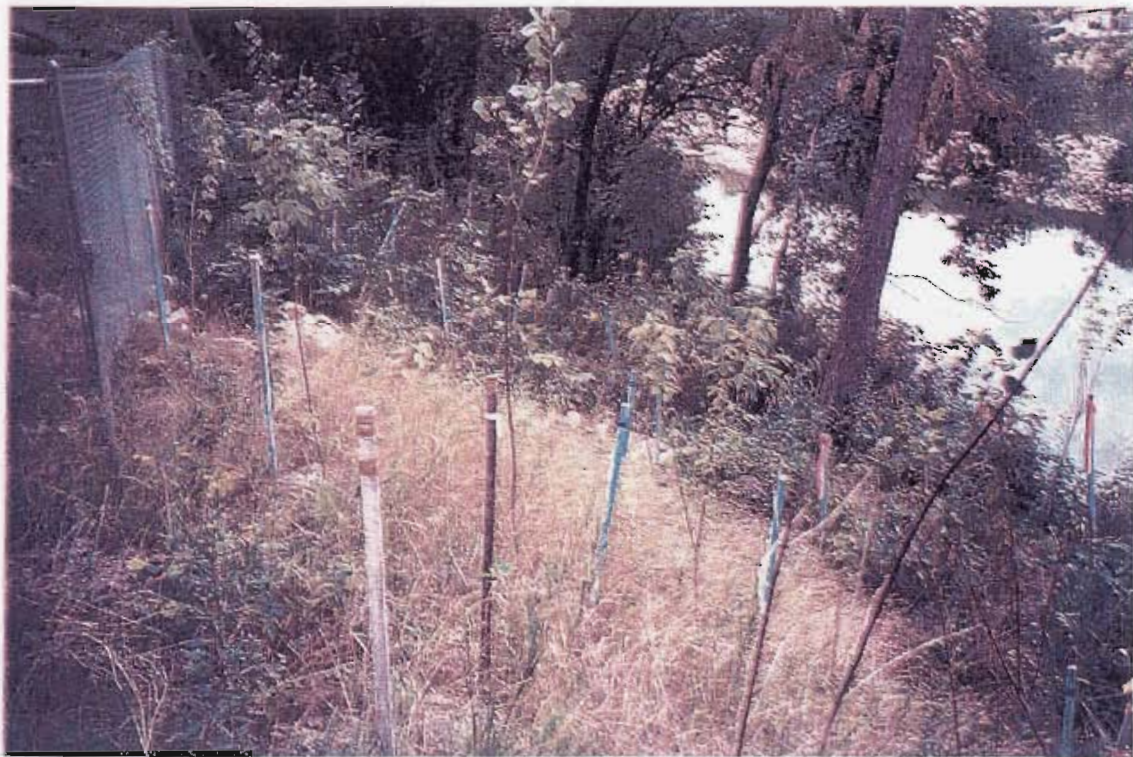
Photograph 6 Planting Area 5

Of the remaining four areas, Area 5 showed the highest degree of planting success, which was expected noting that Area 5 was the most recently planted area. The section of Area 4 that was inspected had the highest degree of stressed specimens of any of the sections (52%) and the highest number of dead specimens (48). The impacts to canopy specimens in Area 4 appeared to be from a combination of herbivorous activities and herbicide drift. Area 4 also had some of the lowest herbaceous cover results (45% cover). While Area 5 had 70% herbaceous coverage, grasses dominated the coverage. Herbicidal impacts to desired specimens was seen, to varying degrees, in all five areas, except Area 5. All five areas, except Area 3, showed water stress in many of the planted specimens due to insufficient rainfall. As a result, supplemental watering was implemented.

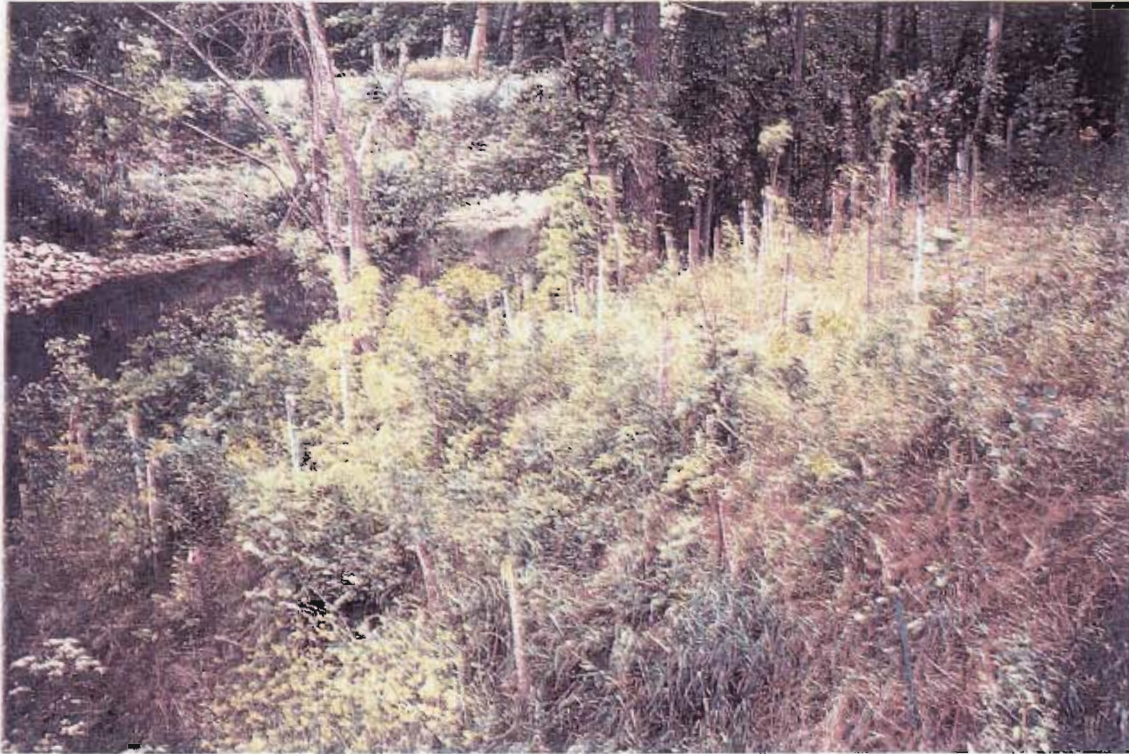
Photograph 7

Planting Area 5

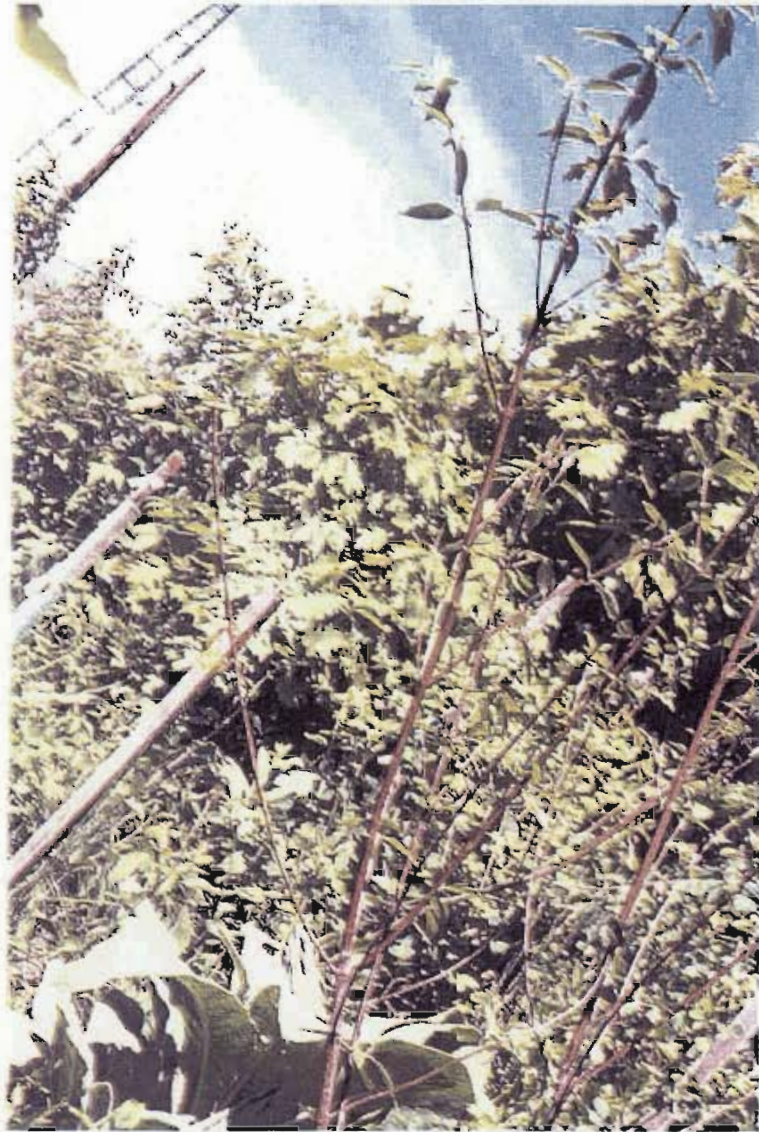
Photograph 11

Regarding the understory species, all of the planted specimens had excellent growth except for the serviceberry. Silky dogwood demonstrated the greatest growth, with as much as 32 inches of new growth in some instances. In general, the serviceberry did not appear to be thriving. While most specimens were leafed out, a number of the specimens (approximately 1/3) showed a lack of leaves or wilted leaves. Very little new growth was apparent in all specimens. Of all of the understory species, the greatest uniform growth was observed in the red-osier dogwood band located adjacent to the river. All specimens showed at least 18 inches of stem growth and excellent foliage development. Some collateral damage by herbicides used in the treatment of invasive species was noted.

Silky Dogwood Showing Extensive New Growth
