2003 Annual Monitoring Report Upper 1/2-Mile Reach of the Housatonic River

**General Electric Company
Pittsfield, Massachusetts**

February 2004

**Re: GE Pittsfield/Housatonic River Site
Upper ½-Mile Reach Removal Action (GECD800)
2003 Annual Monitoring Report**

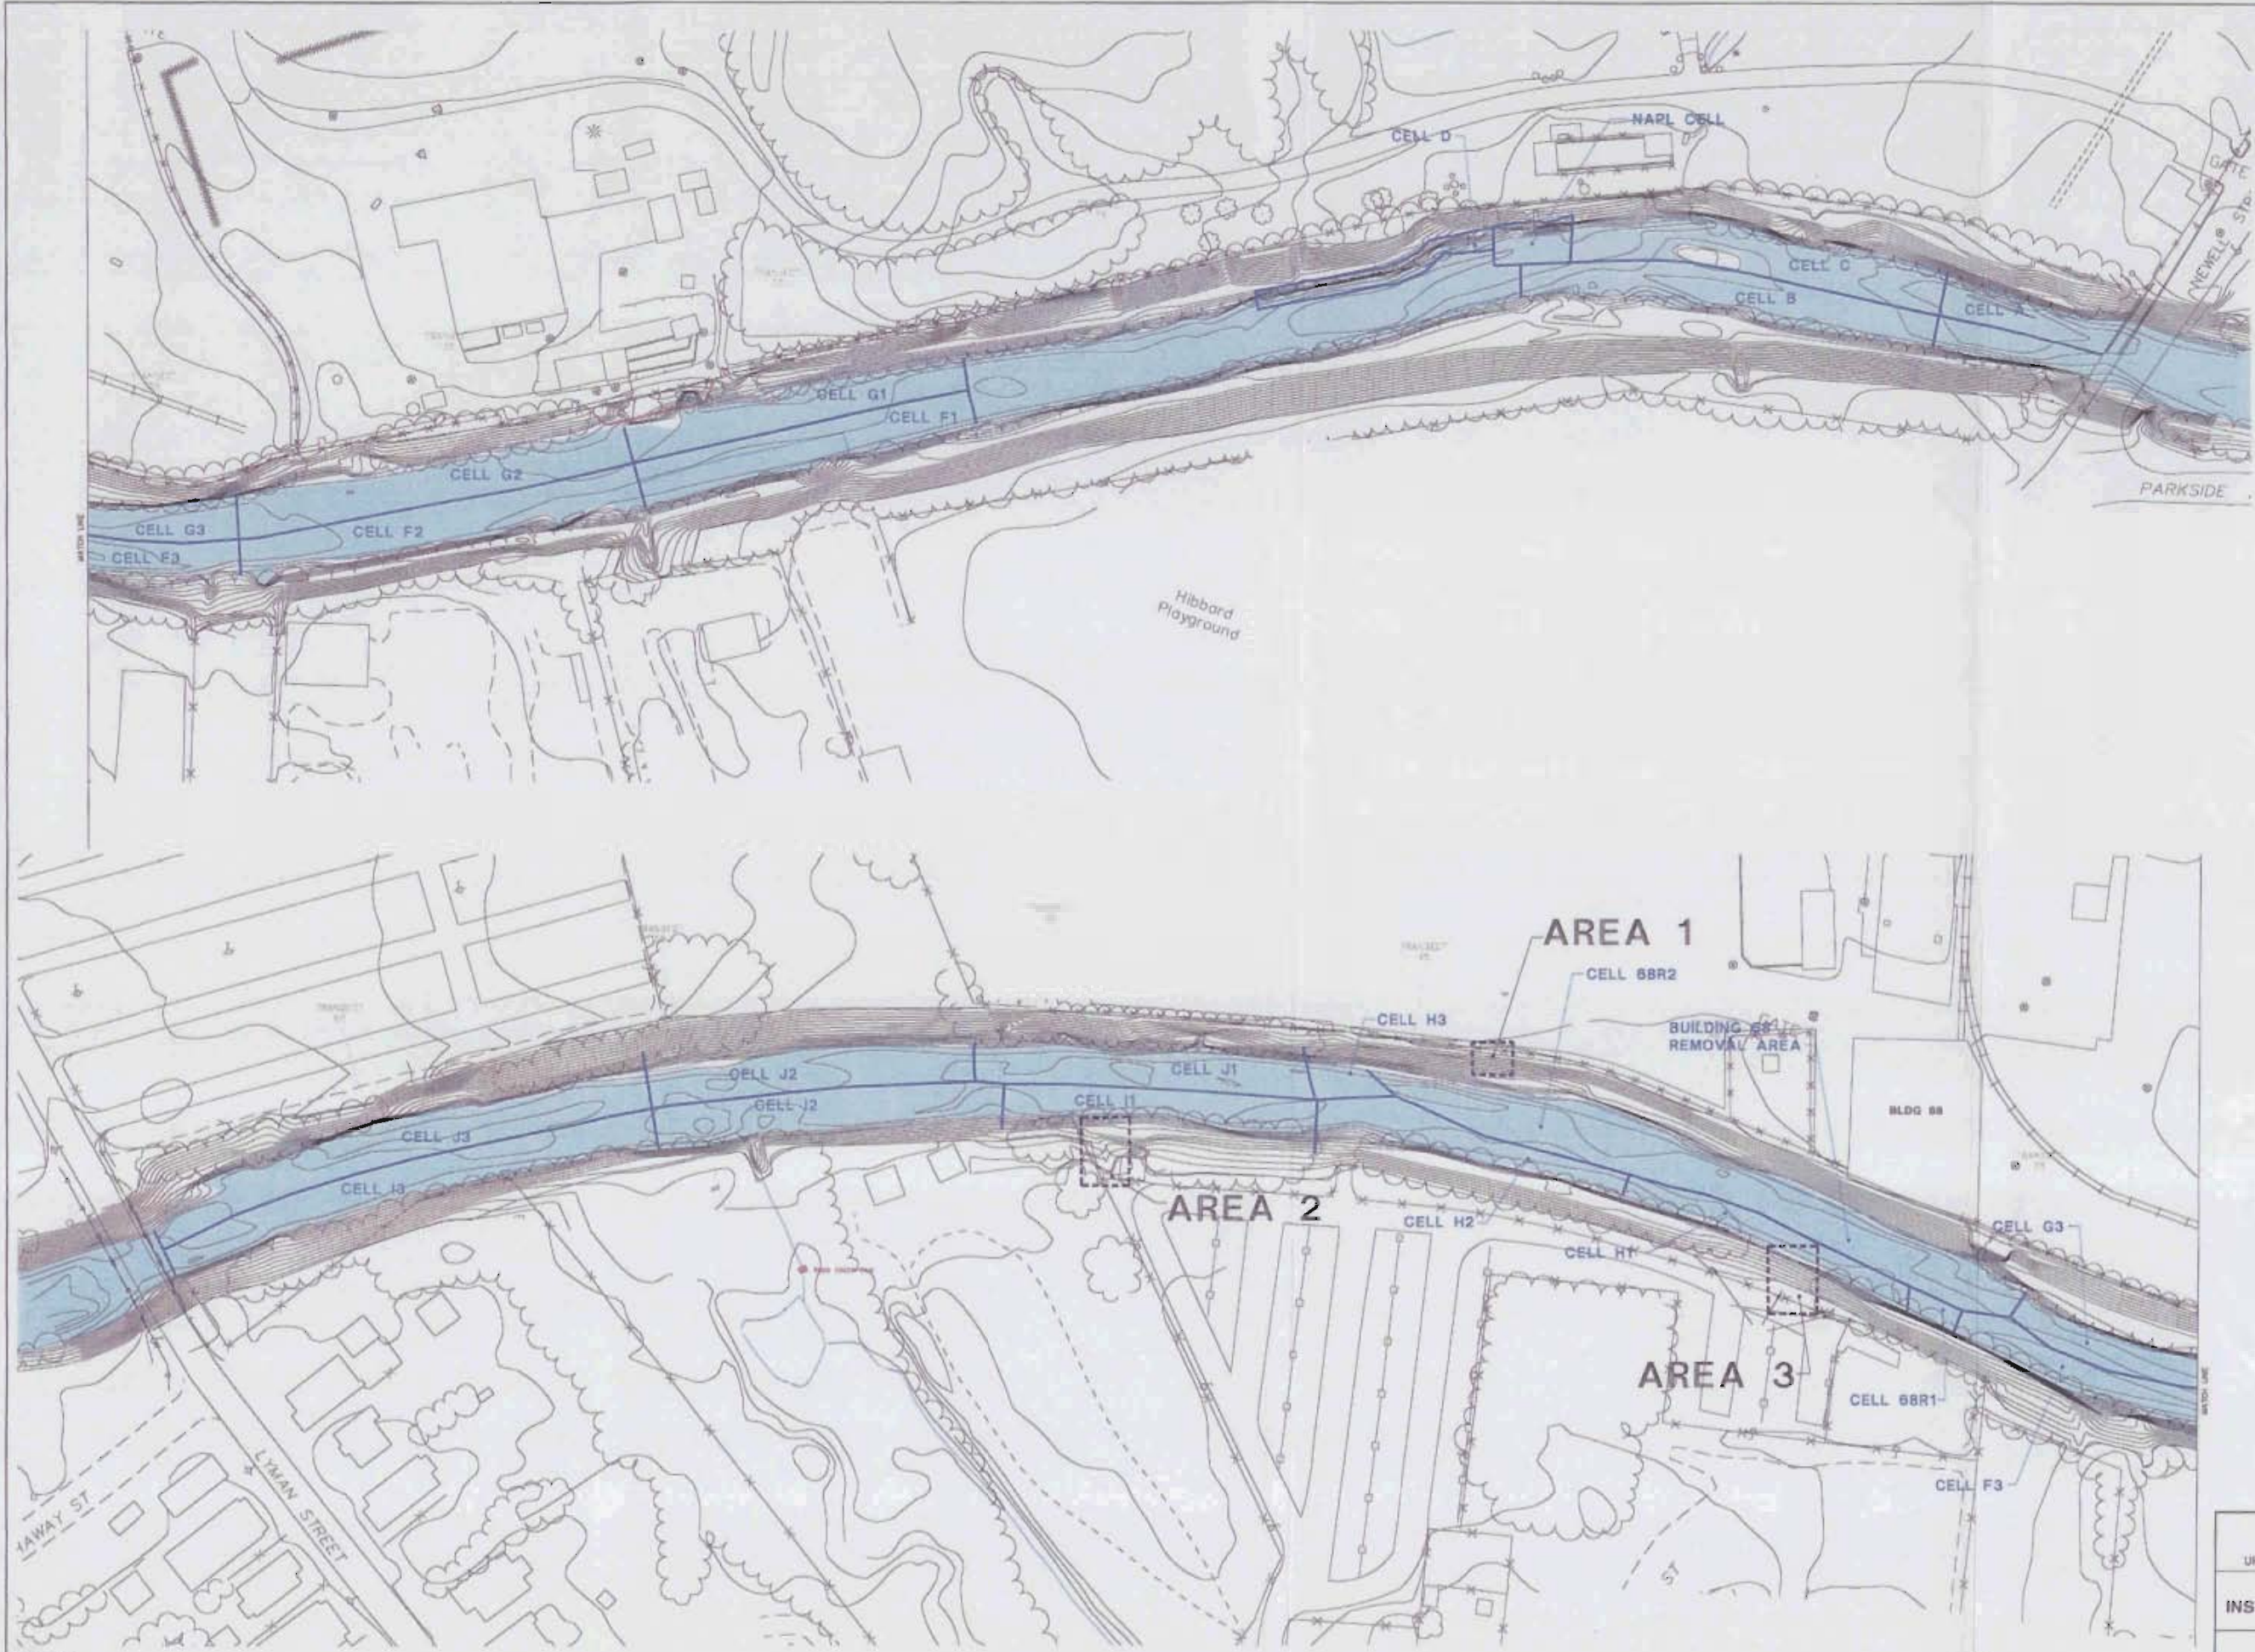
Area 1 is located approximately 30 feet downstream of Building 68 on the northern shore of the river (Figure 3-1). Less than 0.5 cubic yards of clean backfill appeared to have eroded from the restored bank into the River (see Attachment A). The likely cause of the erosion was the placement of hay bales on the storm drain gate, which impeded surface drainage and forced excess water to discharge around the storm drain headwall and over the bank. Evidence of eroded soil was not apparent in the river and no removal was necessary. To address future erosion concerns at this location, the hay bales were removed from the storm drain and placed in a more

Area 2 is located between the southern shore of the river and the Newell St. Parking Lot Area within swale No. 11 (see Figure 3-1). Less than 1 cubic yard of clean backfill from the restored banks appeared to have been eroded from both sides of the swale (see Attachment A). The apparent cause of the erosion was the settling of riprap and sub-soil in the middle of the swale exposing the sides of the swale. No eroded soil was visible in the river and no removal was necessary. In September 2003, hay bales were placed at the head of the swale to reduce water velocities and additional riprap was placed in the swale to protect against future erosion at this location.

Movement of riprap was noted within swale No. 19, between the Newell St. Parking Lot Area and the southern shore of the river. This area is shown as Area 3 on Figure 3-1. To address this issue, in September 2003, additional riprap was placed within swale No. 19.

LEGEND
 TOP OF BANK
 APPROXIMATE LOCATION OF IMPACTED AREA NOTED DURING INSPECTION

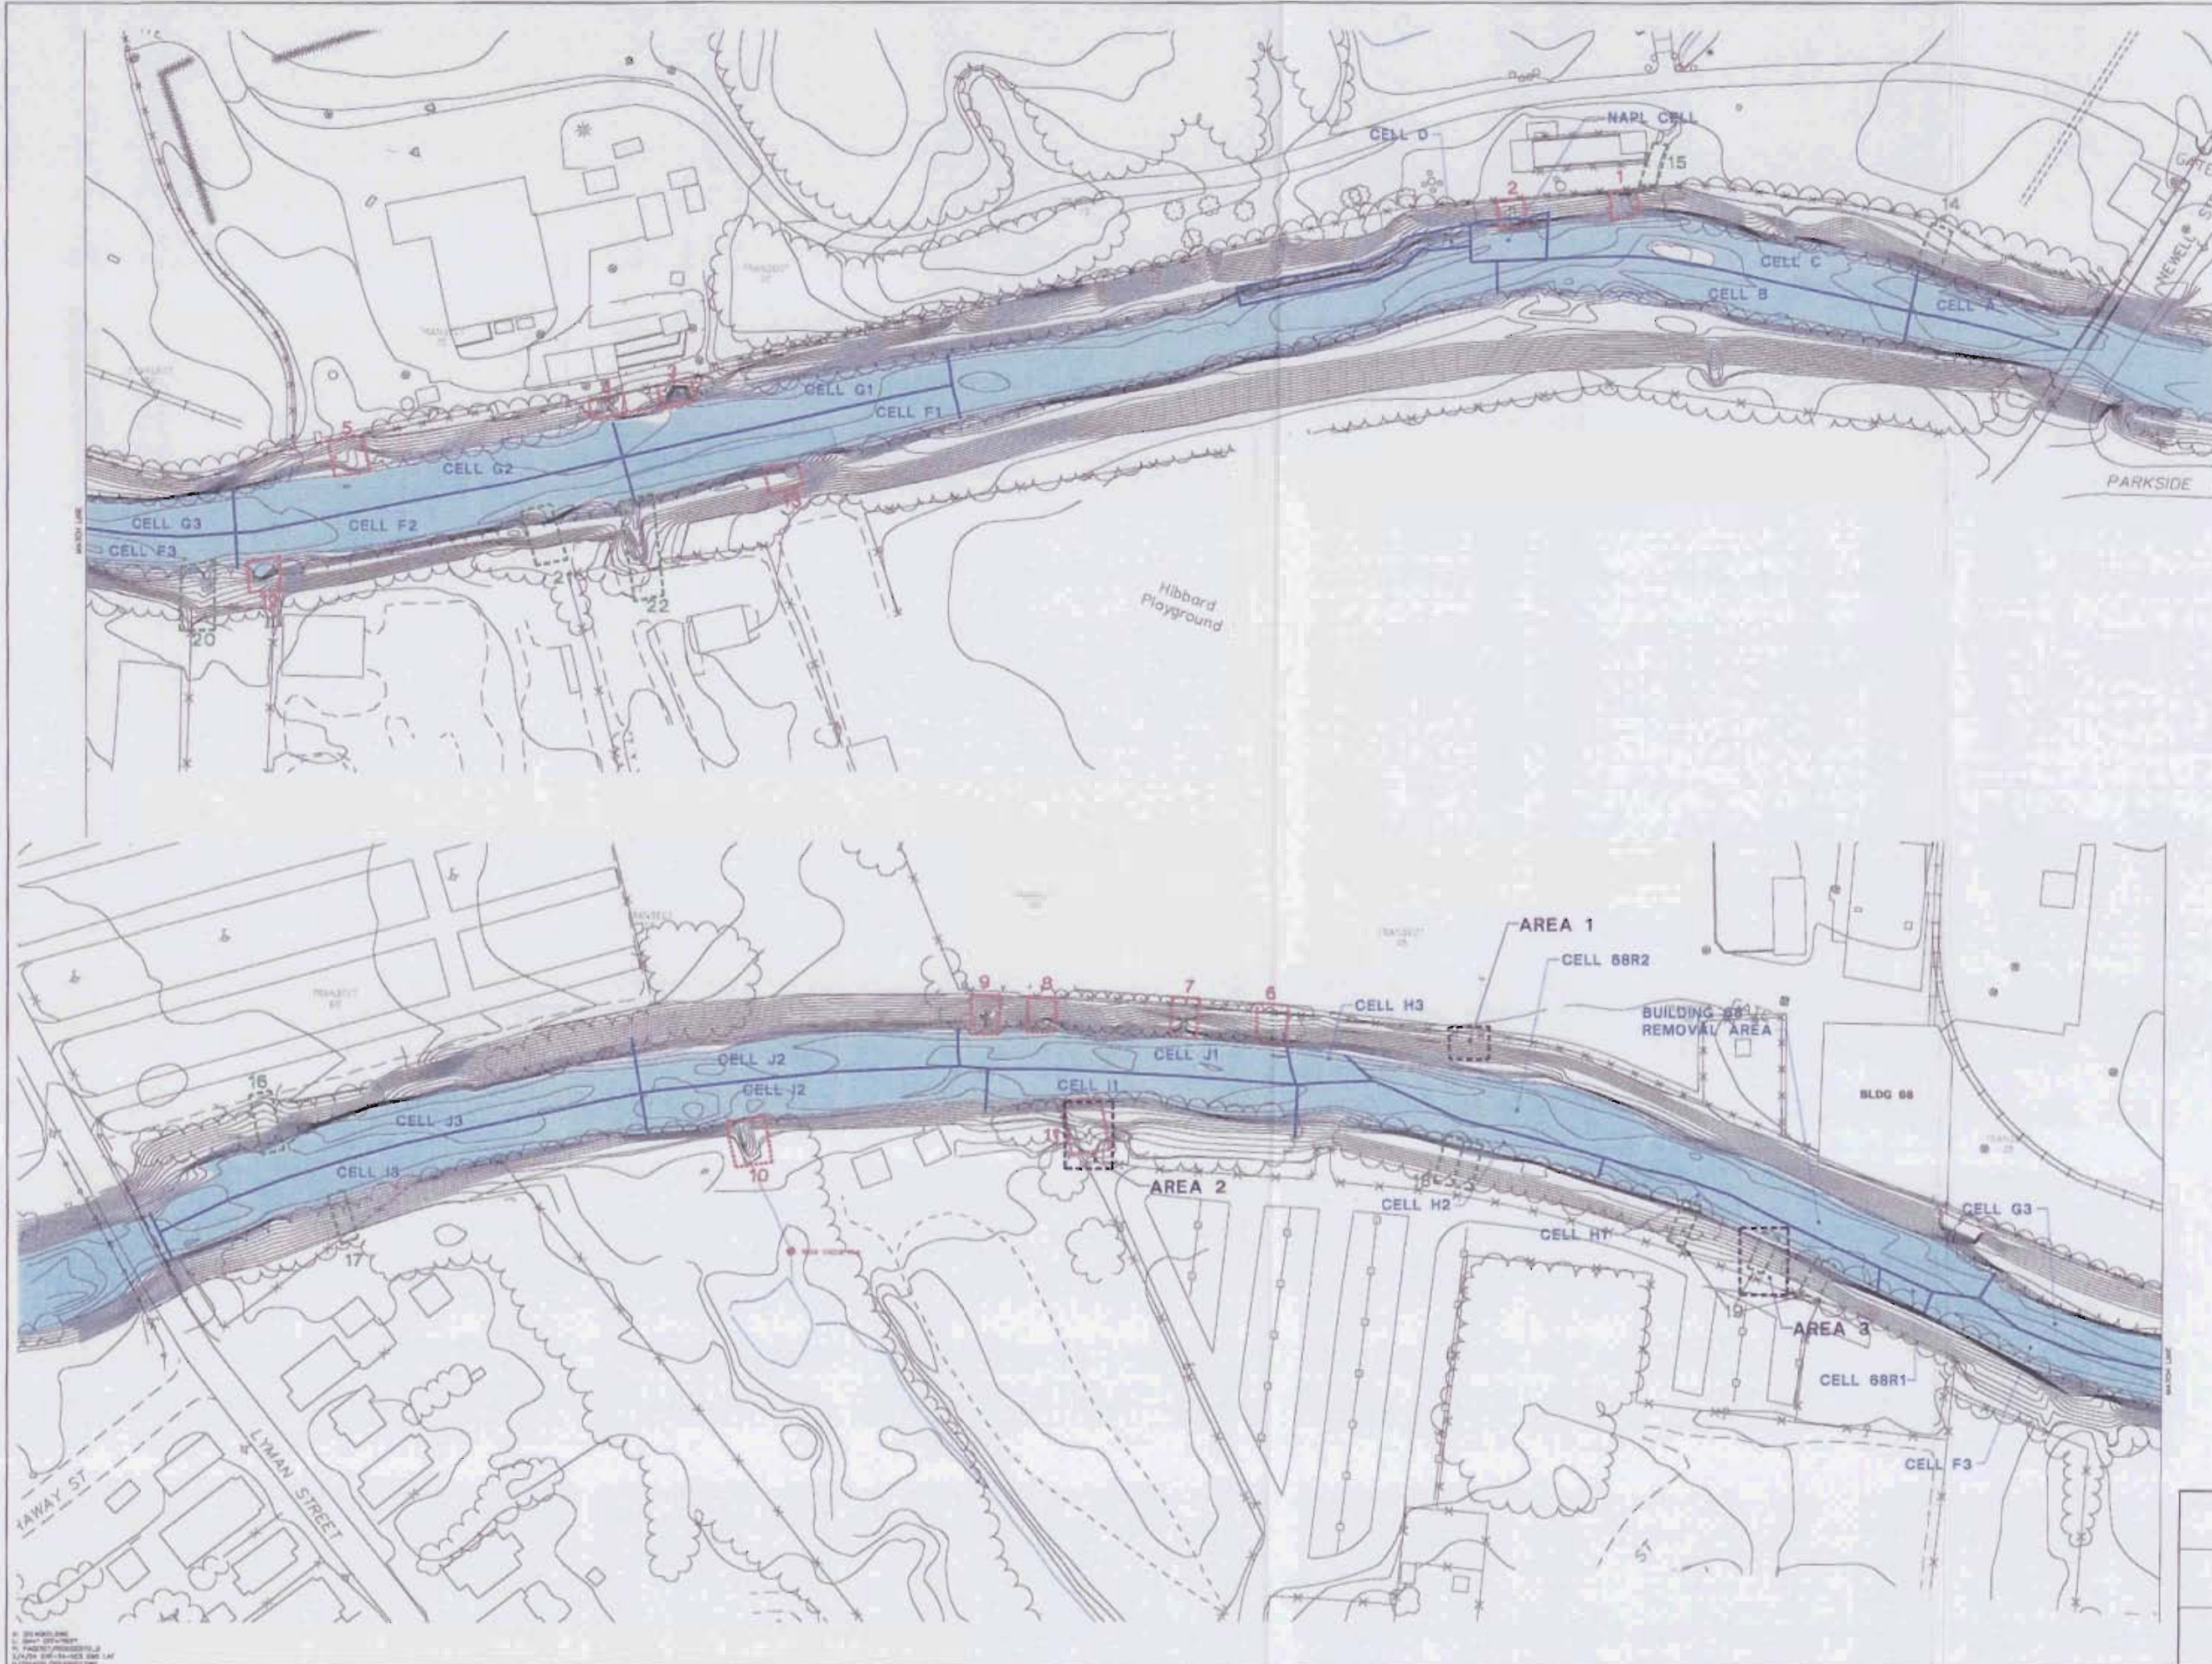
During the May 29, 2003 bank inspection, a measurable loss of bank soil was noted at two areas. These areas are identified as Area 1 and Area 2 on Figure 1 and are shown in Photos 1, 2, and 3. Descriptions of the areas, along with the proposed response action, are presented below and summarized in Table 1

- LEGEND:
- TOP OF BANK
 - - - - - APPROXIMATE LOCATION OF DRAINAGE/CHANNEL RESTORED IN ACCORDANCE WITH THE UPPER 1/2-MILE WORK PLAN
 - - - - - APPROXIMATE LOCATION OF DRAINAGE/CHANNEL RESTORED AT THE REQUEST OF EPA
 - - - - - APPROXIMATE LOCATION OF IMPACTED AREA NOTED DURING INSPECTION

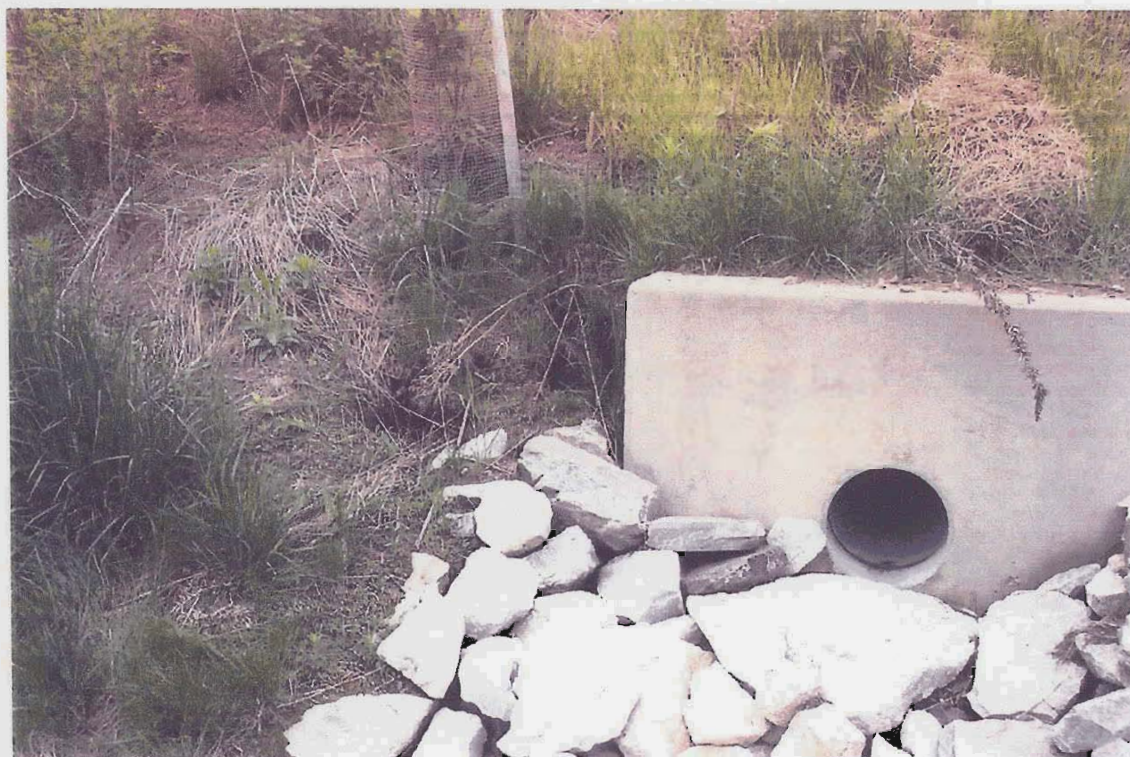
Photograph 6: Spring 2003 Restored Banks Erosion Inspection Area 1 Rip Rap Movement Downstream of Headwall

Area 1 – Less than 0.5 cubic yards (cy) of soil appears to have eroded into the River from the northern bank area approximately 300 feet downstream of Building 68 (see Figure 1, Photos 1 and 2). The source of eroded material was clean backfill from within the bank removal area near the top of the bank. The cause of erosion appears to be haybales placed on the storm drain grate above this area that apparently impeded and backed up the surface drainage causing it to discharge over the bank. No evidence of eroded soil was observed in the adjacent River and, therefore, no removal activities are planned at this location. To reduce potential for future erosion in this area, the haybales were removed from directly over the storm drain grate. It is not anticipated that additional erosion will occur after removal of the haybales. The bank will be restored by placing additional topsoil and seed in the upper bank area (Photo 1) and placing additional rip rap downstream of the headwall (Photo 2).

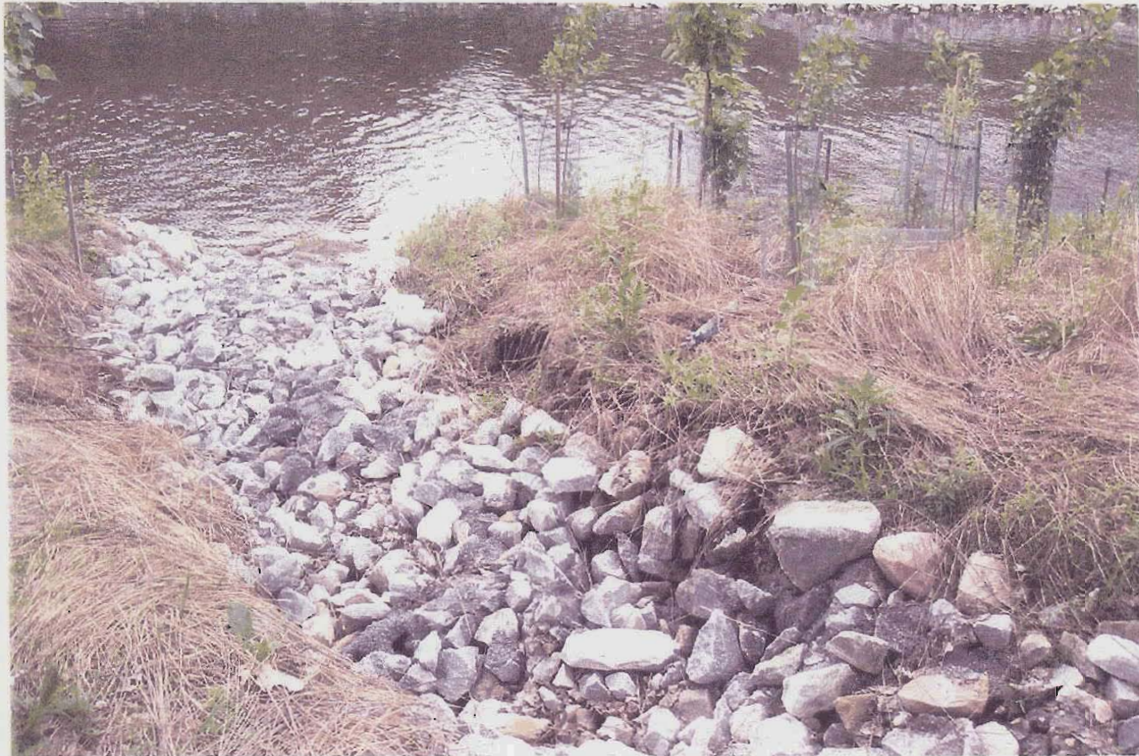
Photograph 7: Spring 2003 Restored Banks Erosion Inspection Settlement/Erosion Swale No. 11

Area 2 – Less than 1 cy of soil appears to have eroded into the River from the southern bank area in the Newell Street Parking Lot Area within swale No. 11 area (see Figure 1, Photo 3). The source of eroded material was clean backfill from within the bank removal area along both sides of the swale. The cause of erosion appears to be settlement of the rip rap and soil in the center portion of the swale exposing the sides of the swale. No evidence of eroded soil was observed in the adjacent River and, therefore, no removal activities are planned at this location. To reduce potential for future erosion in this area, additional rip rap will be placed along both sides of the swale. In addition, haybales will be placed at the head of the swale to reduce water velocities entering the swale.

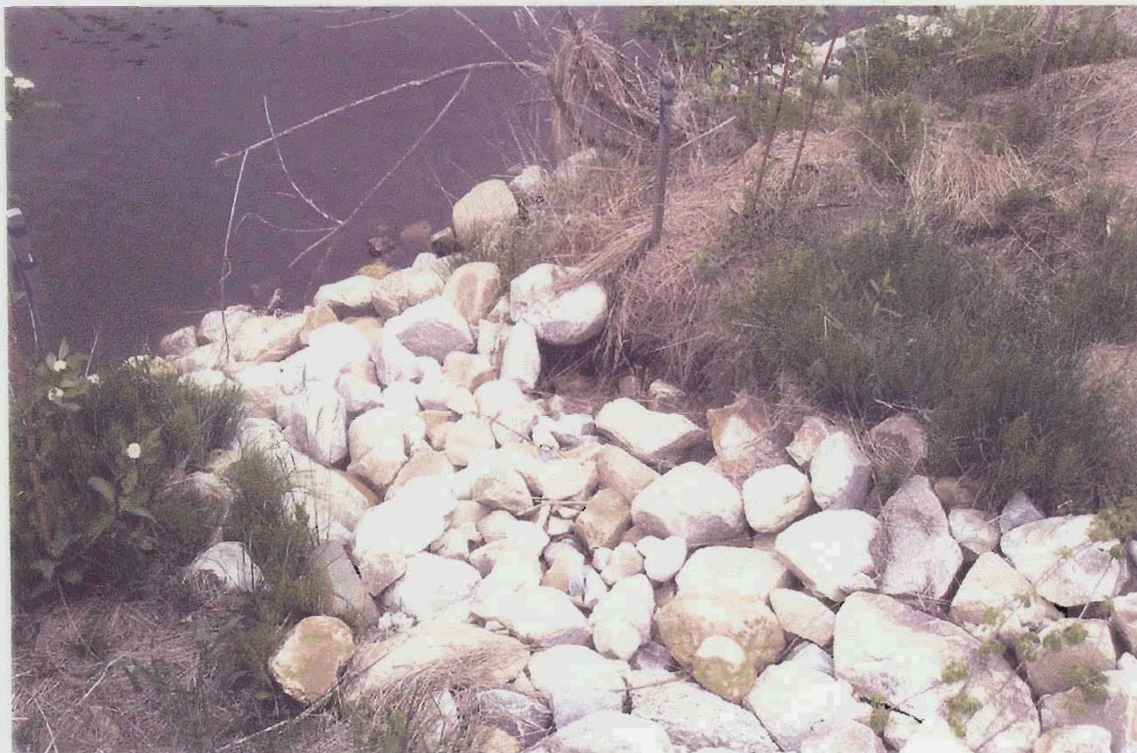
Photograph 8: Spring 2003 Restored Banks Erosion Inspection Rip Rap Movement Swale No. 19 (middle)

During the May 22, 2002 bank inspection, one other impacted area was noted in the Newell Street Parking Lot area within Swale No. 19 (middle swale) where some movement of rip rap had occurred. This area is identified as Area 3 on Figure 1 and shown in Photo 4. This area will be addressed by placing additional rip rap in the swale (see Table 1).

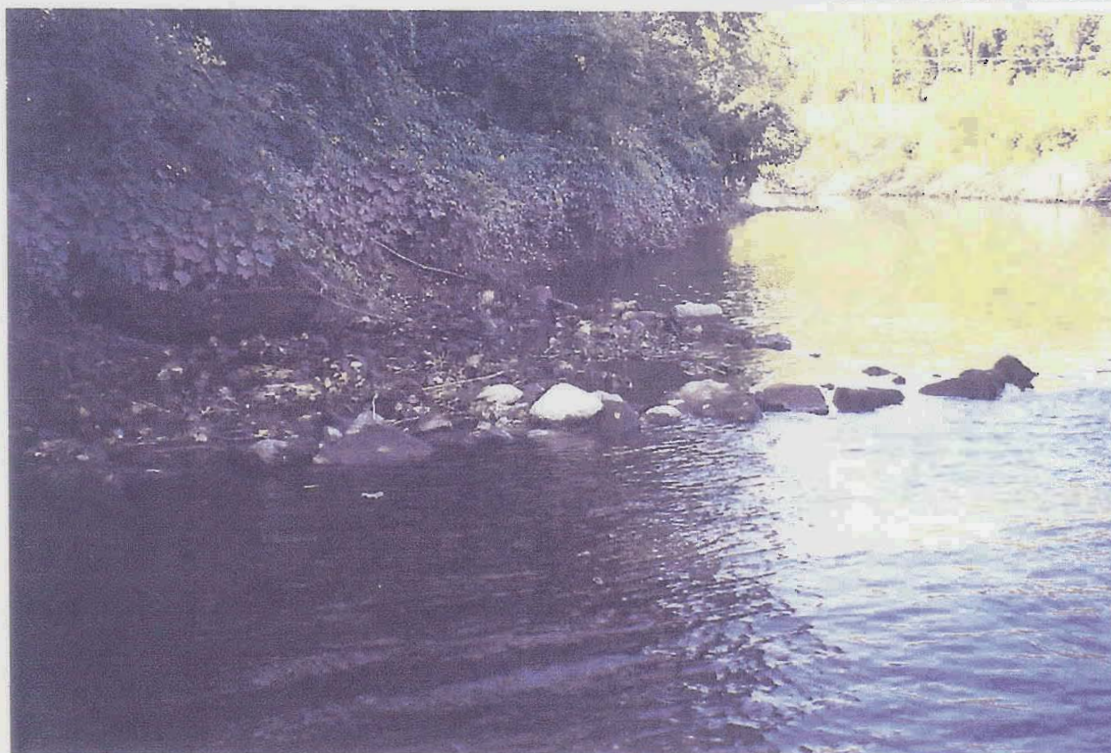
Photograph 9: 2003 Aquatic habitat structures monitoring event; Cell B Single Wing Deflector

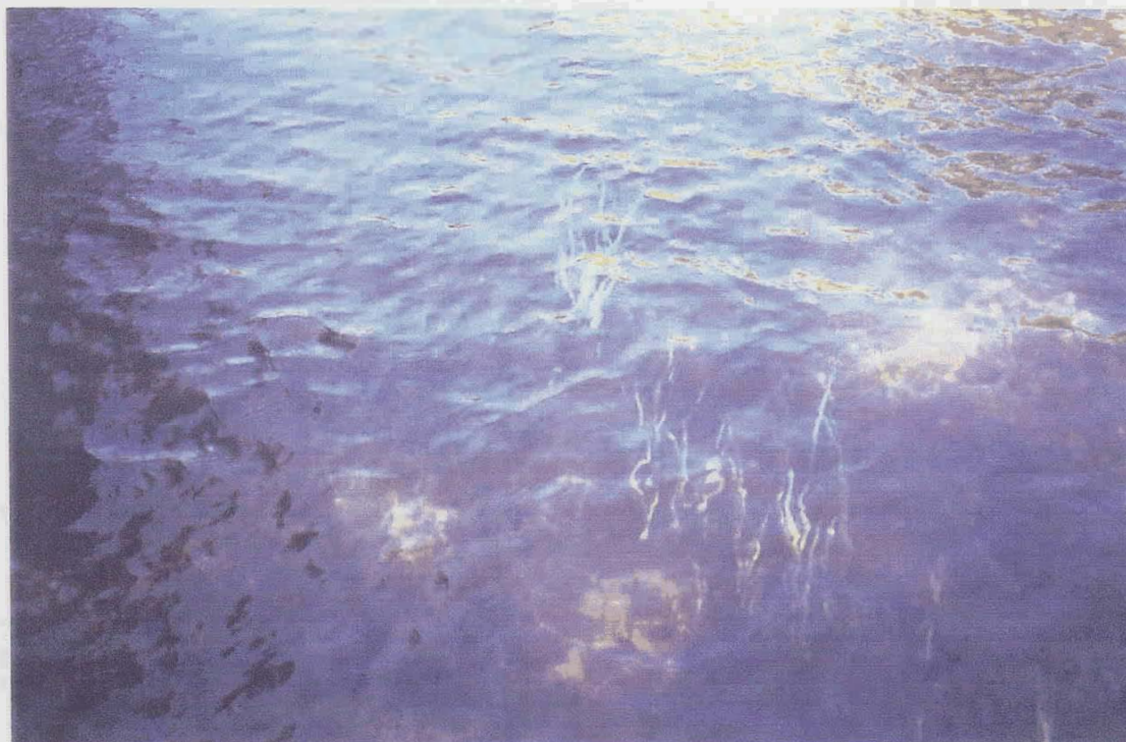
Boulder cluster – This boulder cluster is located in a low velocity reach. The boulders are located at such a water depth, due to the ponding effect from the downstream damming of the river, that there was minimal agitation of the water surface. There is some woody debris that has been retained by the boulders, and a large number of small fish and crayfish were observed in and around the cluster.

Photograph 10: 2003 Aquatic habitat structures monitoring event; Cell C Boulder Cluster (note water-celery)

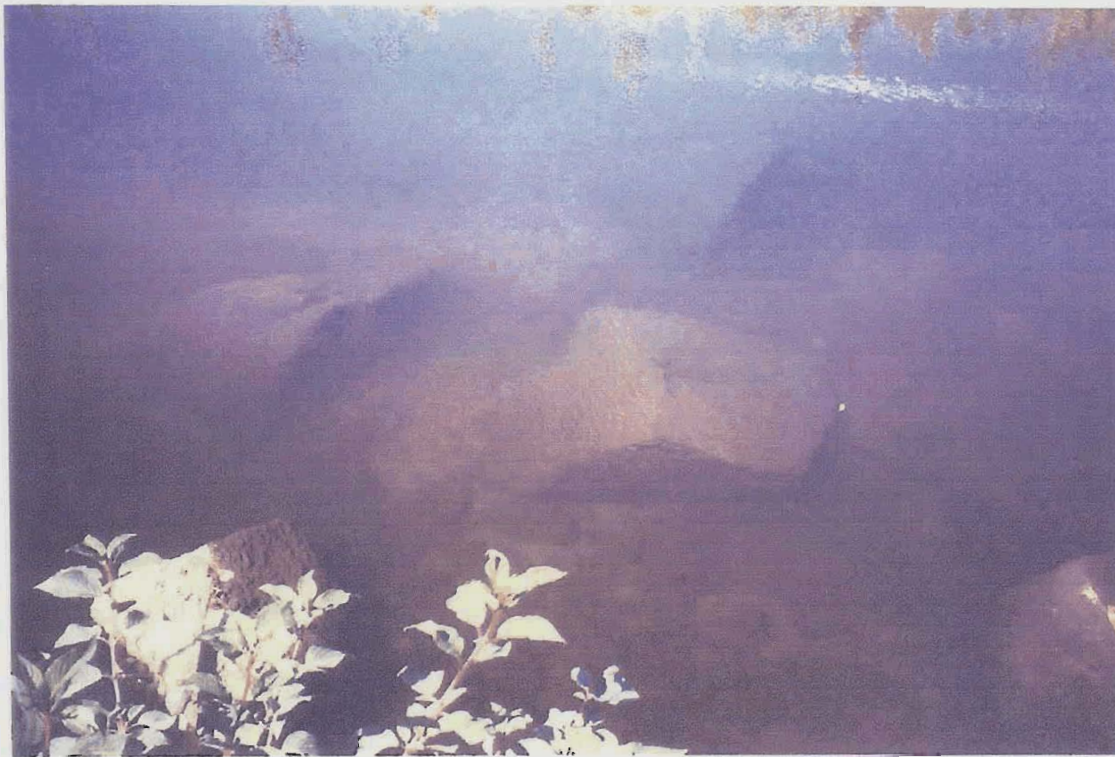
Photograph 11: 2003 Aquatic habitat structures monitoring event; Cell H2 Boulder cluster

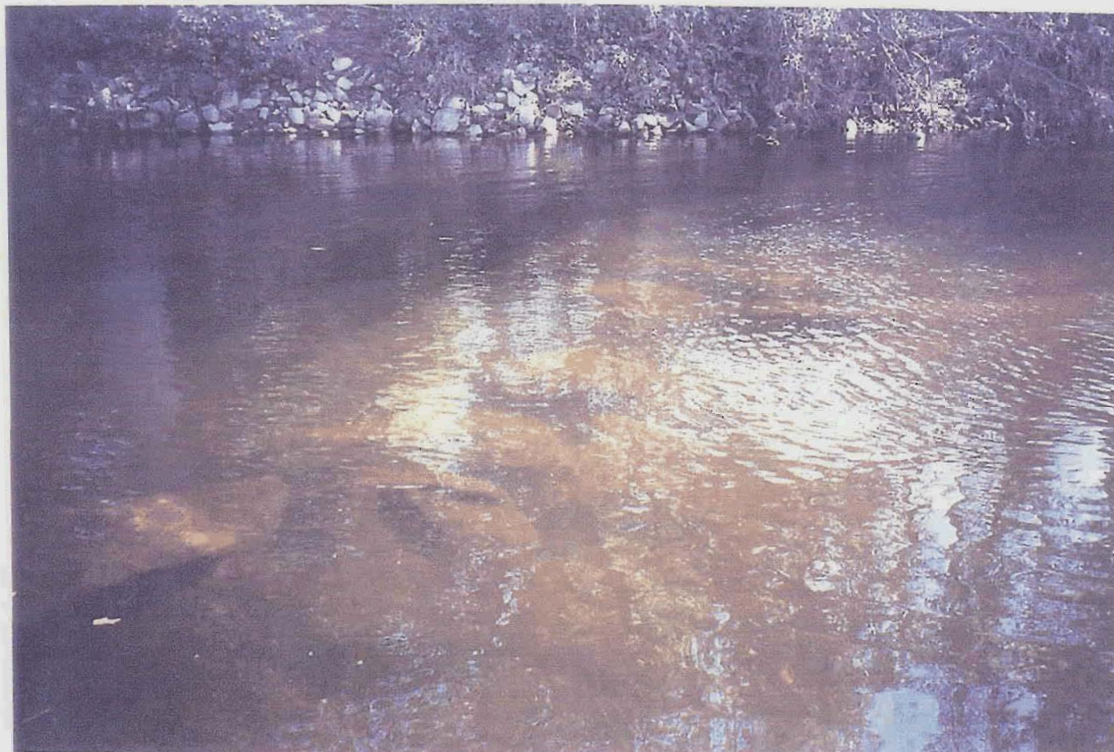
Photograph 12: 2003 Aquatic habitat structures monitoring event; Cell I3/J3 Vortex rock weir

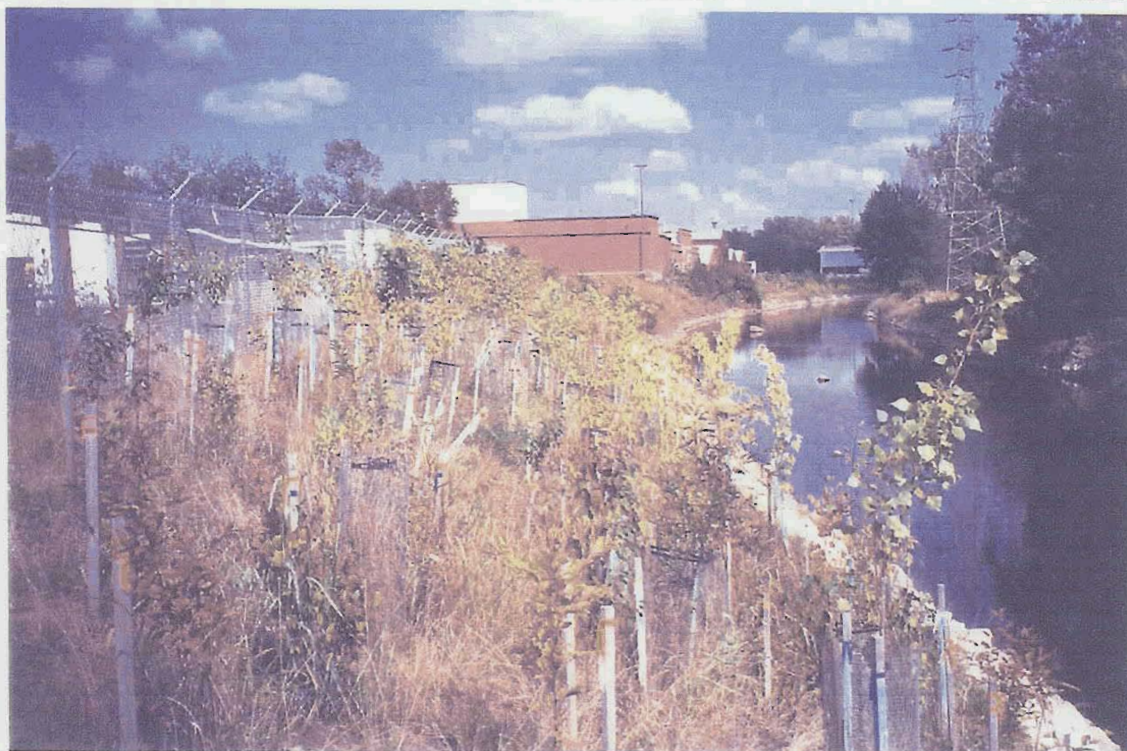
In most areas, herbaceous cover was slightly less than the required performance standard. No significant bare areas or patches (i.e., areas greater than 15-20 square feet) were observed in the planting areas, with the exception of planting areas 2, 3, 4A, composite area 6, 6A, 7, 8A, and planting area 14. The areas that were bare appear to be that way as a result of poor soil.

Photograph 15: Late summer 2003 vegetative monitoring event; Planting area 14
