**Re: GE Pittsfield/Housatonic River Site
Upper 1/2-Mile Reach Removal Action (GECD800)
2005 Annual Monitoring Report**

***2005 Annual Monitoring Report
Upper 1/2-Mile Reach of the
Housatonic River***

**General Electric Company
Pittsfield, Massachusetts**

January 2006

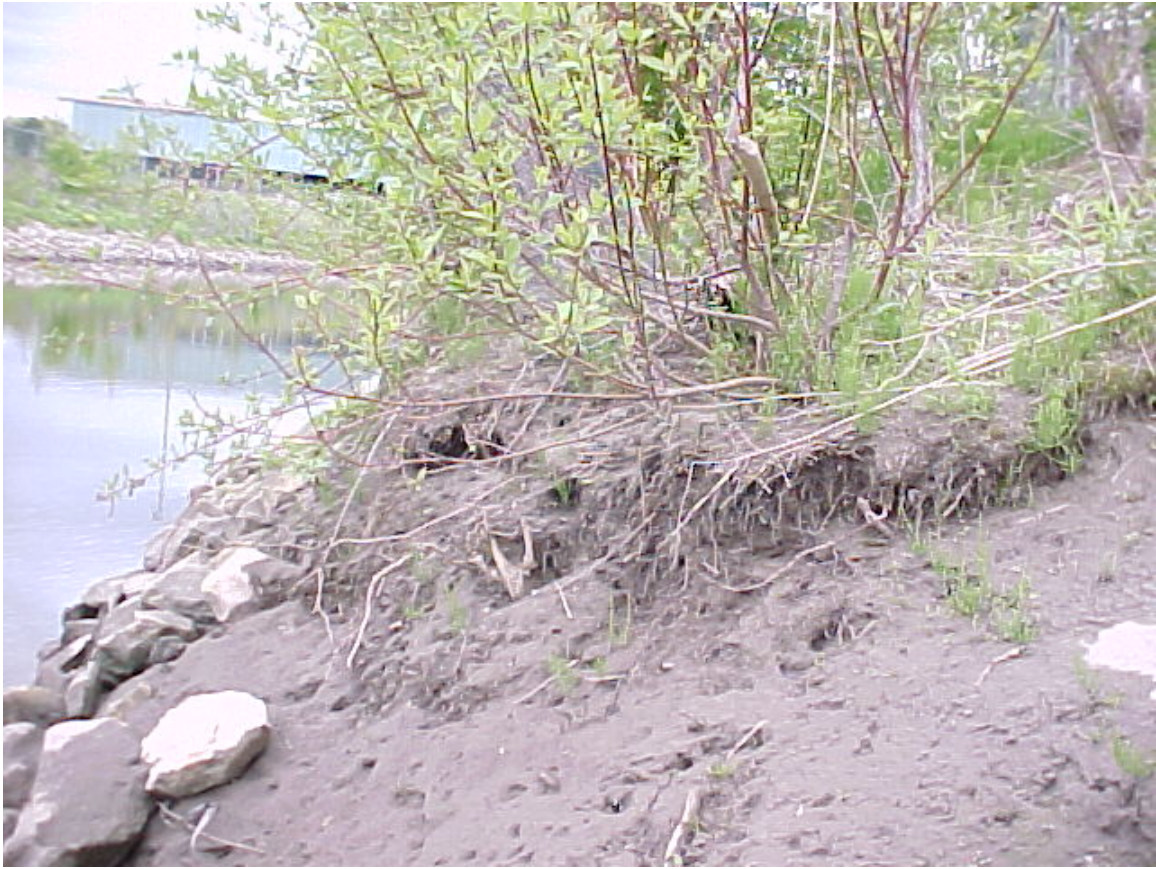
Photo 1 – Area 1: Soil Erosion and Root Exposure. Note the depositional materials, a likely result of the high water caused by the EPA dam at Lyman St.

Following the initial erosion inspection, GE representatives revisited this area on August 17, 2005, and noted that there did not appear to be any further ongoing erosion. Further, exposed roots in this area appeared to have been covered as natural vegetation has become established in depositional materials during the summer months. GE transmitted this development to EPA in a communication dated August 22, 2005 and proposed to continue monitoring this area and that no immediate response actions were necessary. EPA provided verbal approval of that proposal. GE will continue to monitor this area during 2006.

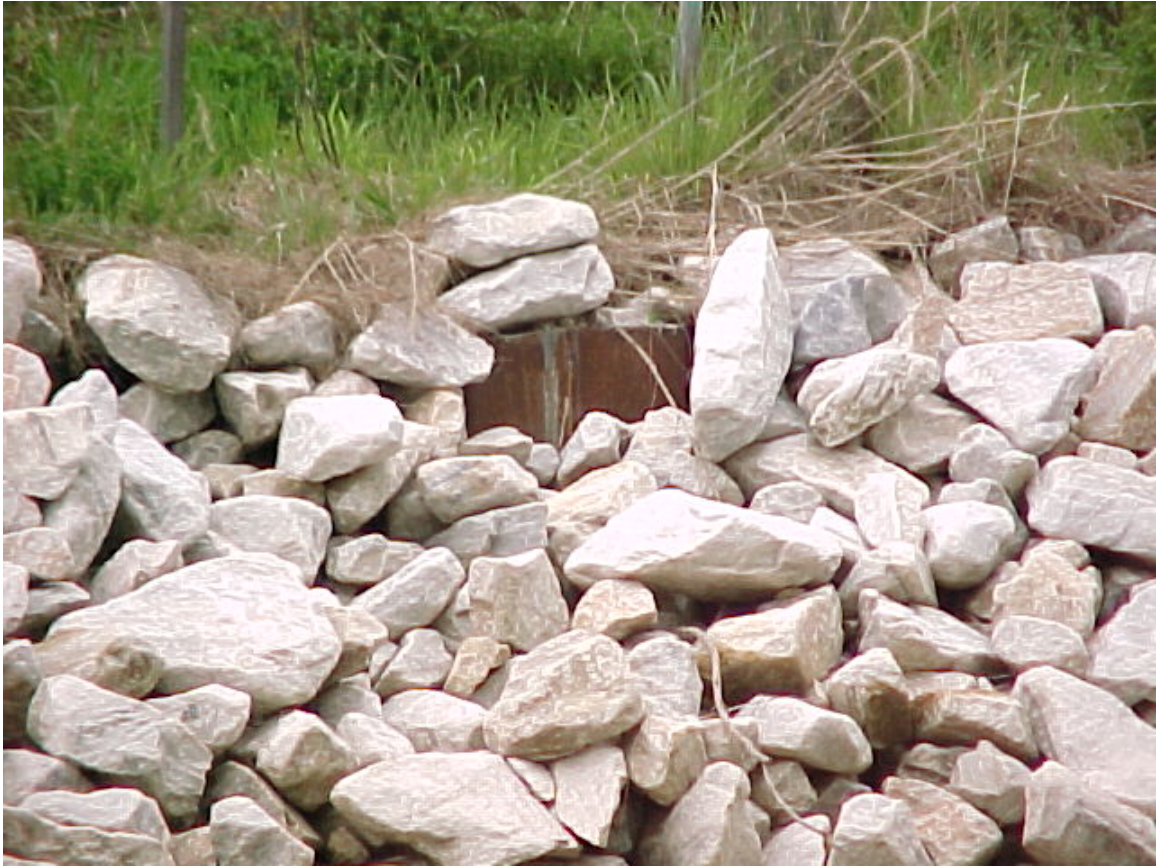
Area 2 is located in a remediated bank area within planting area 14 on the northern bank adjacent to the Lyman Street parking lot. Observations indicated that some riprap had shifted such that, in select locations, the tops of a number of sheetpiles were visible. The areas where riprap appeared to have shifted are not all contiguous, but in total, approximately 75 to 100 feet were affected. While other signs of the sustained high water were observed in this area, the cause of such shifting of riprap was not readily apparent during the inspection. There were no signs of a net loss of riprap material or loss of riprap having fallen into the river. Following the inspection, GE and EPA agreed that this area would continue to be monitored, and that response actions, if required, would be discussed in 2006.

Photo 2 – Area 2: An example of exposed sheeting due to shifted rip rap.

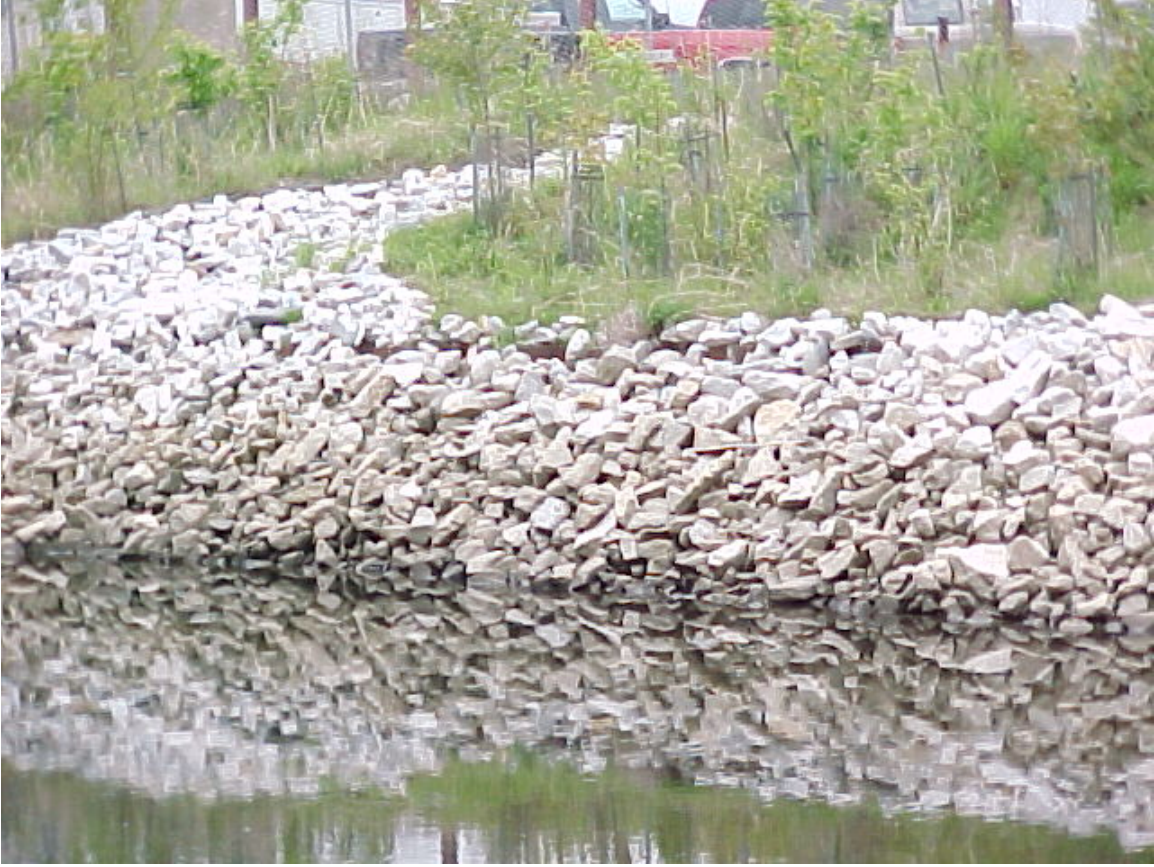
Photo 3 – Area 2: Exposed sheetpile tops.

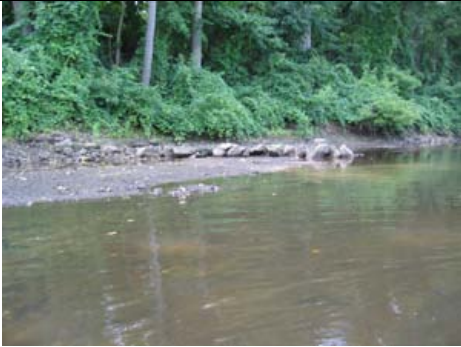
Cell	Aquatic Structures	Armor Stone Condition/General Biological Observations	
B	1. Single wing deflector

<ol style="list-style-type: none"> 1. Structures appear stable 2. Structure induced variations observed in areas immediately downstream of the deflector

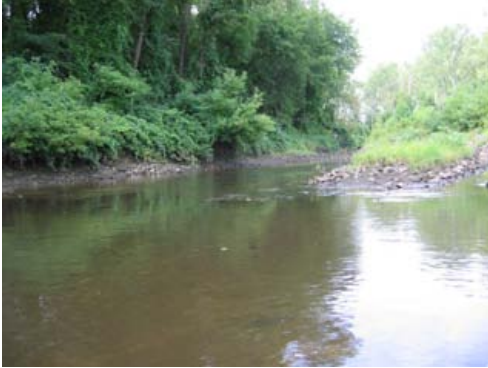
Cell	Aquatic Structures	Armor Stone Condition/General Biological Observations	
C	<ol style="list-style-type: none"> 1. Boulders 2. Island

<ol style="list-style-type: none"> 1. Structures appear stable 2. Structure induced variations observed in areas immediately downstream of the island 3. The island is become well vegetated with wetland herbaceous species and cottonwood seedlings 4. Boulders near island are causing scouring in the
D	<ol style="list-style-type: none"> 1. Boulders 	<ol style="list-style-type: none"> 1. Structure appeared stable, no issue or concern 2. Structure was function and providing variation in habitat 	
G2/F2	<ol style="list-style-type: none"> 1. W-weir

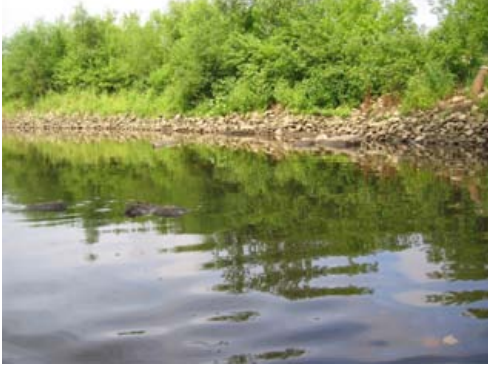
<ol style="list-style-type: none"> 1. Much of the weir is buried in soft silt/sand; portion that is present appears to offer good cover for aquatic organisms 2. Several small fish seen in the vicinity of the weir

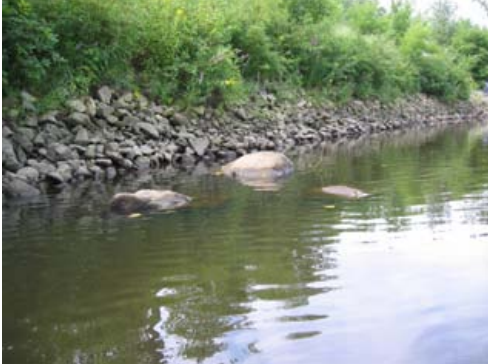
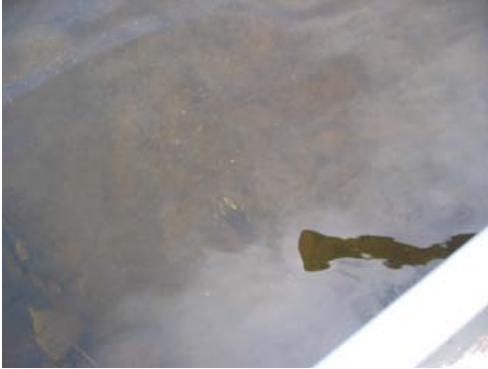
Cell	Aquatic Structures	Armor Stone Condition/General Biological Observations
G3	1. Three-boulder cluster	<ol style="list-style-type: none"> 1. Structure appeared stable, no issue or concern 2. Structure was function and providing variation in habitat
F3	<ol style="list-style-type: none"> 1. Three-boulder cluster 2. Two-boulder cluster 3. Three-boulder cluster 	<div style="display: flex; align-items: center;">

<div style="margin-left: 20px;"> <ol style="list-style-type: none"> 1. All structures in this cell appear stable. 2. Structures appear to be providing diversity in habitat 3. Some small fish seen in the vicinity of the three boulder cluster (seen in top photo) 4. Freshwater mussel (seen in center of the lower photo) was observed in cell F3 towards the centerline of the river </div> </div> <div style="margin-top: 10px;">

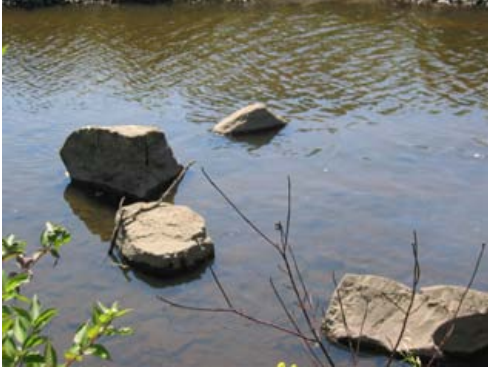
Cell	Aquatic Structures	Armor Stone Condition/General Biological Observations	
J2	1. "J"- boulder formation

<ol style="list-style-type: none"> 1. Structure appears stable and is providing diversity in habitat 2. Good habitat, variations in velocity around structure producing variations in stream bottom topography
I3	1. Single-wing deflector

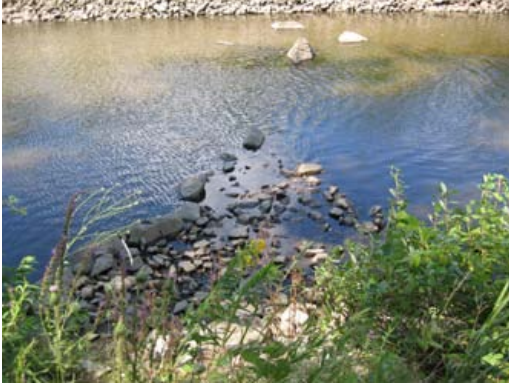
<ol style="list-style-type: none"> 1. Structure appears stable and is providing diversity in habitat 2. Good habitat, variations in velocity around structure producing variations in stream bottom topography

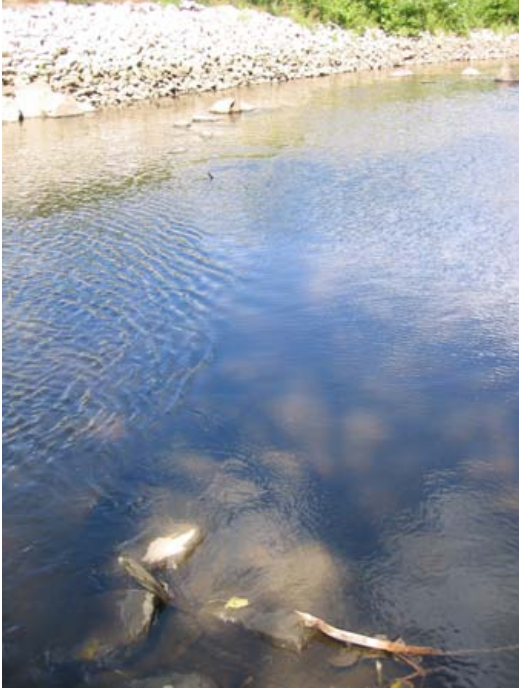
Cell	Aquatic Structures	Armor Stone Condition/General Biological Observations
I3/J3	1. Vortex rock weir

<ol style="list-style-type: none"> 1. Structure appears stable and is providing diversity in habitat 2. In the photo, note the break in the stream flow resulting from the weir presence 3. Good habitat, variations in velocity around structure producing variations in stream bottom topography
J3	<ol style="list-style-type: none"> 1. Boulder cluster 2. Three-boulder cluster 3. Three-boulder cluster 	<ol style="list-style-type: none"> 1. Structures appears stable and is providing diversity in habitat 2. Good habitat, variations in velocity around structures producing variations in stream bottom topography

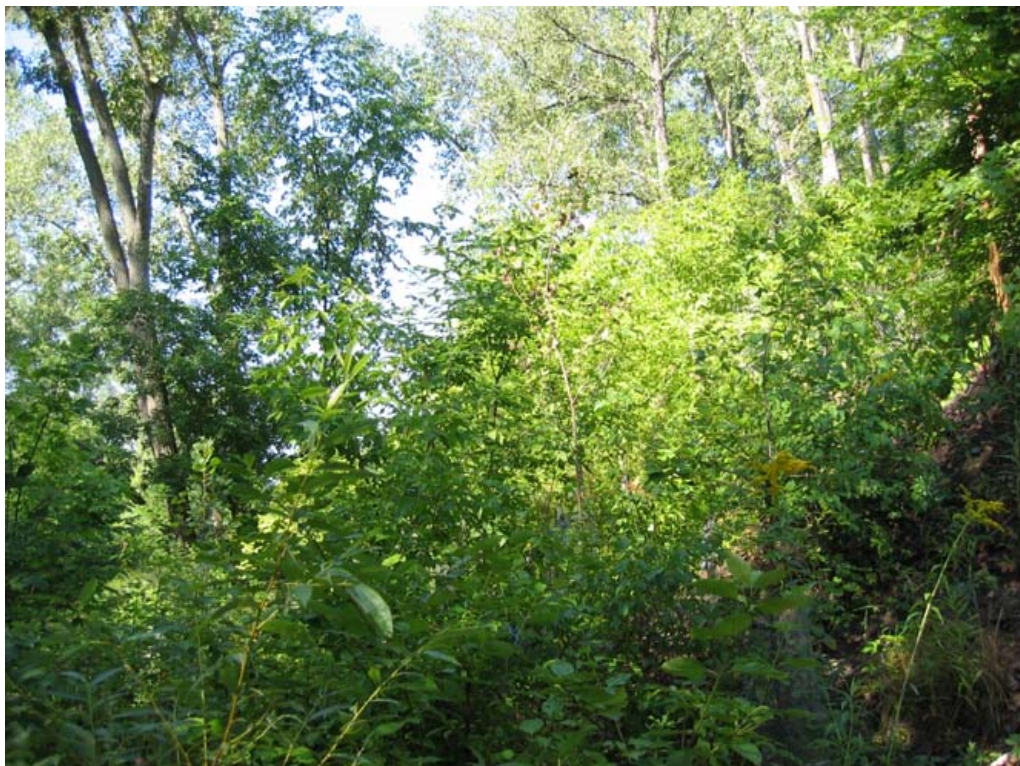
Photograph 2: August 2005; Planting Area 3

For canopy species, most areas met the performance standard. Planting area 3, with a negative variance of 8, is sheltered by surrounding trees left standing during remedial activities. Planting area 4A, with a negative variance of 12, has had difficulty in meeting canopy performance standards. This difficulty could be the result of poor soil quality, herbivorous activity, or both. Planting area 5, with a negative variance of 6, lost canopy species during the implementation of the Newell Street Area I remedial activities and, apparently, these species were not replaced. Canopy species monitoring results are summarized in Table 2-2.

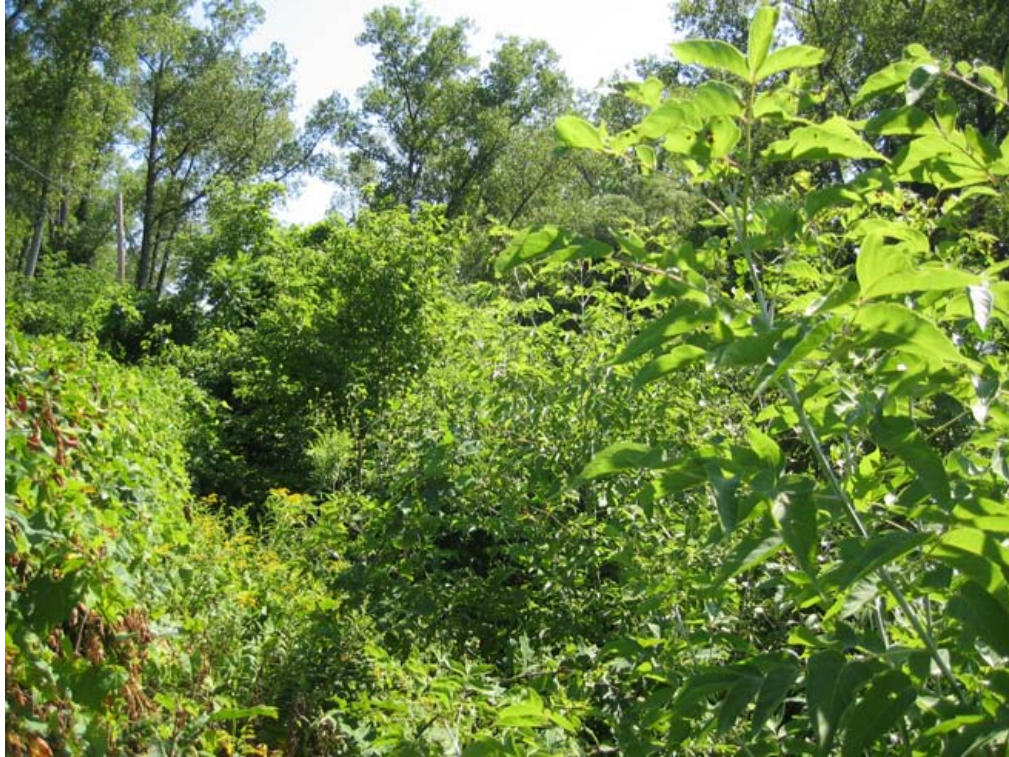
Photograph 3: August 2005; Planting area 4A

For understory species, most areas met the performance standard. Planting area 4A, with a negative variance of 8, has had difficulty historically in meeting understory performance standards. This could be the result of poor soil quality, herbivorous activity, or both. Planting area 5, with a negative variance of 6, lost understory species during the implementation of the Newell Street Area I remedial activities and, apparently, these species were not replaced. All planting areas met the performance standard for red-osier dogwoods and grapevines. Understory species monitoring results are summarized in Table 2-3. Red-osier dogwoods, and grapevine monitoring results are summarized in Tables 2-4 and 2-5.

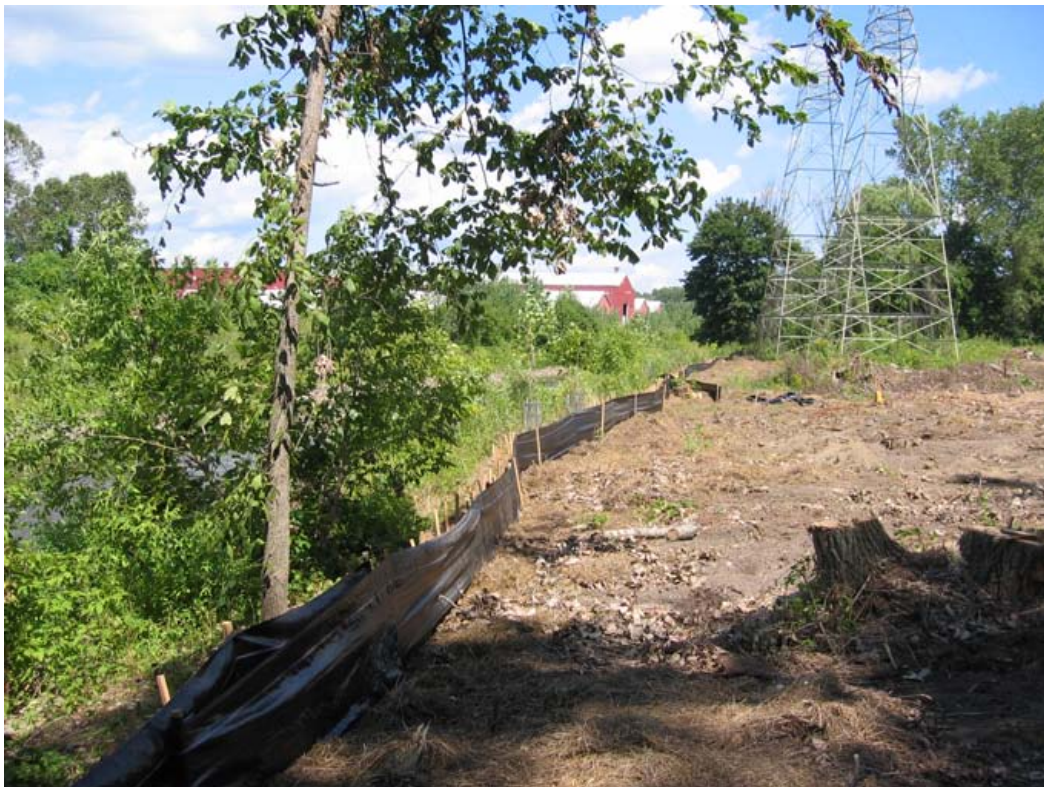
Vegetative conditions in areas 13, 15, and 16 were difficult to verify due to ongoing remedial activities at Newell Street Area II. These three areas will be reexamined in 2006 after the remedial activities and replanting efforts at Newell Street Area II are completed.

Photograph 6: August 2005; Planting Area 16 showing impacts of ongoing remedial action work

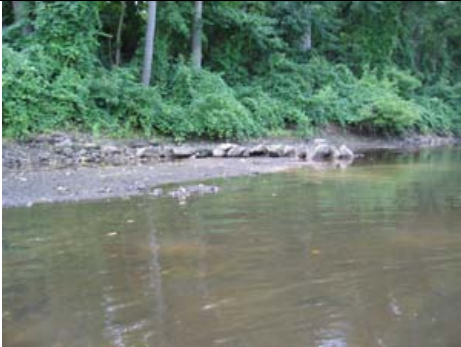
Cell	Aquatic Structures	Armor Stone Condition/General Biological Observations	
B	1. Single wing deflector

<ol style="list-style-type: none"> 1. Structures appear stable 2. Structure induced variations observed in areas immediately downstream of the deflector

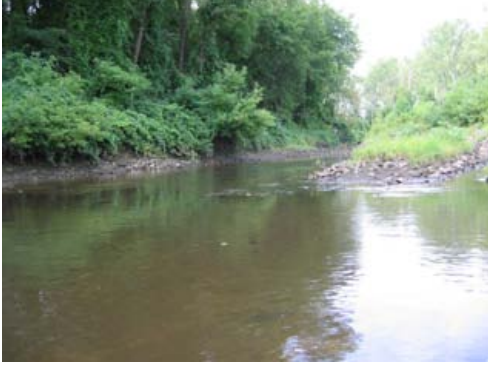
Cell	Aquatic Structures	Armor Stone Condition/General Biological Observations	
C	<ol style="list-style-type: none"> 1. Boulders 2. Island

<ol style="list-style-type: none"> 1. Structures appear stable 2. Structure induced variations observed in areas immediately downstream of the island 3. The island has become well vegetated with wetland herbaceous species and cottonwood seedlings 4. Boulders near island are causing scouring in the immediate area; and appear to be providing good cover
D	<ol style="list-style-type: none"> 1. Boulders 	<ol style="list-style-type: none"> 1. Structure appeared stable, no issue or concern 2. Structure was function and providing variation in habitat 	
G2/F2	<ol style="list-style-type: none"> 1. W-weir

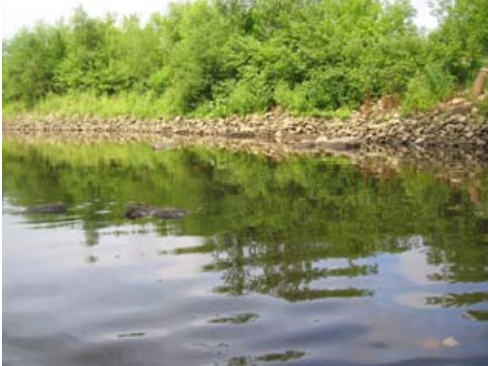
<ol style="list-style-type: none"> 1. Much of the weir is buried in soft silt/sand; portion that is present appears to offer good cover for aquatic organisms 2. Several small fish seen in the vicinity of the weir

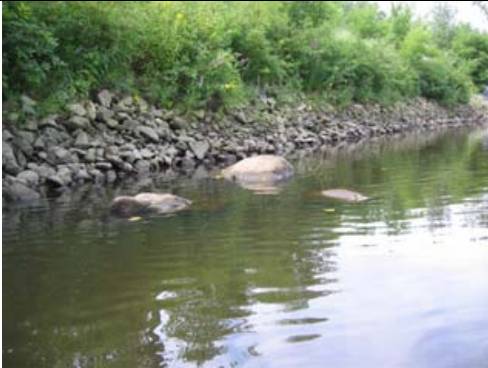
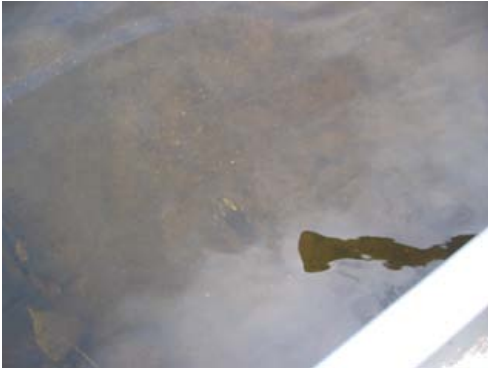
Cell	Aquatic Structures	Armor Stone Condition/General Biological Observations
G3	1. Three-boulder cluster	<ol style="list-style-type: none"> 1. Structure appeared stable, no issue or concern 2. Structure was function and providing variation in habitat
F3	<ol style="list-style-type: none"> 1. Three-boulder cluster 2. Two-boulder cluster 3. Three-boulder cluster 	<div style="display: flex; align-items: flex-start;">

<div style="margin-left: 20px;"> <ol style="list-style-type: none"> 1. All structures in this cell appear stable. 2. Structures appear to be providing diversity in habitat 3. Some small fish seen in the vicinity of the three boulder cluster (seen in top photo) 4. Freshwater mussel (seen in center of the lower photo) was observed in cell F3 towards the centerline of the river </div> </div>

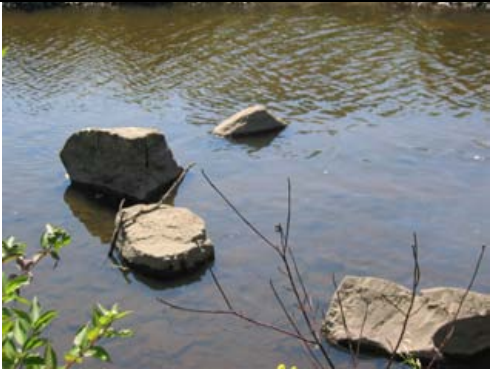
Cell	Aquatic Structures	Armor Stone Condition/General Biological Observations	
J2	1. "J"- boulder formation

<ol style="list-style-type: none"> 1. Structure appears stable and is providing diversity in habitat 2. Good habitat, variations in velocity around structure producing variations in stream bottom topography
I3	1. Single-wing deflector

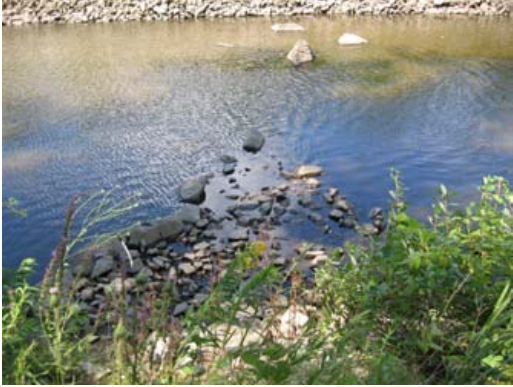
<ol style="list-style-type: none"> 1. Structure appears stable and is providing diversity in habitat 2. Good habitat, variations in velocity around structure producing variations in stream bottom topography

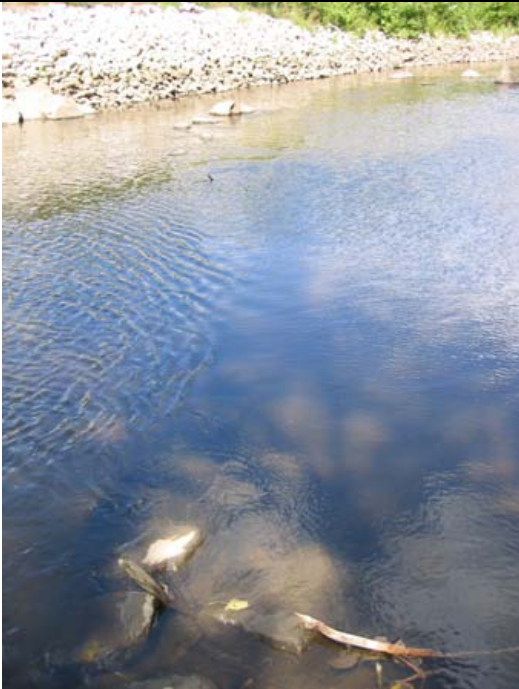
Cell	Aquatic Structures	Armor Stone Condition/General Biological Observations
I3/J3	1. Vortex rock weir

<ol style="list-style-type: none"> 1. Structure appears stable and is providing diversity in habitat 2. In the photo, note the break in the stream flow resulting from the weir presence 3. Good habitat, variations in velocity around structure producing variations in stream bottom topography
J3	<ol style="list-style-type: none"> 1. Boulder cluster 2. Three-boulder cluster 3. Three-boulder cluster 	<ol style="list-style-type: none"> 1. Structures appears stable and is providing diversity in habitat 2. Good habitat, variations in velocity around structures producing variations in stream bottom topography
