*2004 Annual Monitoring Report
Upper 1/2-Mile Reach of the
Housatonic River*

**General Electric Company
Pittsfield, Massachusetts**

January 2005

**Re: GE Pittsfield/Housatonic River Site
Upper ½-Mile Reach Removal Action (GECD800)
2004 Annual Monitoring Report**

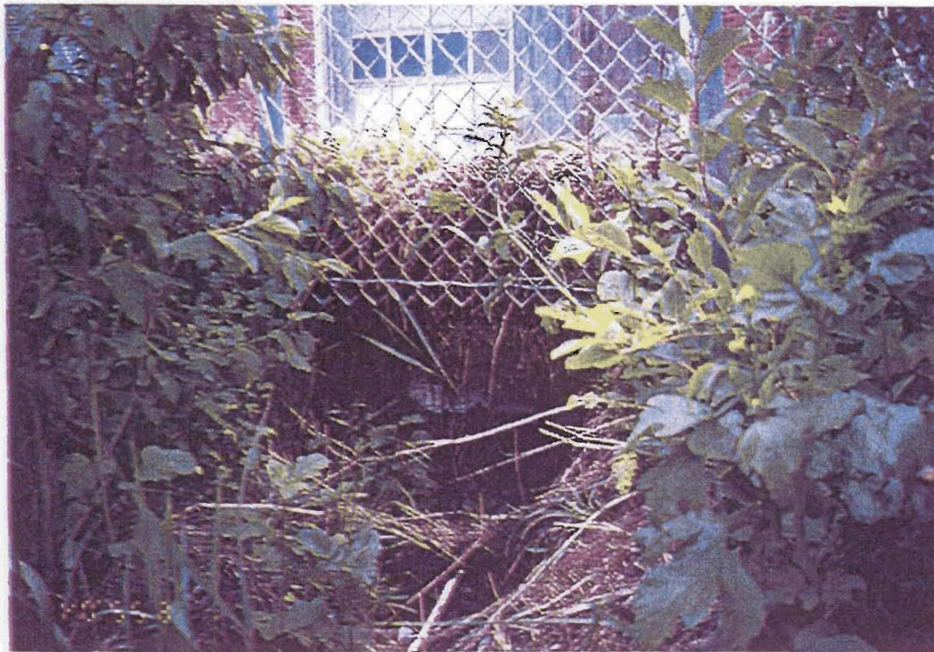
Area 1 is within a non-remediated bank area within planting area 12 on the northern bank directly behind Building 61. Less than 1.0 cubic yard (cy) of soil appeared to have eroded into the River from Area 1. The source of the eroded material appeared to be native material from near the top of the bank. The cause of erosion appeared to be concentrated surface runoff from parking lots and access roads behind Building 61, which apparently caused relatively large rills (3 feet wide by 4 feet long) to form near the top-of-bank. Additionally, small sink holes were formed upstream of the rill area. As an apparent interim measure, hay bales were placed at the top-of-bank, but their placement appeared to have been ineffective in diverting runoff. No evidence of eroded soil was observed in the adjacent River; therefore, no removal activities were conducted at this location. To reduce potential for future erosion in this area, the hay bales were repositioned to re-direct surface run-off flow paths and suitably sized riprap was placed over the affected area. Additionally, minor amounts of topsoil and seed were placed at the toe of the new riprap to protect the area from future erosion. This repair was completed in September 2004 and it is not anticipated that additional erosion will occur following installation of the riprap.

Photo 1 – Area 1: Soil Erosion and Undermining Behind Hay Bale

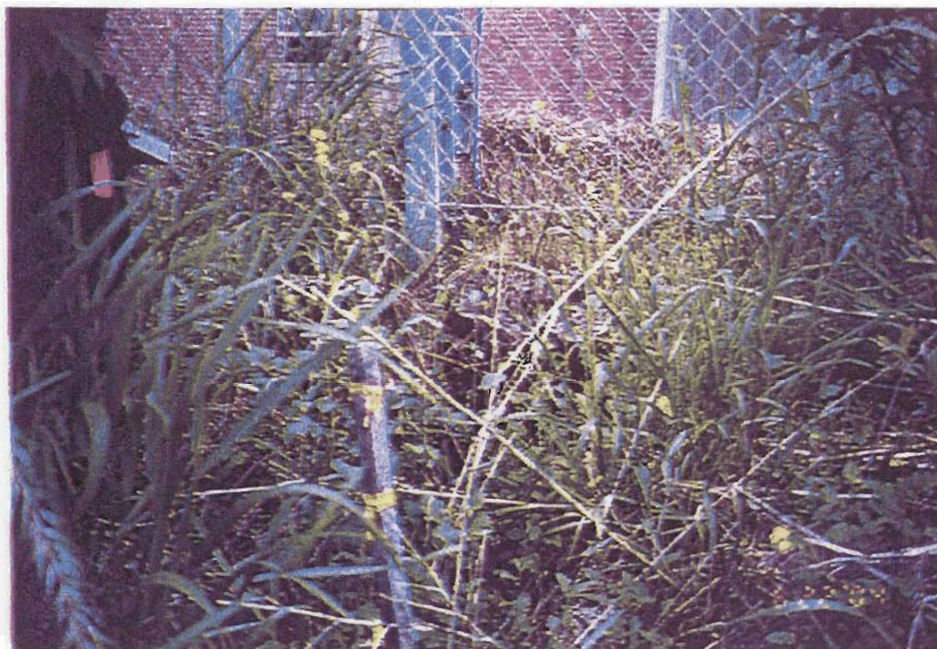
Photo 2 – Area 1: Soil Erosion Near Top-of-Bank Behind Hay Bale

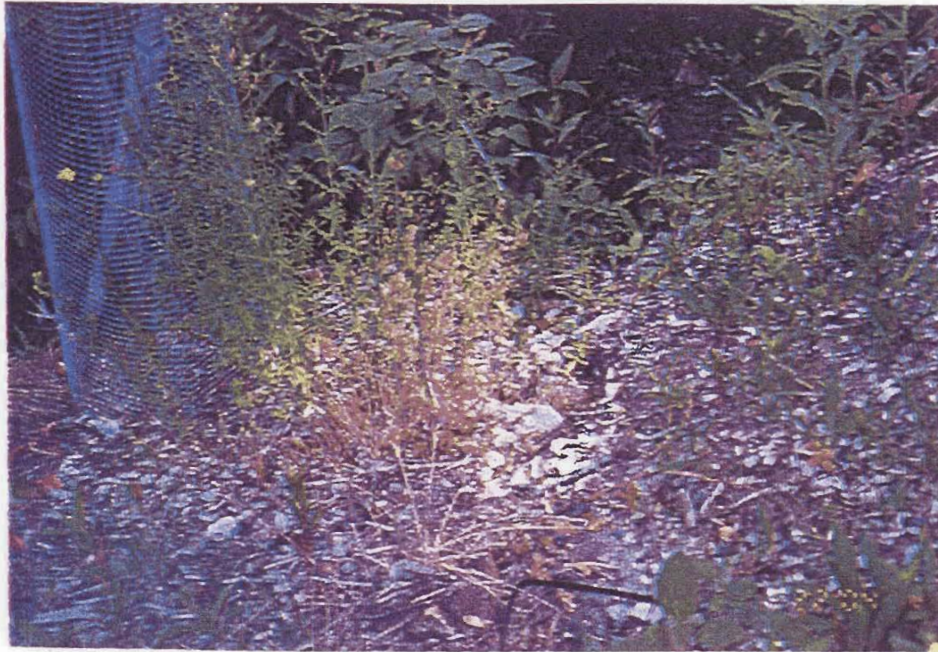
Area 2 is within a non-remediated bank area within planting area 9 on the southern bank adjacent to the Newell Street parking lot. Less than 0.5 cy of soil appeared to have eroded into the River from Area 2. The source of eroded material appeared to be native material from near the top-of-bank. Concentrated surface runoff discharging from the parking lot appeared to have created a relatively small rill (0.5 foot wide by 4 feet long) near the top-of-bank. No evidence of eroded soil was observed in the adjacent River; therefore, no removal activities were conducted at this location. To reduce potential for future erosion in the area, runoff water flowpaths were re-directed to a nearby paved swale. In September 2004, the rill area was backfilled with topsoil, reseeded, and mulched to protect against future erosion.

Photo 3 – Area 2: Soil Erosion Near Top-of-Bank

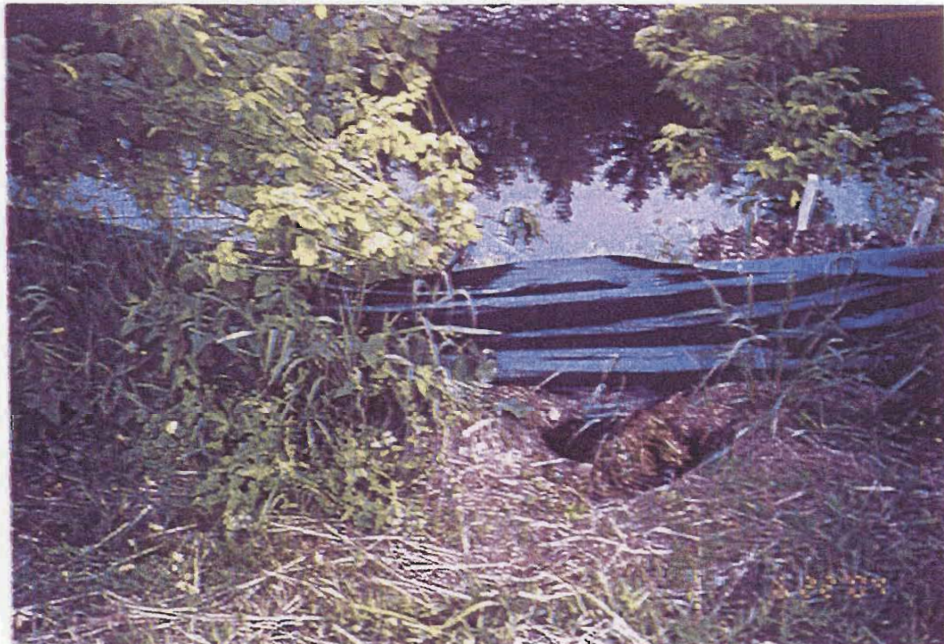
Photo 4 – Area 3: Soil Erosion Near Top-of-Bank

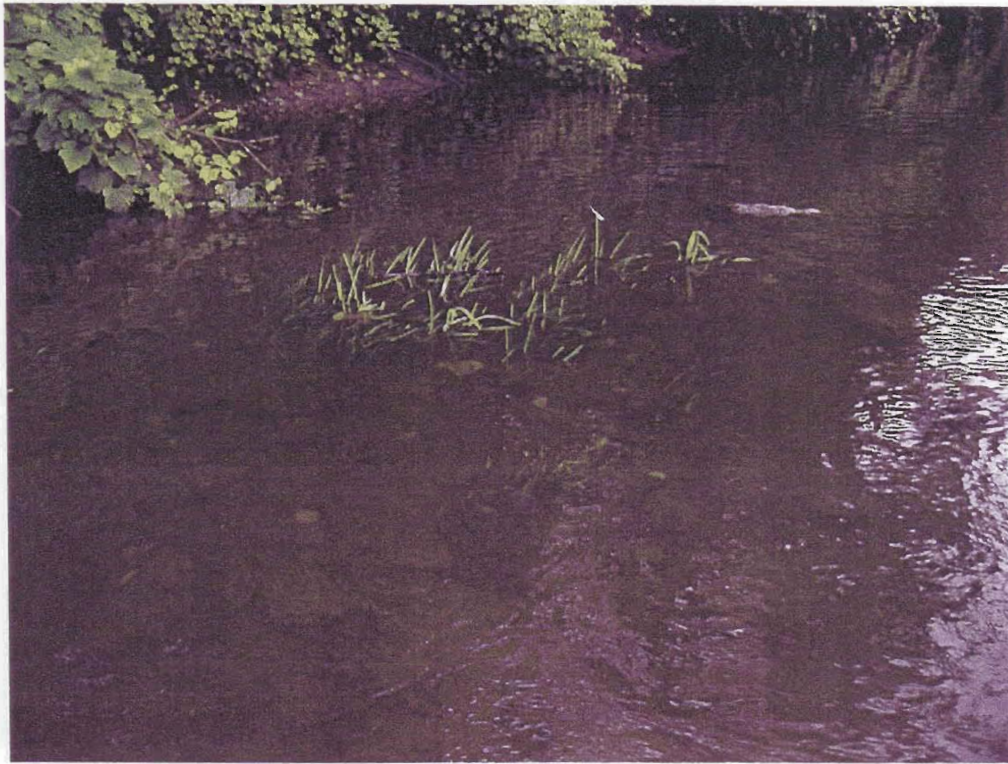
Cell	Aquatic Structure	Variations in Current Velocity	Variations in Streambed Depth	Number of Different Aquatic Biota	Aquatic Macrophytes Present	Condition of Armor Stone Layer	General Notes
B	Single wing deflectors	Little observed variation in current, water velocity apparently below the lower limit of the velocity meter	~ 2.2' in depth off point of deflector, ~ 1' in depth over deflector	None observed	<i>Sagittaria latifolia</i> <i>Vallisneria americana</i>	Interior sections of deflector ~50% covered in sediments	Woody debris was being trapped by deflector
C	Three-boulder cluster	Little observed variation in current, water velocity apparently below the lower limit of the velocity meter	~ 2' to 2.6' in depth in front of upstream boulder, same depth downstream of downstream boulder	None observed	None observed	Armor stone at surface of streambed just upstream of cluster; no sediment deposition	None

Photograph 1: Cell B, Vegetation growing in center of single wing deflector

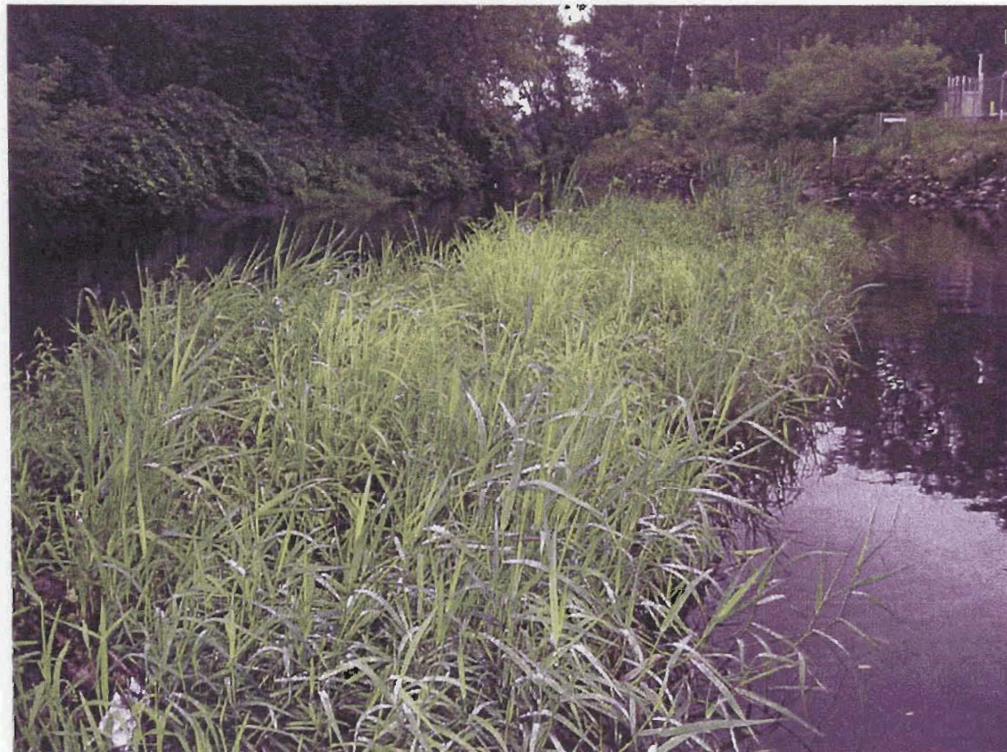
C	Island & Boulders	Little observed variation in current, water velocity apparently below the lower limit of the velocity meter	~ 2' to 2.8' in depth upstream of boulder line edging the island; second boulder in line mostly covered with soft silt/sand	One caddis fly larva (Order Trichoptera) seen on armor stone upstream of island	Island completely covered with vegetation, including <i>Polygonum pennsylvanicum</i> , <i>Polygonum amphibium</i> , <i>Lythrum salicaria</i> , and <i>Verbena hastata</i>	Depositional area covered by silts/sand between island and northern bank	Boulders near island are causing scouring in the immediate area; good cover
C	Three boulders at border of Cell D and DNAPL Cell	Little observed variation in current, water velocity apparently below the lower limit of the velocity meter	~ 1.5' to 2.2' of water over last boulder	None observed	None observed	No issues noted	None

Photograph 2: Cell C, island noting extensive vegetation

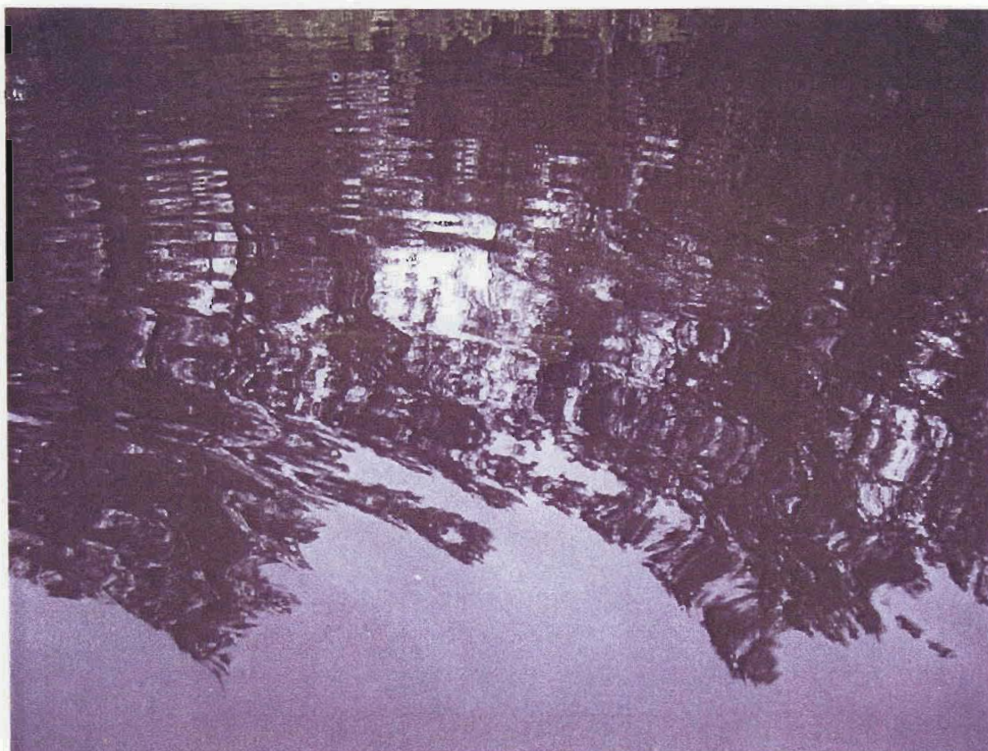
Photograph 3: Cell J1, double boulder cluster in center of photograph, note high water

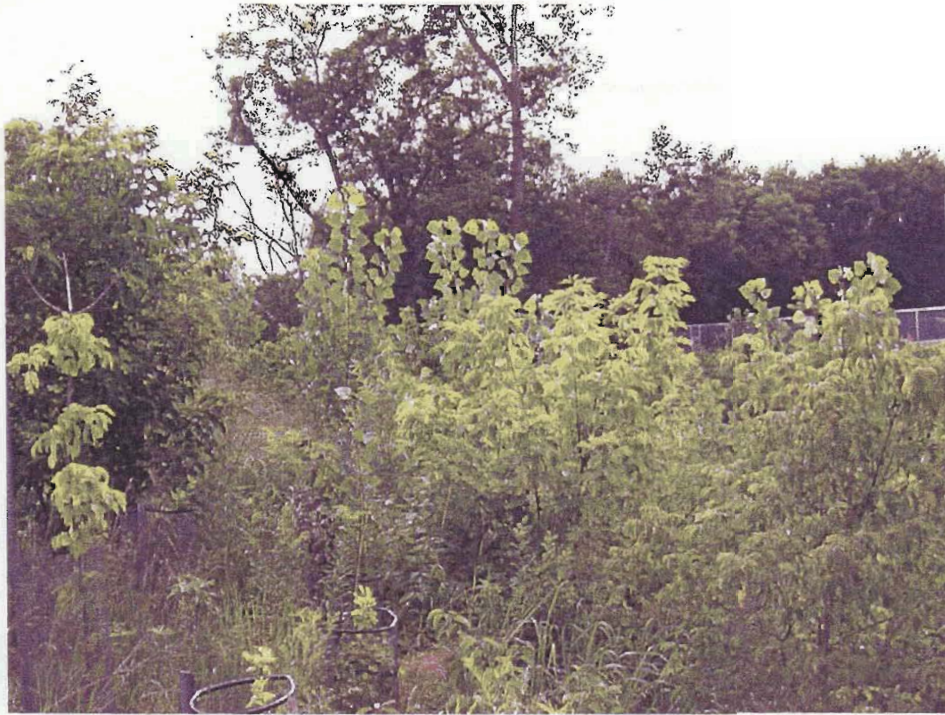
Photograph 5: August 2004; Planting Area 4B

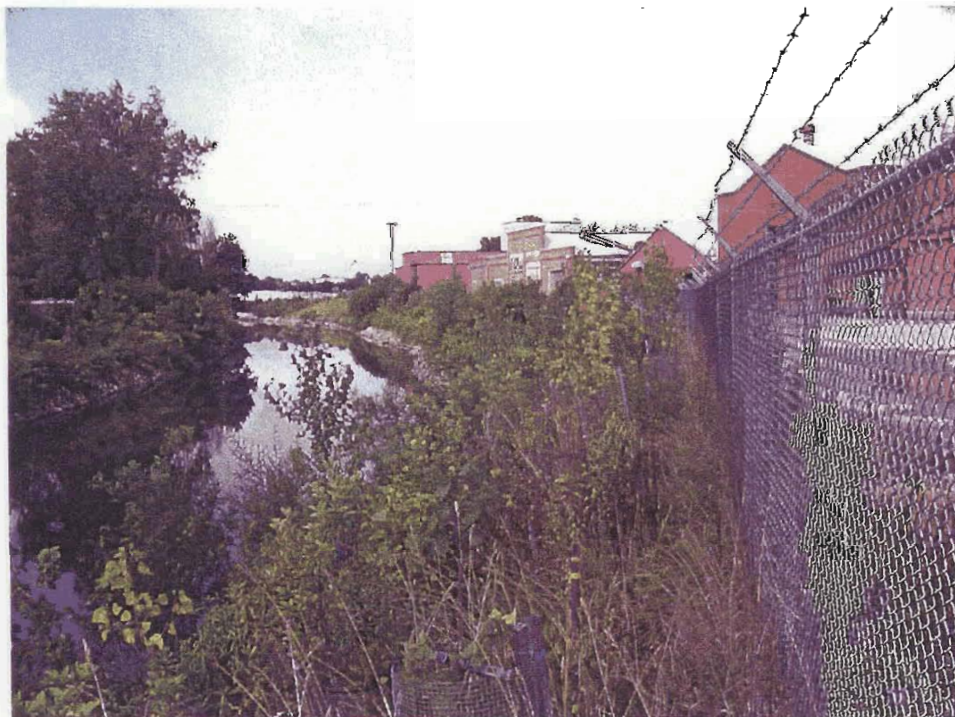
Photograph 6: August 2004; Planting Area 10
