**Re: GE-Pittsfield/Housatonic River Site  
Upper ½-Mile Reach of the Housatonic River (GECD800)  
2007 Annual Monitoring Report**

**2007 Annual Monitoring Report**

**Upper 1/2-Mile Reach of the  
Housatonic River**

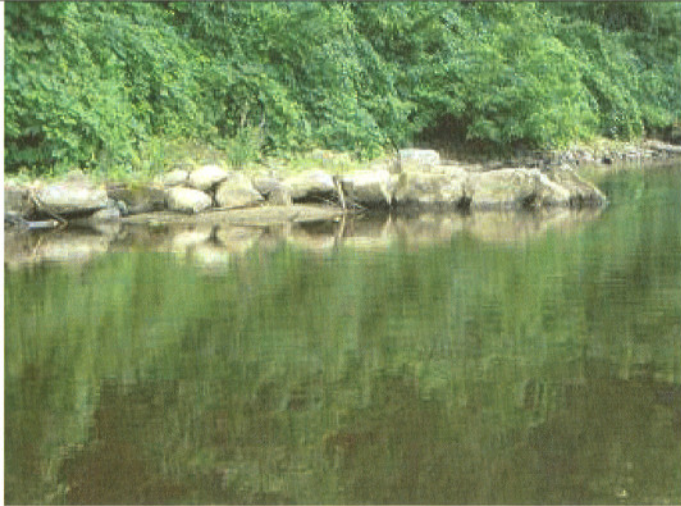
Cell	Aquatic Structures	Armor Stone Condition/General Biological Observations	
B	1. Single wing deflector

<div style="border: 1px solid black; padding: 10px;"> <ol style="list-style-type: none"> <li>1. Structures appear stable</li> <li>2. Structure induced variations observed in areas immediately downstream of the deflector</li> </ol> </div>

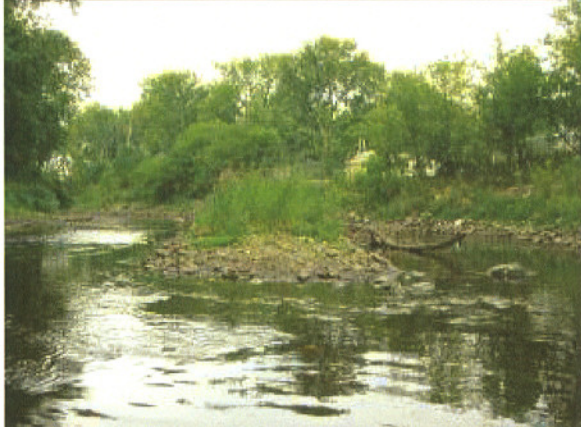
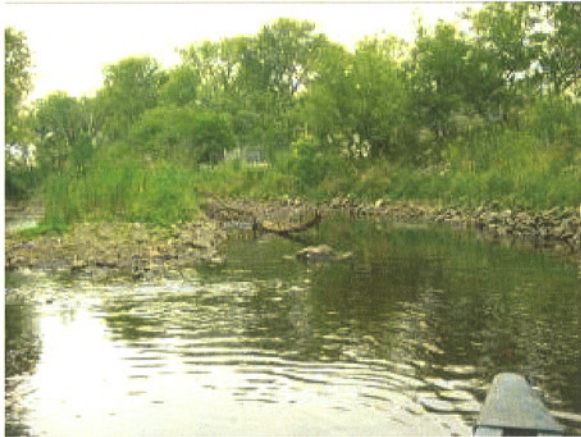
Cell	Aquatic Structures	Armor Stone Condition/General Biological Observations	
C	1. Boulders 2. Island

<div style="border: 1px solid black; padding: 10px;"> <ol style="list-style-type: none"> <li>1. Structures appear stable</li> <li>2. Structure induced variations observed in areas immediately downstream of the island</li> <li>3. The island is well vegetated with wetland herbaceous species</li> <li>4. Boulders near island continue to appear to be creating beneficial scour zones in the immediate area; and are providing good cover</li> </ol> </div>

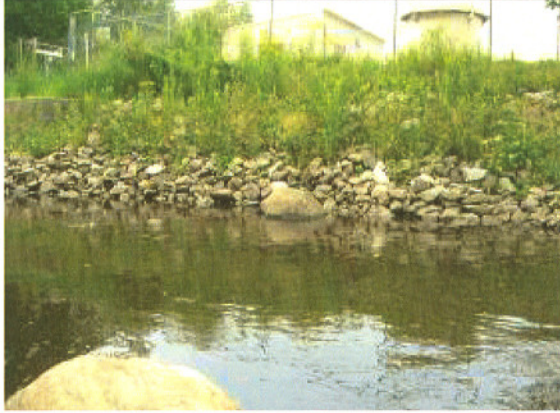
Cell	Aquatic Structures	Armor Stone Condition/General Biological Observations	
D	1. Boulders

<div style="border: 1px solid black; padding: 10px; width: fit-content;"> <p>1. Structures appear to be providing variation in habitat</p> </div>
G1	1. Boulder Cluster

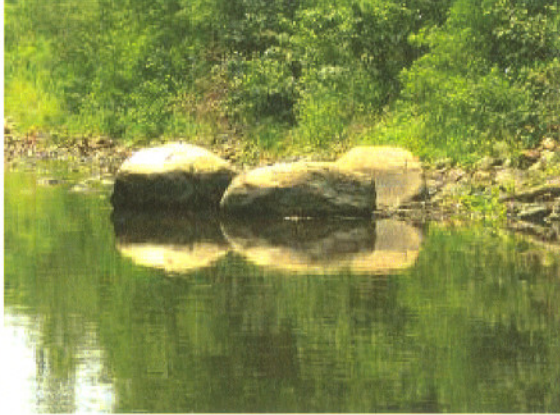
<div style="border: 1px solid black; padding: 10px; width: fit-content;"> <p>1. Structures appear to be providing variation in habitat</p> </div>

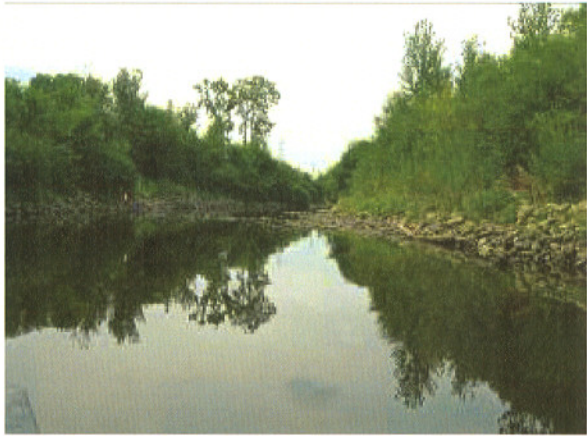
Cell	Aquatic Structures	Armor Stone Condition/General Biological Observations	
G2/F2	1. W-weir

<div style="border: 1px solid black; padding: 10px;"> <ol style="list-style-type: none"> <li>1. Much of the weir is buried in soft silt/sand (i.e., depositional material); appears to offer good cover for aquatic organisms</li> </ol> </div>
G3	1. Three-boulder cluster

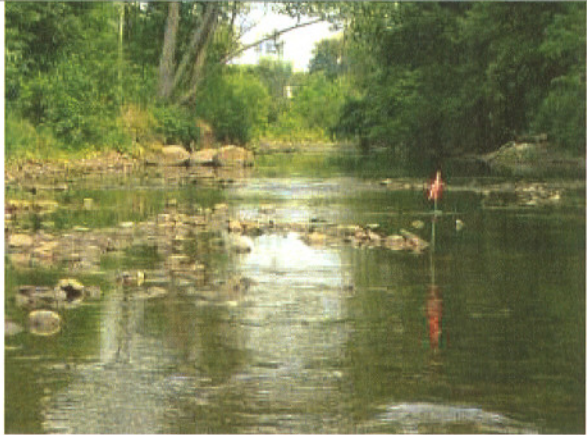
<div style="border: 1px solid black; padding: 10px;"> <ol style="list-style-type: none"> <li>1. Structure appeared stable, no issue or concern</li> <li>2. Structure was functional appears to be providing variation in habitat</li> </ol> </div>

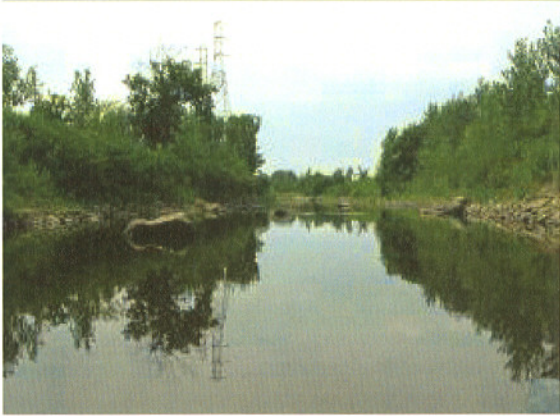
Cell	Aquatic Structures	Armor Stone Condition/General Biological Observations
F3	<ol style="list-style-type: none"> <li>1. Three-boulder cluster</li> <li>2. Two-boulder cluster</li> <li>3. Three-boulder cluster</li> </ol>

<div data-bbox="1227 518 1896 683" style="border: 1px solid black; padding: 5px;"> <ol style="list-style-type: none"> <li>1. All structures in this cell appear stable</li> <li>2. Structures appear to be providing diversity in habitat</li> </ol> </div>
H1	<ol style="list-style-type: none"> <li>1. Boulder cluster</li> </ol>	<ol style="list-style-type: none"> <li>1. Structure appears stable and is providing diversity in habitat</li> <li>2. Good habitat, variations in velocity around structure producing variations in stream bottom topography</li> </ol>
I1/J1	<ol style="list-style-type: none"> <li>1. Vortex weir</li> </ol>

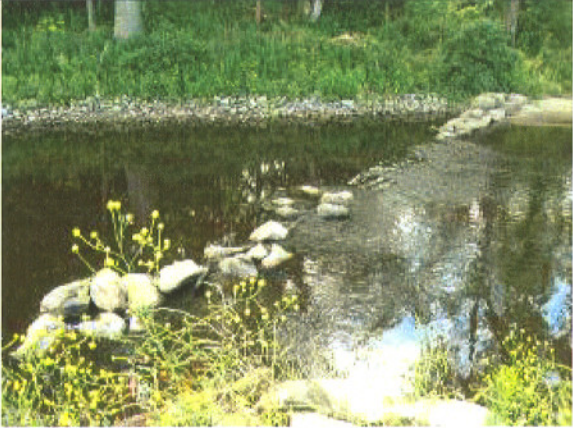
<div data-bbox="1276 1144 1991 1341" style="border: 1px solid black; padding: 5px;"> <ol style="list-style-type: none"> <li>1. Structure appears stable and is providing diversity in habitat</li> <li>2. Good habitat, variations in velocity around structure producing variations in stream bottom topography</li> </ol> </div>

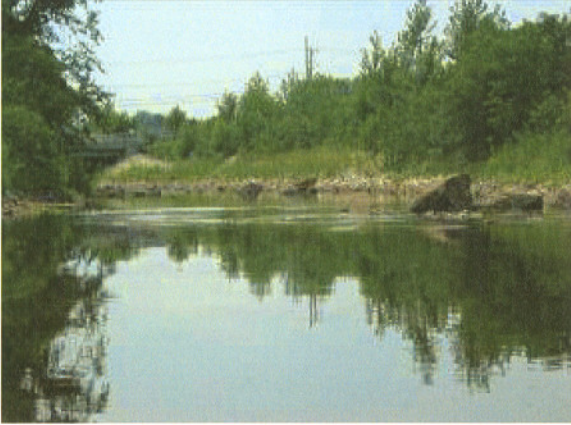
Cell	Aquatic Structures	Armor Stone Condition/General Biological Observations
H2	1. Single boulder	1. Structure appears stable and is providing diversity in habitat 2. Good habitat, variations in velocity around structure producing variations in stream bottom topography
J1	1. Two-boulder cluster 2. Three-boulder cluster 3. Single-boulder	<div style="display: flex; align-items: center;">

<div style="margin-left: 20px; border: 1px solid black; padding: 10px;"> <ol style="list-style-type: none"> <li>1. Structures appear stable and are providing diversity in habitat</li> <li>2. Good habitat, variations in velocity around structures producing variations in stream bottom topography</li> <li>3. Boulders are being used as perches for feeding birds</li> </ol> </div> </div>

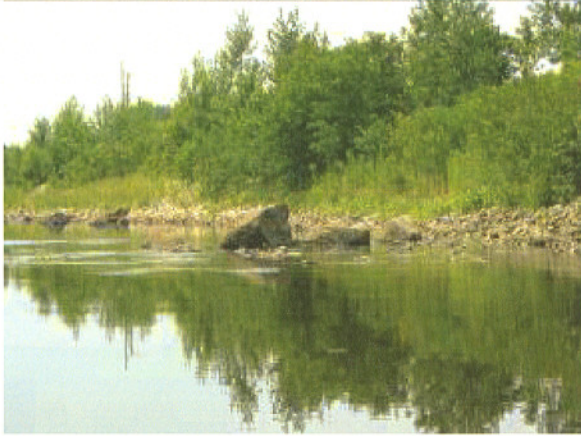
Cell	Aquatic Structures	Armor Stone Condition/General Biological Observations	
J2	1. "J"- boulder formation

<div style="border: 1px solid black; padding: 5px;"> <ol style="list-style-type: none"> <li>1. Structure appears stable and is providing diversity in habitat</li> <li>2. Good habitat, variations in velocity around structure producing variations in stream bottom topography</li> </ol> </div>
I3	1. Single-wing deflector

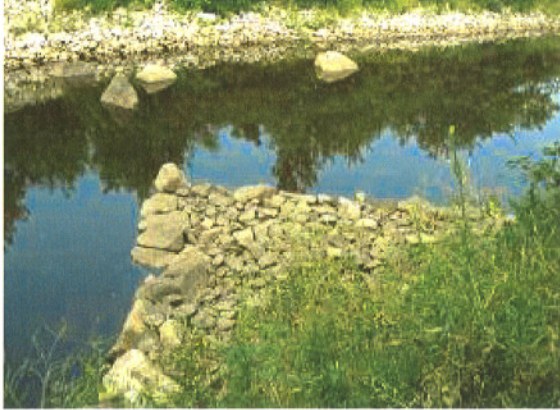
<div style="border: 1px solid black; padding: 5px;"> <ol style="list-style-type: none"> <li>1. Structure appears stable and is providing diversity in habitat</li> <li>2. Good habitat, variations in velocity around structure producing variations in stream bottom topography</li> </ol> </div>

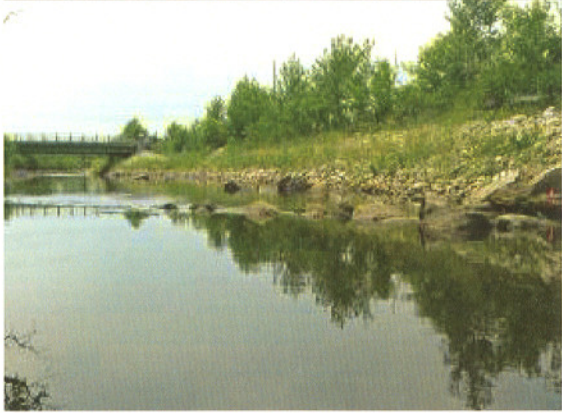
Cell	Aquatic Structures	Armor Stone Condition/General Biological Observations	
I3/J3	1. Vortex rock weir

<div style="border: 1px solid black; padding: 10px;"> <ol style="list-style-type: none"> <li>1. Structure appears stable and is providing diversity in habitat</li> <li>2. Good habitat, variations in velocity around structure producing variations in stream bottom topography</li> </ol> </div>
J3	<ol style="list-style-type: none"> <li>1. Boulder cluster</li> <li>2. Three-boulder cluster</li> <li>3. Three-boulder cluster</li> </ol>

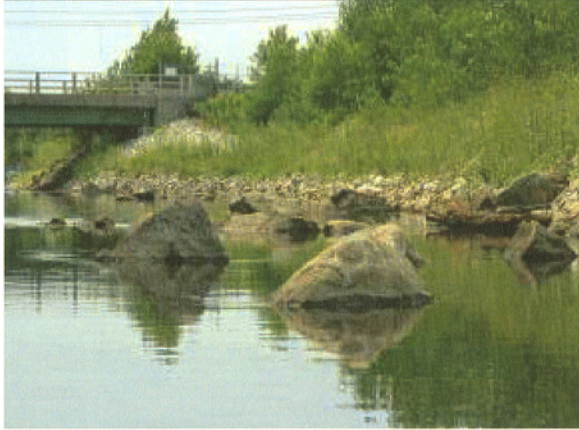
<div style="border: 1px solid black; padding: 10px;"> <ol style="list-style-type: none"> <li>1. Structures appears stable and is providing diversity in habitat</li> <li>2. Good habitat, variations in velocity around structures producing variations in stream bottom topography</li> </ol> </div>
