#### Re: Upper <sup>1</sup>/<sub>2</sub>-Mile Reach of Housatonic River Removal Action Monthly Report – May 2001

# Upper 1/2 –Mile Reach Removal Action Monthly Progress Report: May 2001 Page 3

# Exhibit A - Upper 1/2 Mile Reach Removal Action Sediment and Bank Soil Removal Areas (Cells A-G)

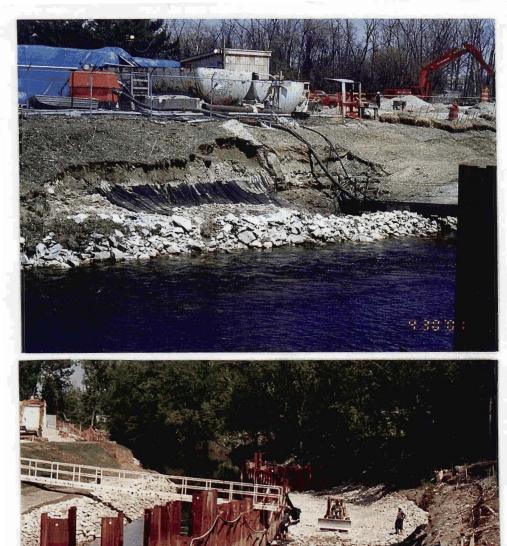
**PHOTO NO. 2**

LOCATION: Cell F3 (Upstream)

DESCRIPTION: River restoration activities.

DATE: May 11, 2001

After the removal activities were completed, restoration efforts began in the upstream river portion of Cell F3. The primary component of the river restoration was installing an isolation cap system. To begin, a geotextile layer was installed over the bottom of the excavation area. The isolation sand layer was placed over the geotextile fabric and compacted to a nominal depth of 12 to 24 inches. After the isolation sand layer was placed, a depth interval sample was collected from the isolation sand for PCB analysis to provide baseline data for the isolation cap monitoring program. Following placement of the isolation sand layer, another layer of geotextile and a layer of geogrid were installed. The stone armor layer was then installed, placing 9- to 12-inch rip-rap on top of the geogrid. This restoration process continued downstream until the entire Cell F3 riverbed was completed. To finish river restoration efforts, habitat enhancement boulders were placed at select locations (with oversight by MEOEA) in the Cell F3 river area. In addition, rip-rap was placed in a depression located outside of Cell F3 along the centerline sheetpile wall.

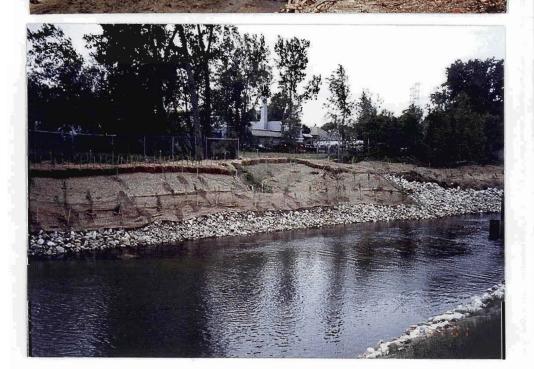
PHOTO NO. 3

LOCATION: Cell F3

DESCRIPTION: Restored bank and Spring 2001 plantings.

DATE: May 31, 2001

During the fourth week of May and following restoration activities in Cell F3, installation of the spring 2001 plantings were initiated on the restored banks of Cells G2, G3, and F3. In accordance with the requirements presented in the Work Plan, both understory and canopy specimens were planted in the three cell areas. In addition, a vine patch was planted upstream near Cell C. These areas, in addition to previous planting areas, will be monitored in accordance with the requirements presented in the Work Plan. After the understory and canopy specimens were planted, a watering system was installed in the planting areas.
