**Re: Upper 1/2-Mile Reach of Housatonic River Removal Action
Monthly Report - July 2001**

Exhibit A - Upper 1/2 Mile Reach Removal Action

Sediment and Bank Soil Removal Areas (Cells H-J)

**½-MILE RIVER REMOVAL ACTION
MONTHLY PROGRESS REPORT
JULY 2001
FIGURE 1: PHOTO DOCUMENTATION**

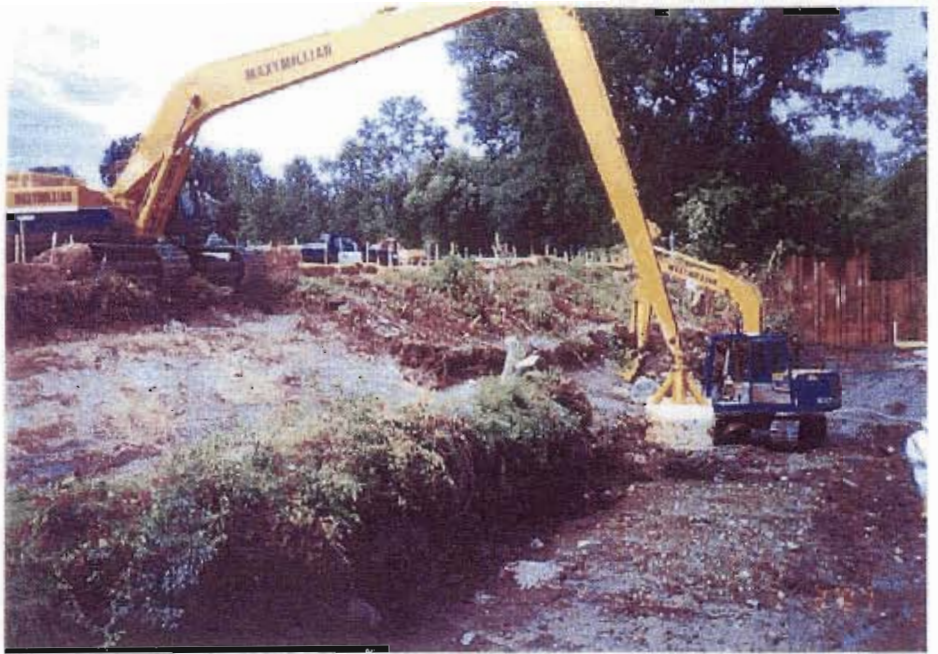
PHOTO NO. 1

LOCATION: Cell H2

DESCRIPTION: Removal activities with clamshell bucket.

DATE: July 3, 2001.

During the first week of July, Cell H2 bank soil and river sediment removal activities were completed. TSCA-sediment and soil removed from the cell was transported by truck on GE-owned property to Building 33X for temporary stockpiling prior to transfer to the Building 71 OPCA. Non-TSCA material removed from the cell was transported by truck (with bills of lading) over public roads to Building 33-north for temporary stockpiling prior to transfer to the Hill 78 OPCA. In addition, the dense non-aqueous phase liquid (DNAPL) encountered (on June 29, 2001) in Cell H2 was addressed. Response actions included an excavation of the affected sediment from that cell. With U.S. Environmental Protection Agency (EPA) approval and oversight, that excavation involved the removal of approximately 62 cubic yards (cy) of NAPL-impacted sediment and, based on visual

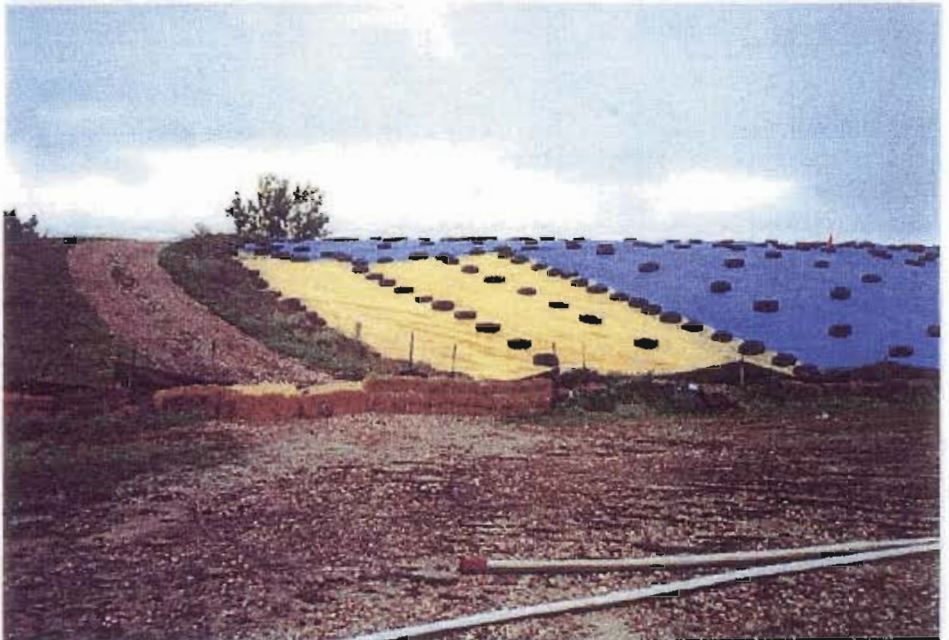
PHOTO NO. 2

LOCATION: Hill 78 OPCA

DESCRIPTION: Consolidated material from the ½ Mile Reach.

DATE: July 10, 2001.

The first week of July ended with completing the soil/sediment transfer to the Hill 78 OPCA. Non-TSCA material stockpiled in Building 33-north was transported via truck to the Hill 78 OPCA for final disposition. The soil/sediment was subjected to a paint filter test prior to transfer to confirm that the material did not contain excess water. The material was loaded into poly-lined trucks and covered with poly-sheets for transportation to the OPCA.

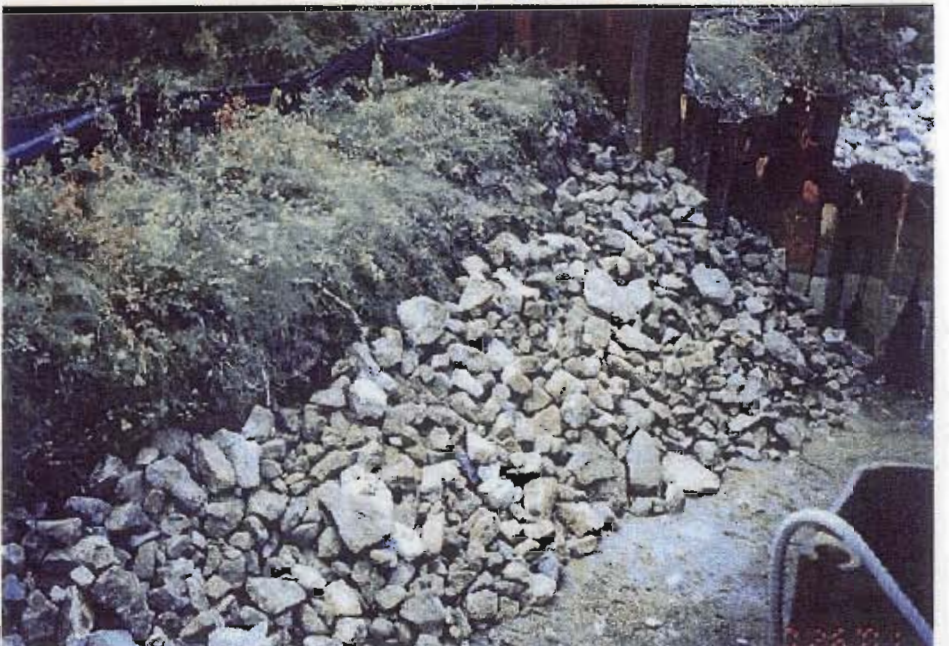
PHOTO NO. 3

LOCATION: Cell 68R1

DESCRIPTION: Rip-rap at toe-of-bank in restored cell.

DATE: July 26, 2001.

During the fourth week of July, Building 68 Area supplemental removal activities continued. Cell 68R1 was initially dewatered by pumping the cell water over the cutoff wall and into the river. Once the water level was six inches above the top of the sediment, the cell water was then pumped to the on-site water treatment system. Following dewatering of the cell, a baseline survey was performed to record existing elevations. Sediment removal activities were completed from the south side of the river using a horizontal-cut clam-shell bucket attached to the arm of an excavator. Sediment was removed to the top of the existing armor stone protective cap. The removed sediment was placed in the dewatering pad to decant excess water. The decanted sediment was then loaded into trucks for transportation to the Building 33 stockpile area. Following removal of the sediment, a post-removal survey was performed to document the extent of removal. Restoration work efforts focused on the undercut bank area and included installing a layer of geotextile and geogrid, and installing rip-rap over the geogrid to backfill the undercut bank area. Following restoration activities, a post-restoration survey was completed to record the final restored bank elevations.
