**Re: Upper ½-Mile Reach of Housatonic River Removal Action (GECD800)
Monthly Report – August 2001**

1.0 Overview:

Exhibit A - Upper 1/2 Mile Reach Removal Action

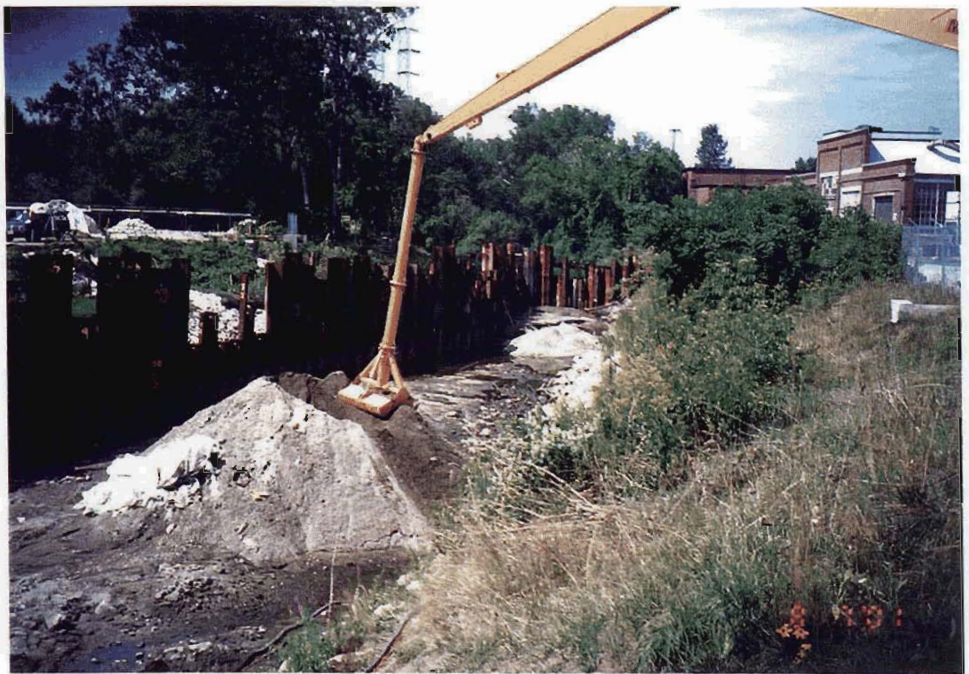
PHOTO NO. 1

LOCATION: Building 68 / Cell 68R2

DESCRIPTION: Supplemental sediment
removal activities.

DATE: August 7, 2001

During the second week of August, Cell 68R2 supplemental removal activities were completed. Cell 68R2 was initially dewatered by pumping the cell water over the cutoff wall and into the river. Once the water level was six inches above the top of the sediment, the cell water was pumped to the on-site water treatment system. Following dewatering of the cell, a baseline survey was performed to record existing elevations. Sediment removal activities were completed from the north side of the river using a horizontal-cut clamshell bucket attached to the arm of an excavator. Sediment was removed to the top of the existing armor stone protective cap. The removed sediment was placed in the Cell 68R2 dewatering pad (on the north side of the river) to decant excess water. The decanted sediment was then loaded into trucks for transportation to the Building 33-north stockpile area.

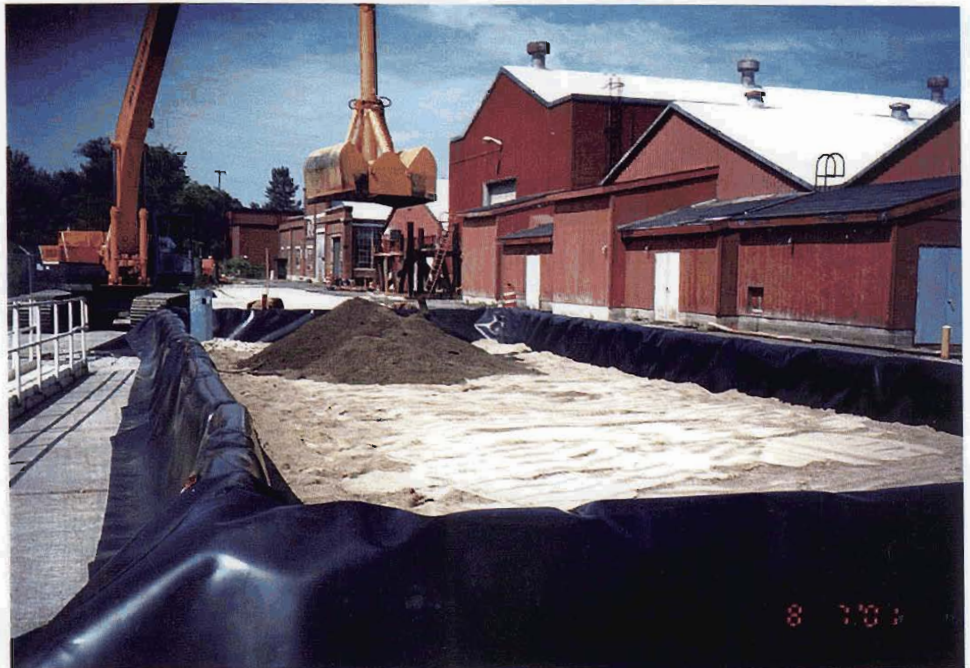
PHOTO NO. 2

LOCATION: Building 68 / Cell 68R2

DESCRIPTION: Dewatering pad.

DATE: August 7, 2001

During the first week of August, work efforts began in the Building 68 Area by constructing a dewatering pad (for the excavated sediment) on the north side of the river. A 60-mil poly-liner was placed over concrete berms and filled with a drainage layer of sand to form the dewatering pad. In addition, upstream and downstream cutoff sheetpile walls were placed, driven, and connected to the existing centerline wall to create Cell 68R2 (on the north side of the river). To minimize delays in the project schedule, the sheetpile walls were installed to encompass both cells H3 and 68R2 with no cutoff wall between the cells.

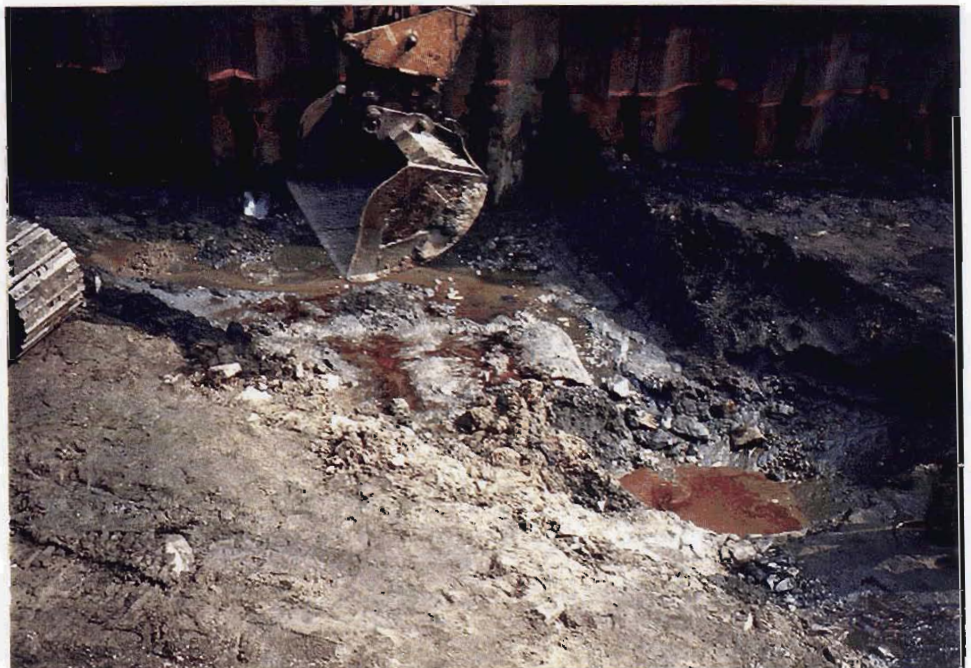
PHOTO NO. 3

LOCATION: Cell H3

DESCRIPTION: DNAPL removal activities.

DATE: August 13, 2001

Also during the second week of August, Cell H3 bank soil and river sediment removal activities were initiated. All material removed from Cell H3 was handled as TSCA-material due to the small amount of non-TSCA material and the corresponding time required to handle this material separately. TSCA-sediment and soil removed from the cell were transferred by truck to Building 33X for temporary stockpiling. During excavation activities on August 8, 2001, a light gray sheen was observed on the surface water within the contained cell, in the downstream part of Cell H3. This observation was verbally reported to EPA, Massachusetts Department of Environmental Protection (MDEP), and the National Response Center (NRC) on the same date (the NRC issued Tracking Number 575791). The following day, August 9, 2001, small droplets of DNAPL were observed on the bottom of the excavation in the middle part of Cell H3. Response actions included placing a berm around the DNAPL and placing oil booms at the pump intake for the water handling system. In addition, an excavation of the affected sediment from Cell H3 was completed. With EPA approval and oversight, that excavation involved the removal of approximately 61 cubic yards (cy) of NAPL-impacted sediment and, based on visual observation, the DNAPL was successfully removed from the river bottom. The excavated sediment was staged in the Cell 68R2 dewatering pad for decanting prior to being characterized for disposal purposes. Following removal activities in Cell H3, post-excavation surveys were completed to confirm removal limits (including the DNAPL area). After the surveys were complete, restoration activities were initiated in Cell H3.
