**Re: Upper ½-Mile Reach of Housatonic River Removal Action
Monthly Report – June 2001**

Exhibit A - Upper 1/2 Mile Reach Removal Action

Sediment and Bank Soil Removal Areas (Cells H-J)

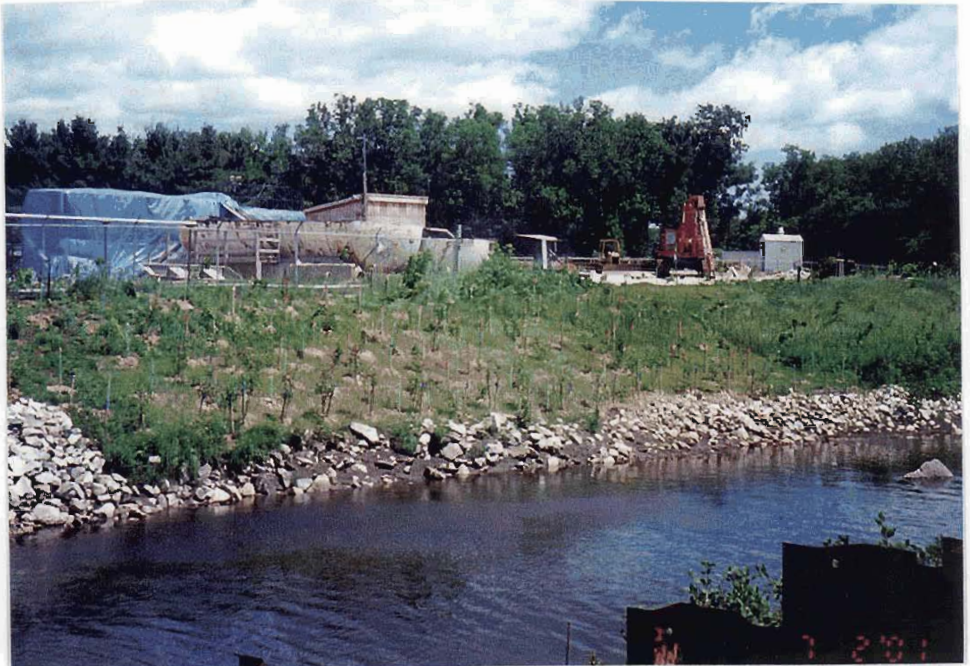
DESCRIPTION: Restored bank erosion area.

DATE: July 2, 2001

During the first week of June, restoration activities for two Cell G3 bank erosion areas identified during the ½-Mile bank inspection (conducted in May) were completed. Restoration efforts for these bank areas included replacing geotextile fabric as needed, placing rip-rap at 1:1 slope areas and at the toe of the bank, placing backfill over the geotextile to the original design elevations, placing and compacting topsoil, and installing grass seed and erosion mats.

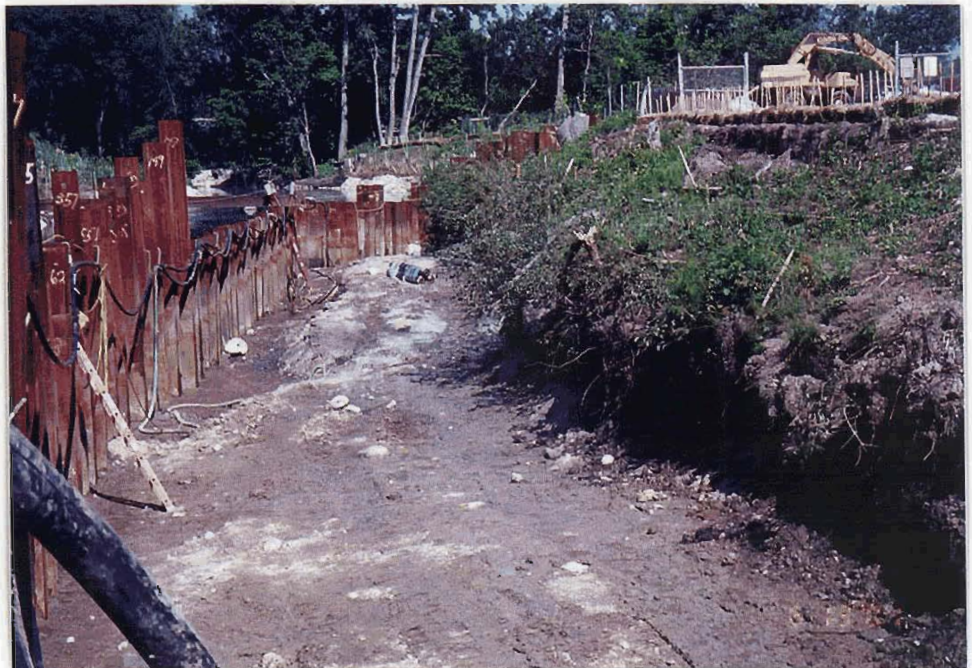
PHOTO NO. 2

LOCATION: Cell H1 (Upstream)

DESCRIPTION: Post-excavation riverbed.

DATE: June 13, 2001

Cell H1 bank soil and river sediment removal activities were also completed during this week. Following removal activities in Cell H1, a post-excavation survey was completed and submitted to EPA and ACE. After the post-excavation survey was completed, small droplets of DNAPL were observed on June 12, 2001, near the centerline sheetpile wall in the middle area of Cell H1 (approximately 1,900 feet downstream from the Newell Street Bridge). On the same date, GE verbally reported this observation to EPA, MDEP, and the NRC (the NRC issued Tracking Number 569223). In response to this observation, an earthen berm was constructed around the area of the DNAPL, and oil-absorbent booms were placed between the DNAPL and the pump intake for the water handling system. A sample of the DNAPL was collected for PCB, VOC, and SVOC analysis.

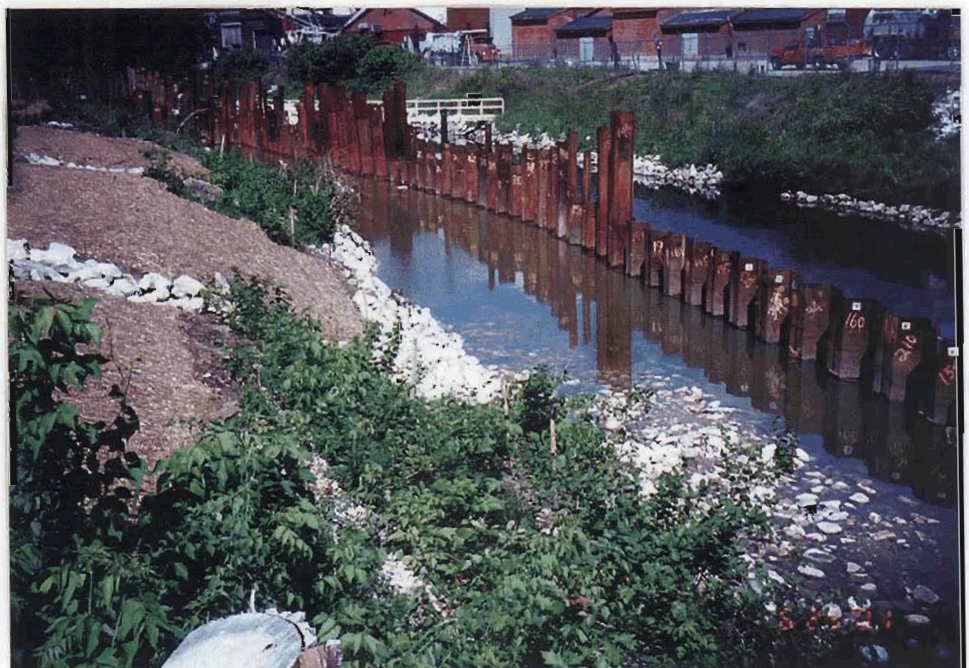
PHOTO NO. 3

LOCATION: Cell H1 (Downstream)

DESCRIPTION: Restored bank and river area.

DATE: June 25, 2001

To begin the third week of June, restoration activities for the Cell H1 river and bank areas were completed. The primary component of the river restoration was installing an isolation cap system. To begin, a geotextile layer was installed over the bottom of the excavation area. The isolation sand layer was placed over the geotextile fabric and compacted to a nominal depth of 12 to 24 inches. Following placement of the isolation sand layer, another layer of geotextile and a layer of geogrid were installed. The stone armor layer was then installed, which consisted of placing 12-inch rip-rap on top of the geogrid. (This armor stone layer consisted of 12-inch rip-rap instead of 9-inch rip-rap, with EPA concurrence, due to potential diverting of the river over this restored area.) This restoration process continued downstream until the entire Cell H1 riverbed was completed. To finish river restoration efforts, seven habitat enhancement boulders were placed at select locations in the Cell H1 river area (with oversight by the Massachusetts Executive Office of Environment Affairs [EOEA]).

Bank restoration activities for Cell H1 included placing rip-rap, backfilling excavation areas, and placing topsoil and grass seed. Rip-rap was placed at the toe-of-the-bank to revised design elevations and at 1:1 bank slope areas. Further up the bank above the rip-rap, the excavation areas were backfilled with soil and compacted. A 6-inch layer of topsoil was placed over the backfill, followed by placement of grass seed and erosion mats to complete the bank restoration activities. In addition, as part of the Cell H1 bank restoration activities, GE restored three additional swales identified by EPA by excavating the swales (as required), placing a geotextile liner over the bottom of the swale, and then placing 12-inch rip-rap in the swale. Excavated material was placed in the Building 33-north (non-TSCA) stockpile area. A post-restoration survey was completed for Cell H1 and was submitted and approved by EPA and ACE.
