**Re: Upper 1/2-Mile Reach of Housatonic River Removal Action
Monthly Report – September 2000**

HOUSATONIC RIVER - UPPER 1/2 MILE REACH REMOVAL ACTION
MONTHLY PROGRESS REPORT: SEPTEMBER 2000

**½ MILE RIVER REMOVAL ACTION
MONTHLY PROGRESS REPORT
SEPTEMBER, 2000
FIGURE 1 PHOTO DOCUMENTATION**

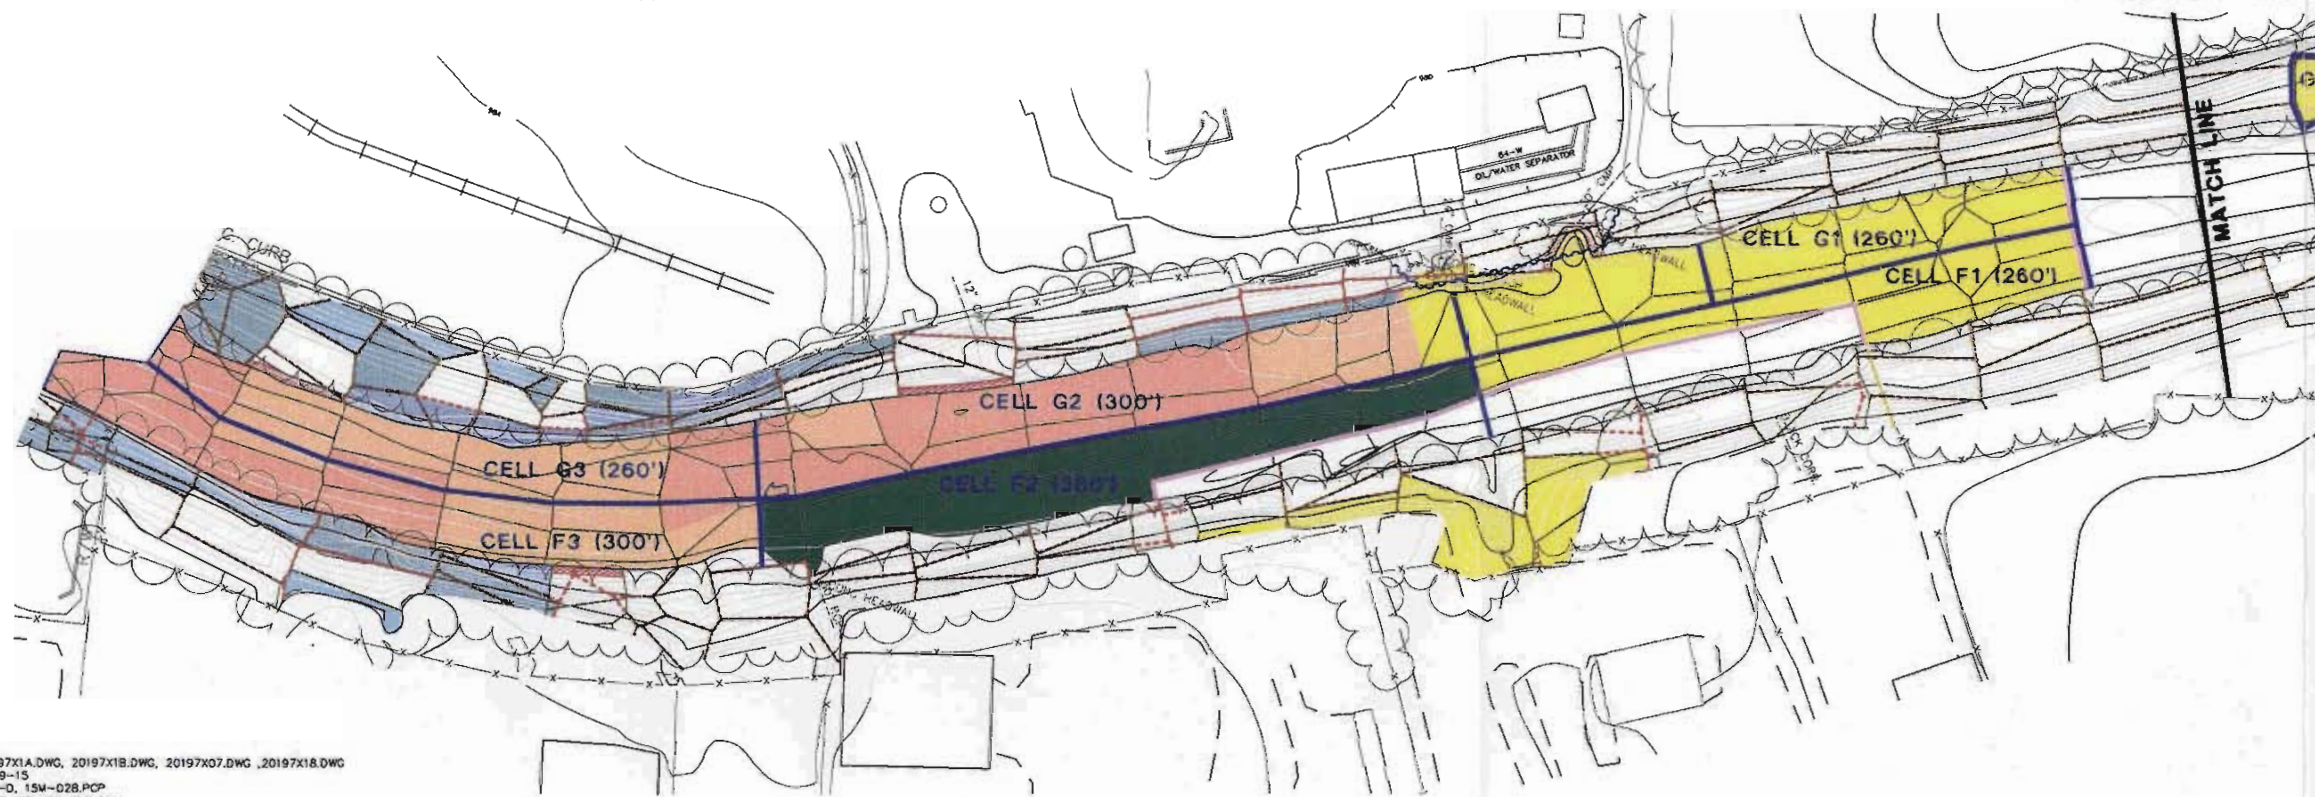
Exhibit A - Upper 1/2 Mile Reach Removal Action

A diagram labeled as Exhibit A shows the location of the Cells (A, B, C, D, E, F, and G) and is attached to this report for reference.

Sediment and Bank Soil Removal Areas (Cells A-G)

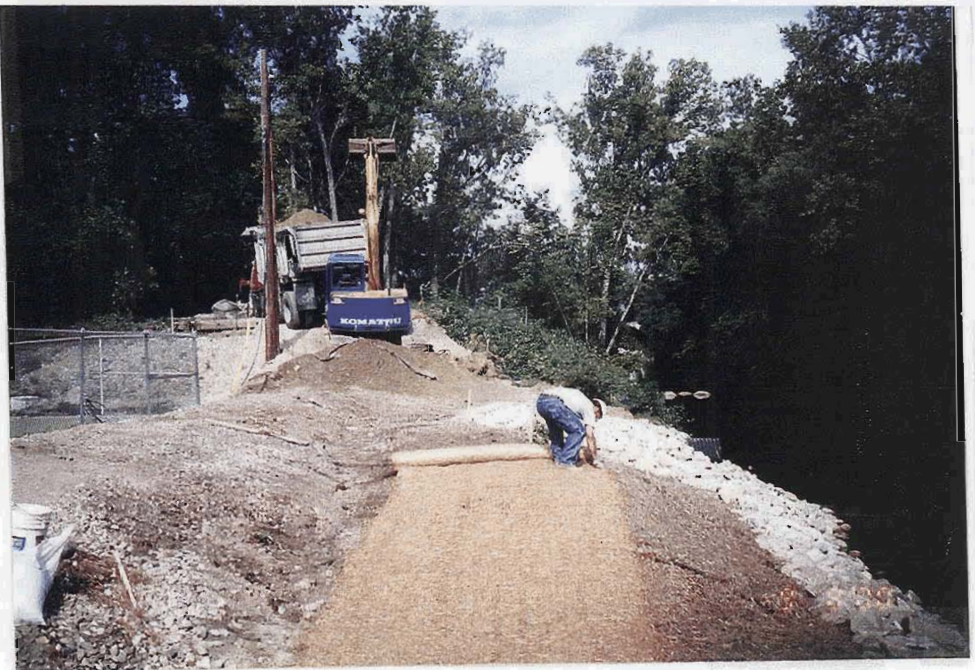
PHOTO NUMBER: 1

PHOTO LOCATION: Cell G-1/G-2
Bank area, north side of river looking upstream.

PHOTO DESCRIPTION:
Final grading. Removal of access roads
and staging areas followed by planting

At the beginning of September, the downstream sheetpile cutoff wall dividing Cell G-1 from Cell G-2 was lowered to allow flow on the north side of the river, and the upstream cutoff wall and center line of sheetpile were removed from Cell G-1/G-2. The final backfilling and grading were also completed along the upper bank area adjacent to Cell G-1/G-2, and the access roads and staging areas were removed from the area adjacent to Cell G-1/G-2.

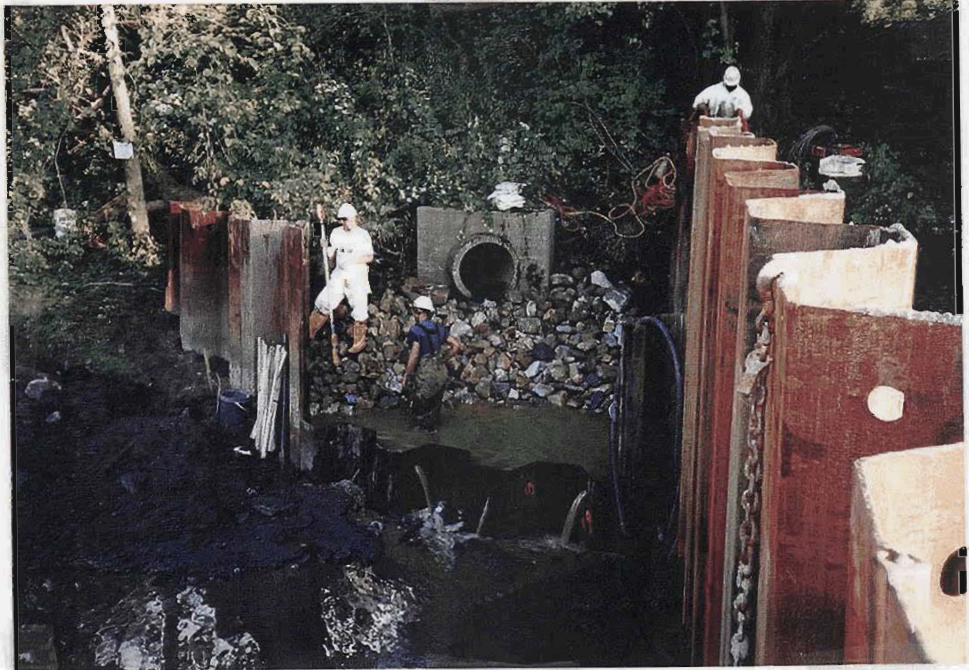
PHOTO NUMBER: 2

PHOTO LOCATION: Cell F-2 (downstream).

PHOTO DESCRIPTION:
Additional sheetpile installed to divert stormwater
Area was excavated and restored separately.

On September 11, 2000, while additional sheetpiling was being installed in the downstream portion of Cell F-2 to temporarily divert the discharge from Outfall 13 away from the cell, a thin rainbow-colored oil sheen along with small pockets of dense non-aqueous-phase liquid (DNAPL) were observed in the downstream portion of Cell F-2. The volume of DNAPL was insufficient for sampling. GE promptly reported this observation to the National Response Center (NRC), EPA, and MDEP. The NRC issued a tracking number 541755 for this release. MDEP did not issue a tracking number. Additionally on September 13, 2000, during a period of high flow, a thin rainbow-colored oil sheen was observed in the flowing section of river (north side) adjacent to Cell F-2. GE promptly reported this observation to the NRC, EPA, and MDEP. The NRC issued a tracking number 541966 for this release. MDEP did not issue a tracking number.

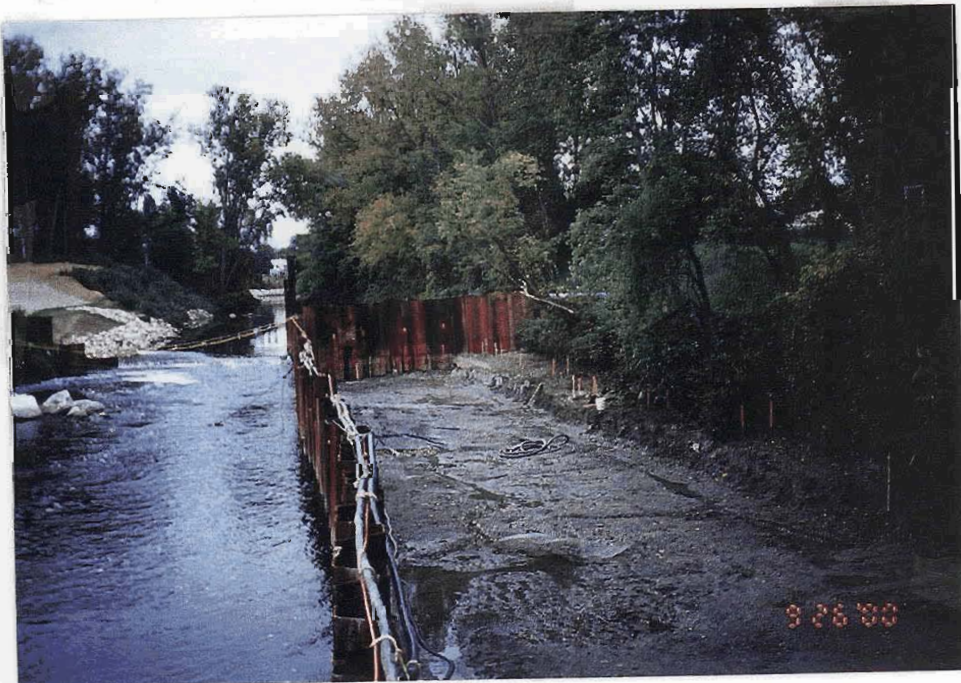
PHOTO NUMBER: 3

PHOTO LOCATION:
Cell F-2 looking upstream.

PHOTO DESCRIPTION: Cell F-2
Sediment excavation complete.

The upstream and downstream cutoff sheetpile walls were then installed in Cell F-2, and that cell was dewatered (utilizing the 500,000 gallon storage tank). Excavation was then initiated in Cell F-2. This excavation was slowed by stormwater discharging directly into the cell from a newly constructed swale at the upstream end of the cell and from Outfall 13 located in the downstream part of the cell. With EPA approval, GE implemented a plan to temporarily divert these two sources away from the cell and into the river through the use of a 12" pipe at the upstream location and installation of additional sheetpiling at Outfall 13. These water diversion measures worked effectively, and excavation in Cell F-2 was completed on September 25, 2000.
