**Re: Upper 1/2-Mile Reach of Housatonic River Removal Action
Monthly Report - April 2001**

In accordance with the approved Removal Action Work Plan - Upper 1/2 Mile Reach of Housatonic River, enclosed please find the April 2001 Monthly Report.

**½-MILE RIVER REMOVAL ACTION
MONTHLY PROGRESS REPORT
APRIL 2001
FIGURE 1: PHOTO DOCUMENTATION**

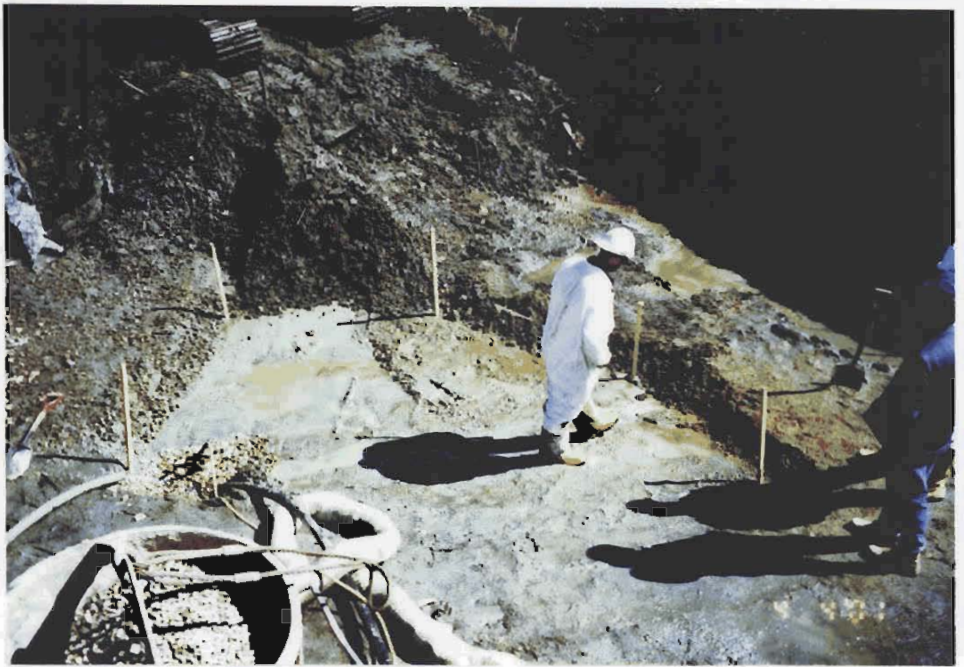
PHOTO NO. 1

On April 4, 2001, during excavation work in the downstream part of Cell F3, DNAPL was again observed in that cell in the form of a couple of small pools of DNAPL located near the previous location of DNAPL observed on March 27, 2001 (approximately 1,700 feet downstream from the Newell Street Bridge). On April 5, as a further supplement to its prior notification regarding the DNAPL in Cell F3, GE verbally reported this observation to EPA, MDEP, and the NRC (which issued release tracking number 561980), including a notification that the PCBs in this DNAPL could potentially exceed the Reportable Quantity. In response to this observation, an earthen berm was constructed around the area of the DNAPL, and oil-absorbent booms were placed between the DNAPL and the pump intake for the water handling system. GE conducted a relatively shallow further excavation in the area of the DNAPL in an effort to remove the DNAPL. With EPA approval and oversight, that excavation involved the removal of

approximately 8 cubic yards (cy) of NAPL-containing sediment and, based on visual observation, successfully removed the DNAPL from the river bottom. The excavated sediment was transported to the Building 65 containment area for staging prior to being characterized for disposal purposes. The excavation was then backfilled with washed stone to address the presence of small boils and stabilize the excavation area.

LOCATION: Cell F3 (Downstream)

DESCRIPTION: DNAPL Removal Area

DATE: April 4, 2001

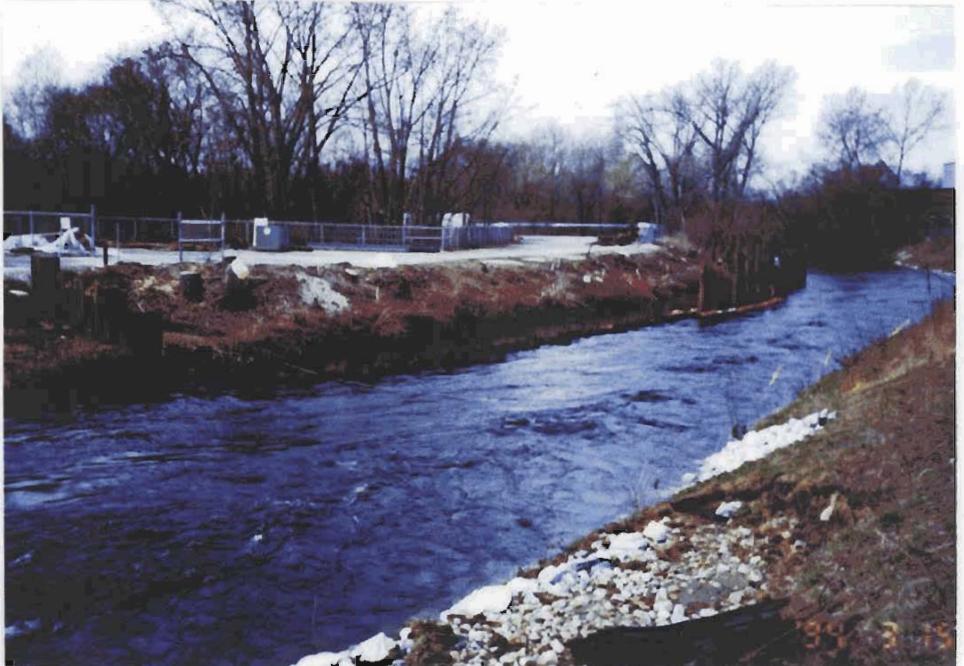
PHOTO NO. 2

Over the course of the weekend of April 7-8, the combination of heavy rains, warm temperatures, and snow melt caused the river to rise substantially. On Sunday, April 8, the rising waters overtopped the sheetpiling at Cell F3 and flooded that cell. Rain continued through April 10, when the river flow exceeded 1,000 cfs. On that date, GE notified EPA and MDEP that this flooding could potentially constitute a force majeure event under the Consent Decree. Further, in response to this high-flow event, Cell G2 NAPL monitoring wells were monitored on April 11 and NAPL was not observed. In addition, Cells G2 and G3 recovery wells were to be monitored, but were submerged below the flooded river and could not be accessed. The river flow continued to overtop the cell during the week of April 9 – April 13.

LOCATION: Cell H1

DESCRIPTION: Flood conditions

DATE: April 12, 2001

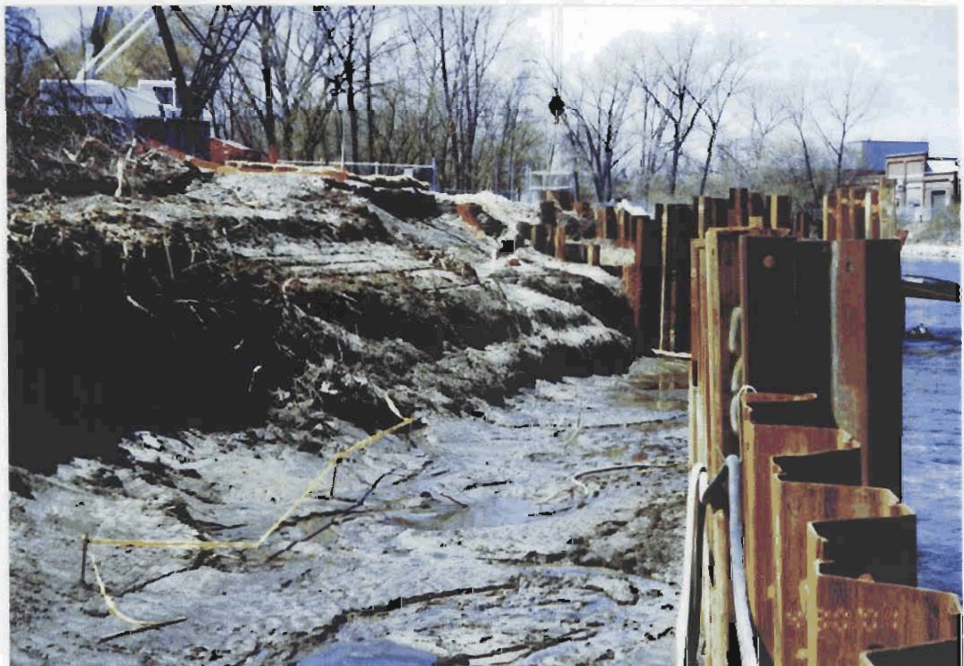
PHOTO NO. 3

During the week of April 23, the river flow continued to decrease and dewatering of Cell F3 was initiated on April 27 in response to river flow dropping below the sheetpiling. The Cell F3 work area was inspected for areas of erosion and possible presence of DNAPL following dewatering of cell. Based on the inspection, no significant erosion was noted and NAPL was not observed. The month ended with the re-initiation of removal activities in Cell F3.

LOCATION: Cell F3 (Downstream)

DESCRIPTION: Dewatered cell
after flood

DATE: April 30, 2001
