**Re: Upper 1/2-Mile Reach of Housatonic River Removal Action
Monthly Report - March 2000**

GENERAL ELECTRIC COMPANY
 PITTSFIELD, MASSACHUSETTS
REMOVAL ACTION
 UPPER 1/2-MILE REACH OF HOUSATONIC RIVER
EXHIBIT B
 APPROXIMATE DNAPL REMOVAL AREA

**½ MILE RIVER REMOVAL ACTION
MONTHLY PROGRESS REPORT
MARCH, 2000
FIGURE 1 PHOTO DOCUMENTATION**

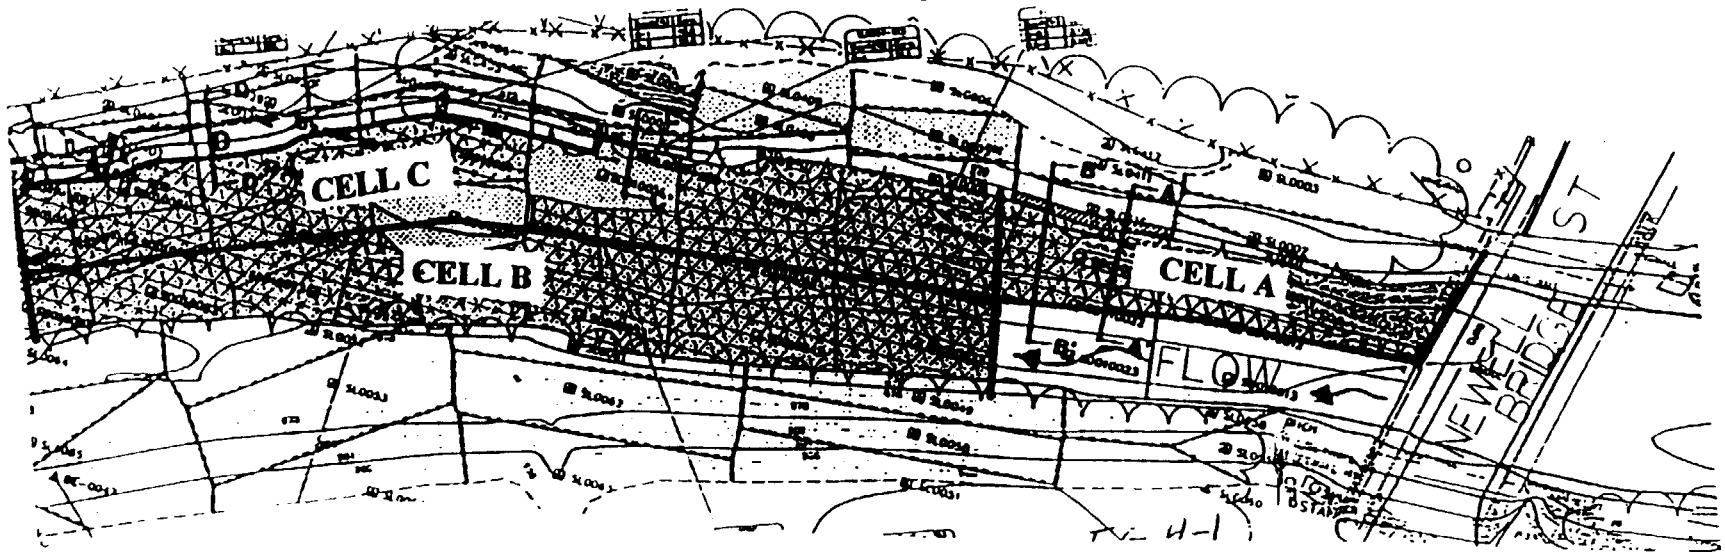
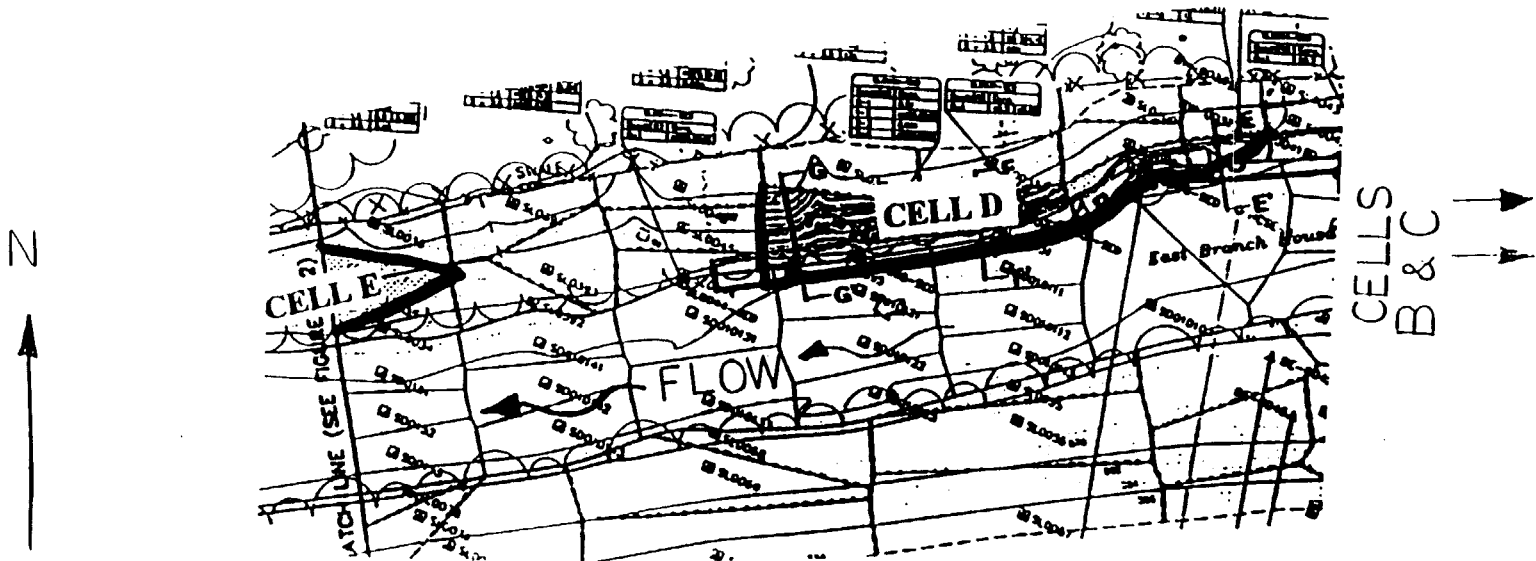
EXHIBIT A
UPPER 1/2 MILE REACH REMOVAL ACTION
LOCATION OF CELLS A, B, C, D and E FOR THE UPSREAM SECTION

A diagram labeled as Exhibit A shows the location of the Cells (A, B, C, D and E) and is attached to this report for reference. Additionally, Exhibit B shows the area where DNAPL may exist based on the results of the DNAPL investigation conducted by GE.

Refer to the diagram (Exhibit A) referenced in Section 4.0 and attached to this report for an orientation of the sheetpile cells and their respective locations. In the month of March, GE Bldgs. 33X and 65 were used as temporary storage facilities for TSCA and non-TSCA material.

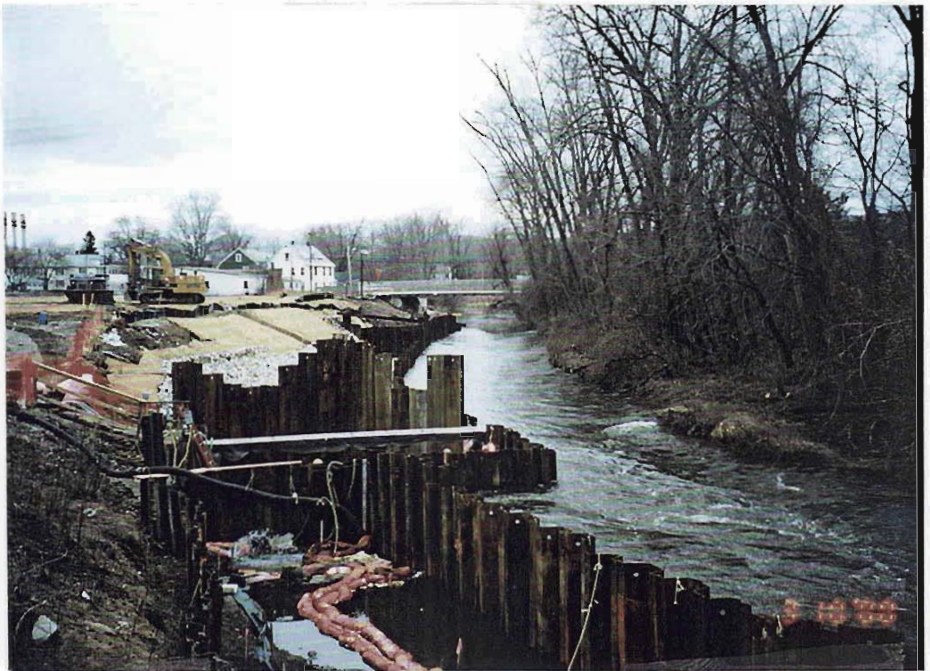
PHOTO NUMBER: 1

PHOTO LOCATION: Cell C
Looking east, upstream.

PHOTO DESCRIPTION: Cell C and Cell D during a rain event on March 10, 2000

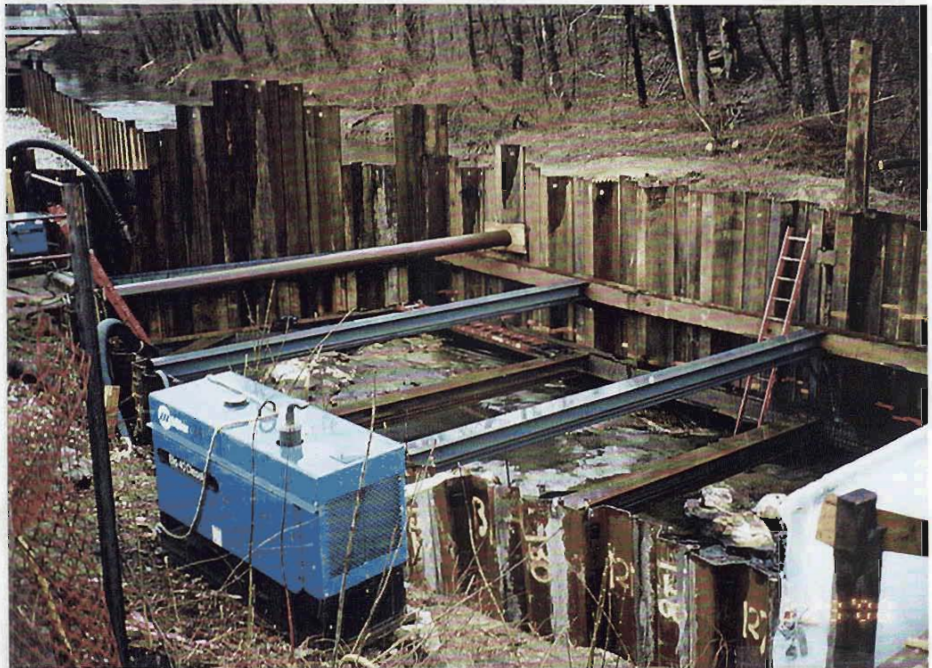
PHOTO NUMBER: 2

PHOTO LOCATION: From North bank.
Looking southeast into the DNAPL Cell.

PHOTO DESCRIPTION
Double water perimeter bracing is complete.
Pipe has been installed to divert flow from the outfall to the river.

Approximately 85 feet of 30 foot long sheetpile were installed along the western (downstream) edge and the southern (river) edge of the newly isolated DNAPL Cell. The existing sheetpile that had defined the Cell C and Cell D interface in this area was removed. A pipe was installed to divert surface runoff flowing through an outfall and allow the water to discharge into the river through a sealed frame constructed through the sheetpile wall (see photos). Based on the amount of DNAPL in the DNAPL cell and the need to increase pumping rates during the excavation (to provide "dry" conditions), a 500,000 gallon settling tank was constructed to allow significant amounts of DNAPL and water to separate prior to treatment via Bldg. 64 G. Construction and piping to this prefabricated tank was completed on March 31, 2000.

The excavation to remove DNAPL down to elevation of 960 feet required a double waler perimeter bracing system. This system was designed, revised and installed within the DNAPL cell. Bracing was completed on March 28, 2000. The installation of the lower steel brace required a limited amount of excavation within the DNAPL cell. After this activity was completed, DNAPL and a corresponding oil sheen was observed on March 24, 2000. This observation was promptly report to EPA, MDEP and the NRC. The NRC provided a release tracking number (524007). MDEP did not issue a new release tracking number.

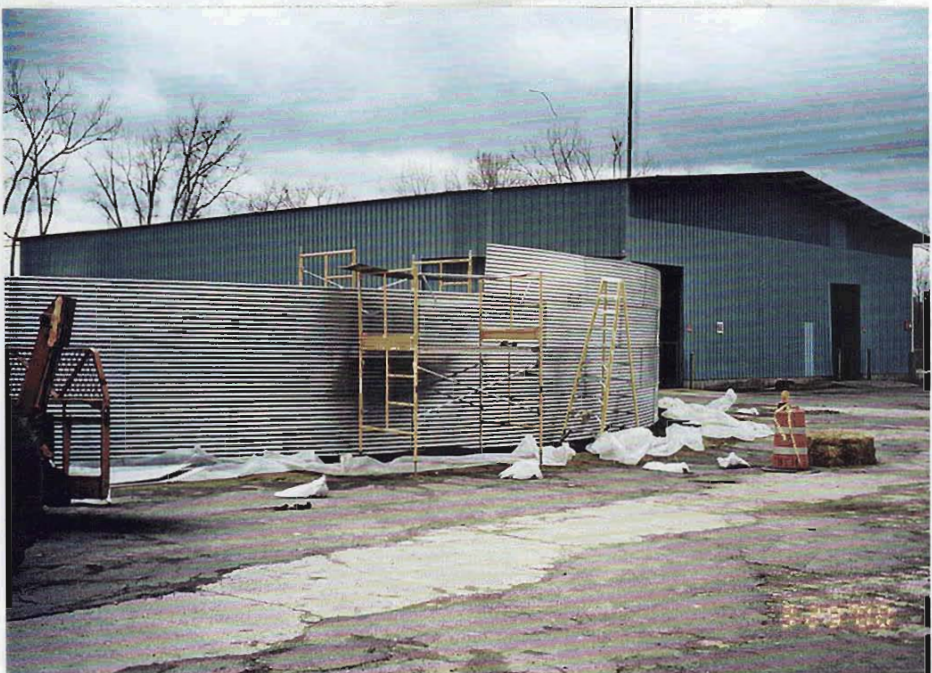
PHOTO NUMBER: 3

PHOTO LOCATION: Bldg. 68 area, near
staging point for water handling operations

PHOTO DESCRIPTION
Construction of a large steel settling tank
(500,000 gallons) to allow oil to separate
from the "cleaner" water prior to treatment.
